Bridge Number : 55C0093
Facility Carried: BROOKHURST STREET
Location : AT MCFADDEN AVENUE
City : WESTMINSTER
Inspection Date : 04/06/2019

Bridge Inspection Report

STRUCTURE NAME: EAST GARDEN GROVE-WINTERSBURG CHANNEL

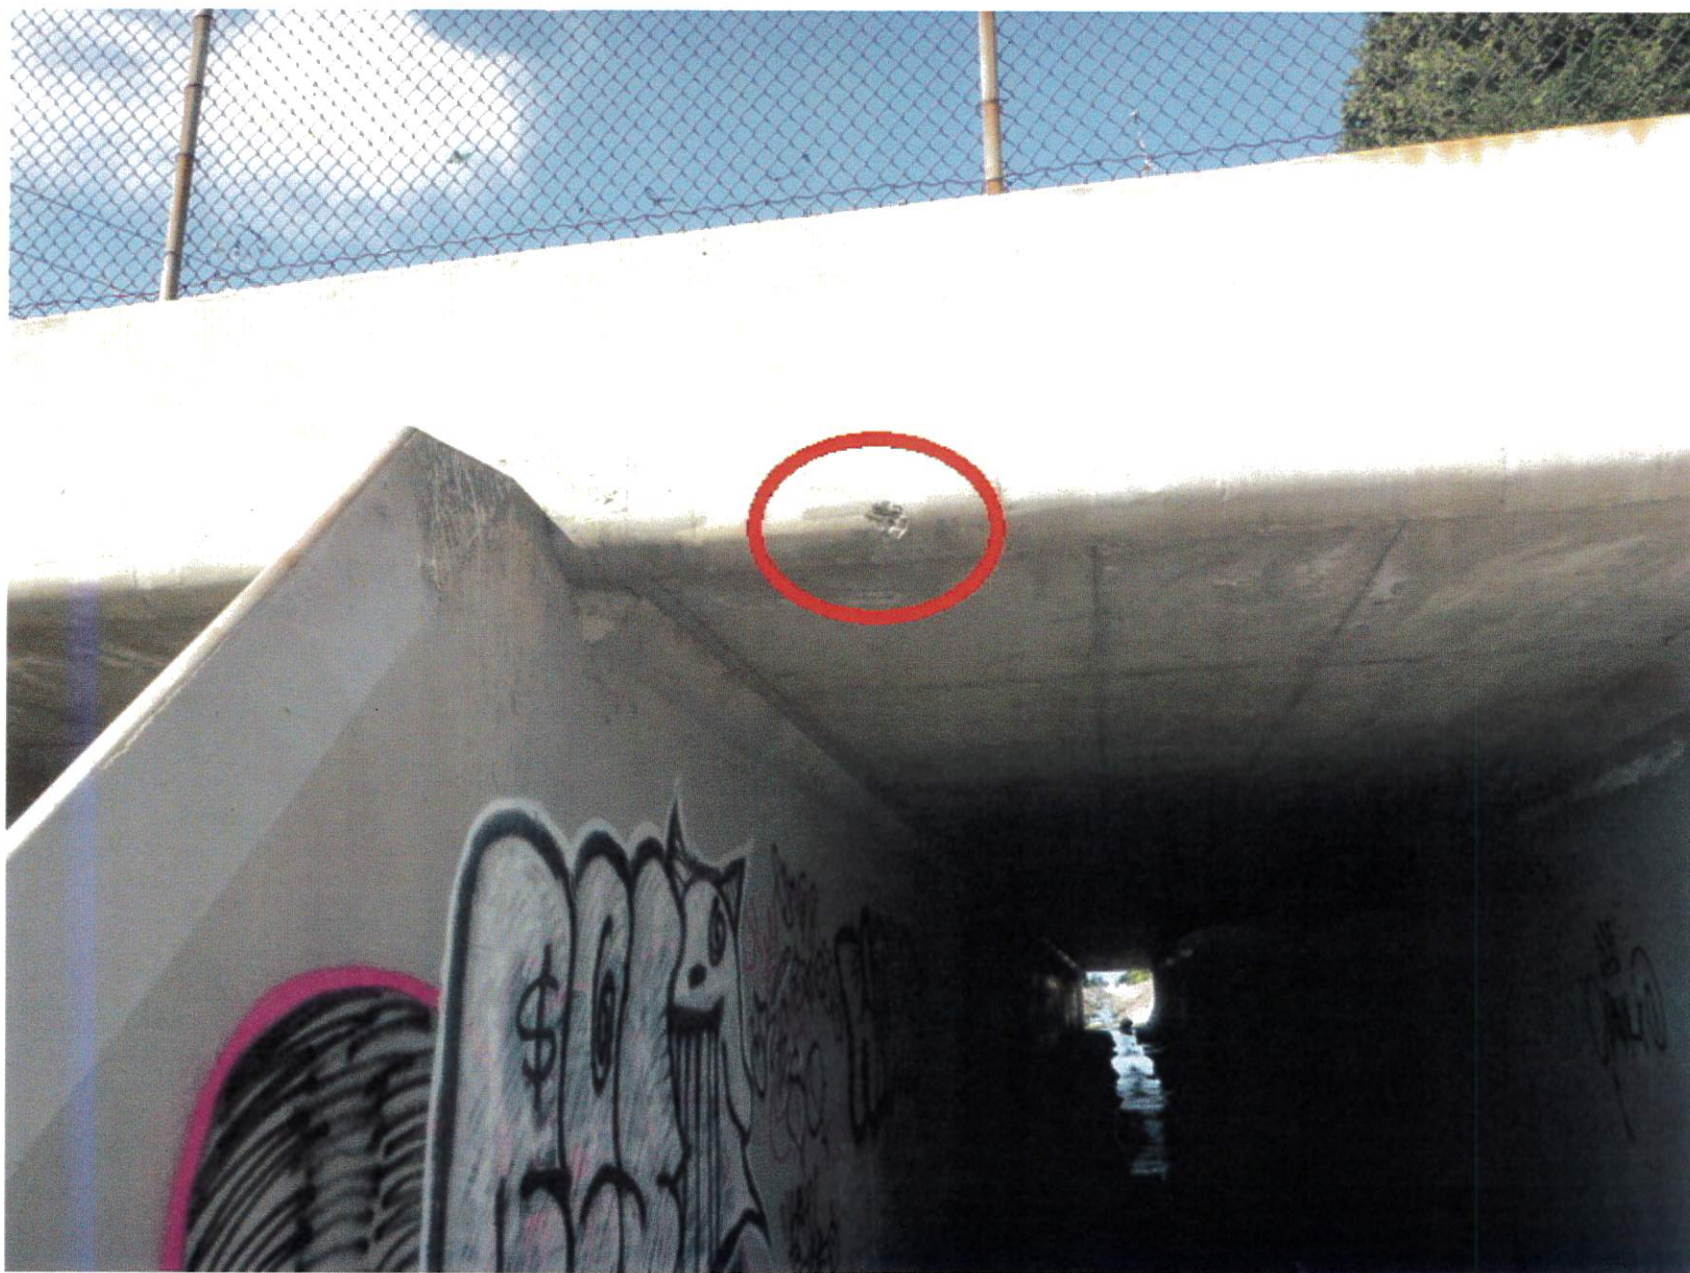
The culvert soffit of barrel #1 has a spall at (4.0 inches L X 4.0 inches W X 1.0 inch D) with exposed rebar and rusted at east end (see the attached photo no. 3).

Photo No. 3
Spall at the east end of barrel 2.

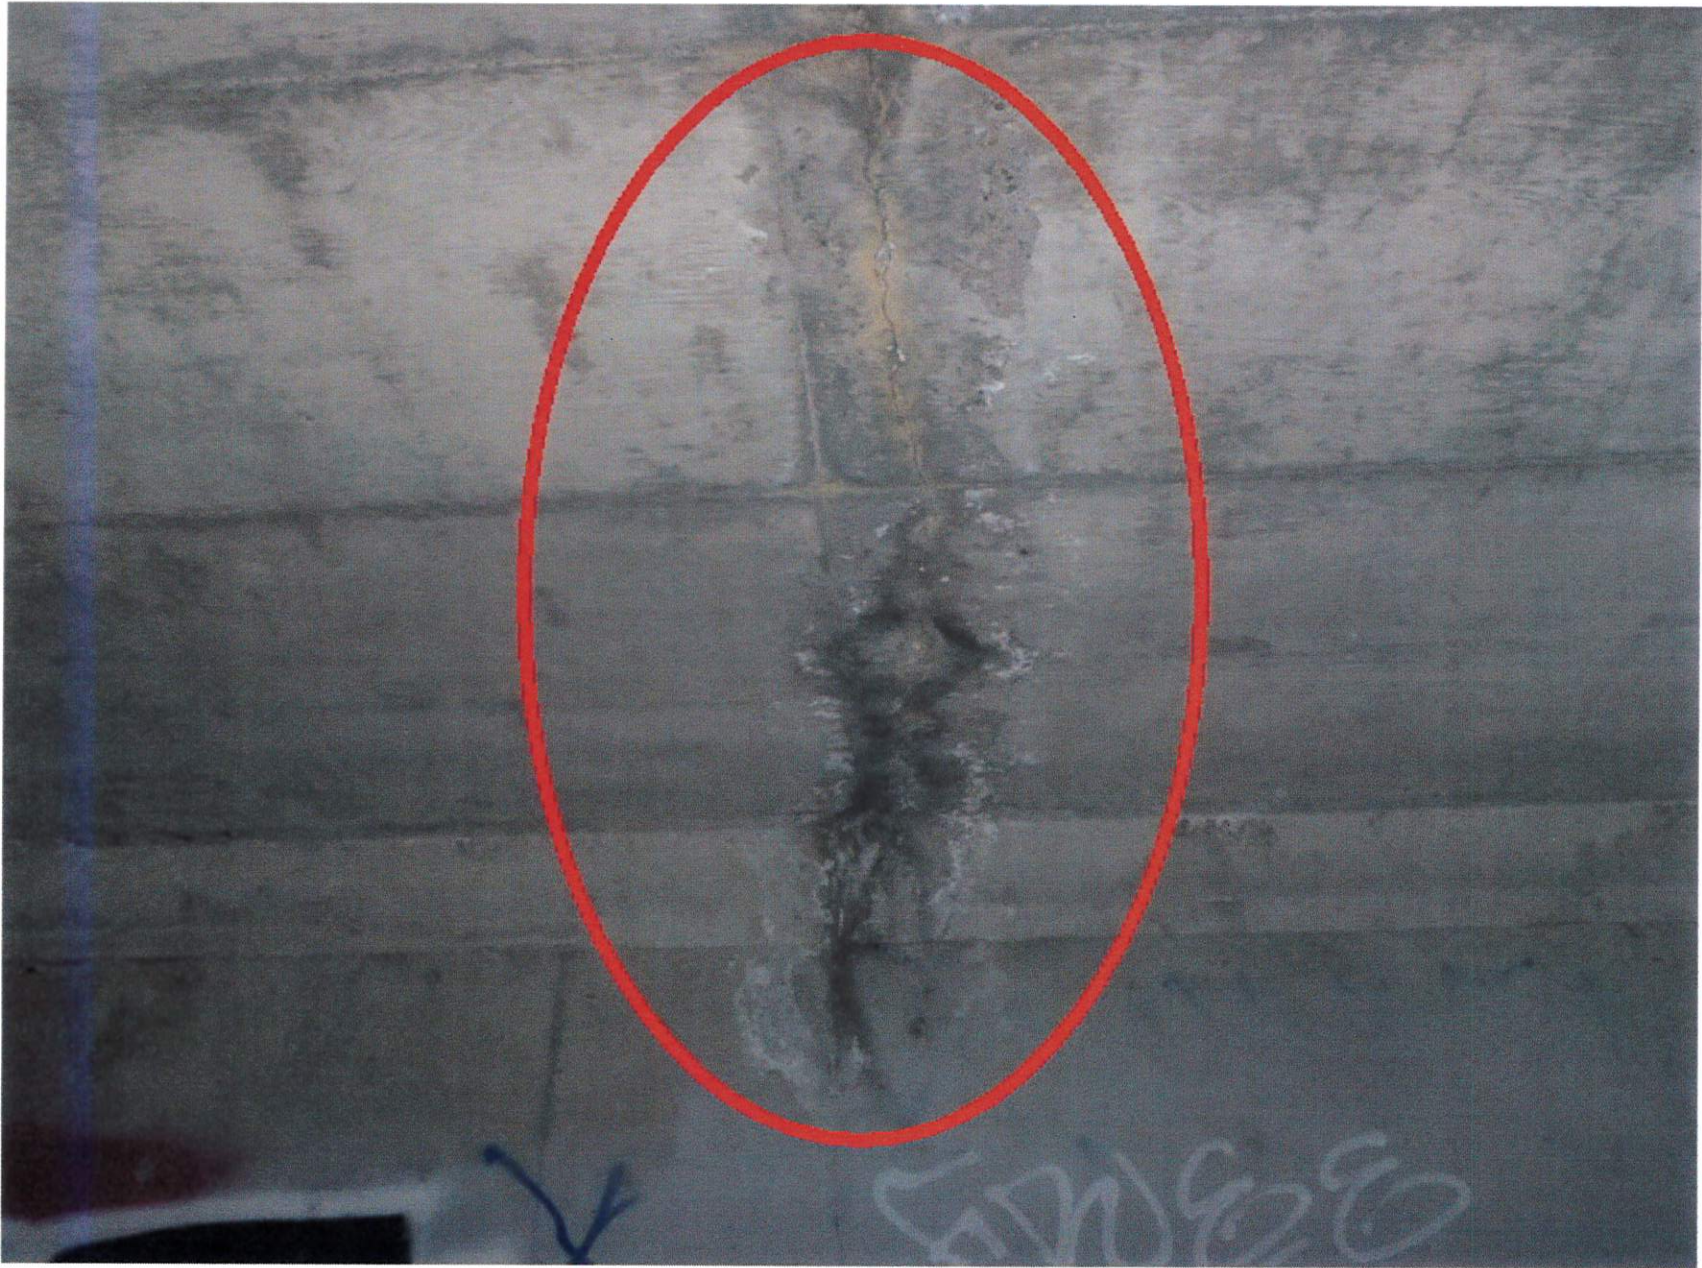
The culvert soffit of barrel #1 and #2 have random longitudinal cracks, up to 0.08 inches wide with efflorescence. These wide cracks are visible at 50.0 feet from east end at barrel #1 (see the attached photos no. 1 and 2).

Photo No. 2
Soffit cracks 0.08 inches wide with efflorescence.

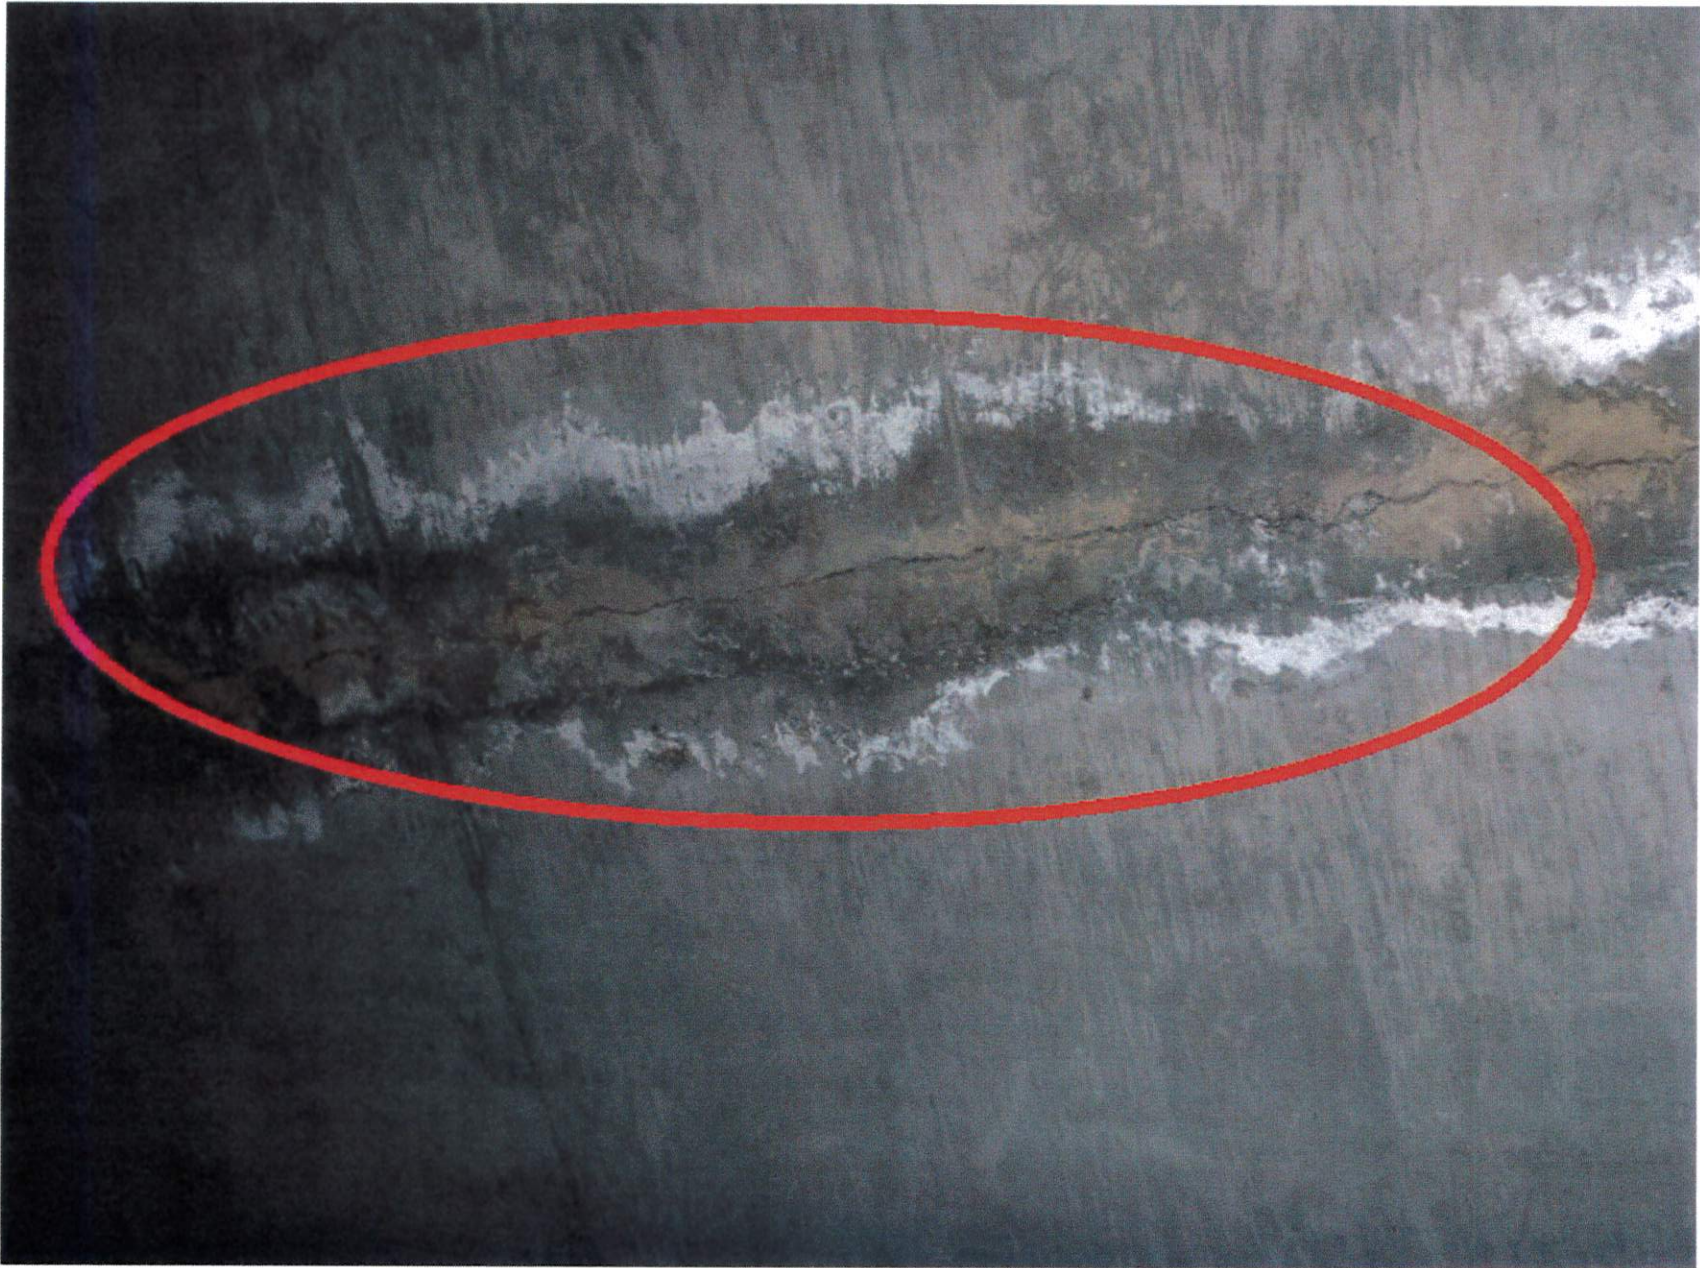
Photo No. 1
Soffit cracks 0.08 inches wide with efflorescence.
