Bridge Number : 55C0135
Facility Carried: GOLDEN WEST ST
Location : 0.1 MI S ROUTE 1-405
City : WESTMINSTER
Inspection Date : 04/06/2019

Bridge Inspection Report

STRUCTURE NAME: WESTMINSTER CHANNEL

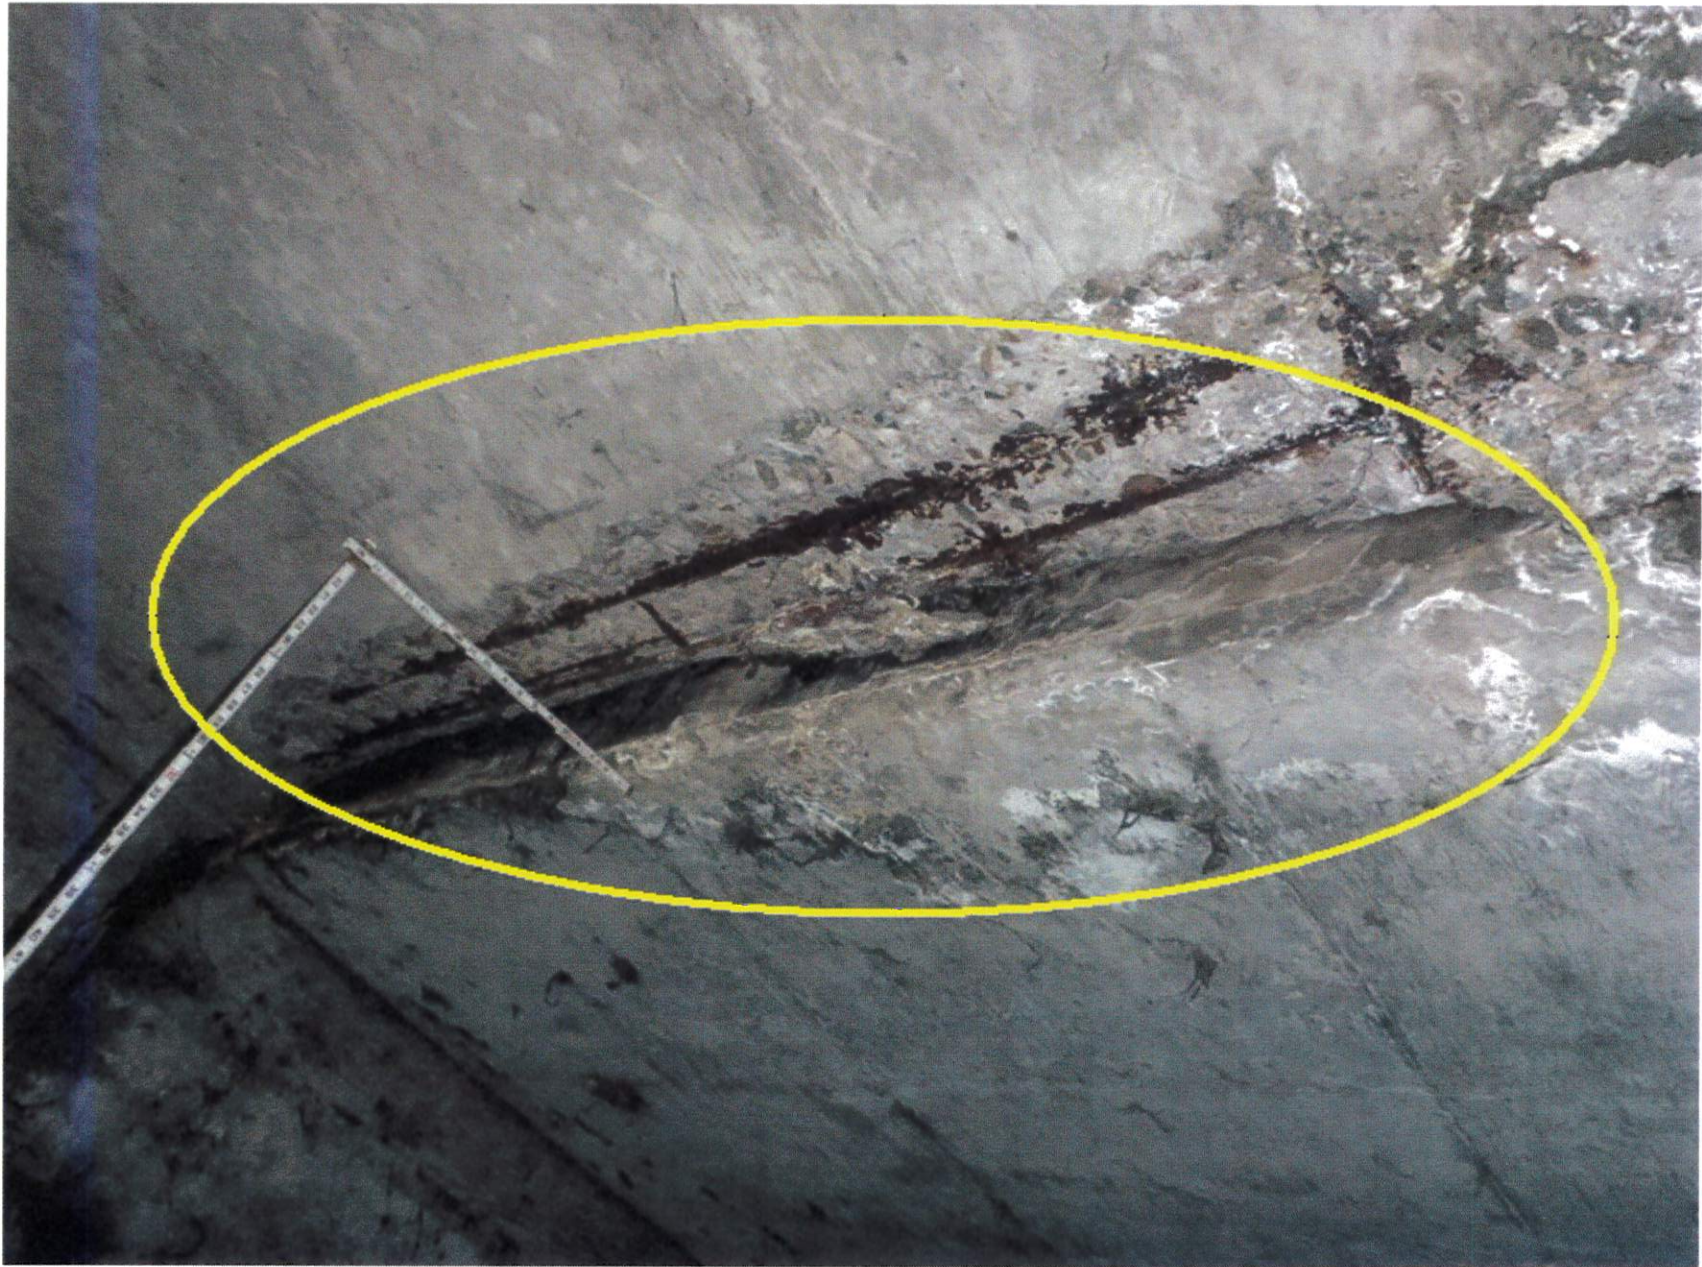
The soffit of barrel #2 has a spall at (1.5 feet L X 8.0 feet W X 2.0 inches D) with exposed and corroded rebars about 60.0 feet from the west end (see the attached photos no. 3).

Photo No. 3
Spall 1.5 ft X 8 ft at soffit of barrel 1 at 60 feet from west end.

Patch all the spalls at the soffit of culvert and the walls.

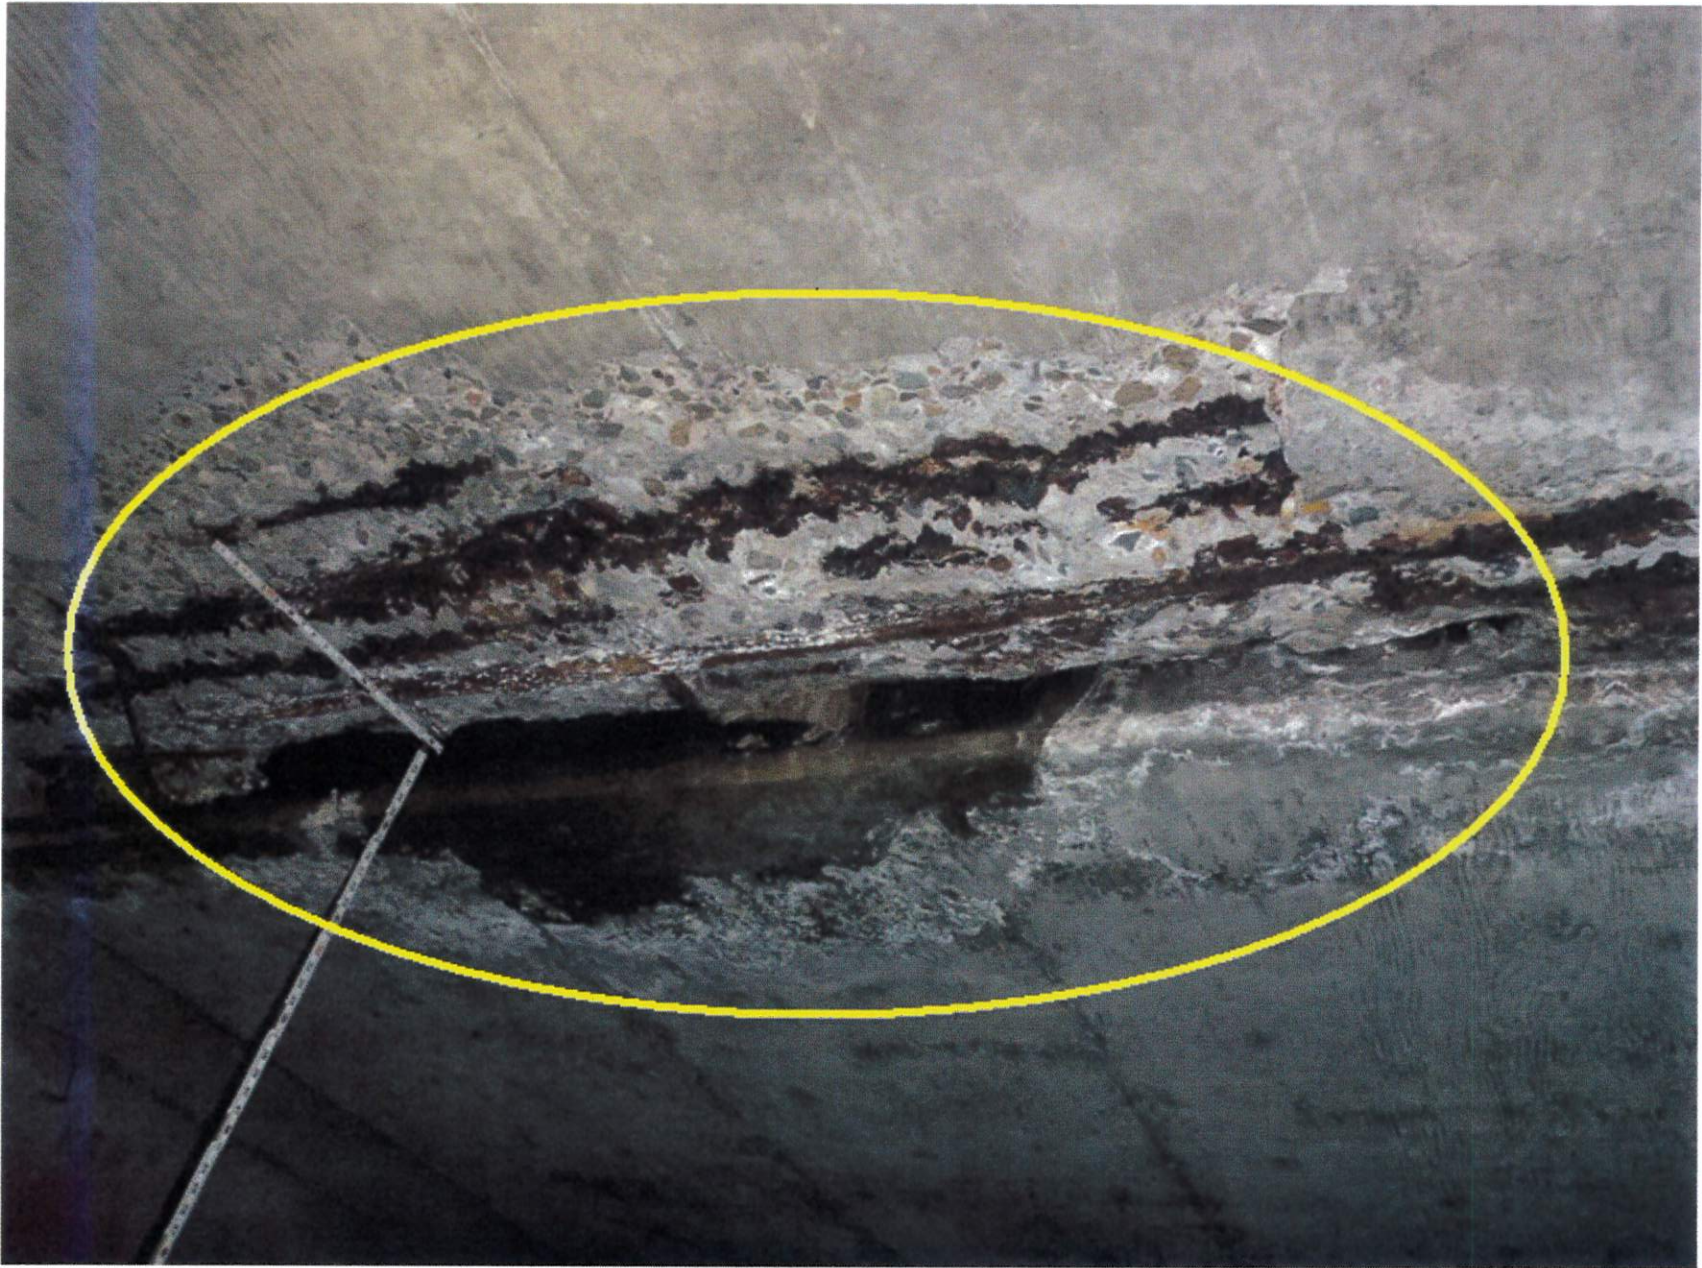
The soffit of barrel #1 has a spall (2.5 feet L X 12.0 feet W X 2.0 inches D) with exposed and corroded rebars about 60.0 feet from the west end (see the attached photos no. 1 and 2).

Photo No. 2
Spall 2.5 ft X 12 ft at soffit of barrel 1 at 60 feet from west end.

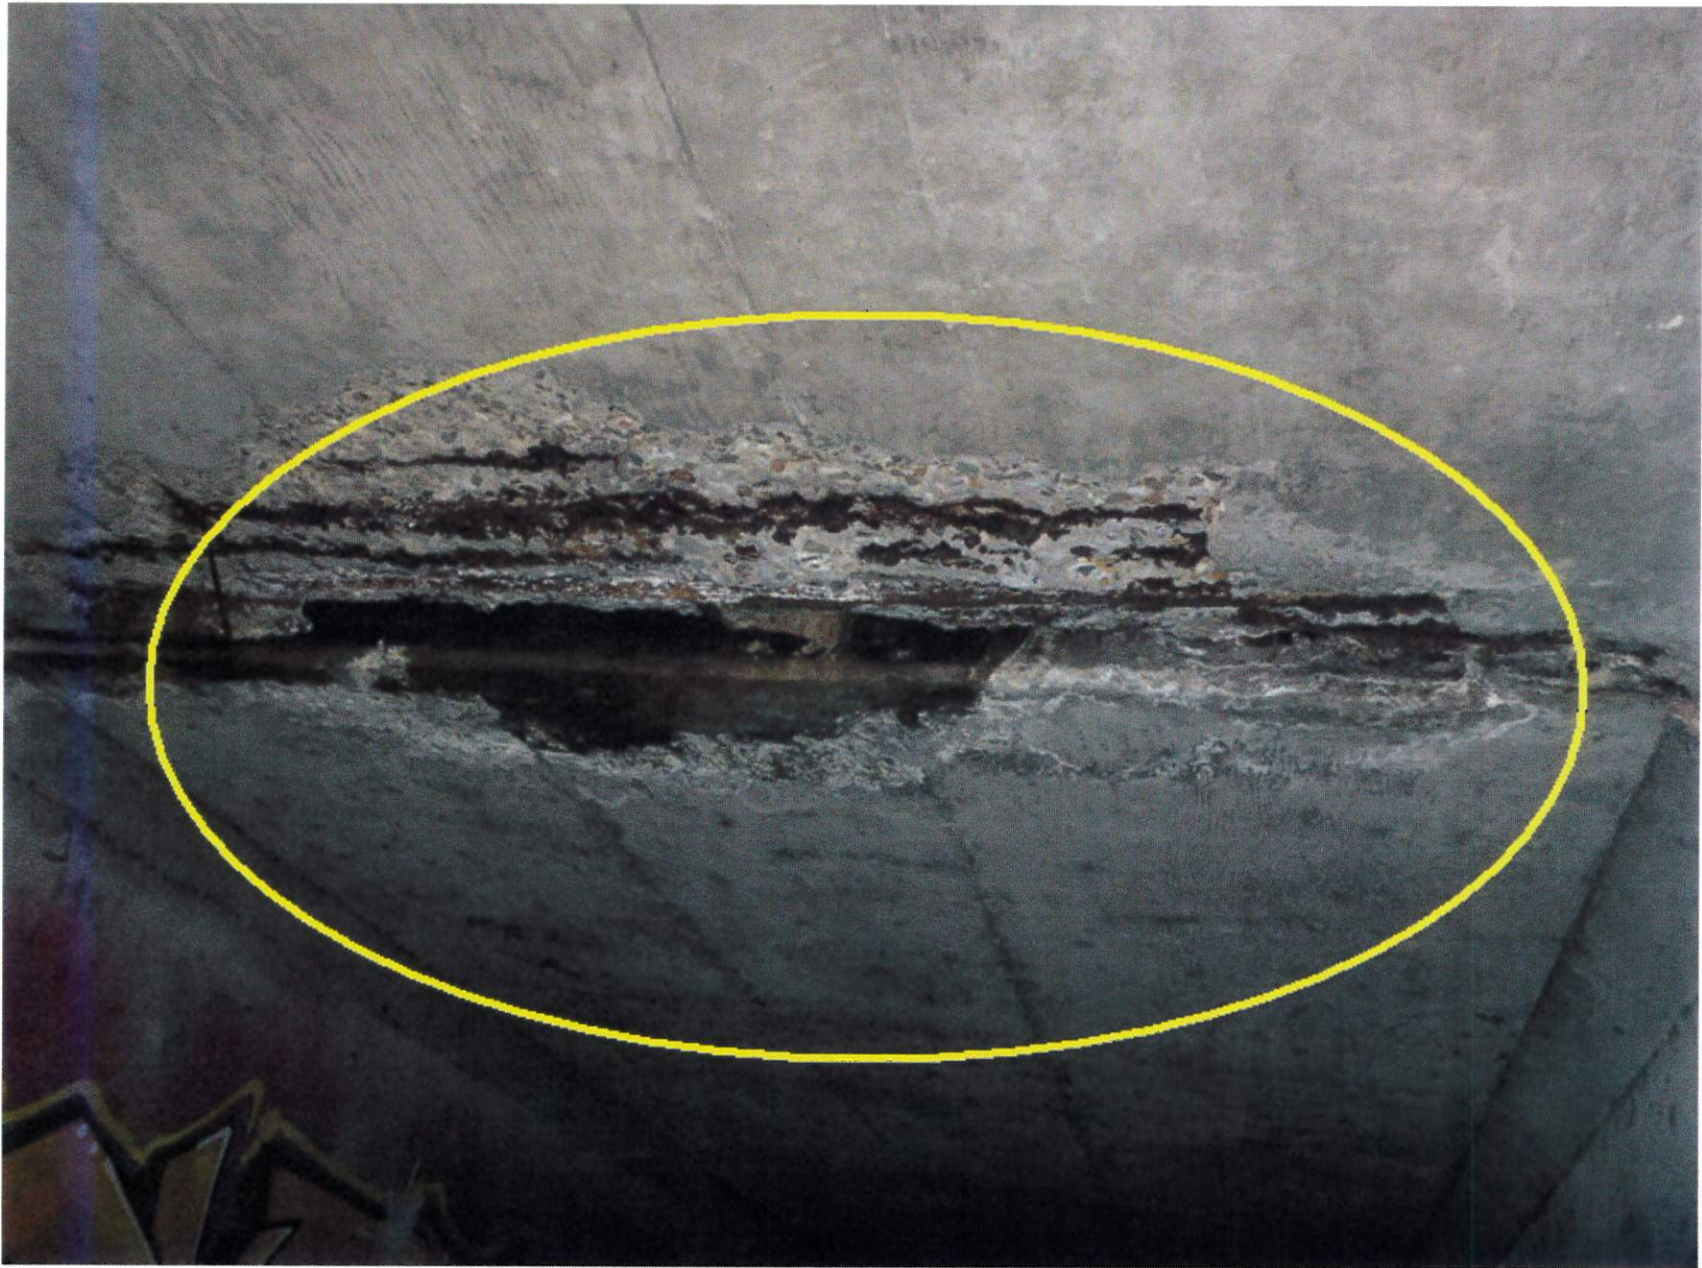
Photo No. 1
Spall 2.5 ft X 12 ft at soffit of barrel 1 at 60 feet from west end.
