Bridge Number : 55C0402

: WESTMINSTER City Inspection Date: 04/05/2019

Bridge Inspection Report

STRUCTURE NAME: ANAHEIM-BARBER CITY CHANNEL

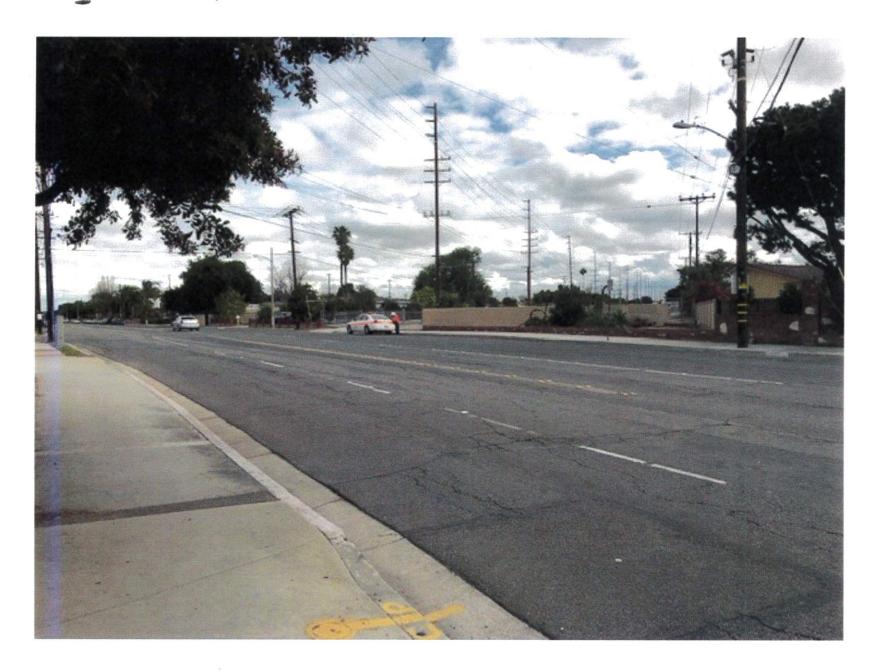
There are longitudinal and transverse cracks 0.05 inches wide throughout the entire AC surface.

Photo No. 1 Deckview looking north

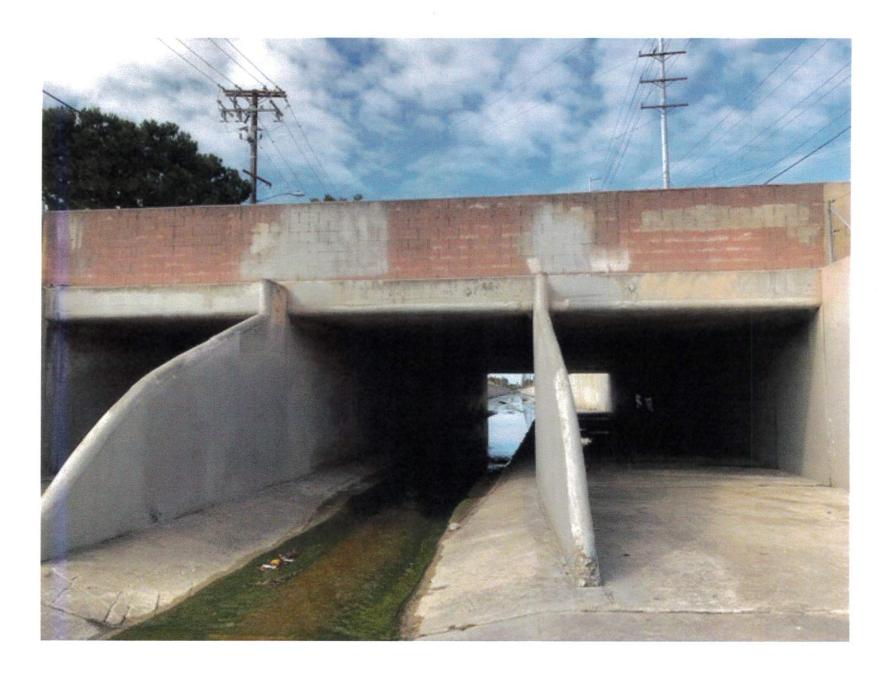
Photo No. 1 Elevation looking west

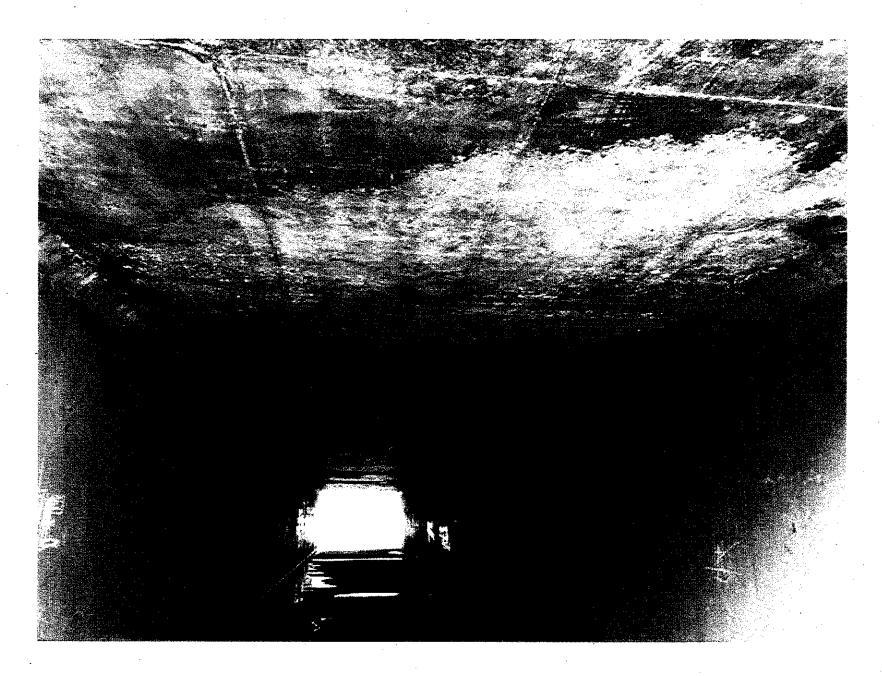
Photo No. 1
Transverse cracks with efflorescense inside Box 2 Soffit
