Bridge Report Transmittal Sheet**Batch 51287****City of Westminster**

Bridge Number : 55C0424
Facility Carried: BUSHARD STREET
Location : 0.25 MI N EDINGER AVE
City : WESTMINSTER
Inspection Date : 04/06/2019

Bridge Inspection Report

STRUCTURE NAME: EAST GARDEN GROVE-WINTERSBURG CHANNEL

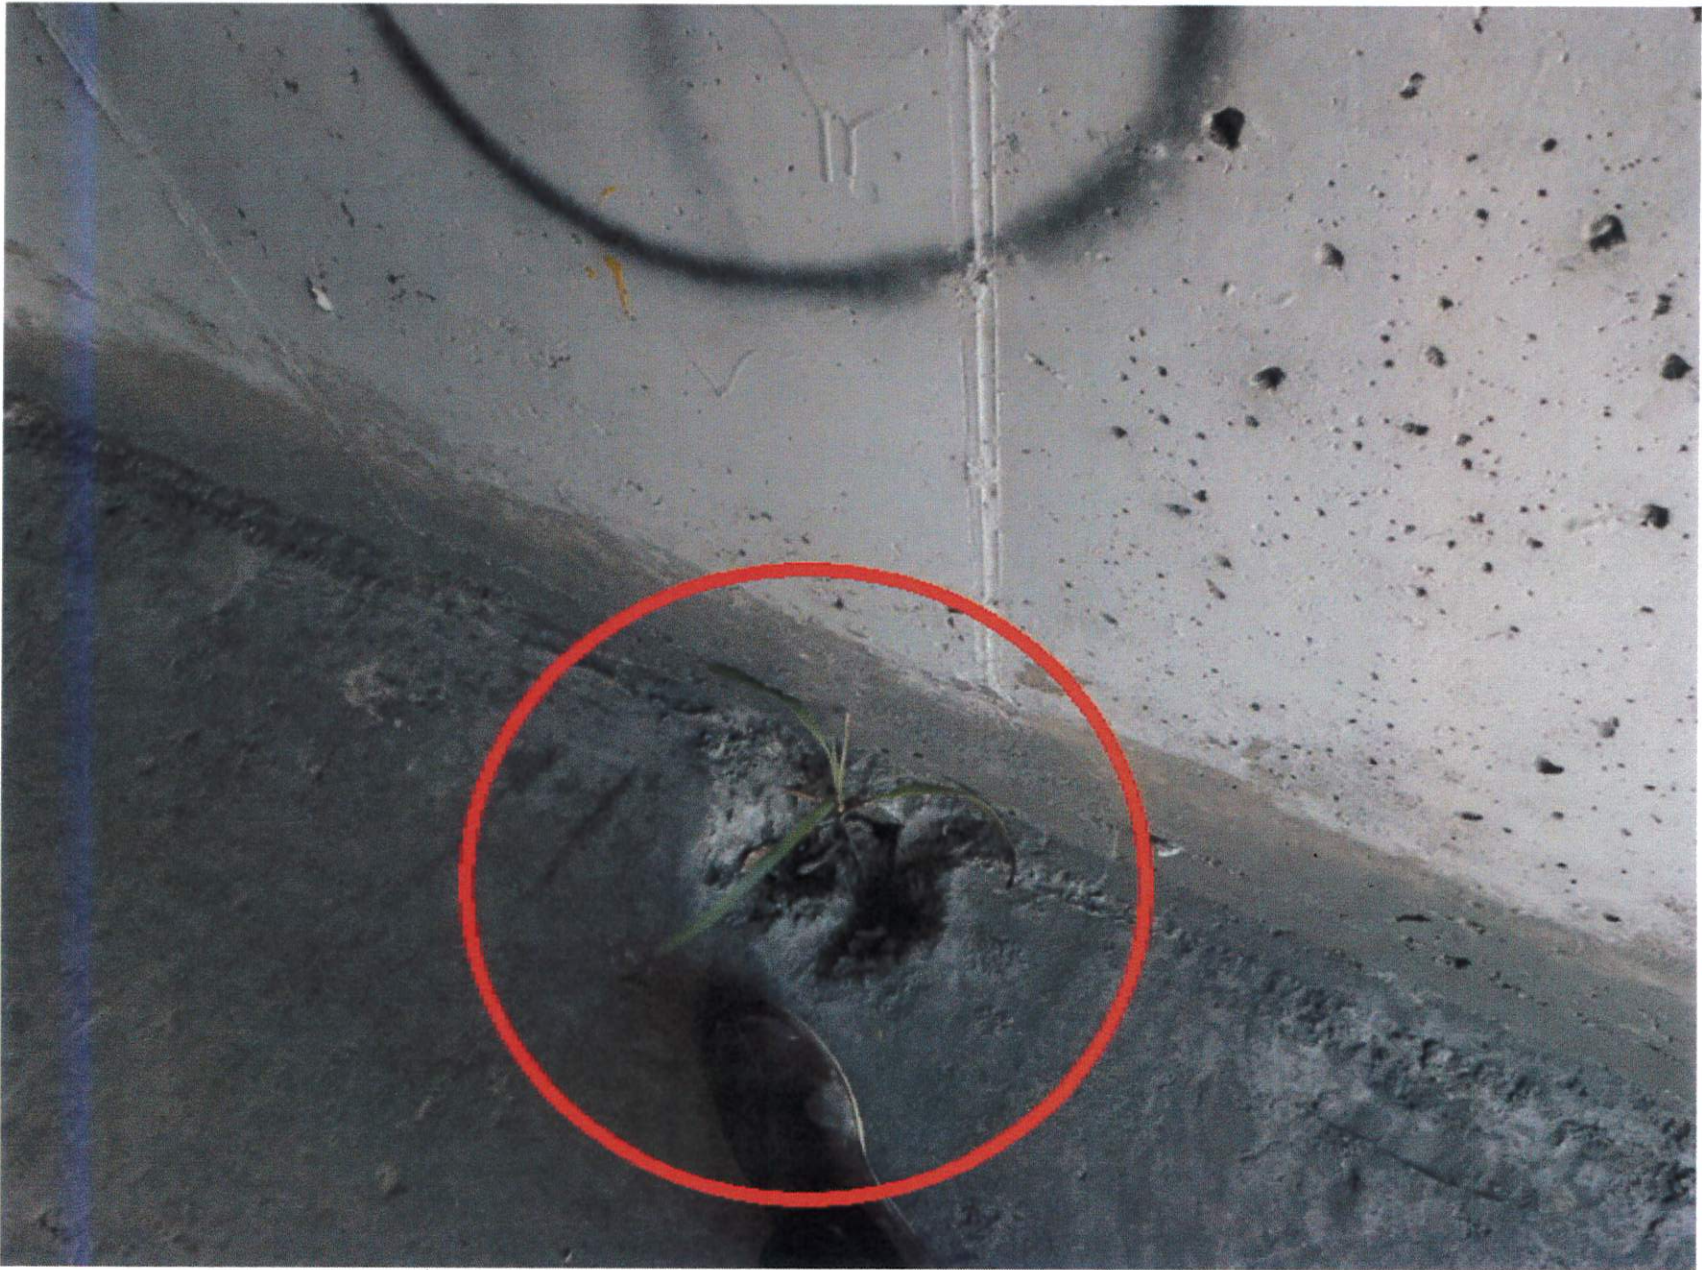
Barrel #2, there is a spall at (12.0 inches L X 5.0 inches W X 2.0 inches D) on the soffit approximately 15.0 feet from the west end next to wall #2 (see the attached photo no. 8).

| Elem No. | Defect /Prot | Element Description | Env Qty | Total Qty | Units | Qty in each Condition State | | | |
|---|---|---|---|---|---|---|---|---|---|
| Barrel #2, there is a spall at (12.0 inches L X 5.0 inches W X 2.0 inches D) on the soffit approximately 15.0 feet from the west end next to wall #2 (see the attached photo no. 8). | | | | | | | | | |

Photo No. 8
Spall at the invert of barrel 2 at 15 feet from west end.

Remove all unsound concrete soffit

Action : Deck-Patch spalls

spalls, clean all loose materials around

these spalls before patching with cement

mortar concrete.

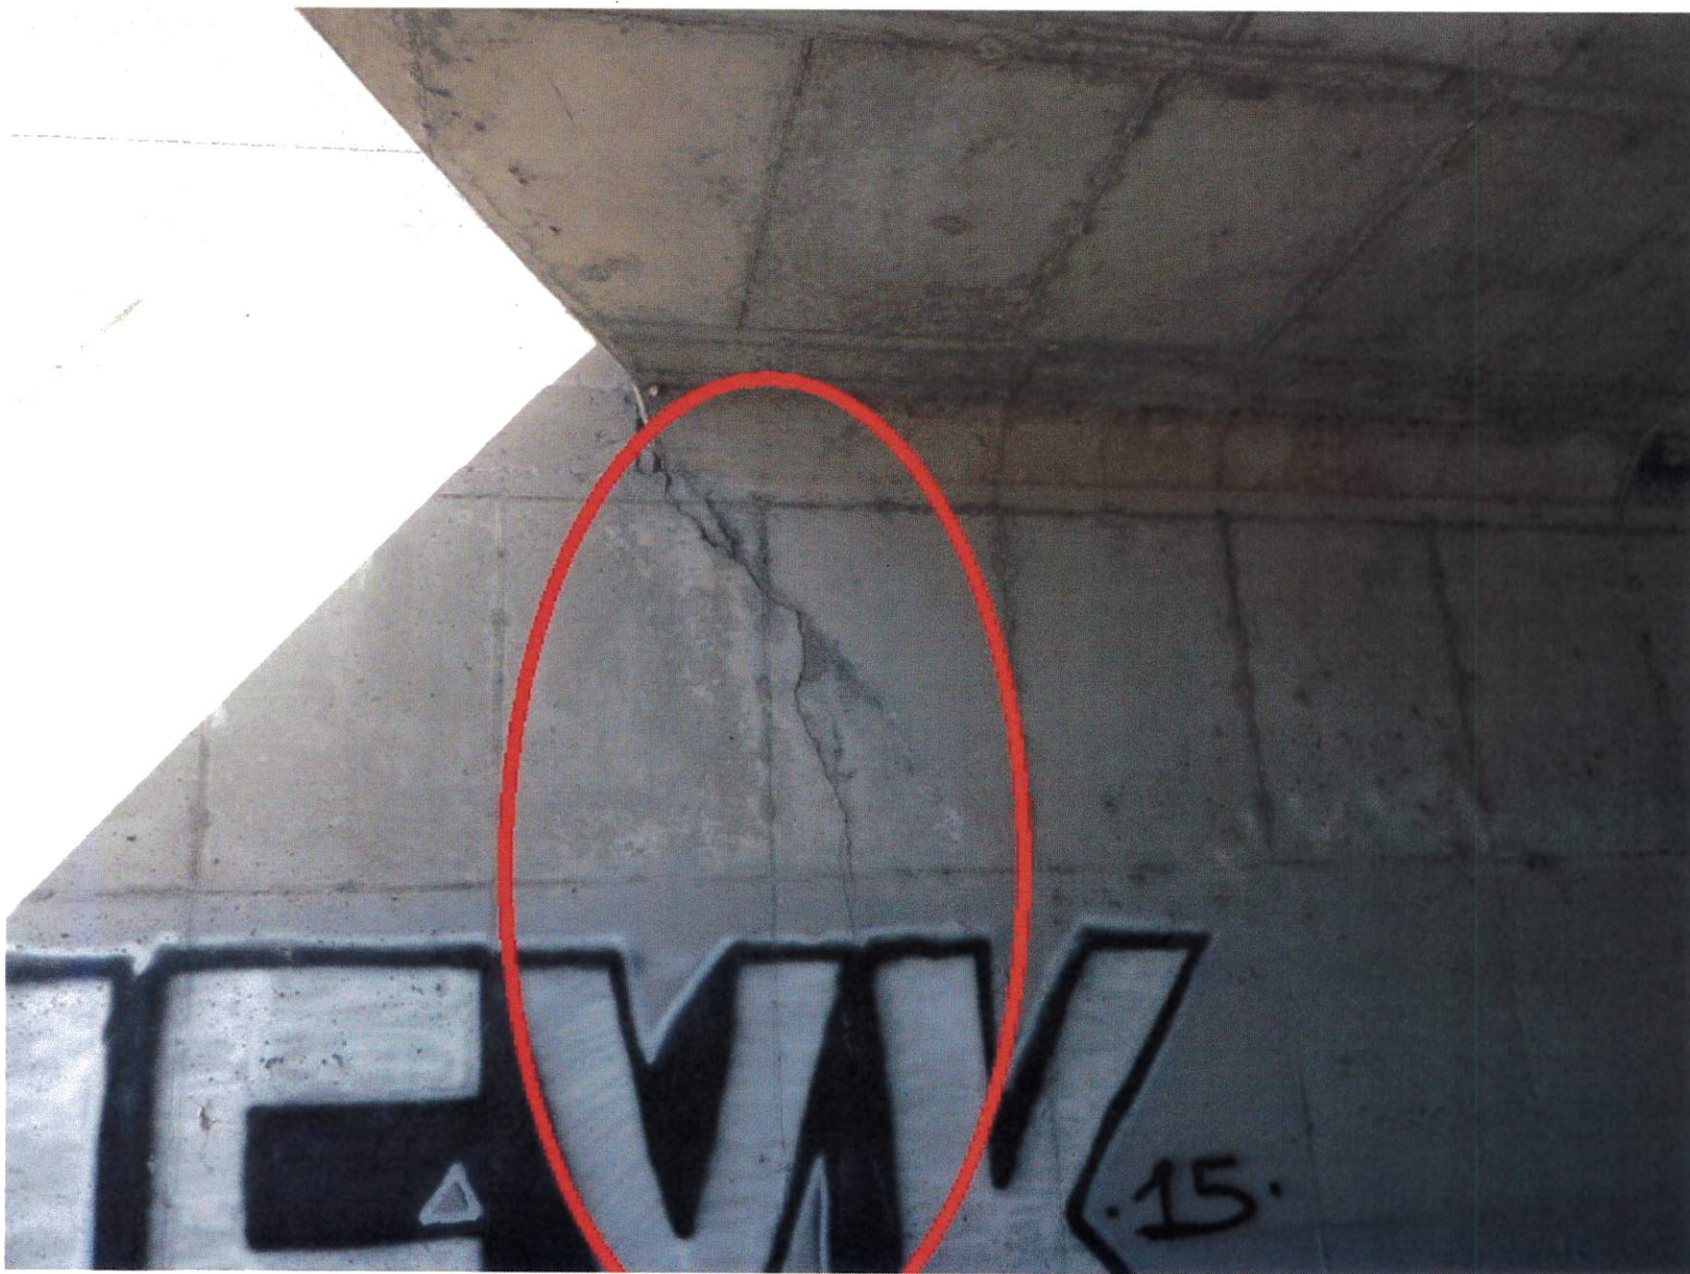
Photo No. 7

Culvert wall #3 has (see the attached photos no. 6 & 7) eight vertical cracks, up to 0.05 inches wide. In addition, there are two cracks. One horizontal crack is at 0.03 inches wide, 40.0 feet long about 6.0 feet above the invert; and the other is a diagonal to vertical crack at the west end at 0.08 inches wide.

| Elem No. | Defect /Prot | Element Description | Env Qty | Total Qty | Units | Qty in each Condition State | | | |
|---|---|---|---|---|---|---|---|---|---|
| Culvert wall #3 has (see the attached photos no. 6 & 7) eight vertical cracks, up to 0.05 inches wide. In addition, there are two cracks. One horizontal crack is at 0.03 inches wide, 40.0 feet long about 6.0 feet above the invert; and the other is a diagonal to vertical crack at the west end at 0.08 inches wide. | | | | | | | | | |

Vertical crack 0.08 inches wide at the west end.

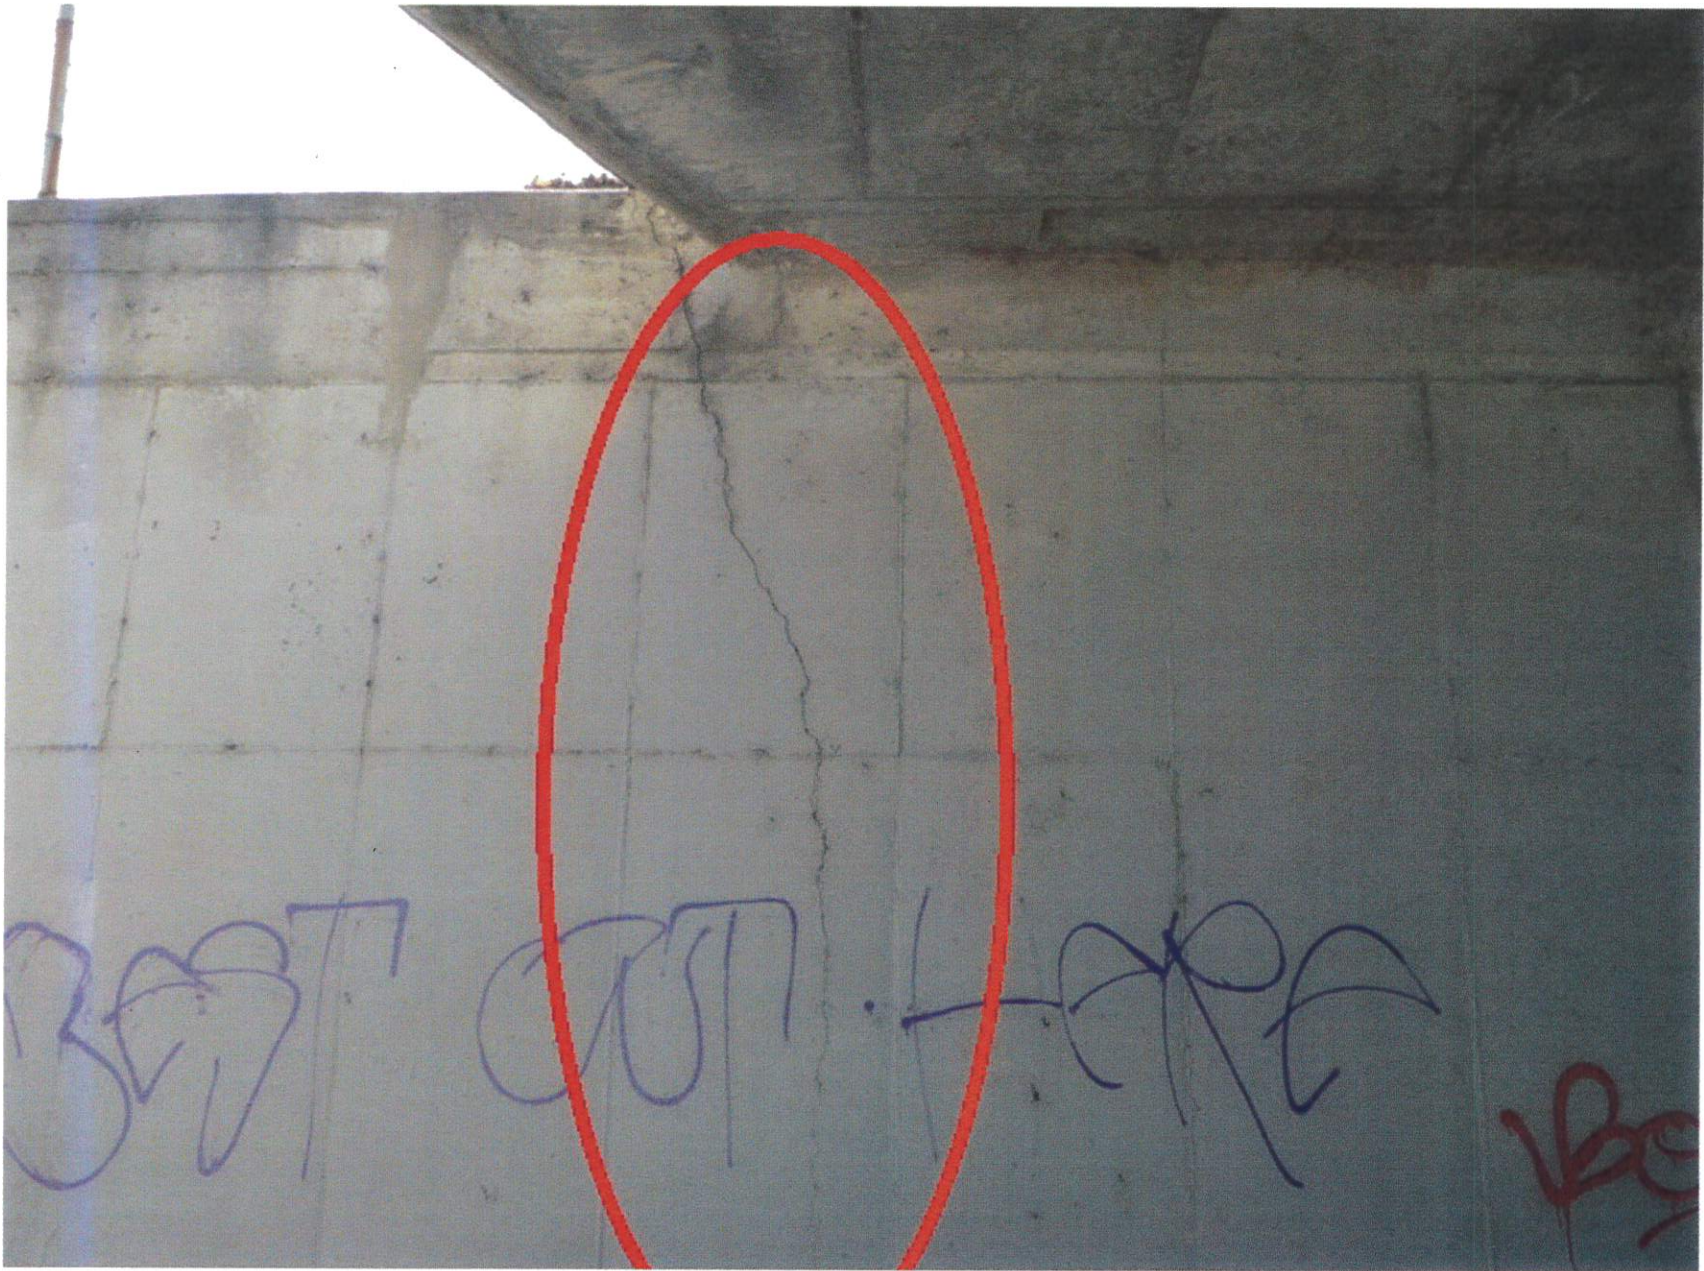
Photo No. 6

Vertical crack 0.08 inches wide at the west end.

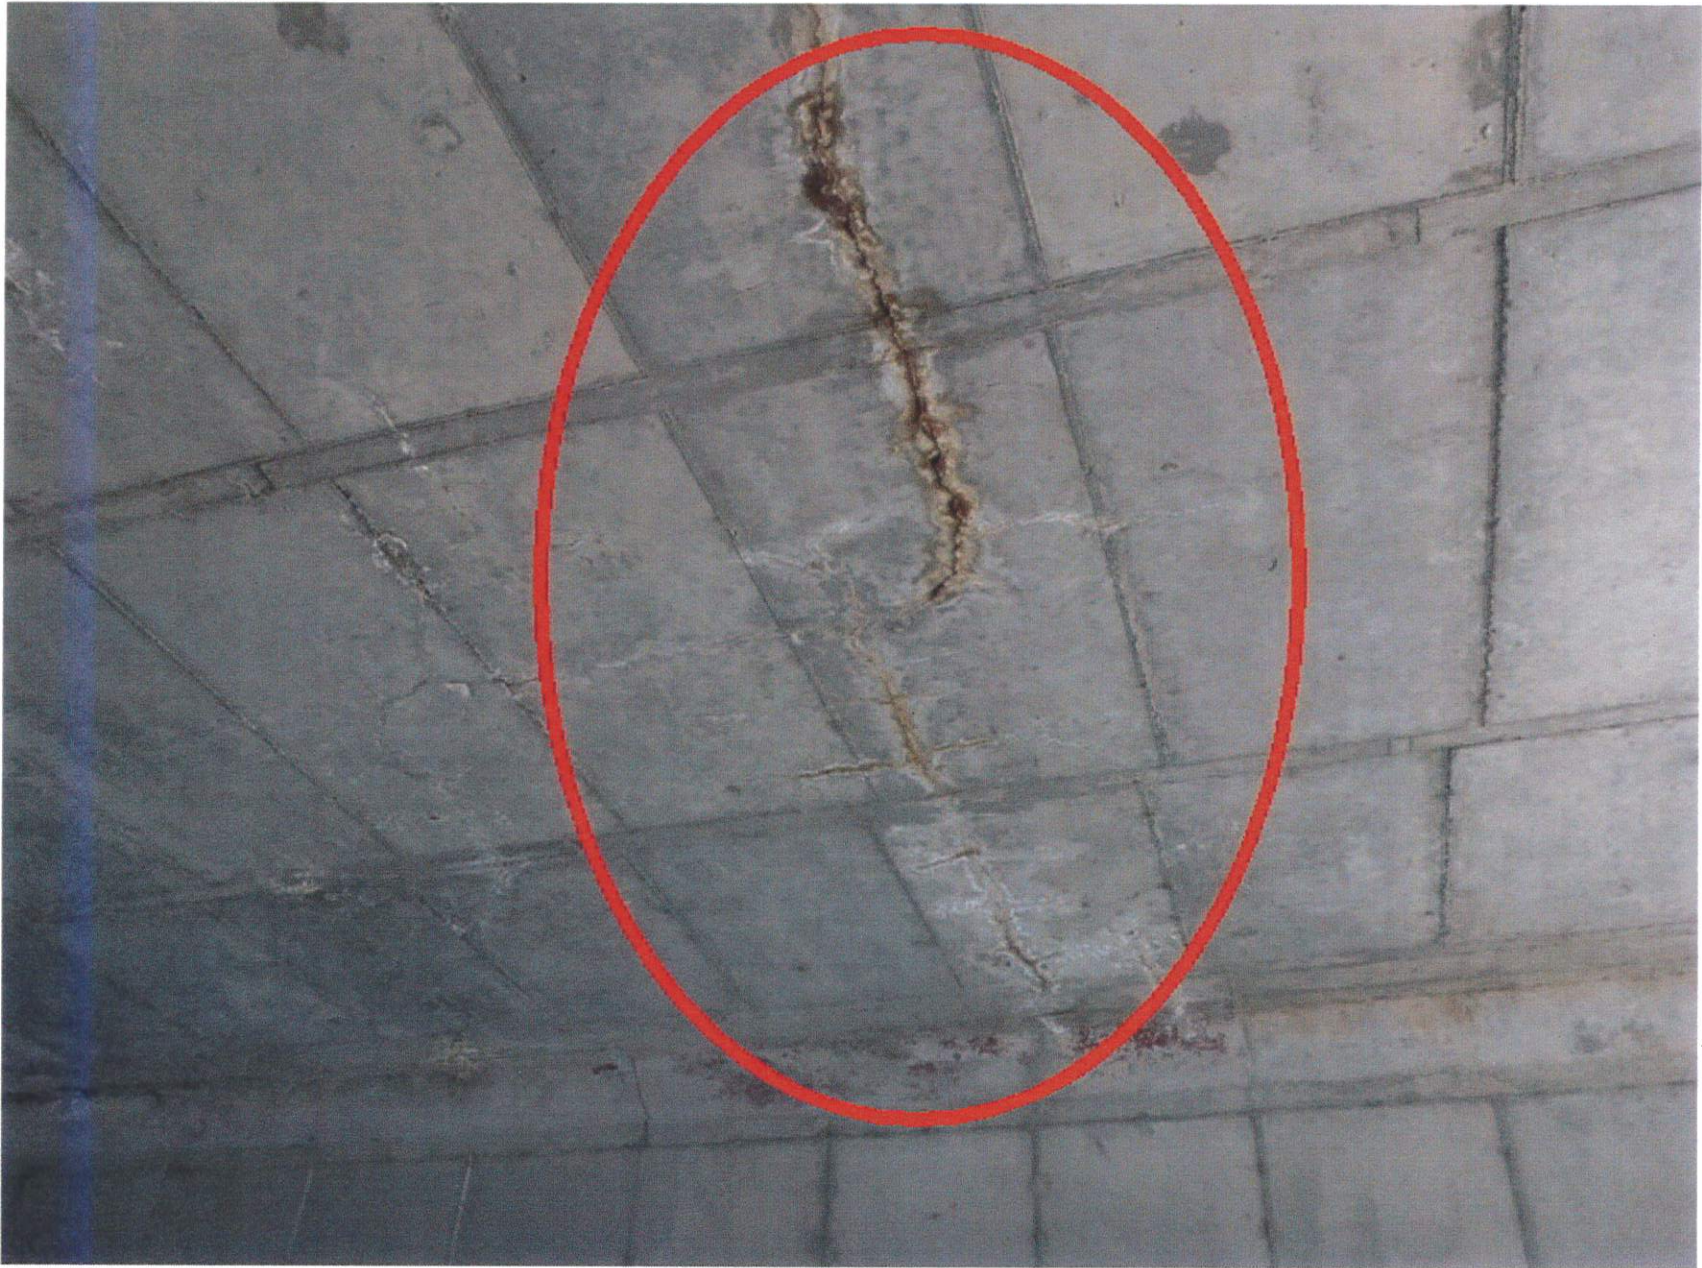
The following is the locations of culvert soffit with cracks below (see the attached photos no. 3 to 5):

Barrel #2 has three longitudinal full length cracks with brown efflorescence; and one crack with efflorescence about 17.0 feet from the west.

Barrel #1 has four longitudinal cracks at 6.0 feet long with brown efflorescence about 17.0 feet from the east; and also, four longitudinal cracks at 8.0 feet long with brown efflorescence about 14.0 feet from the west.

Photo No. 5
Cracks with brown efflorescence at the soffit of the culvert.

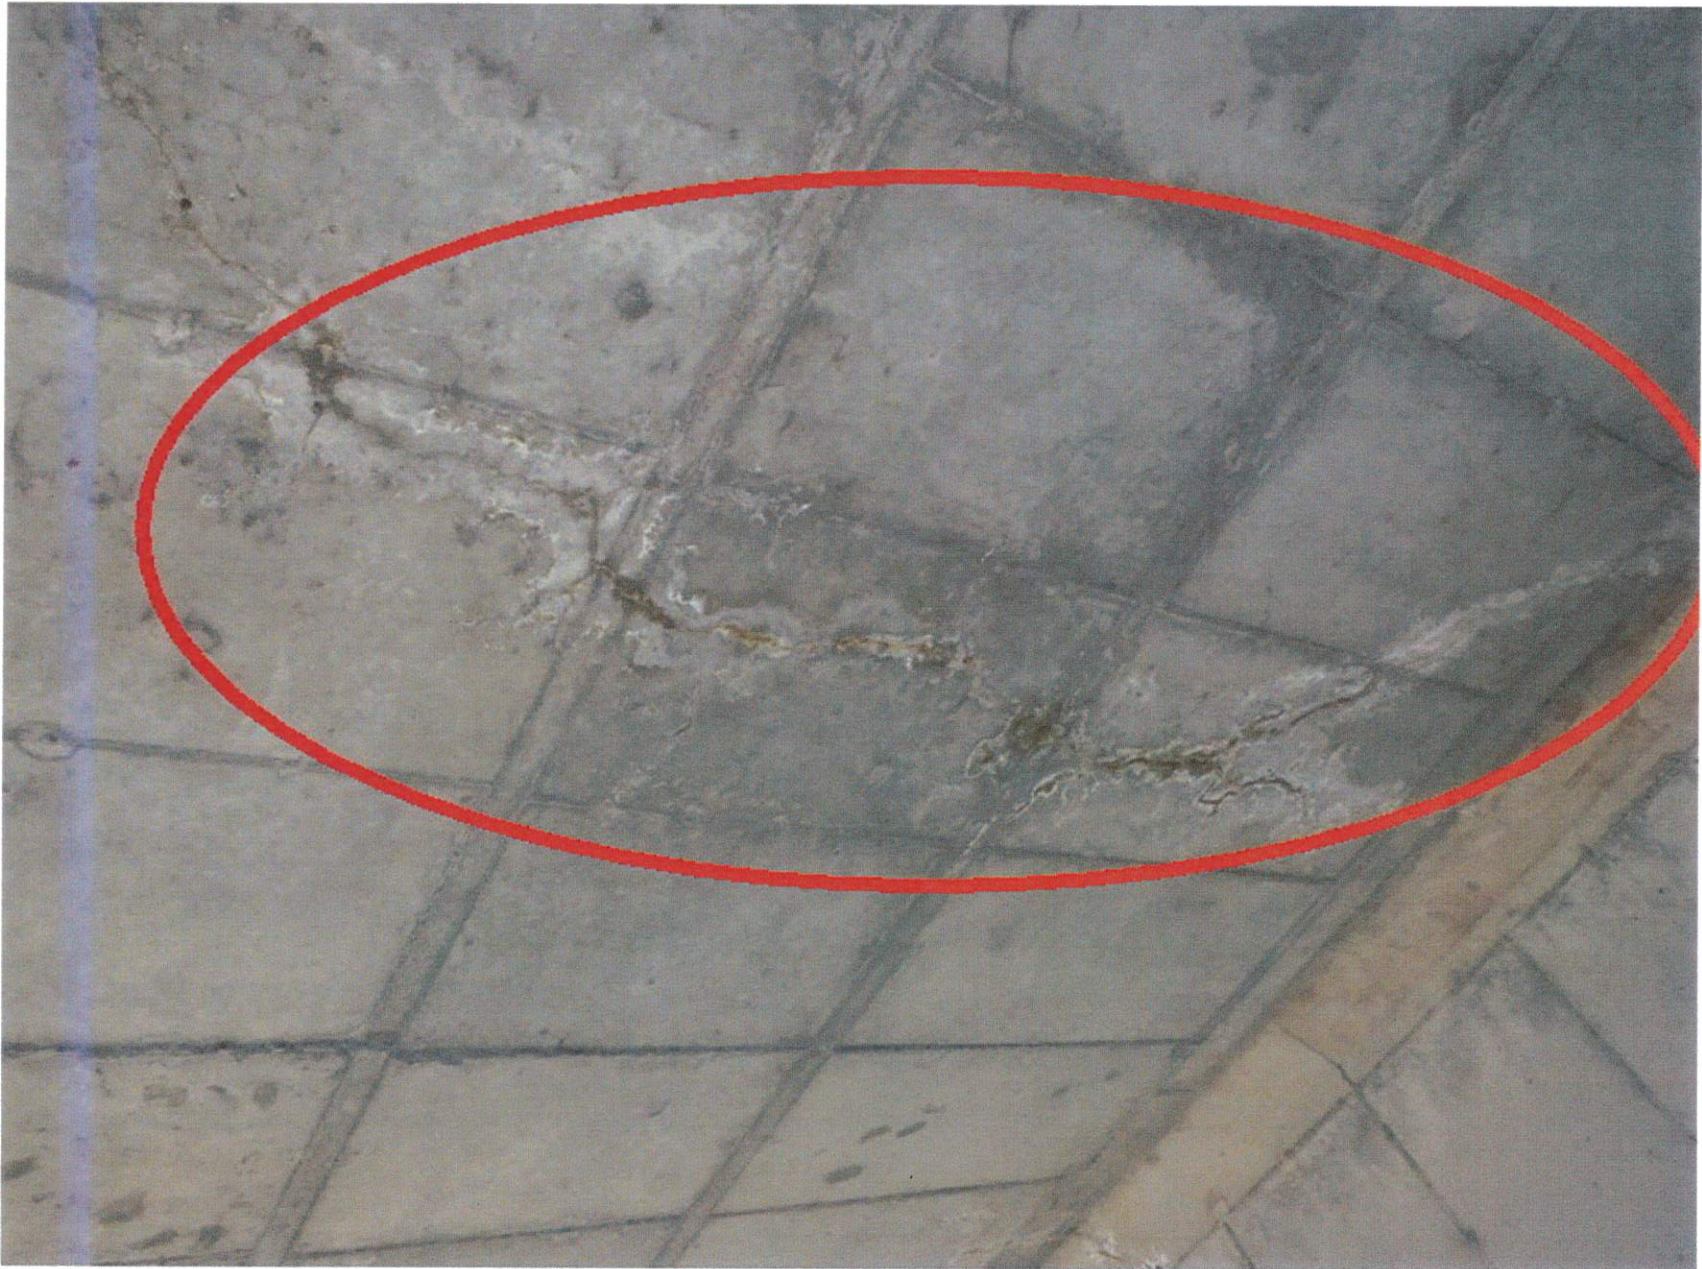
Photo No. 4
Cracks with brown efflorescence at the soffit of the culvert.

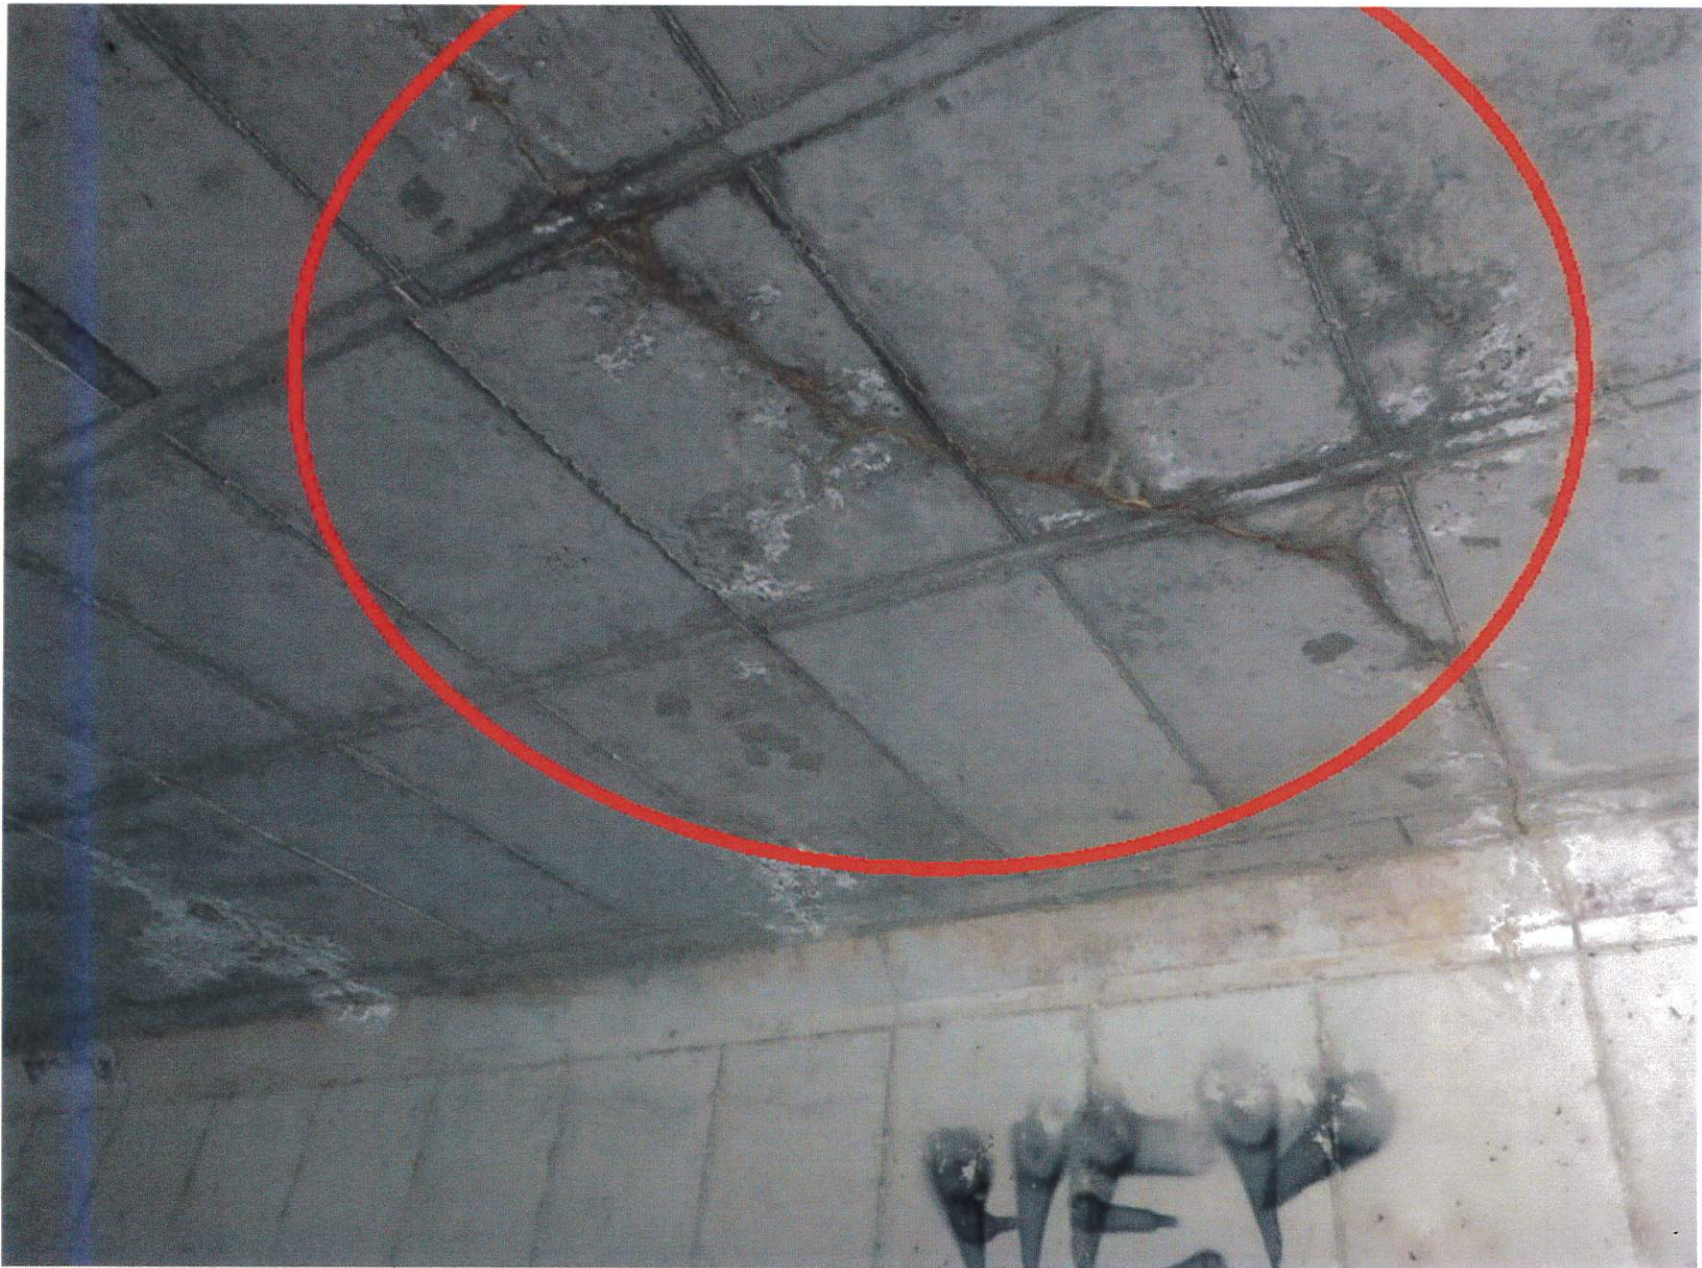
Photo No. 3
Cracks with brown efflorescence at the soffit of the culvert.
