Bridge Number : 55C0426
Facility Carried: WARD STREET
Location : 0.10 MI N MCFADDEN AVE
City : WESTMINSTER
Inspection Date : 04/06/2019

Bridge Inspection Report

STRUCTURE NAME: EAST GARDEN GROVE-WINTRSBURG CHANNEL

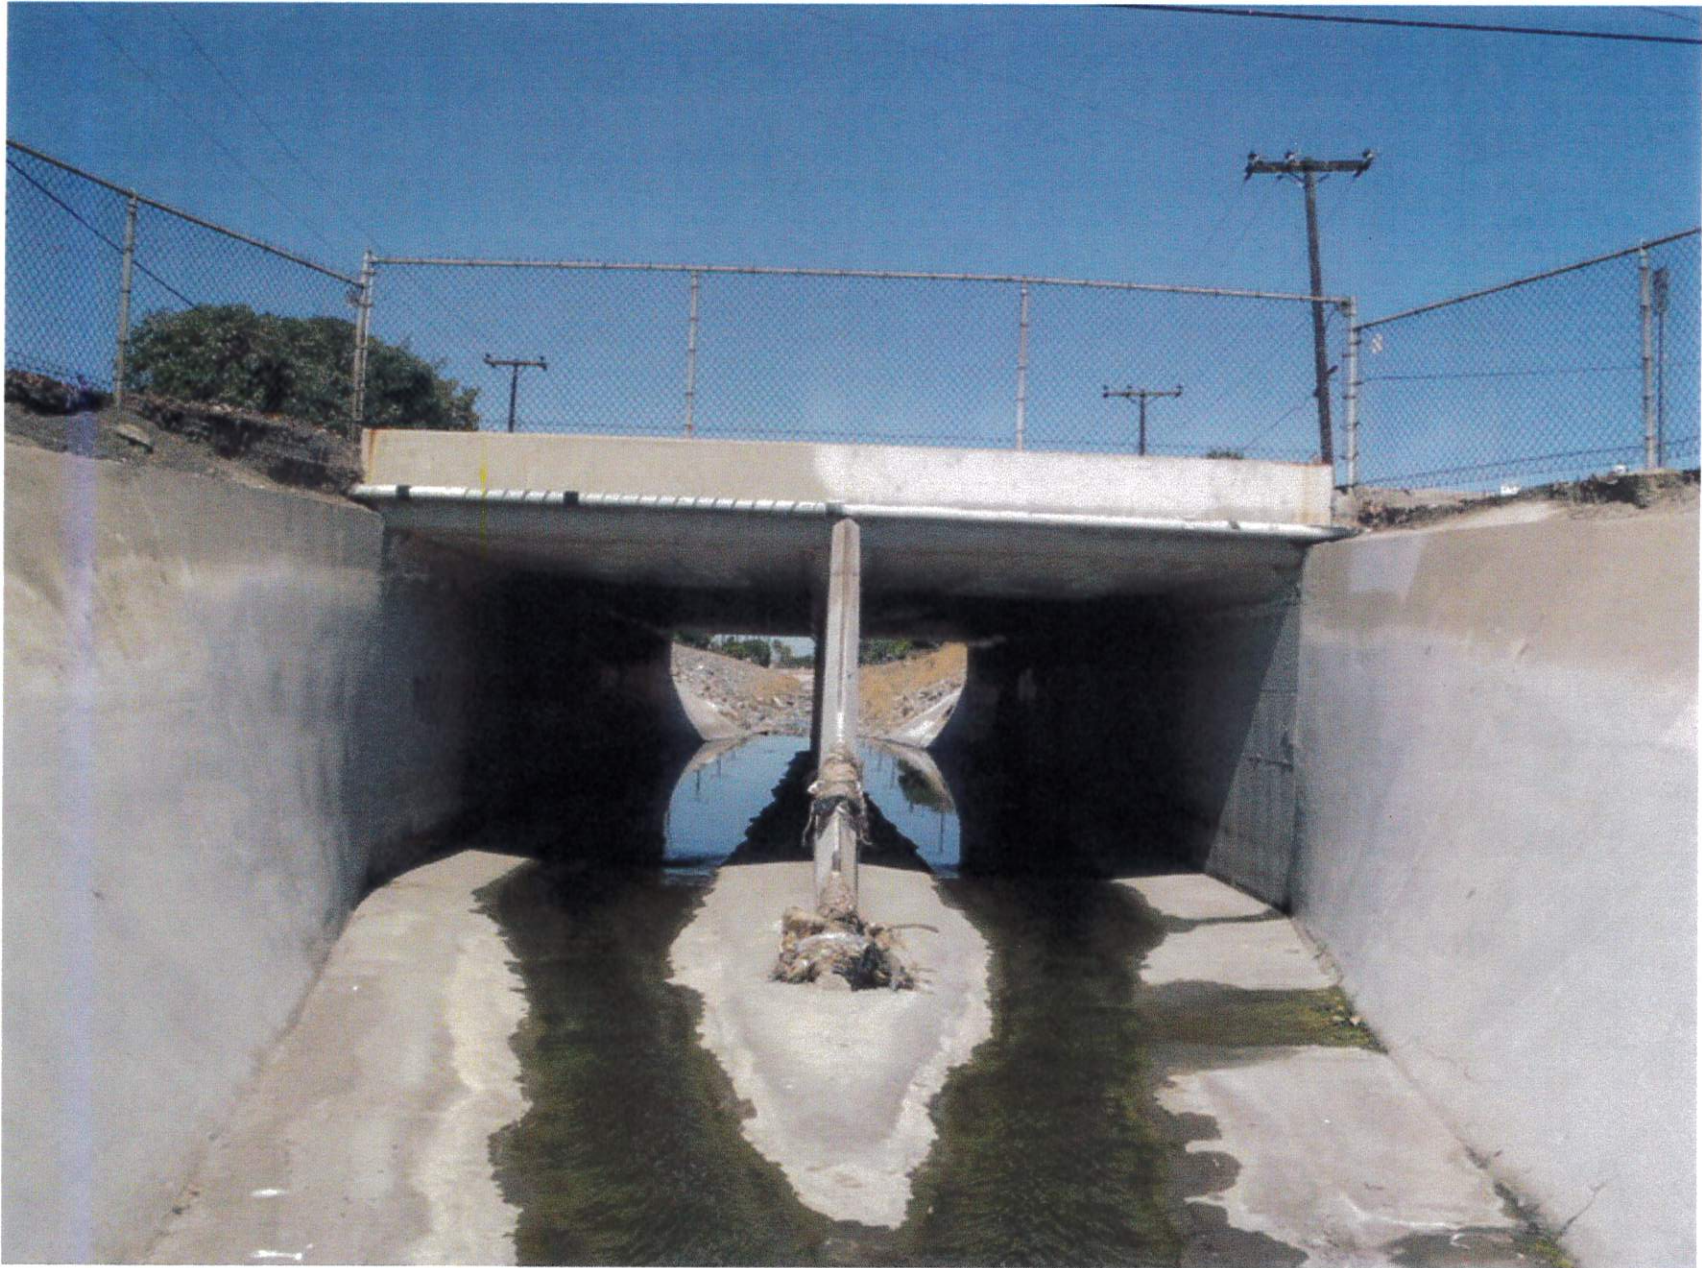
Photo No. 1
Side View looking West.

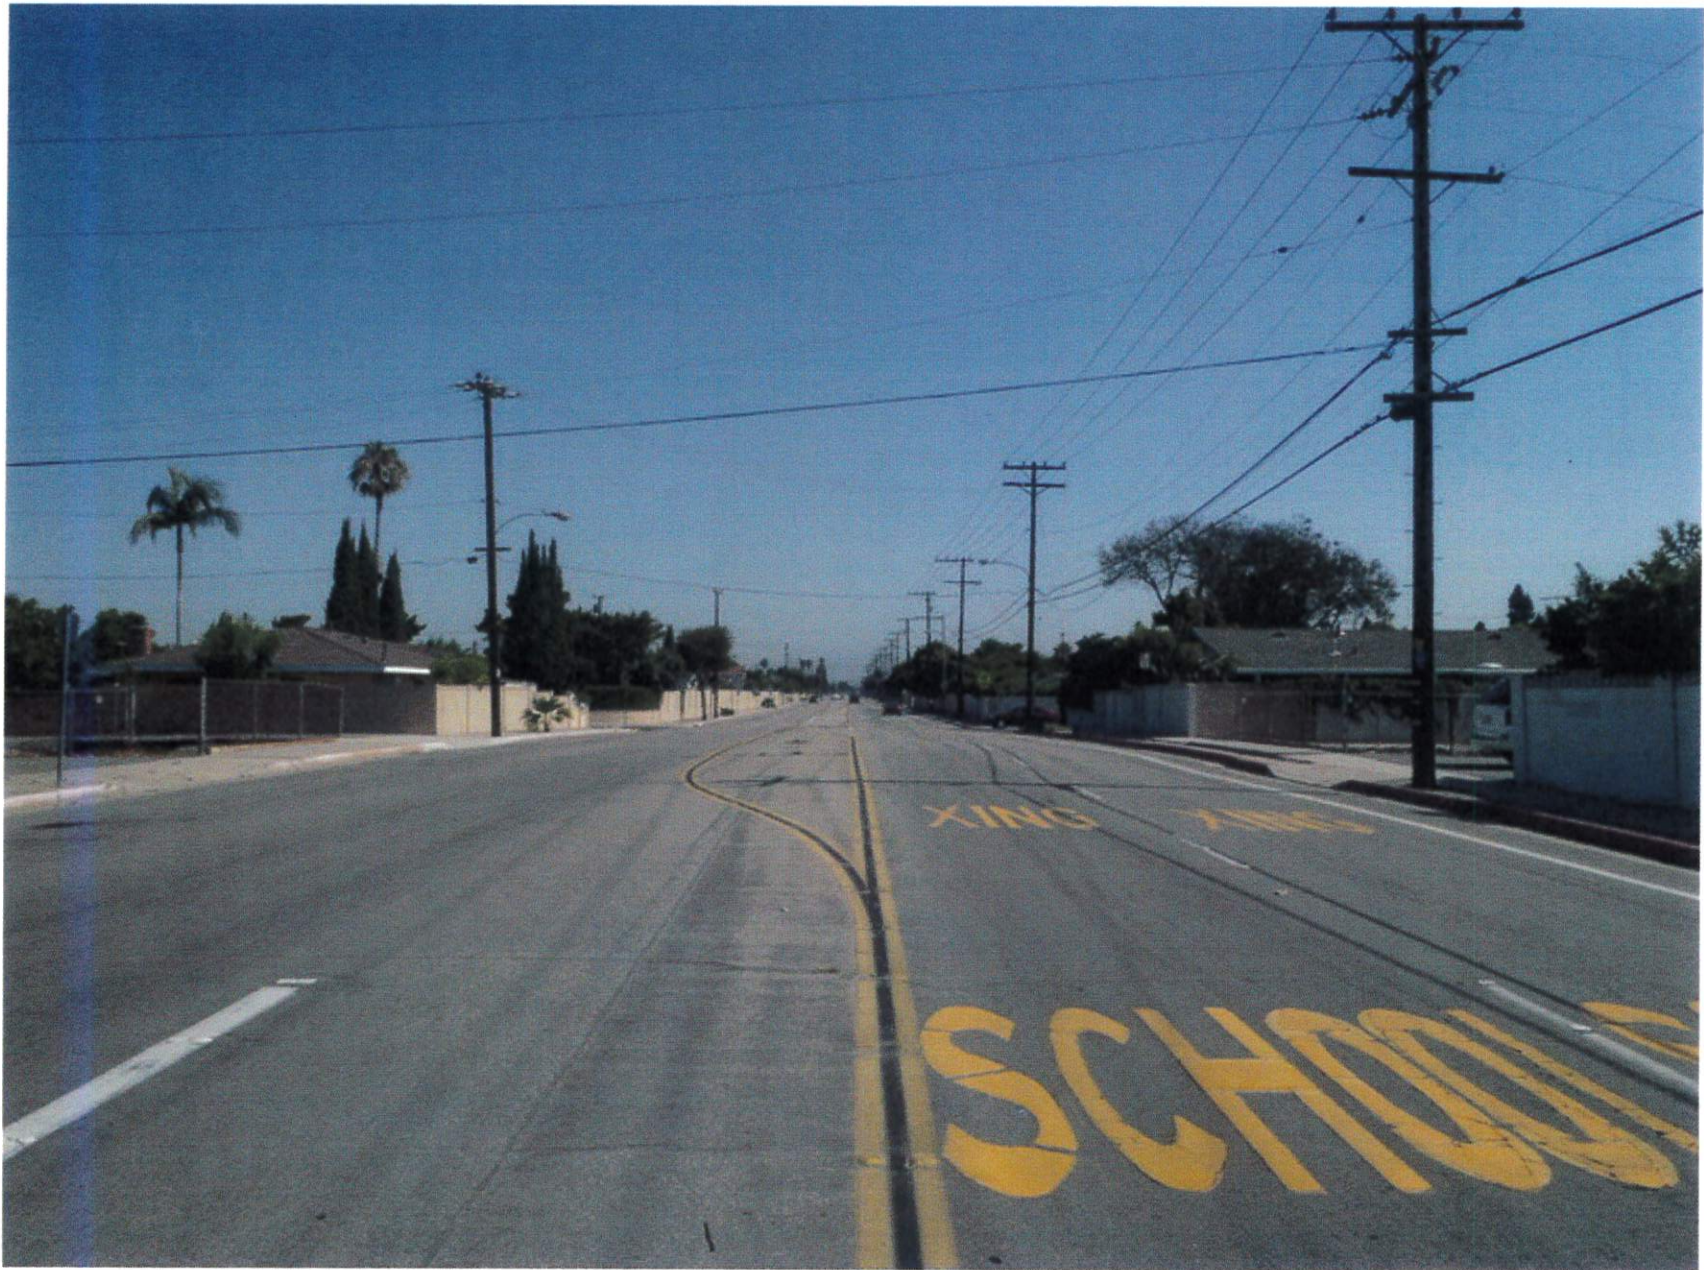
Photo No. 1
Deck View looking North

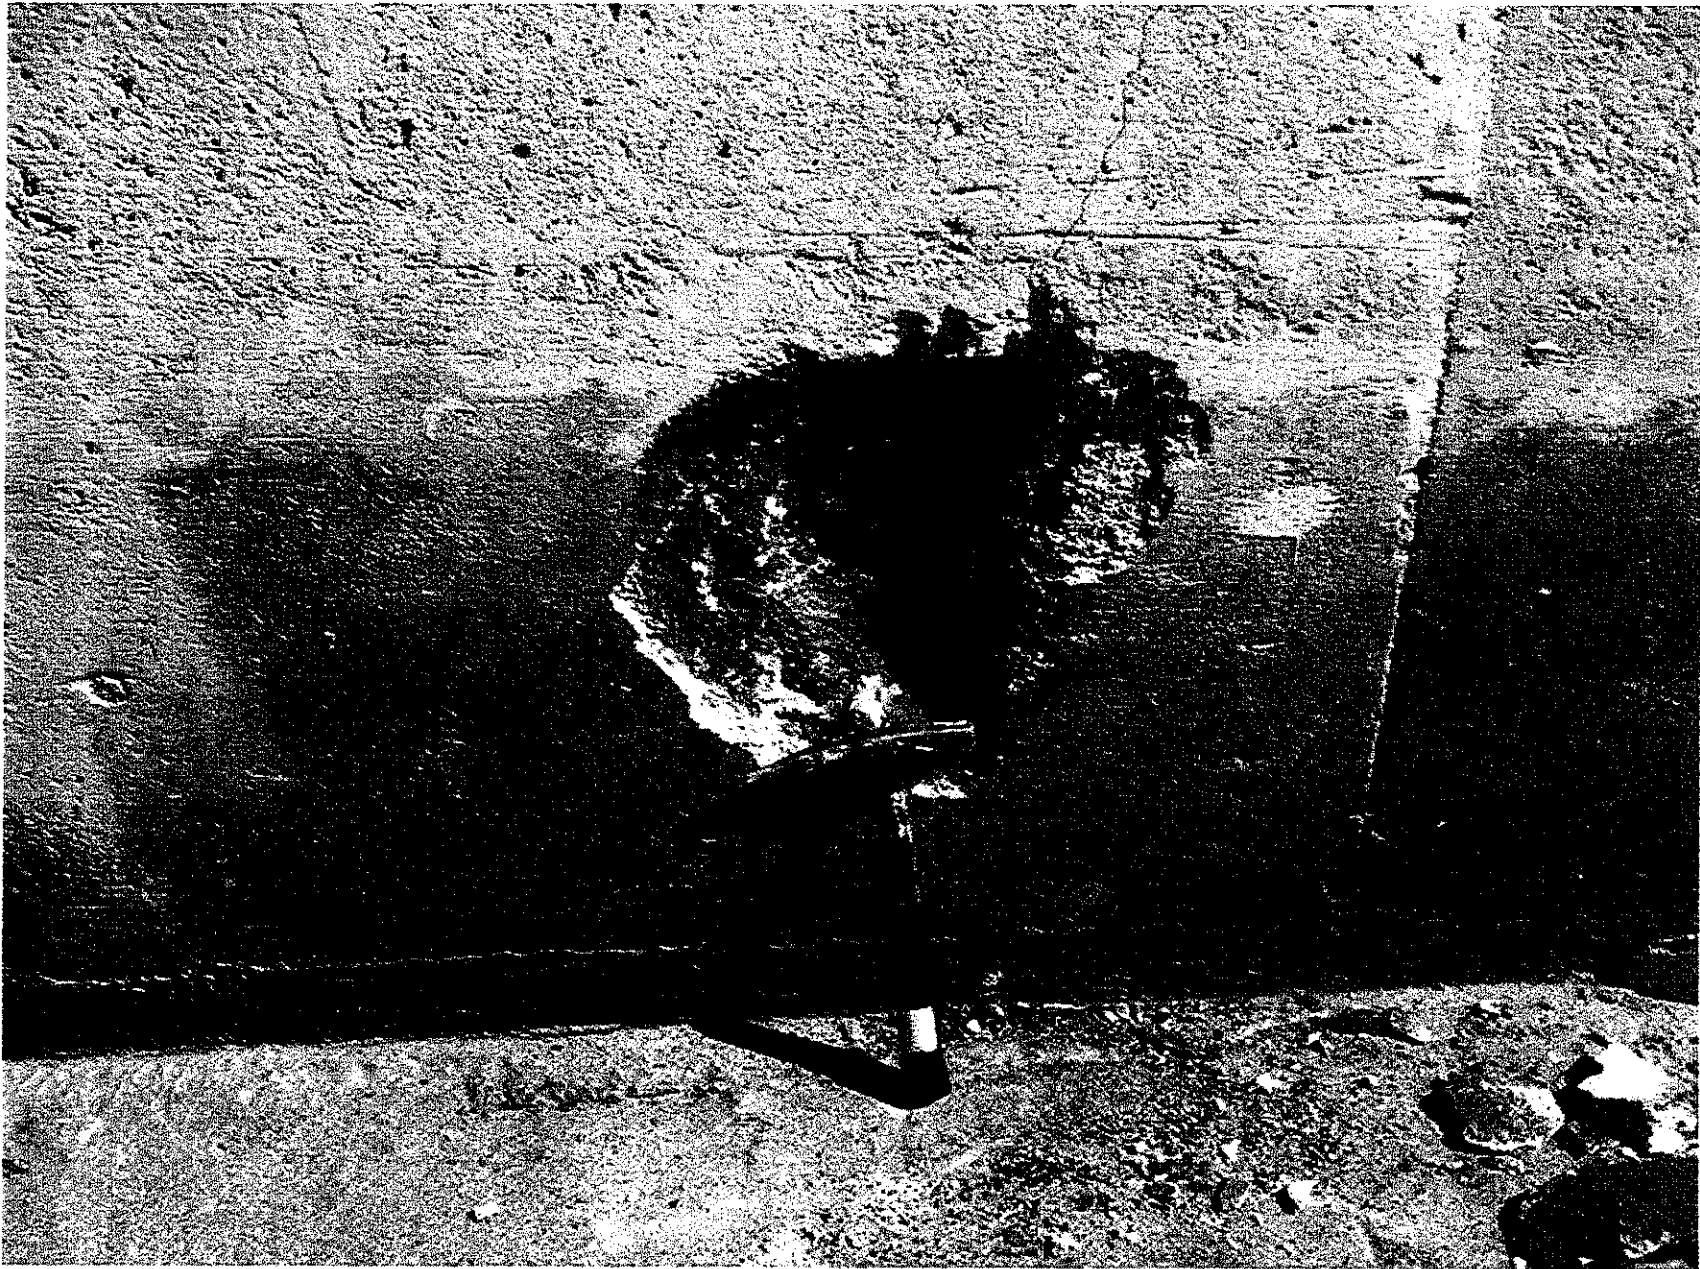
Photo No. 1

Box wall #2 (southerly face) has a spall at (16.0 inches L X 24.0 inches w X 2.5 inches D) with exposed rusted rebars about 24.0 inches from the invert at the east end (see the attached photos no. 2 and 3).

A spall at box wall 2 southerly face 20" X 24" X 2" at east end.

RecDate: 04/06/2019	EstCost:	Repave the entire culvert deck surface
Action : Deck-Resurface	StrTarget: 2 YEARS	with asphalt concrete.
Work By: LOCAL AGENCY	DistTarget:	
Status : PROPOSED	EA:	
RecDate: 04/20/2017	EstCost:	Patch the spall (16.0 inches L X 24.0
Action : Sub-Patch spalls	StrTarget: 2 YEARS	inches W X 2.5 inches D) with exposed
Work By: LOCAL AGENCY	DistTarget:	rusted rebars at culvert wall #2 (south
Status : PROPOSED	EA:	face) about 24.0 inches from the invert
		at the east end (see the attached photos
		no. 2 and 3).

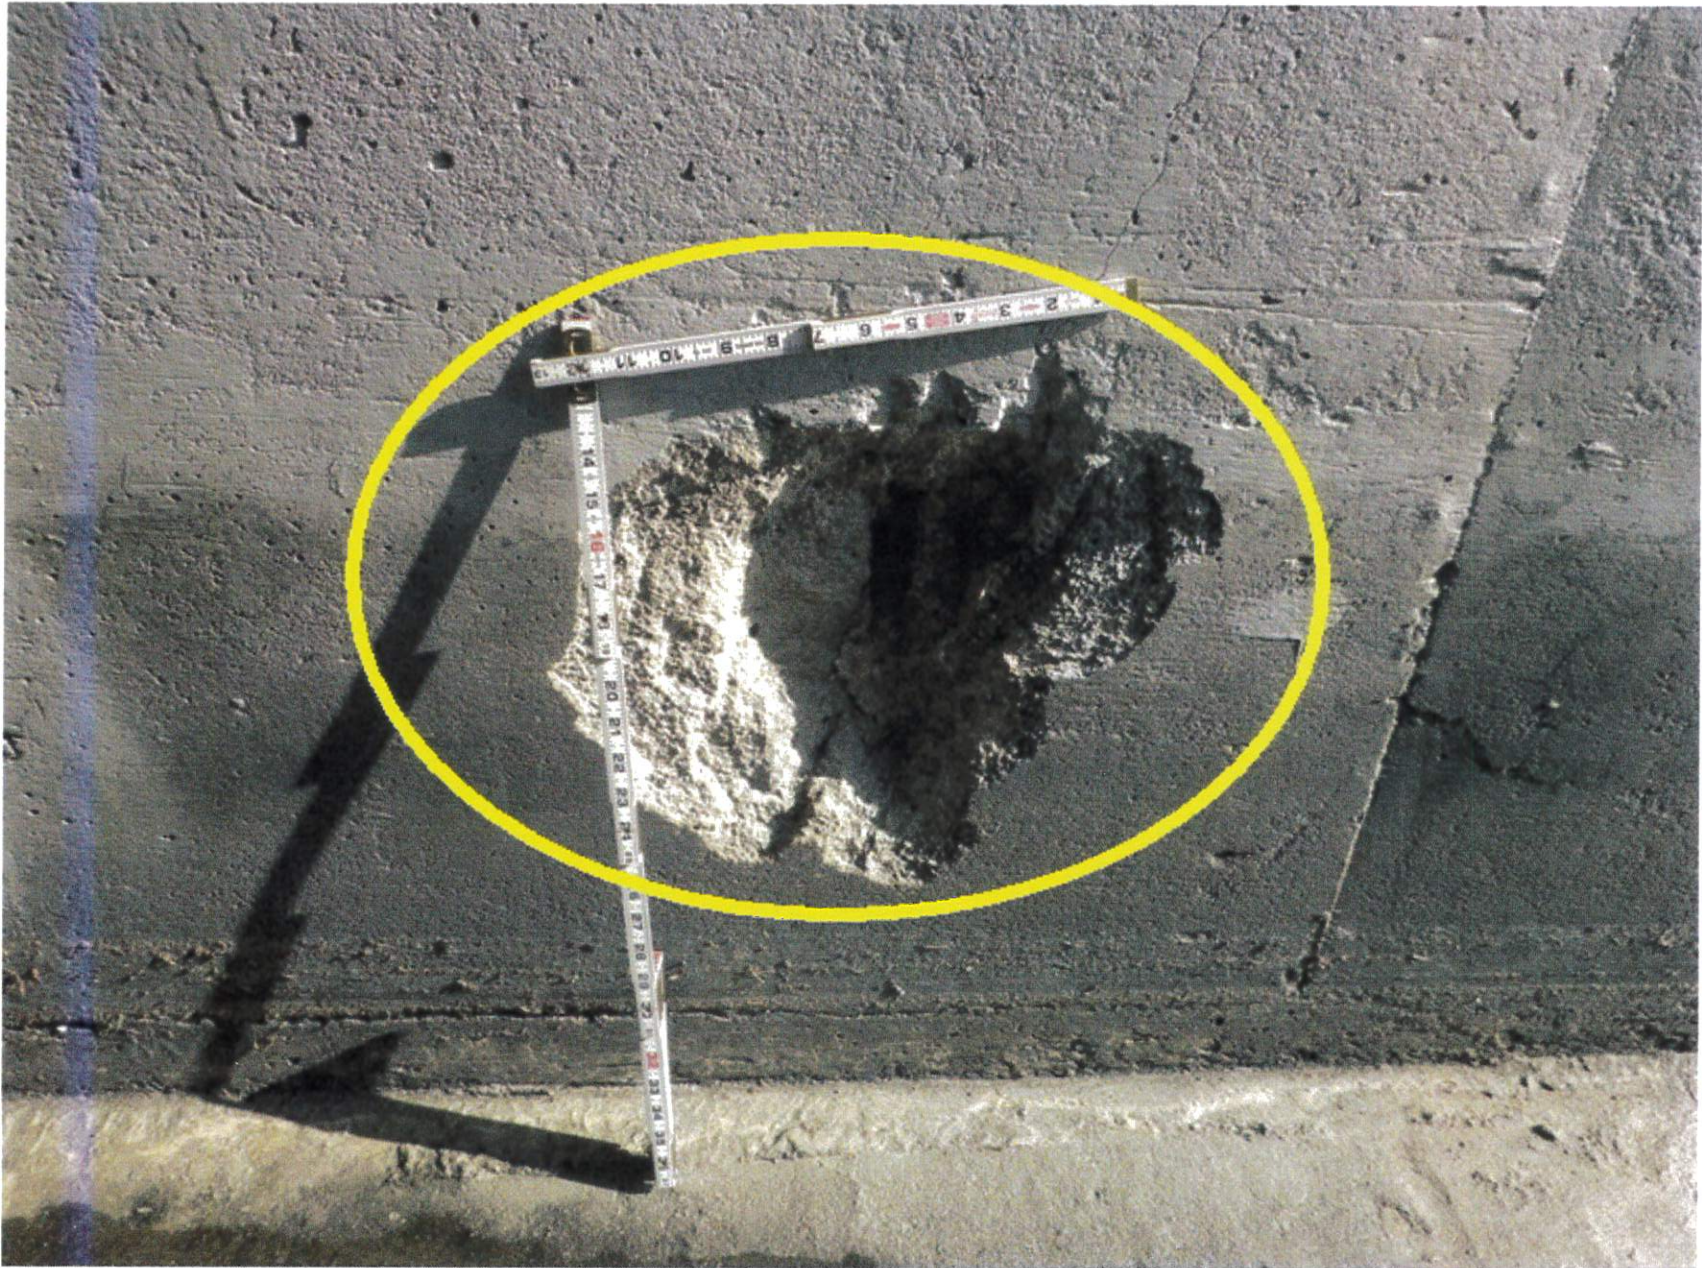
Box wall #2 (southerly face) has a spall at (16.0 inches L X 24.0 inches w X 2.5 inches D) with exposed rusted rebars about 24.0 inches from the invert at the east end (see the attached photos no. 2 and 3).

Photo No. 3
Spall at the east end of culvert wall 2.
