Bridge Number : 55C0427
Facility Carried: MAGNOLIA ST
Location : AT EDINGER AVE
City : WESTMINSTER
Inspection Date : 04/06/2019

Bridge Inspection Report

STRUCTURE NAME: EAST GARDEN GROVE-WINTERSBURG CHANNEL

Structure Description: Double (12.00 feet W x 9.50 feet H x 277.00 feet L) RC box culvert
(grade top) beneath 1.00 foot of earth fill.

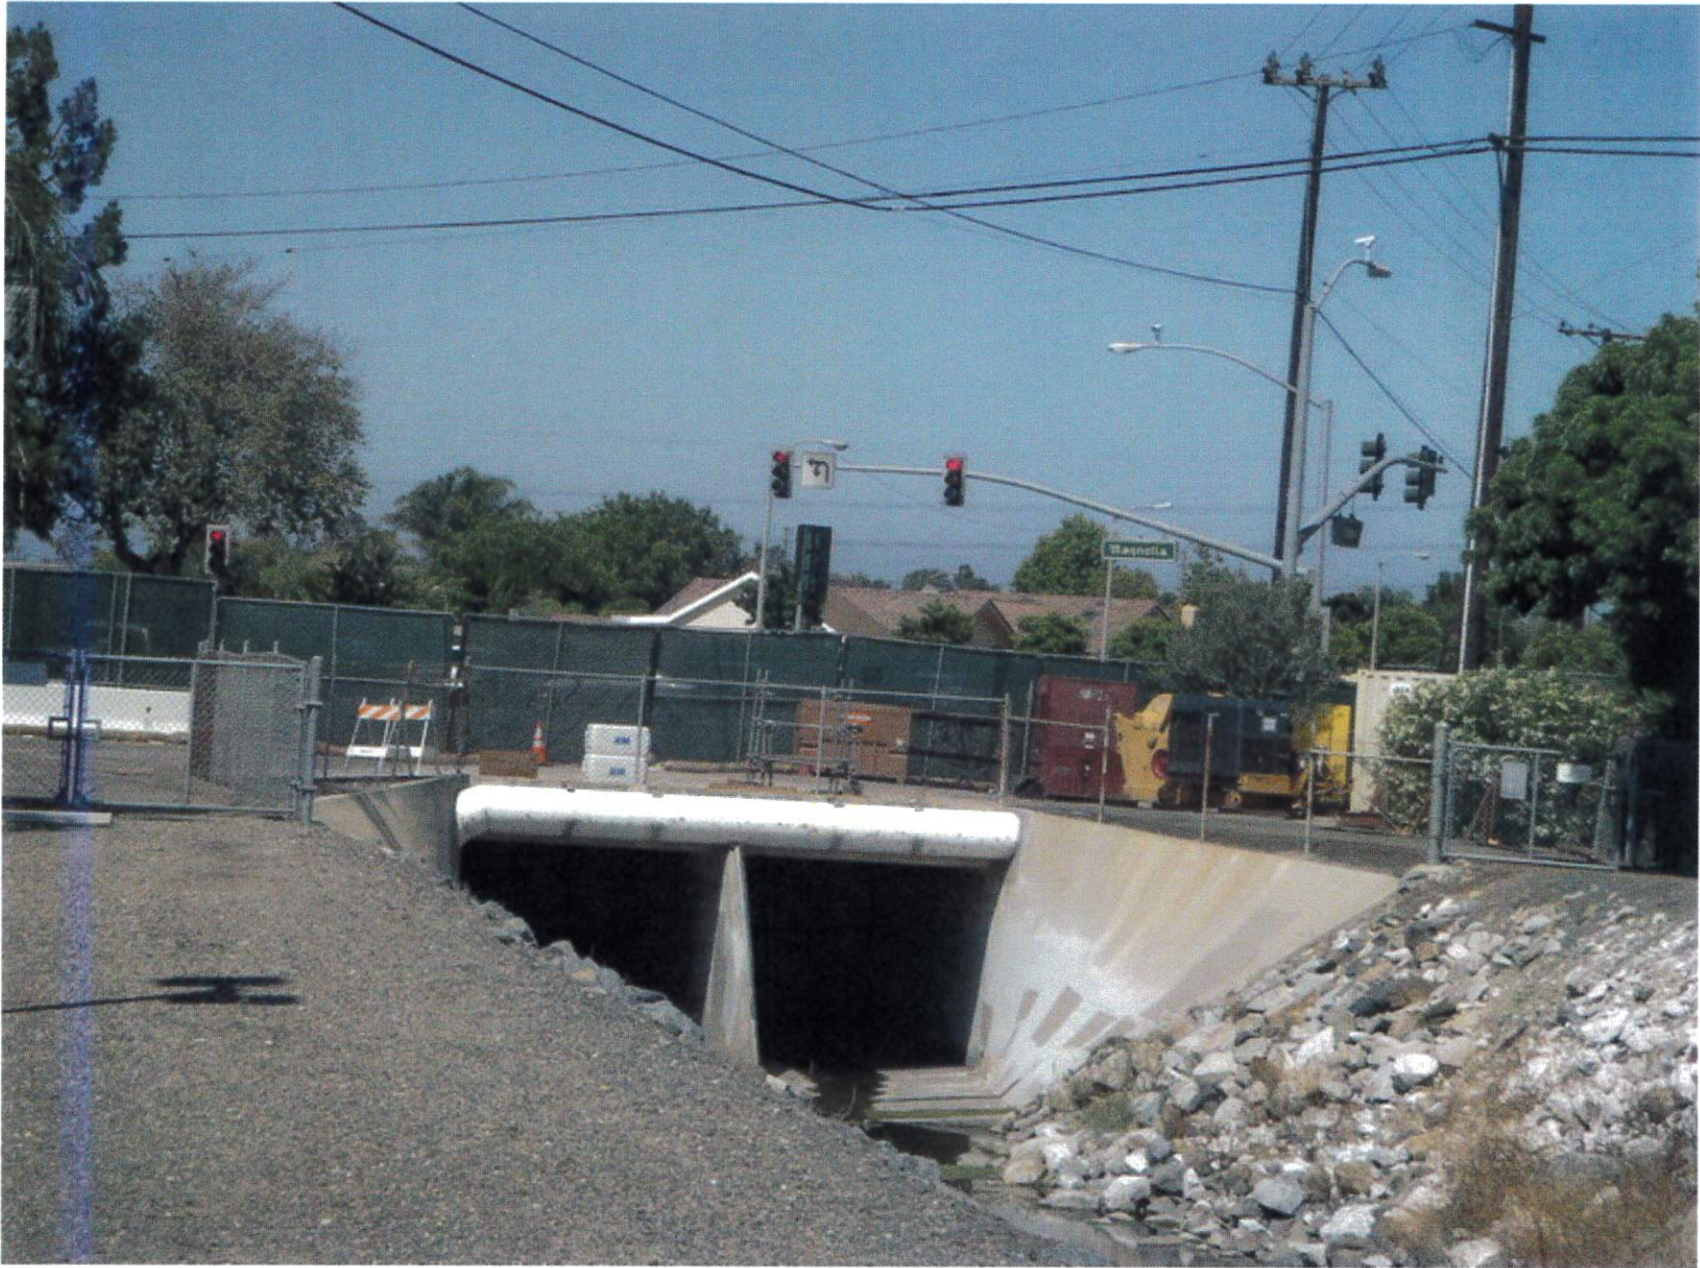
Photo No. 1
Side View looking West-South.

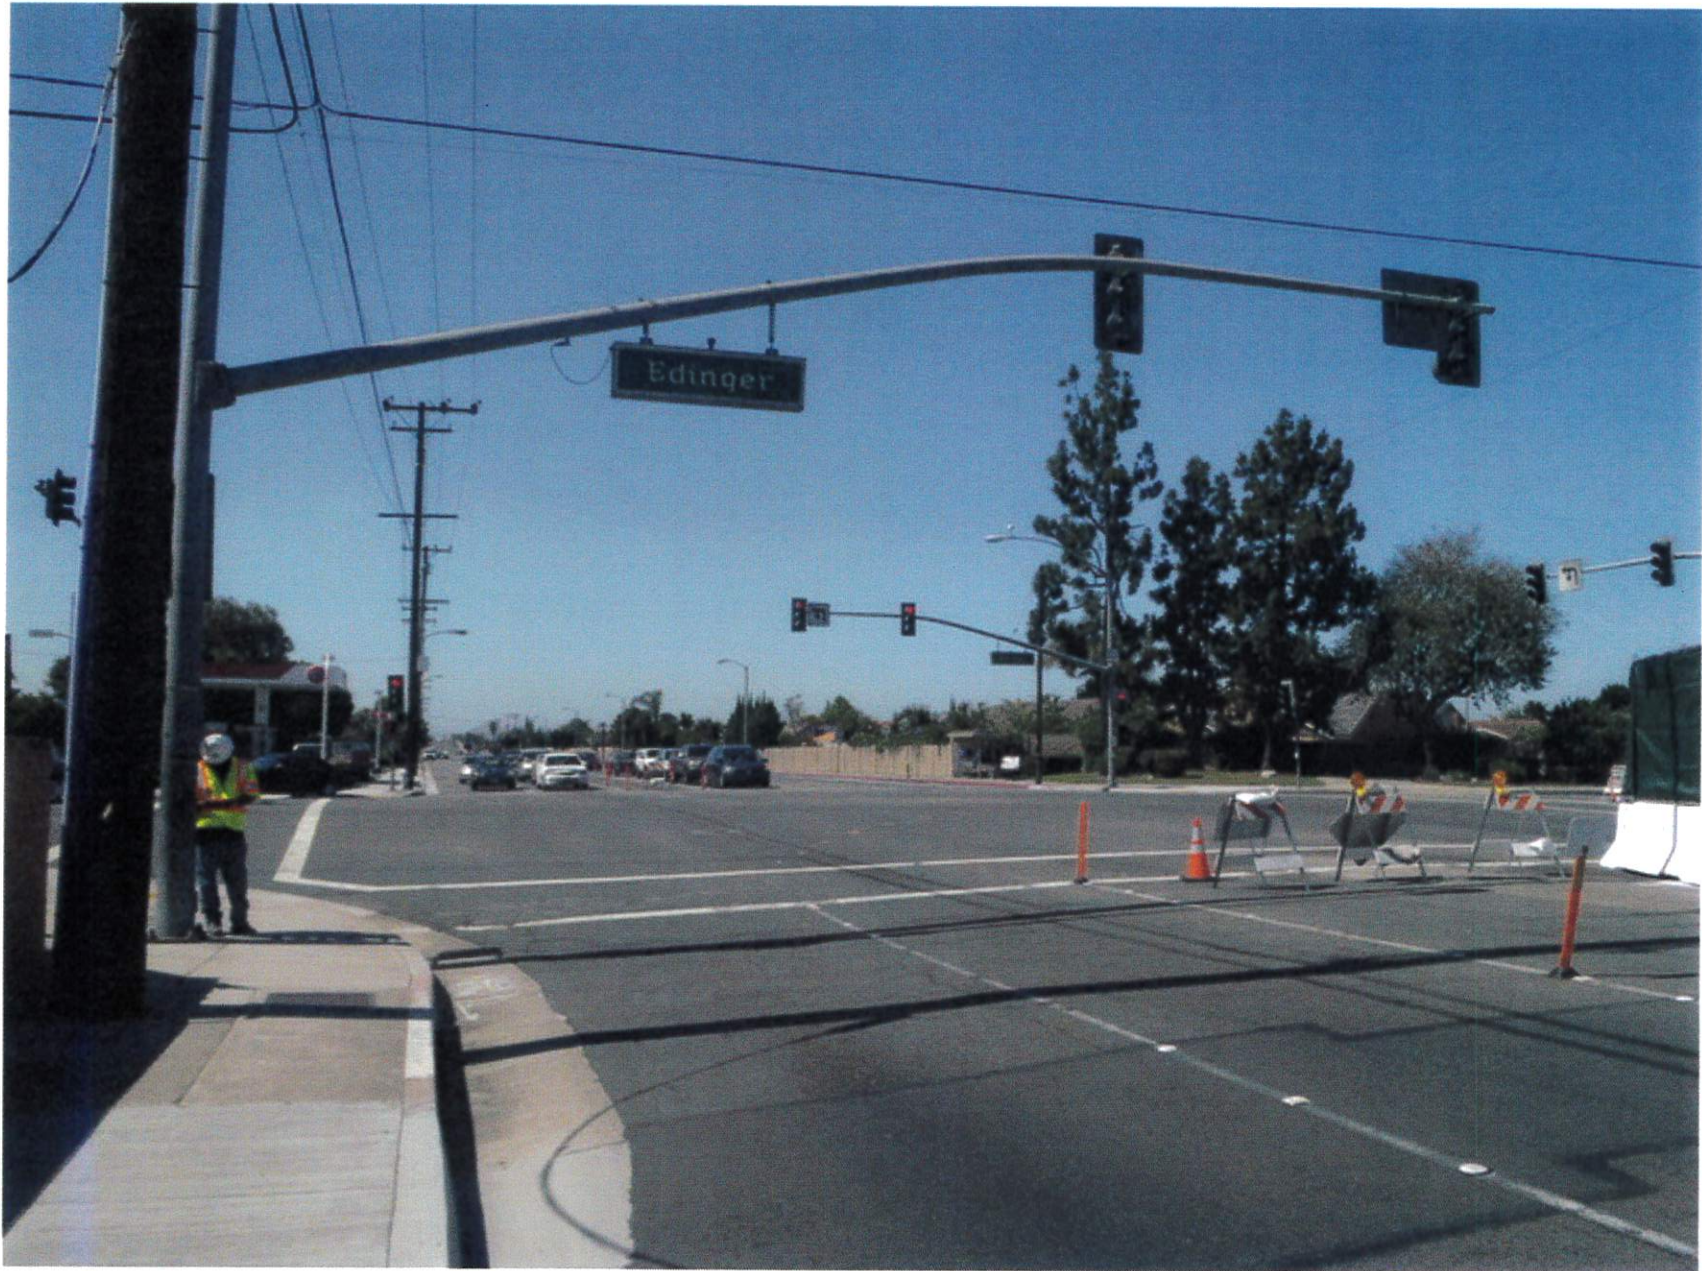
Photo No. 1
Deck View looking South.
