Bridge Number : 55C0457  
Facility Carried: EDWARDS ST  
Location : 100' N BOLSA AVE  
City : WESTMINSTER  
Inspection Date : 04/06/2019

# Bridge Inspection Report

**STRUCTURE NAME:** WESTMINSTER CHANNEL

Structure Description: Quadruple (10.00 feet W x 9.00 feet H x 107.00 feet L) RC box culvert (grade top) beneath 1.00 foot of earth fill.

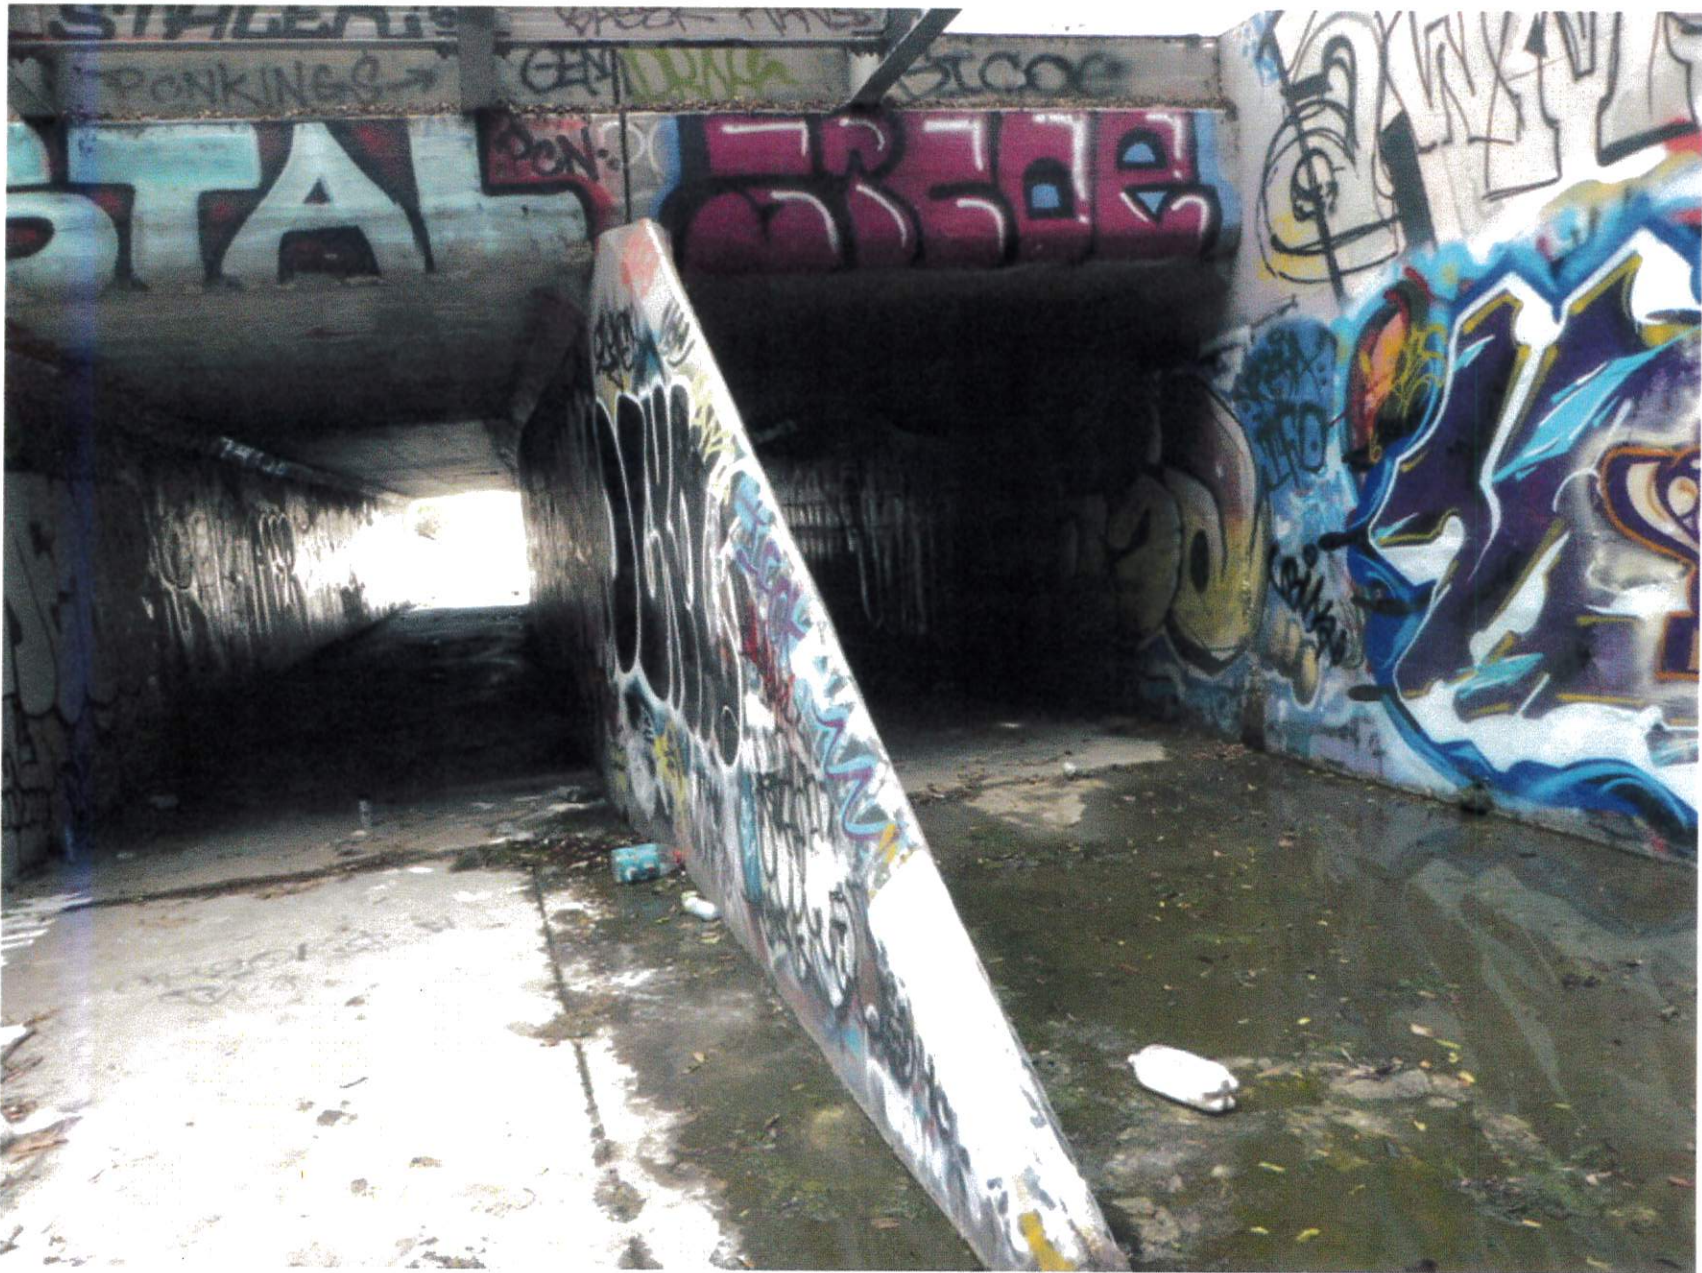
All of the culvert walls are covered with graffiti (see the attached photos no. 4 and 5).

Photo No. 5  
Graffiti is on the walls at the east end.

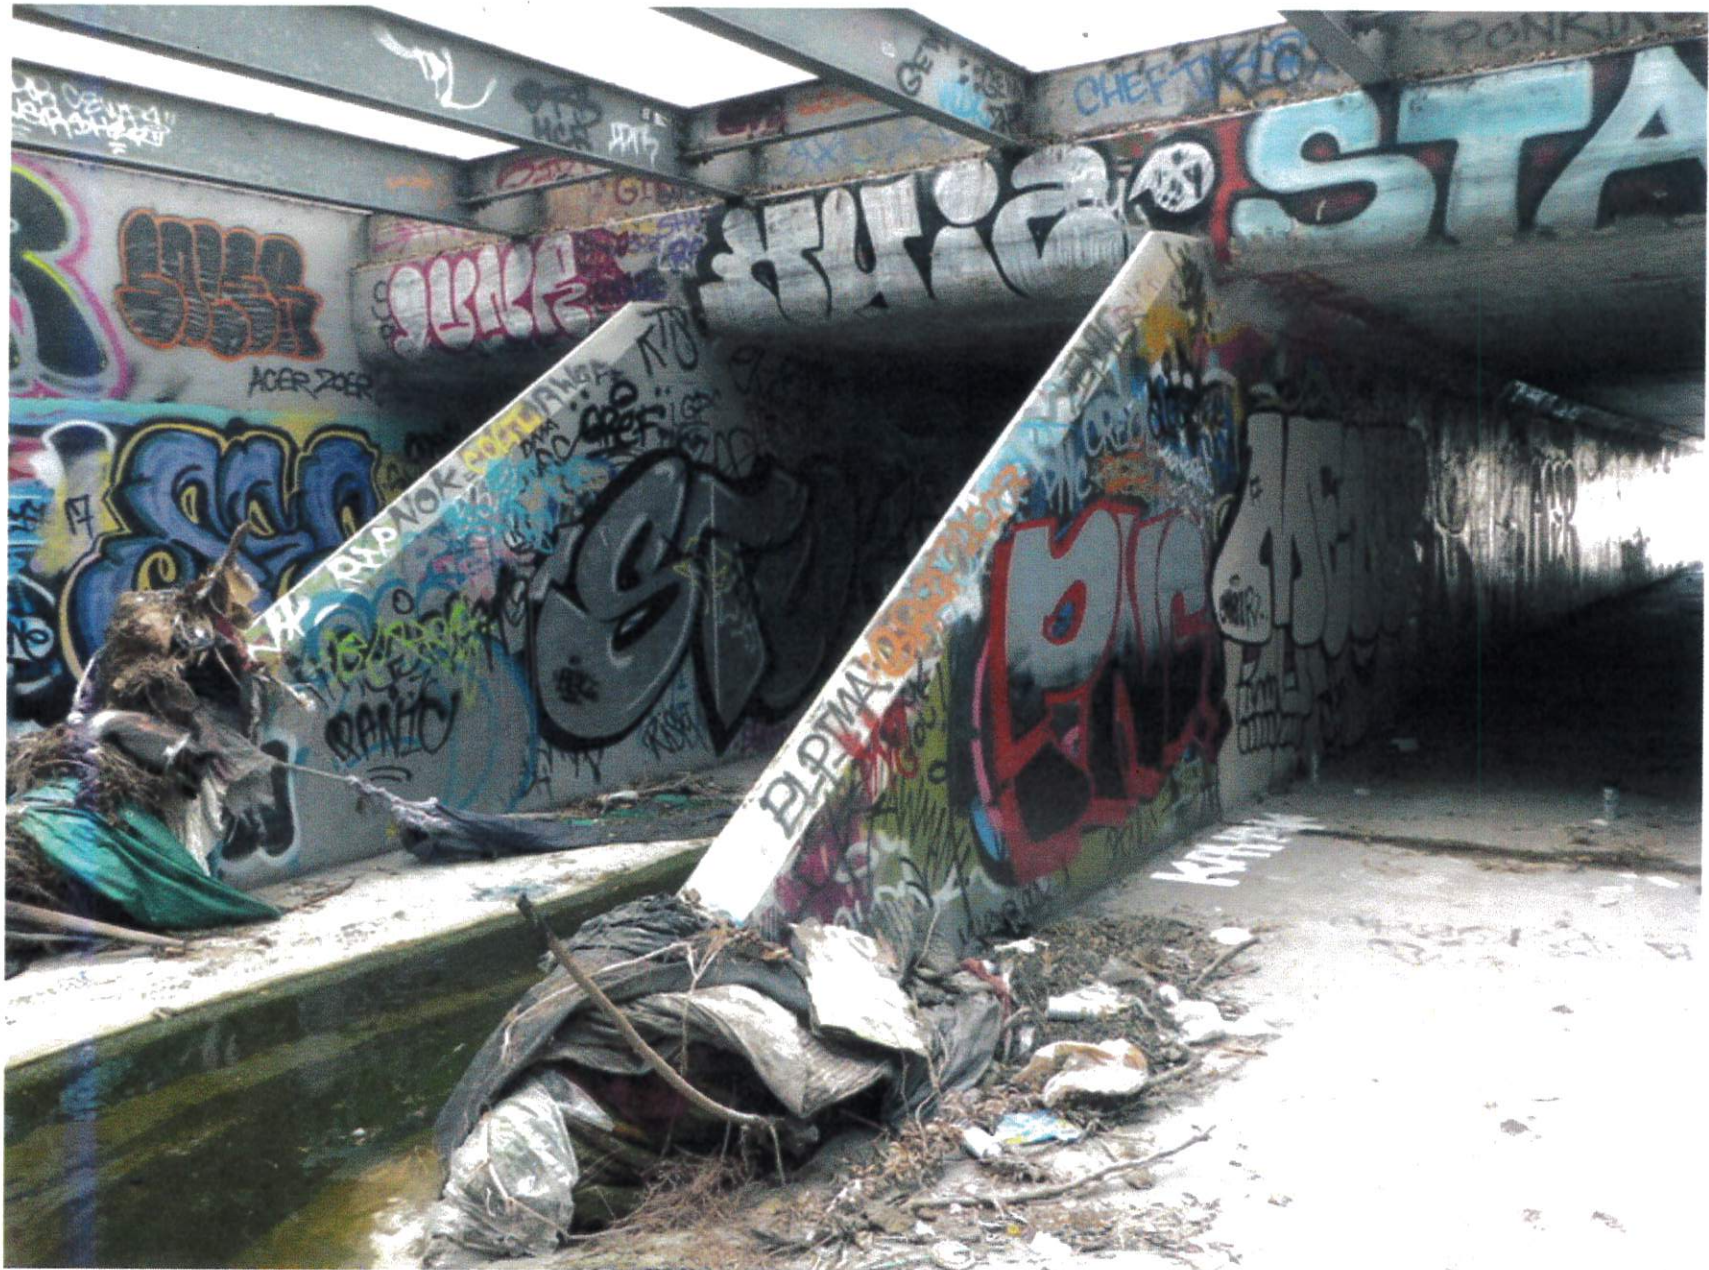
Photo No. 4  
Graffiti is on the walls at the east end.

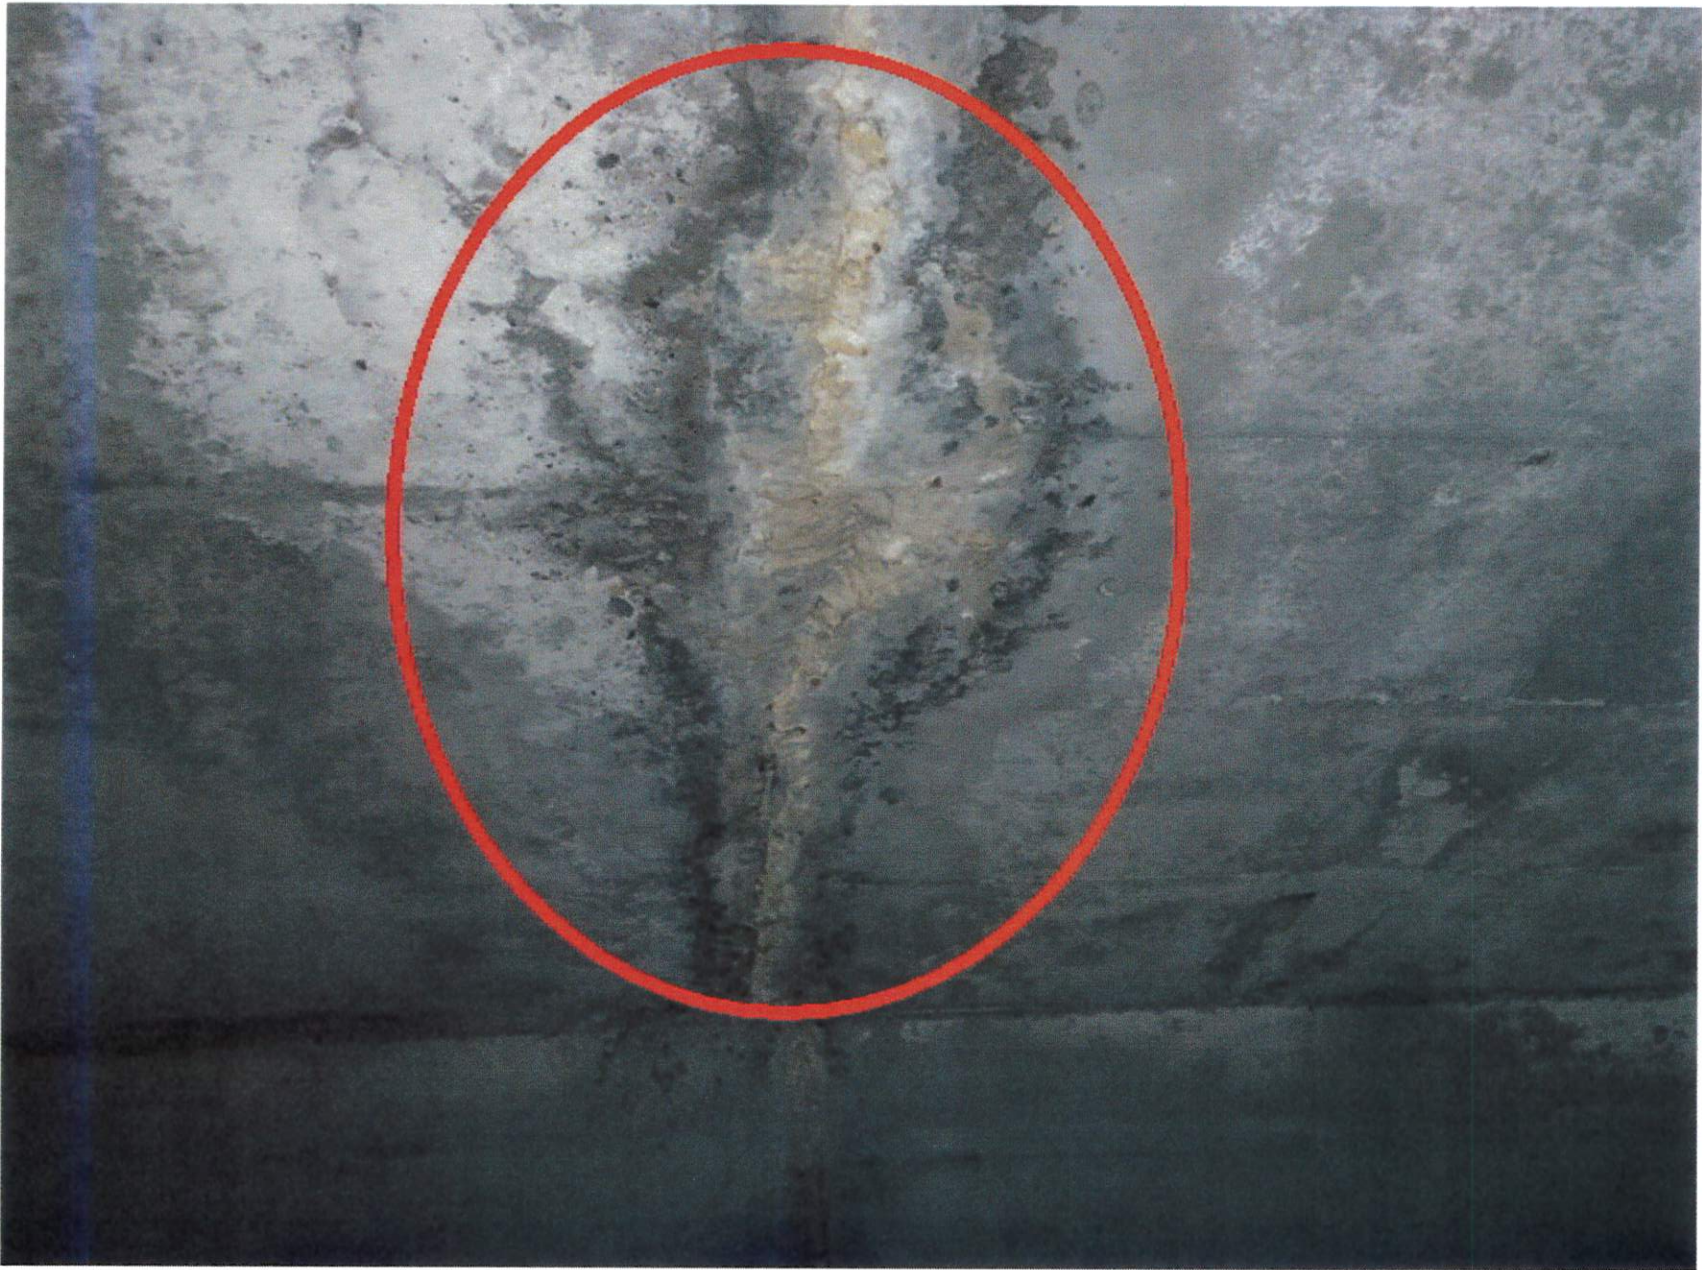
The culvert soffit of the top slab, there are two longitudinal construction joints with white efflorescence in between all barrels. The easterly construction joint has a sign of water leaking more than the westerly construction joint (see the attached photos no. 2 and 3).

Photo No. 3  
White efflorescence at the construction joint.

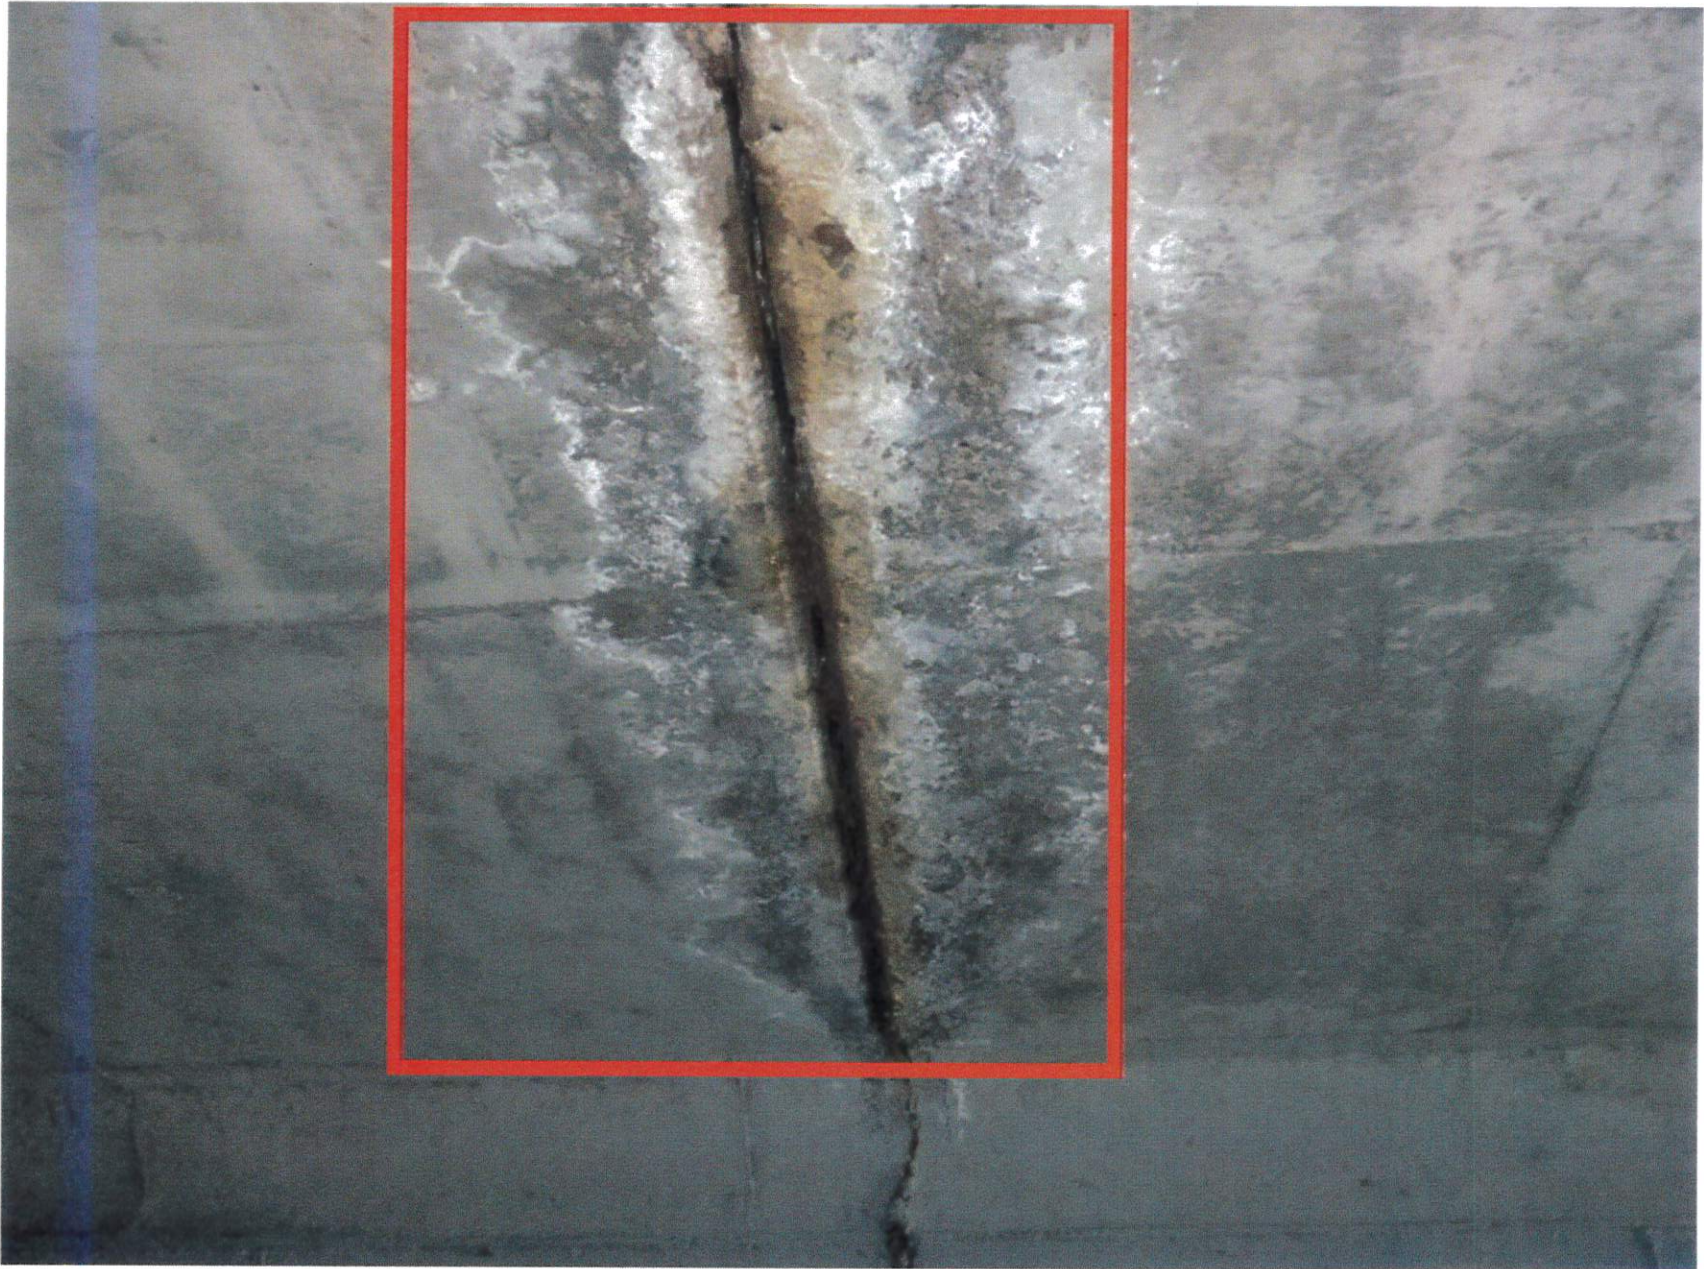
Photo No. 2  
White efflorescence at the construction joint.
