Bridge Number : 55C0545
Facility Carried: NEWLAND ST
Location : 0.3 MI S WESTMINSTER AVE
City : WESTMINSTER
Inspection Date : 04/05/2019

Bridge Inspection Report

STRUCTURE NAME: WESTMINSTER CHANNEL

Structure Description: Double (12.0 feet W X 8.8 feet H X 82.0 feet L) RC box culvert (non-grade top) beneath 2.0 feet of earth fill.

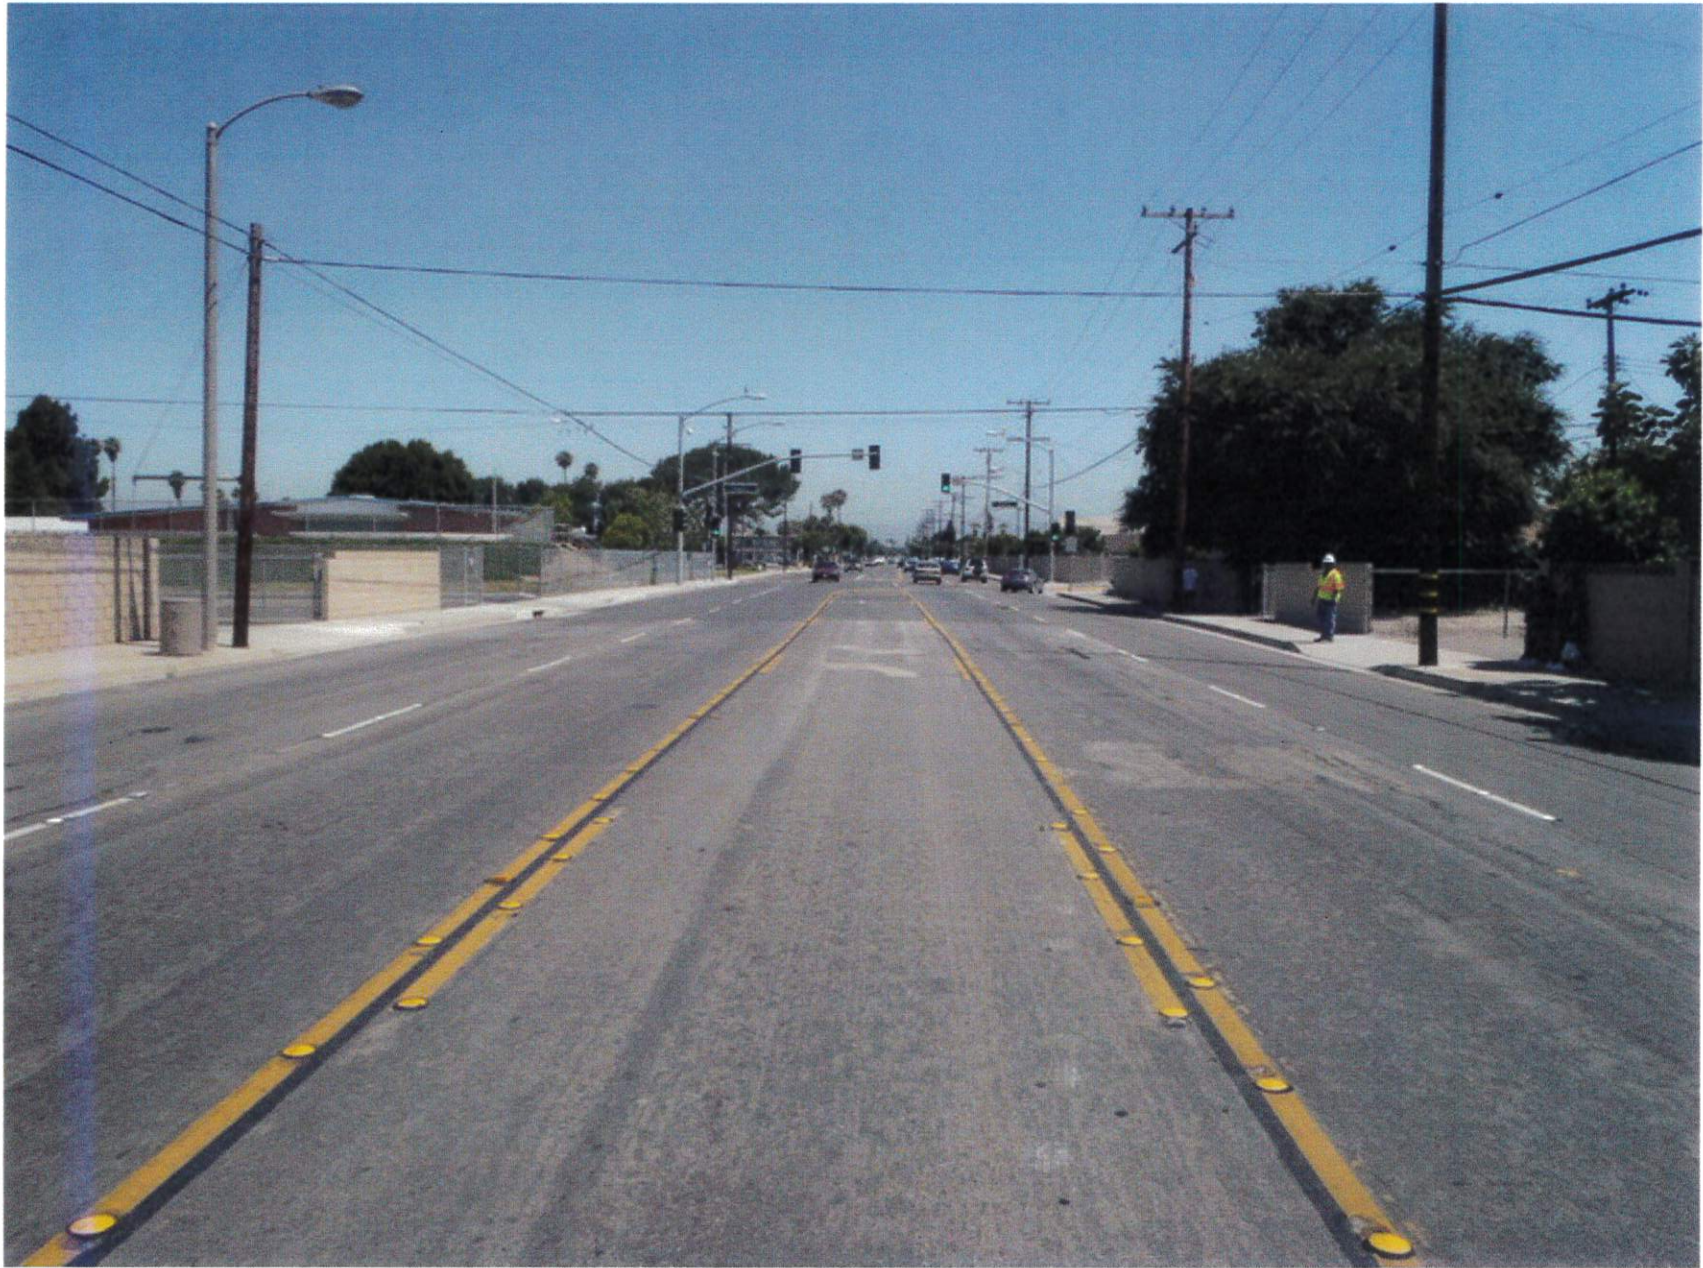
The Asphalt overlay has longitudinal and transverse cracks at (0.05 to 0.07 inches wide, 5.0 feet long) throughout entire deck surface. In addition, there are locations of AC depression approximately 1.0 to 2.0 inches settlement.

Photo No. 1
Deck View looking North.

RecDate: 04/05/2019 EstCost: Repave the entire Asphalt Culvert
 Action : Deck-Resurface StrTarget: 2 YEARS Roadway.
 Work By: LOCAL AGENCY DistTarget:
 Status : PROPOSED EA:

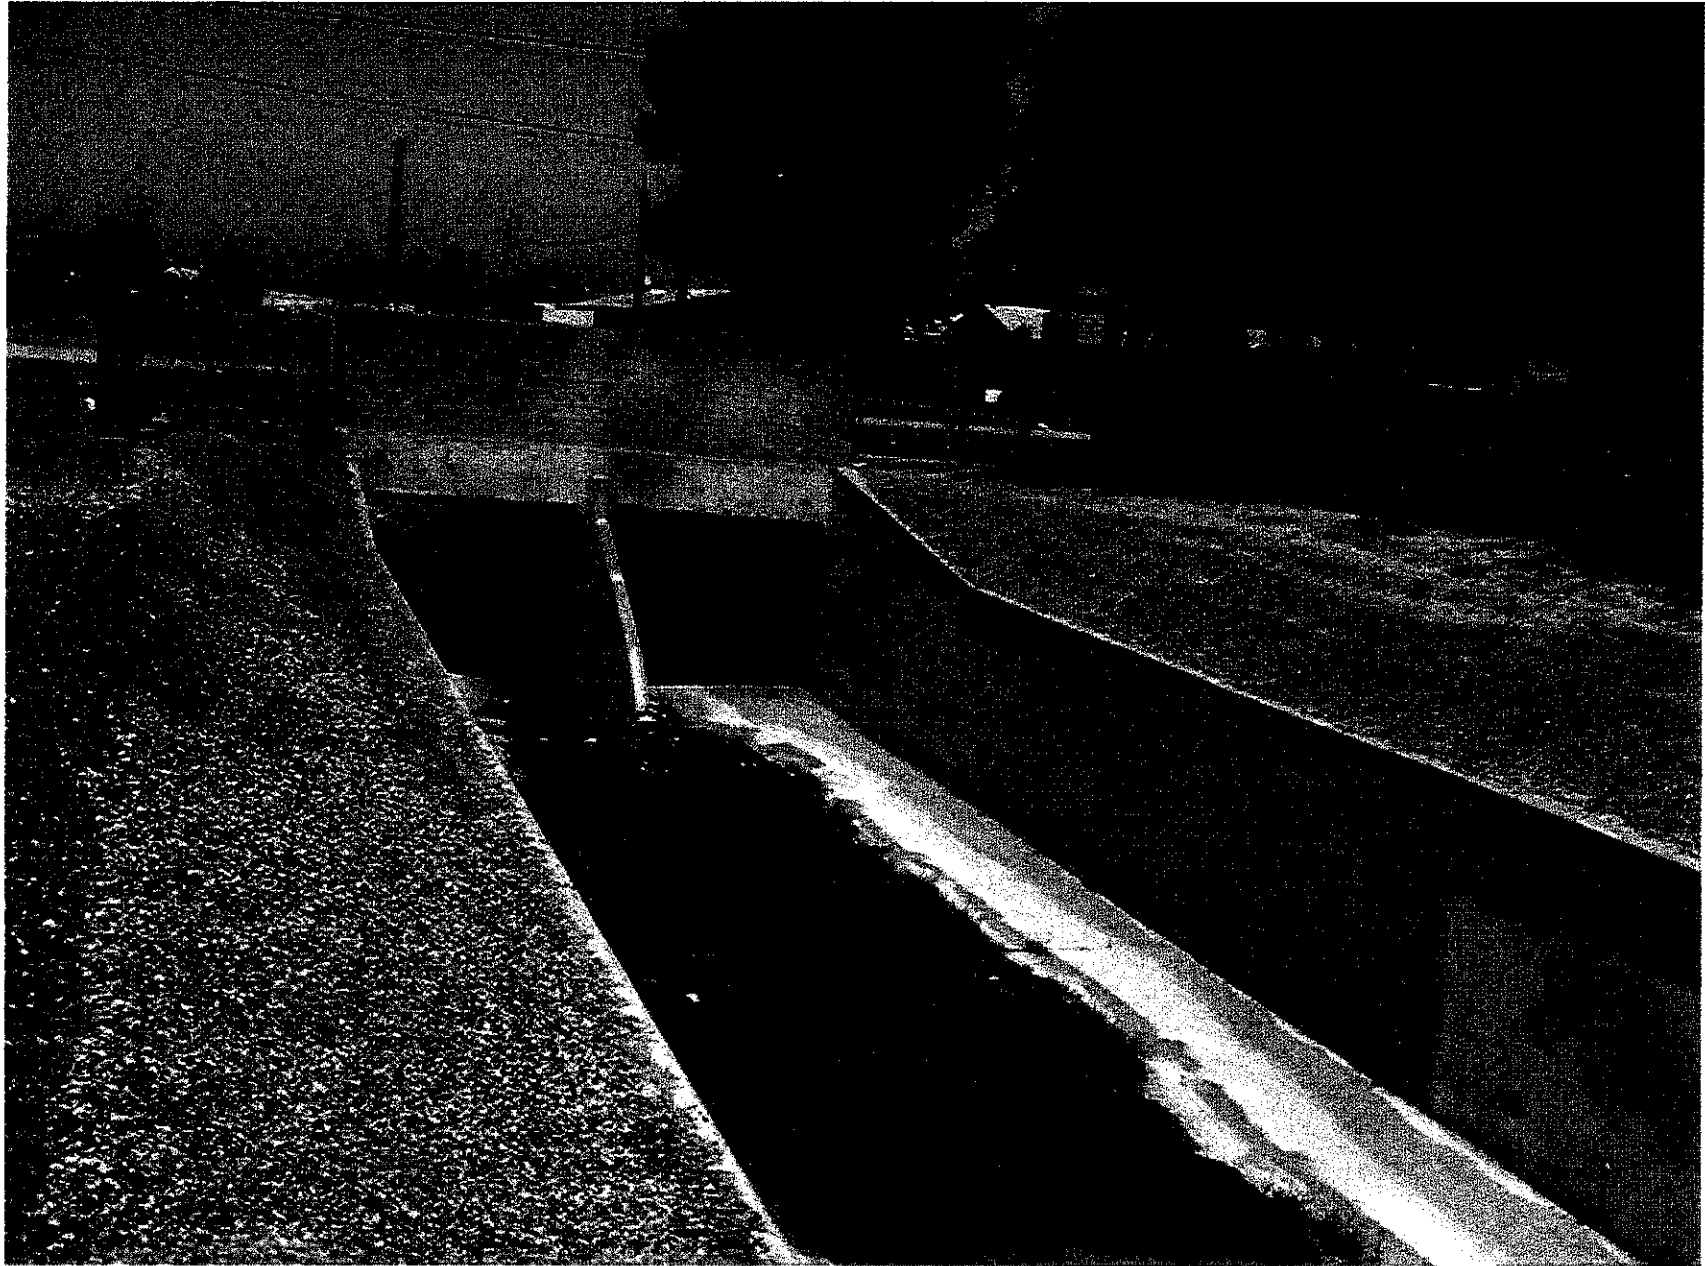
West headwall has two vertical cracks at (0.05 inches wide) right above both barrels.

Photo No. 1
Side View looking West.
