Bridge Number : 55C0648  
Facility Carried: WOODRUFF STREET  
Location : 0.2 MI N/O DREY ROAD  
City : WESTMINSTER  
Inspection Date : 04/05/2019

**Bridge Inspection Report**

**STRUCTURE NAME: EAST GARDEN GROVE-WINTERSBURG CHANNEL**

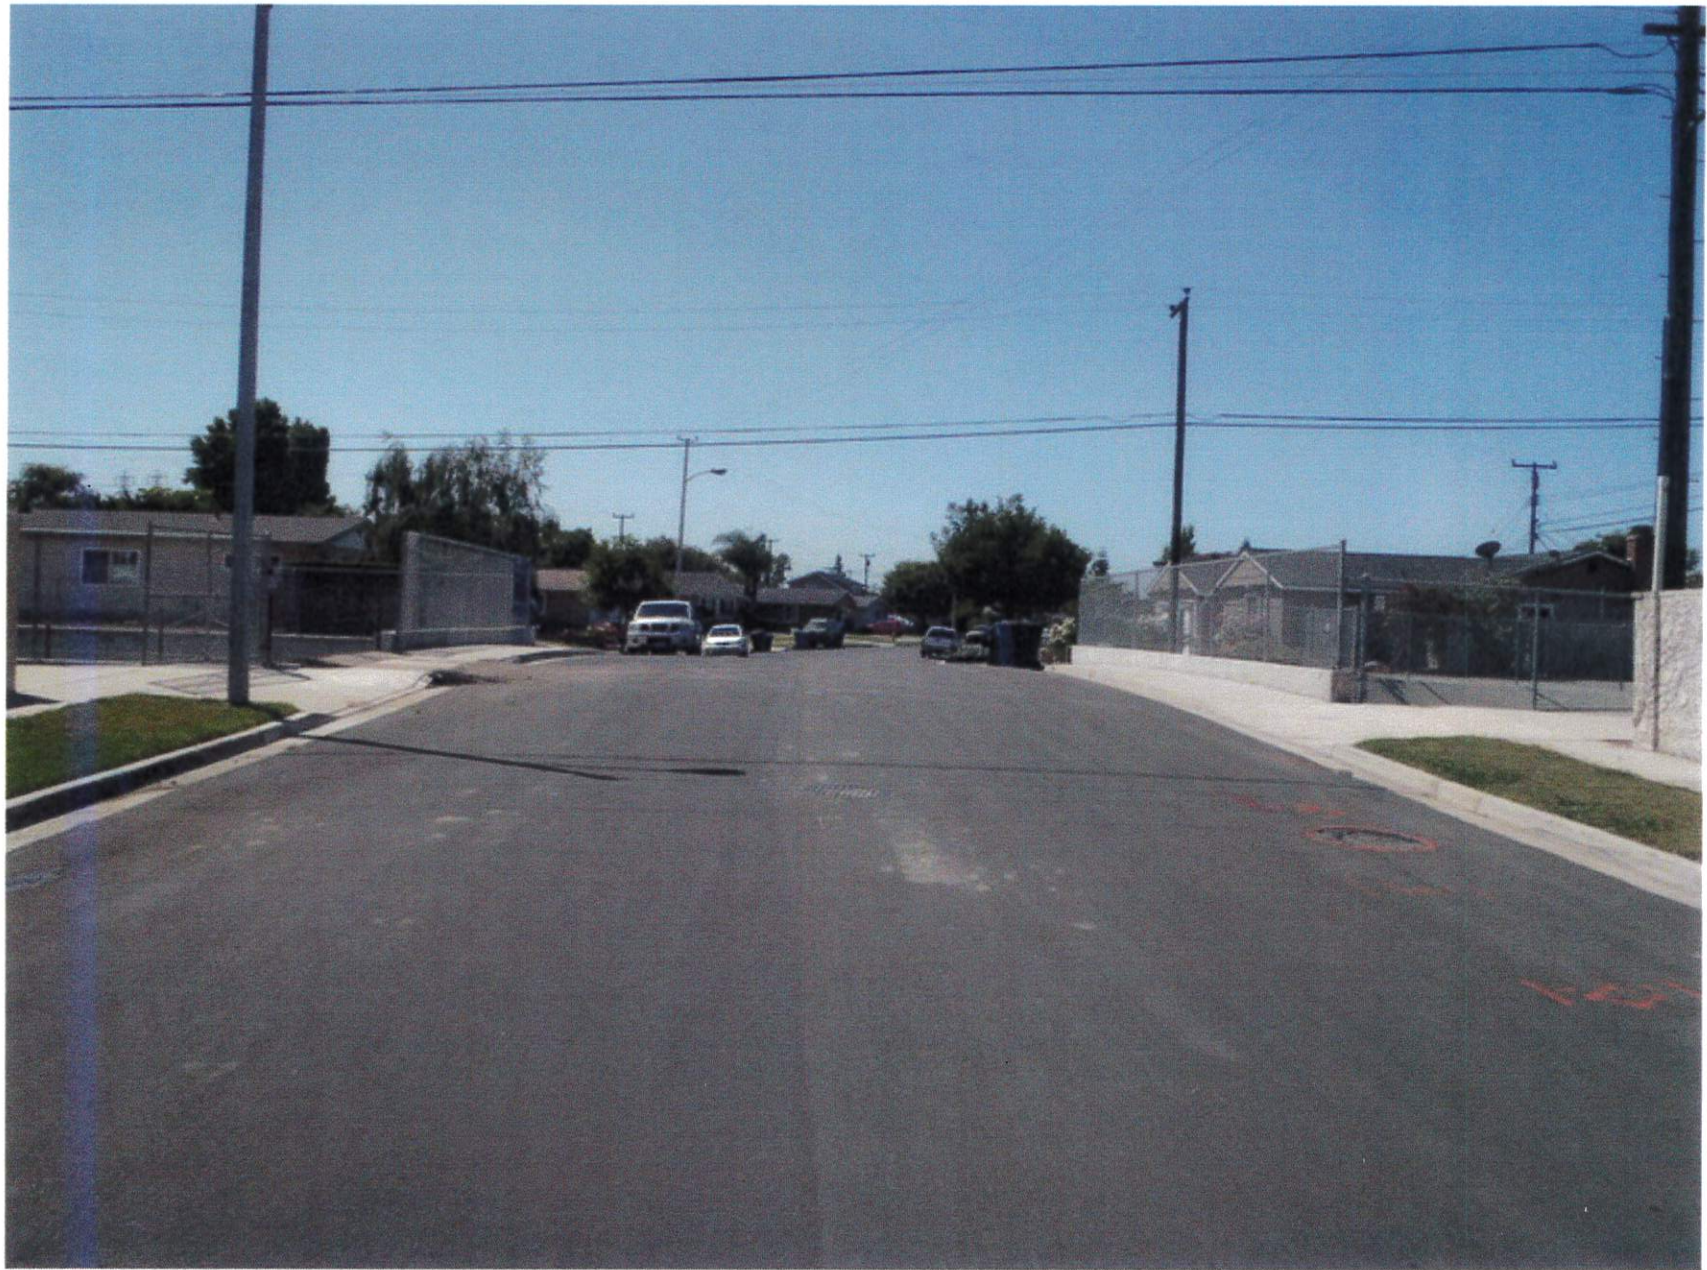
Photo No. 1  
Deck View looking South.

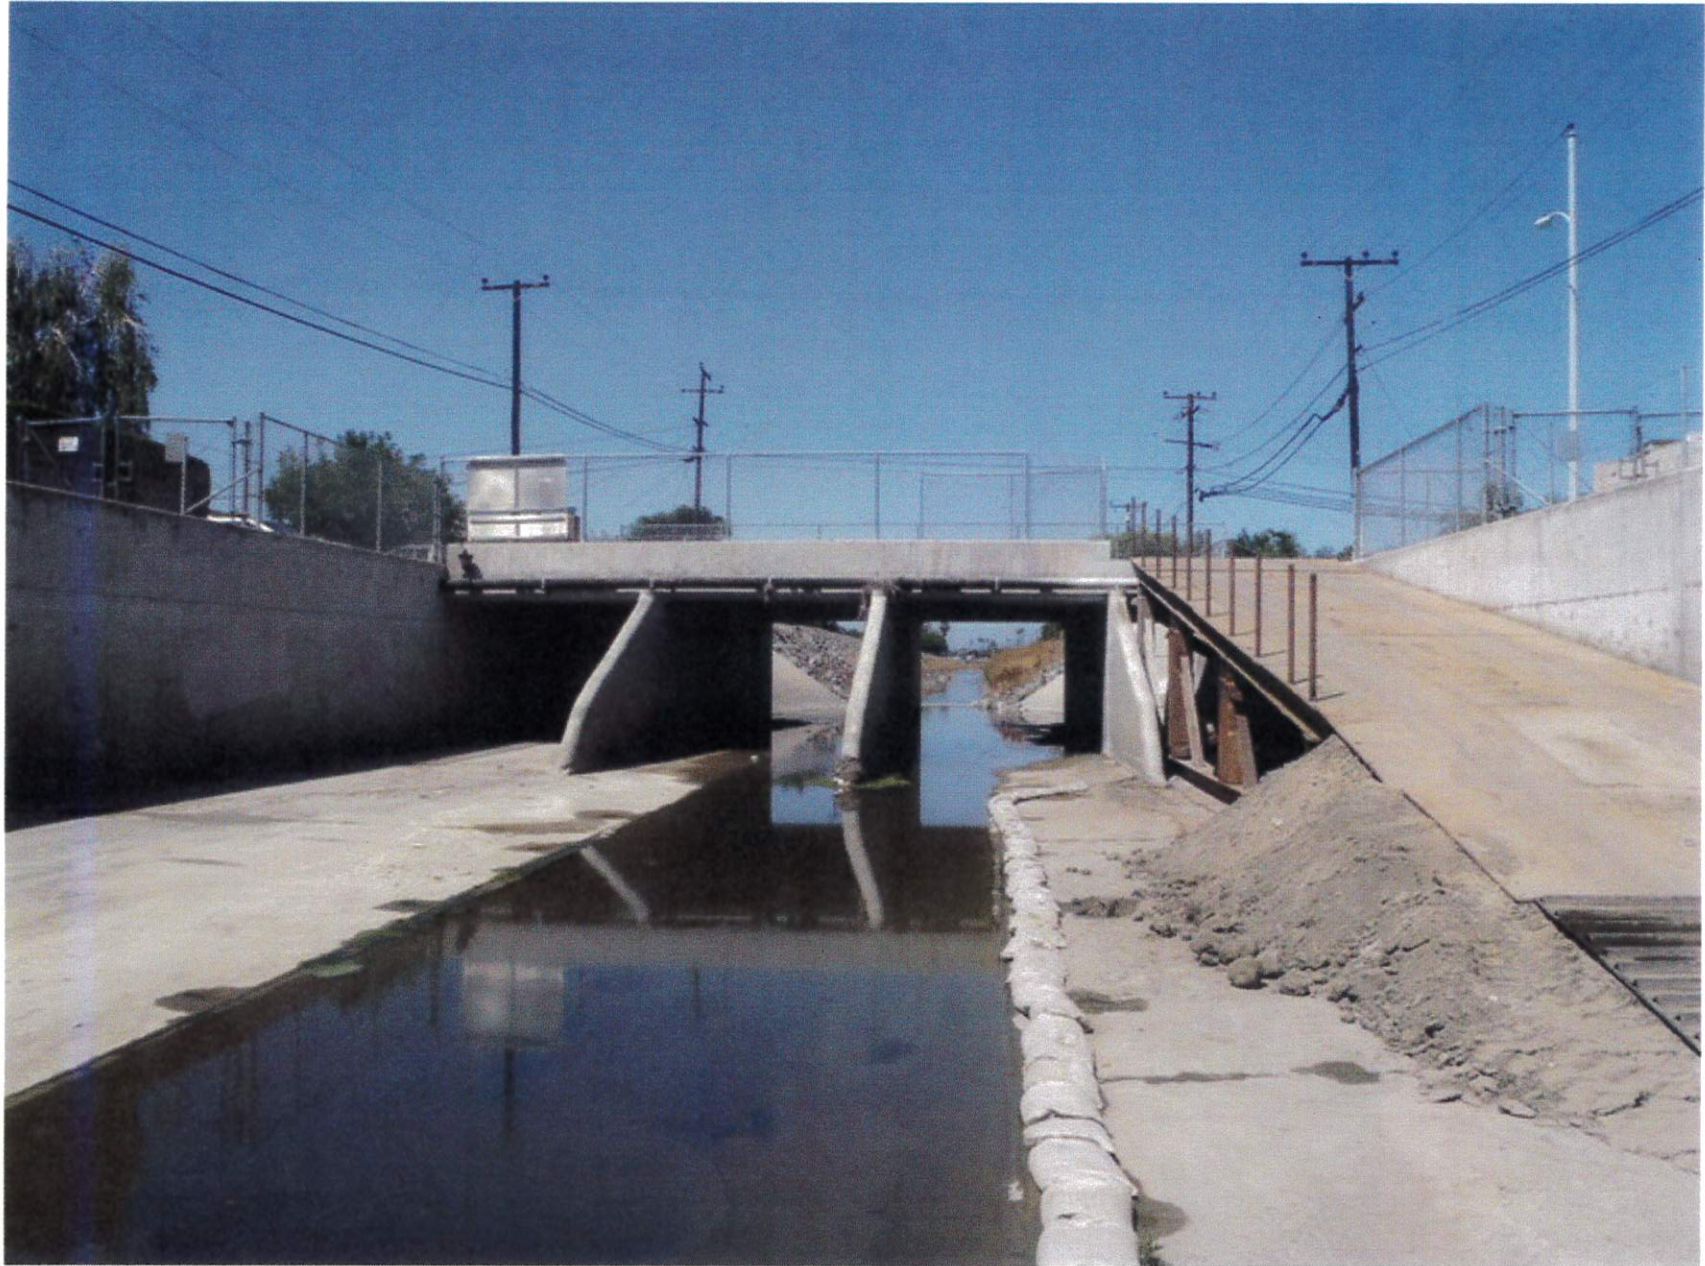
Photo No. 1  
Side View looking West.

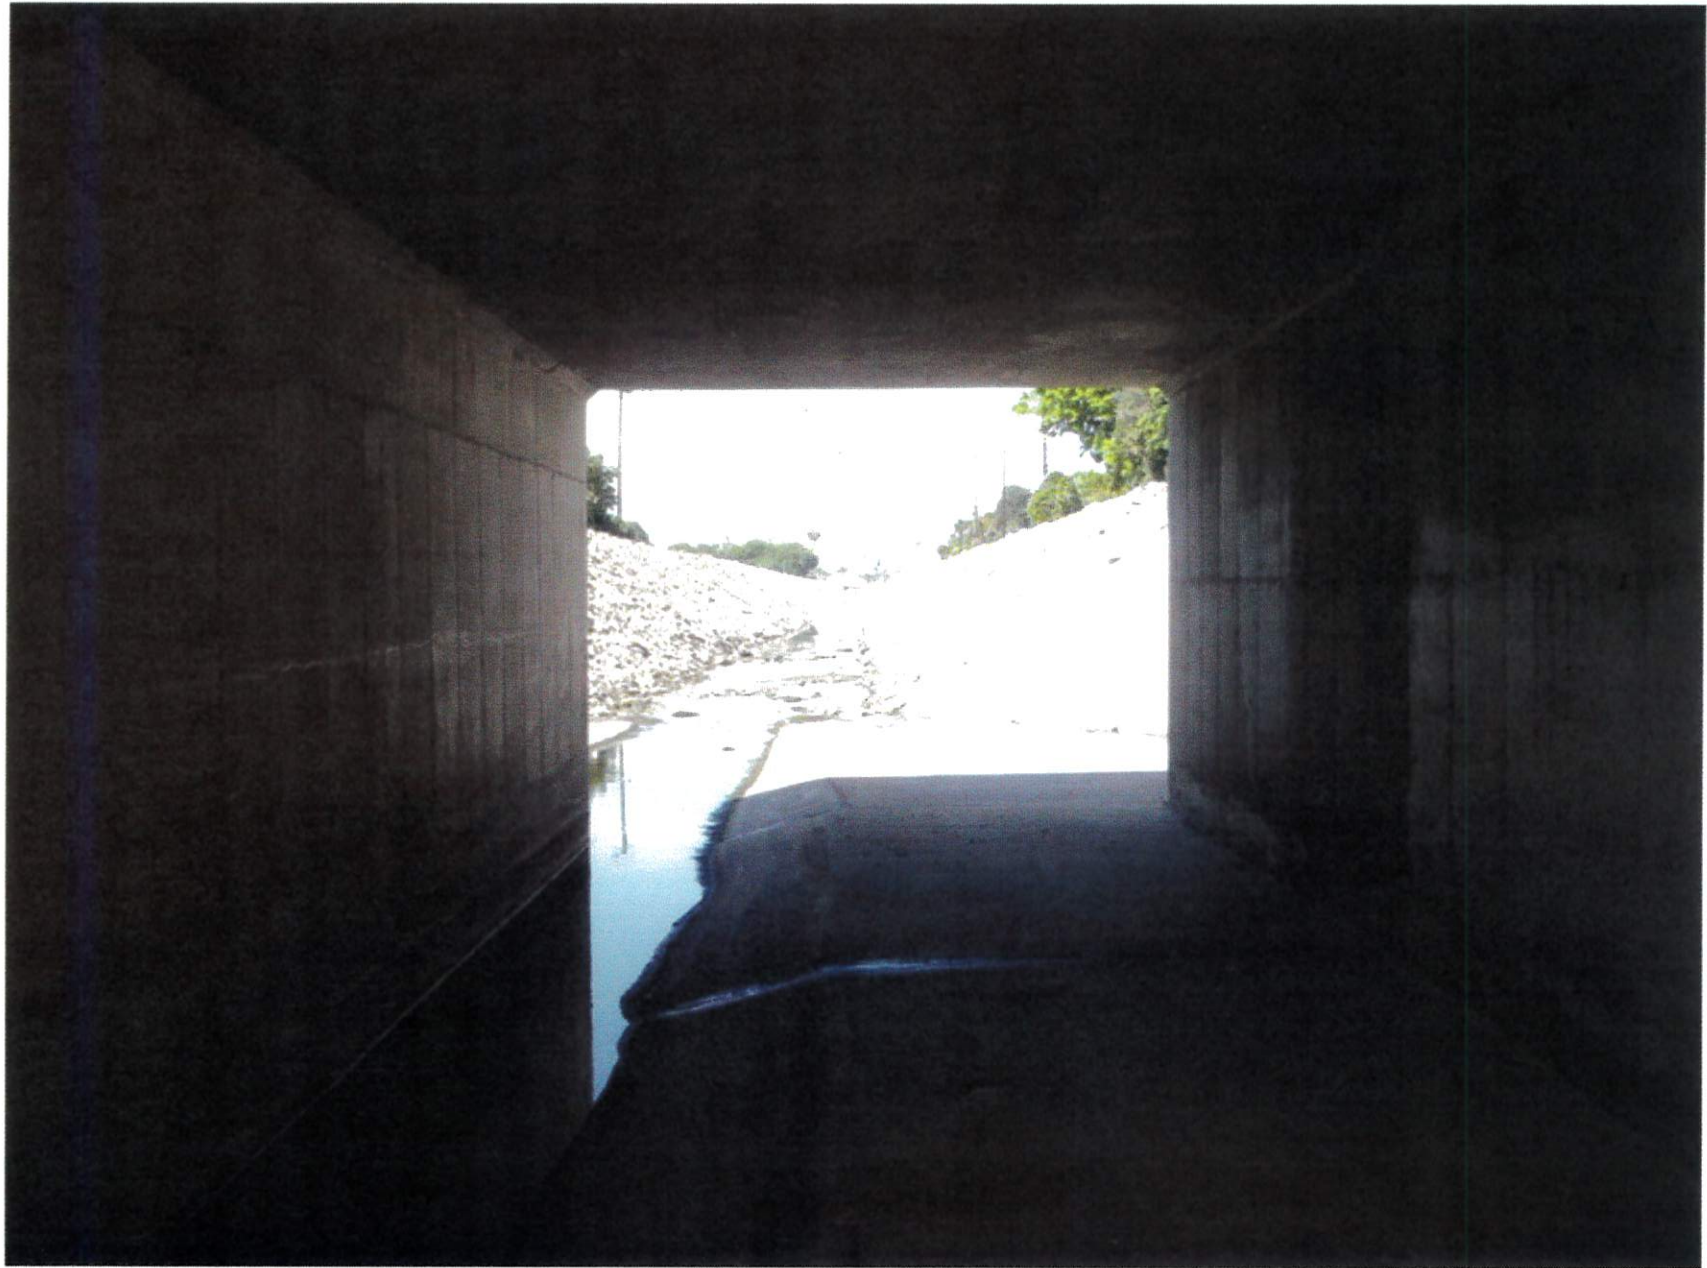
Photo No. 1  
Underside (barrel 3) View looking West.

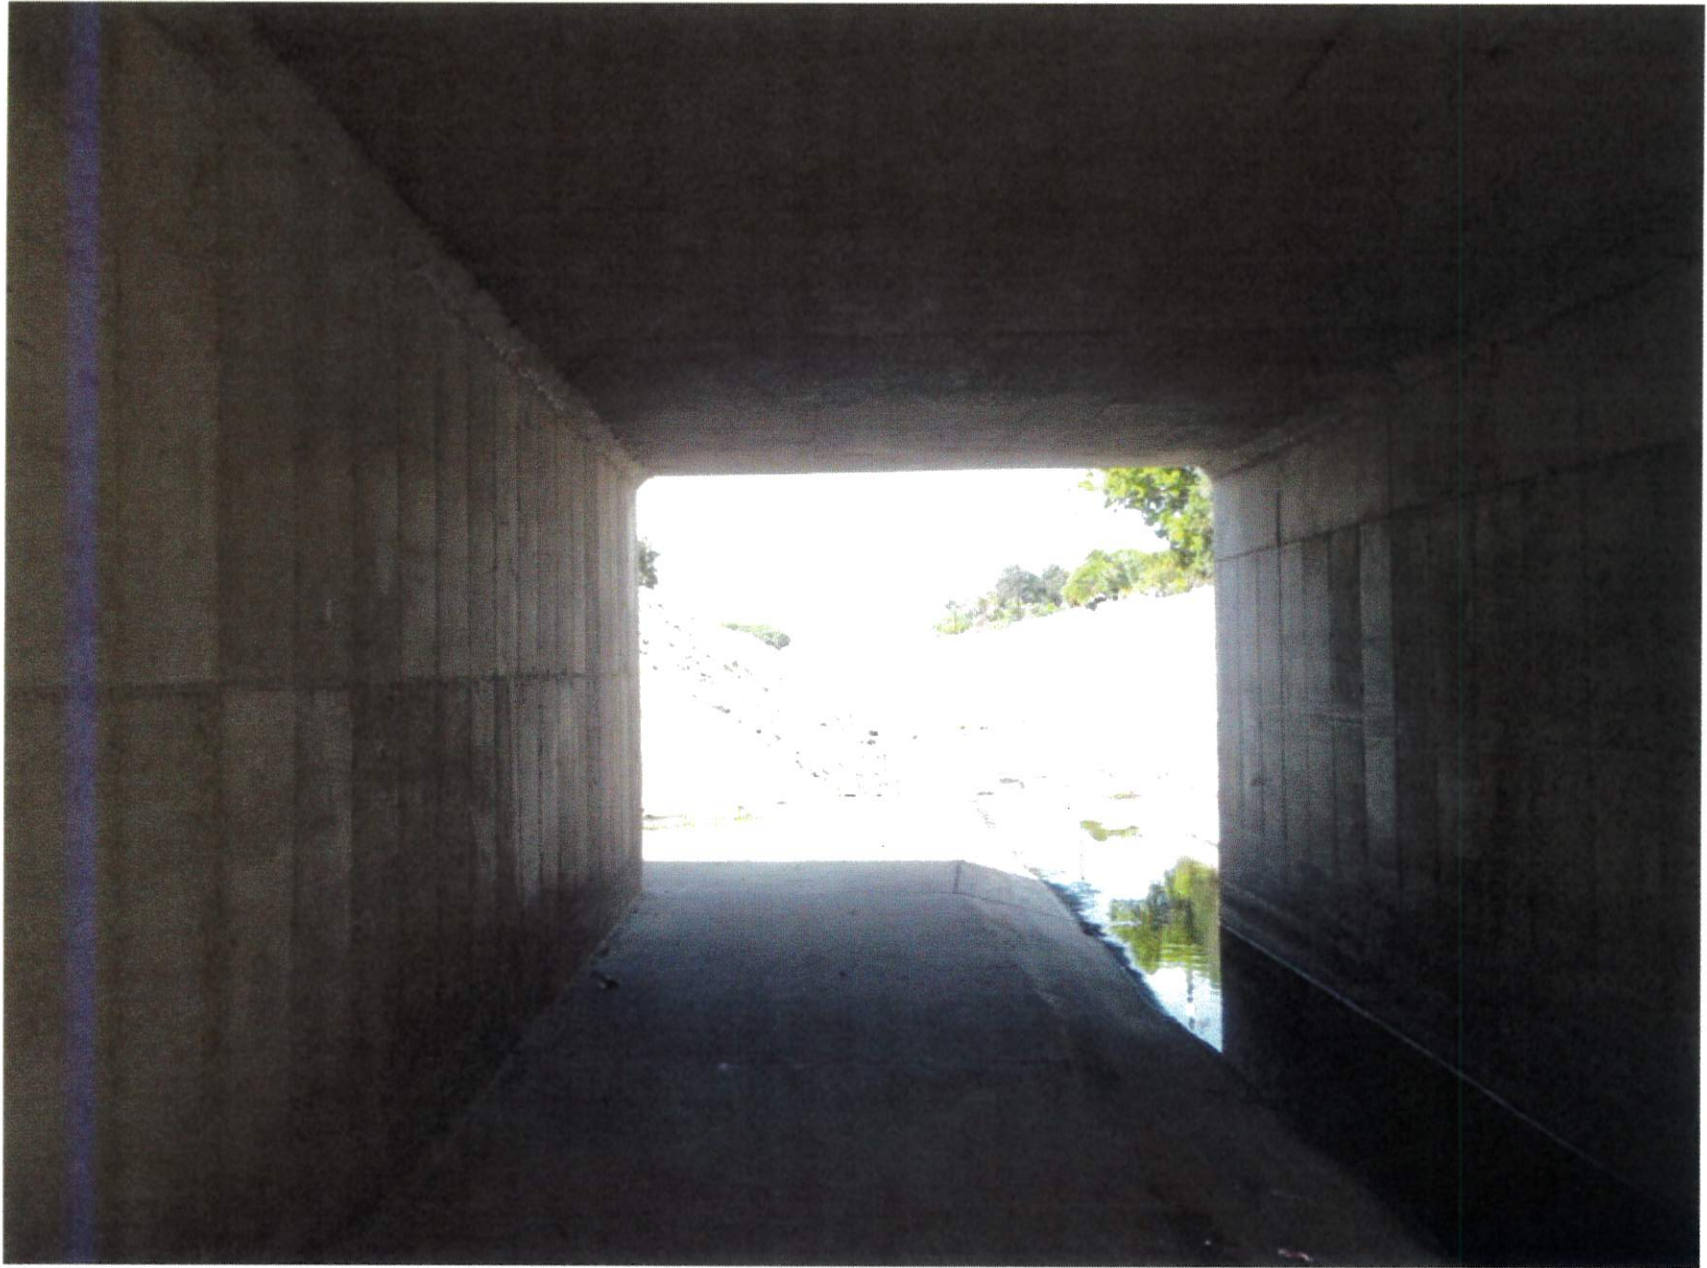
Photo No. 1  
Underside (barrel 2) View looking West.
