**Bridge Report Transmittal Sheet****Batch 51286****City of Westminster**

Bridge Number : 55C0649  
Facility Carried: QUARTZ STREET  
Location : 0.1 M S/O EDINGER  
City : WESTMINSTER  
Inspection Date : 04/05/2019

## Bridge Inspection Report

**STRUCTURE NAME:** EAST GARDEN GROVE-WINTERSBURG CHANNEL

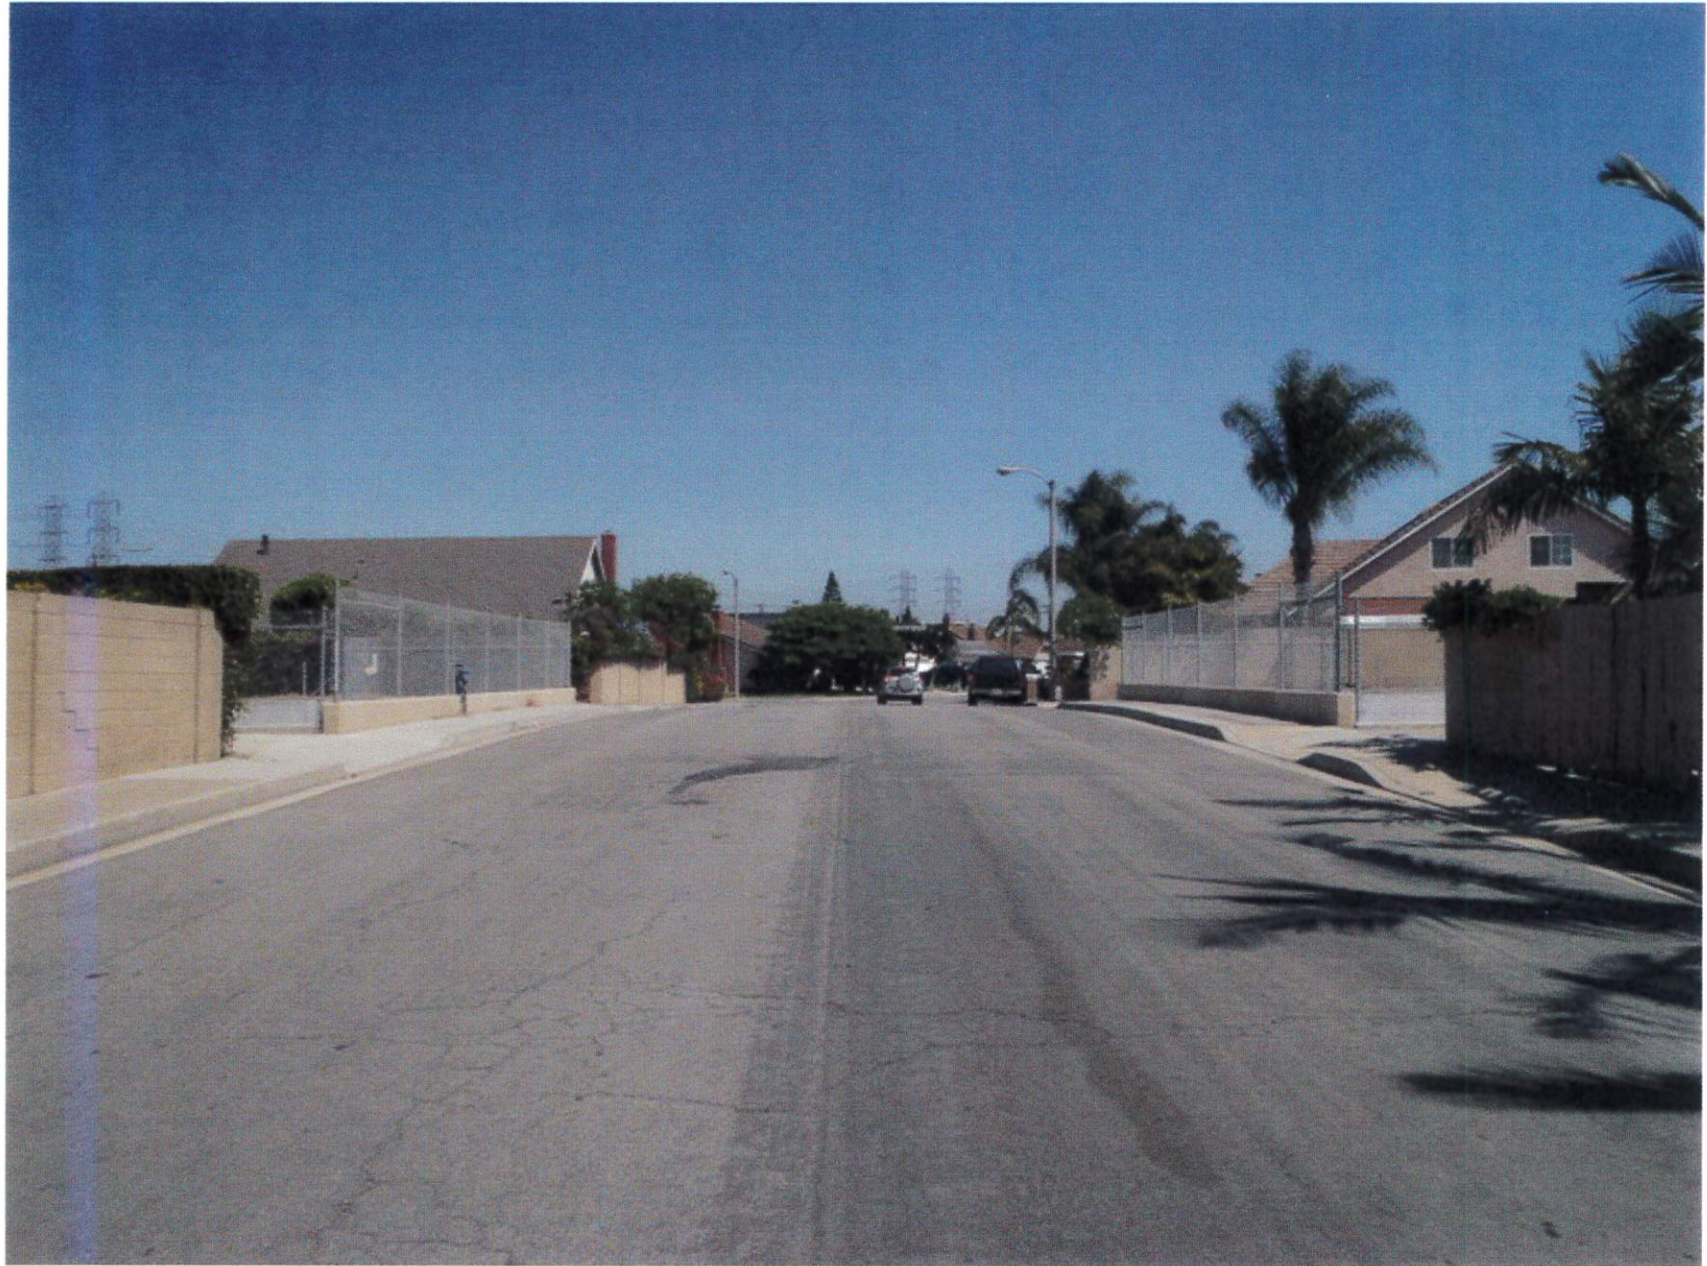
Photo No. 1  
Deck View looking North

The Asphalt overlay of culvert surface is in good condition.

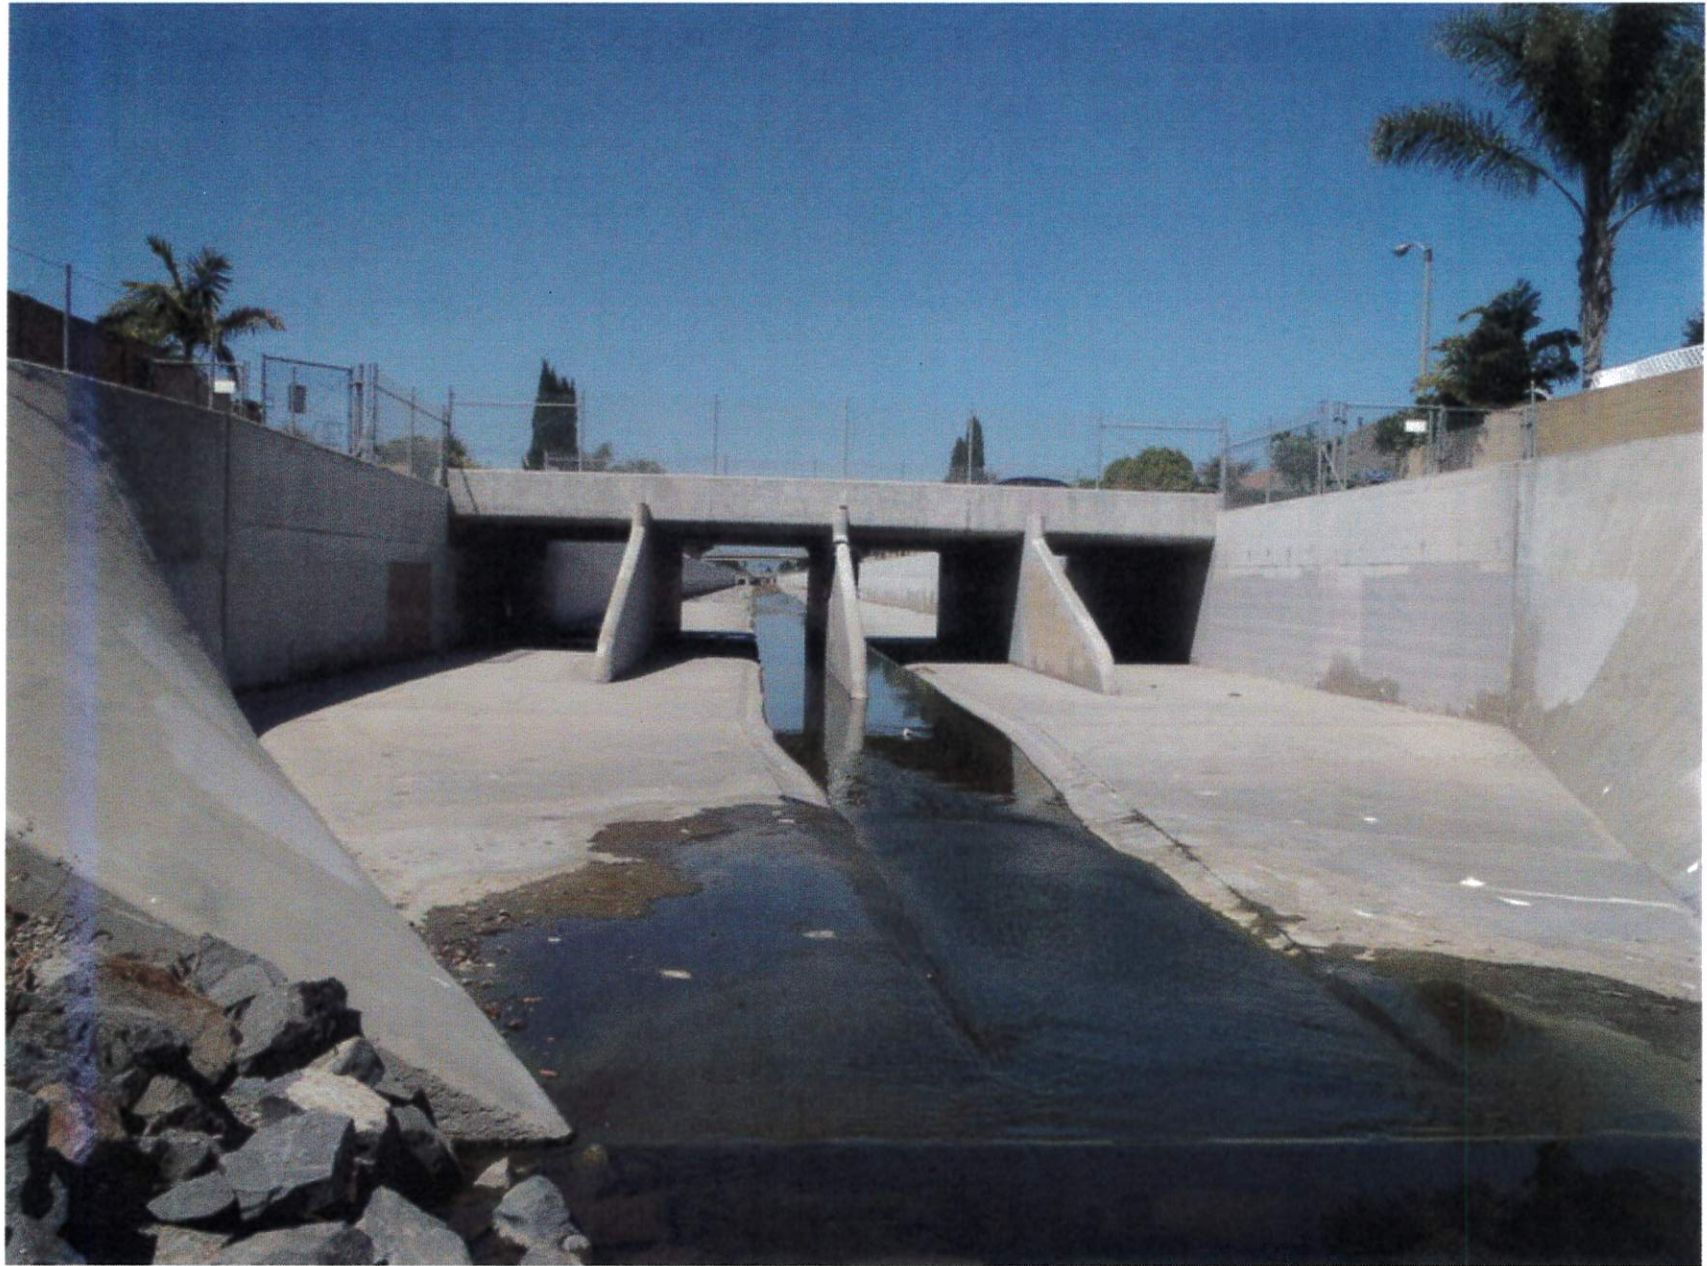
Photo No. 1  
Side View looking West

Each headwall has three vertical cracks at (0.04 inches wide) mainly above the interior box walls.
