**Bridge Report Transmittal Sheet****Batch** **40274****County of Orange**

**Bridge Number** : 55C0008  
**Facility Carried**: TRABUCO CANYON RD.  
**Location** : 1.4 mi n/o Santa Margarit  
**City** :  
**Inspection Date** : 09/07/2017

**Bridge Inspection Report**

**STRUCTURE NAME:** TRABUCO CREEK

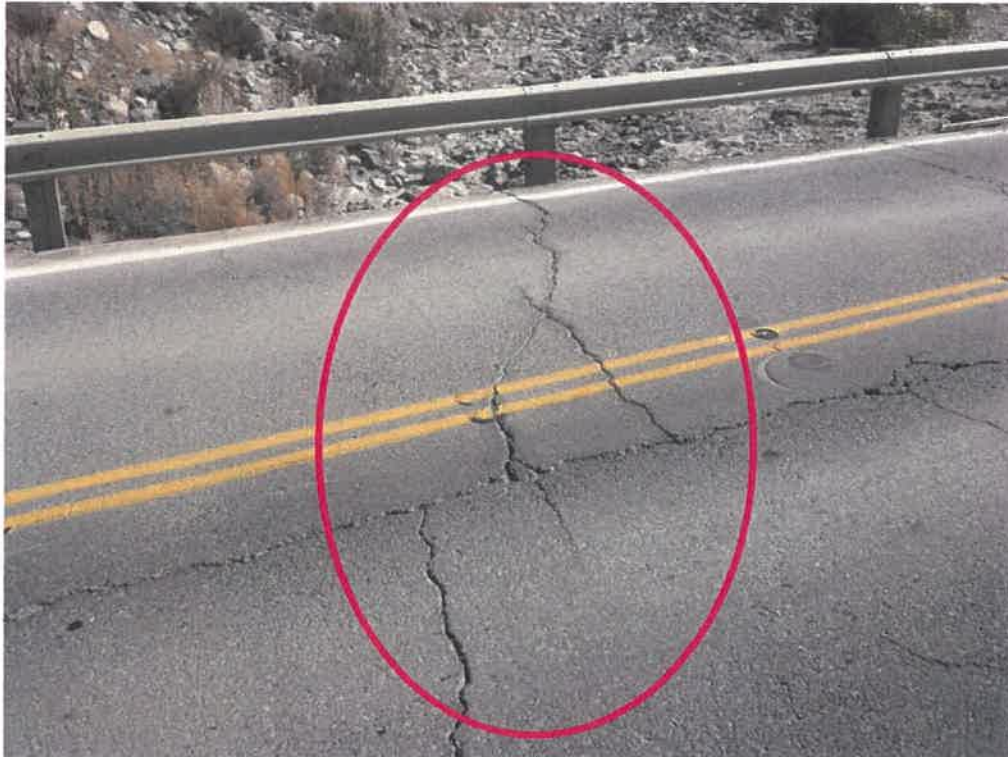
Photo No. 2

There are longitudinal crack at the middle of the bridge almost full bridge length and up to 1.0 inch wide; and transverse cracks above the supports 20 feet long, up to 1.0 inches wide. (see the attached photos no. 2 & 3)

Ac overlay transverse and longitudinal cracks up to 1 inch wide.

Seal all AC overlay cracks, that are up to 1 inch wide on the bridge deck.

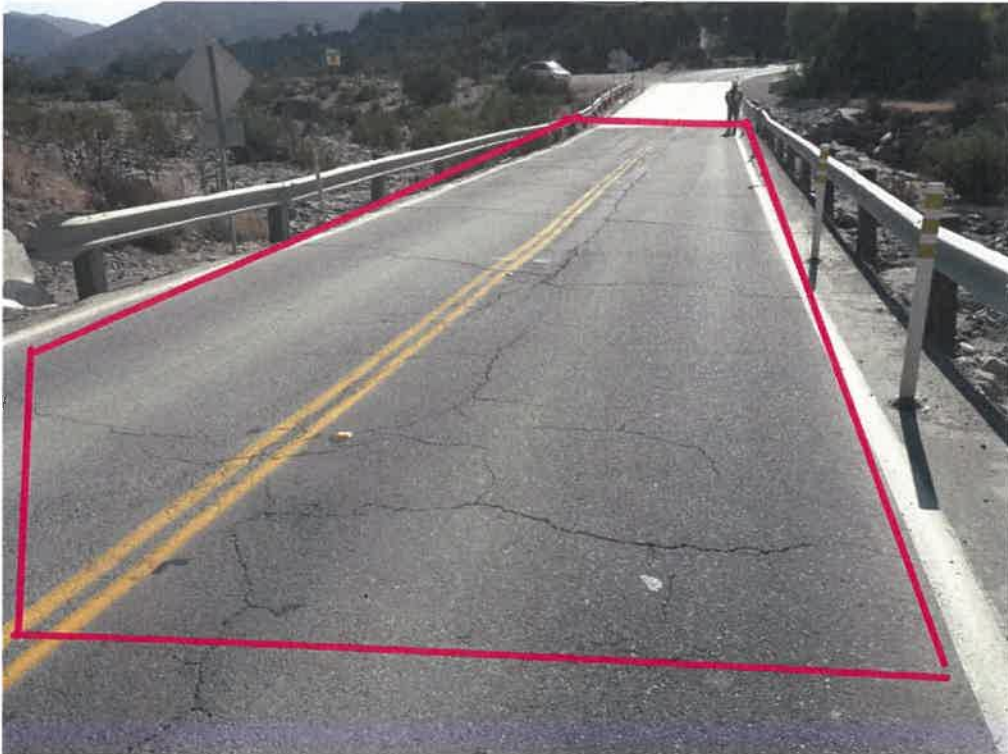
Photo No. 3

Ac overlay transverse and longitudinal cracks up to 1 inch wide.

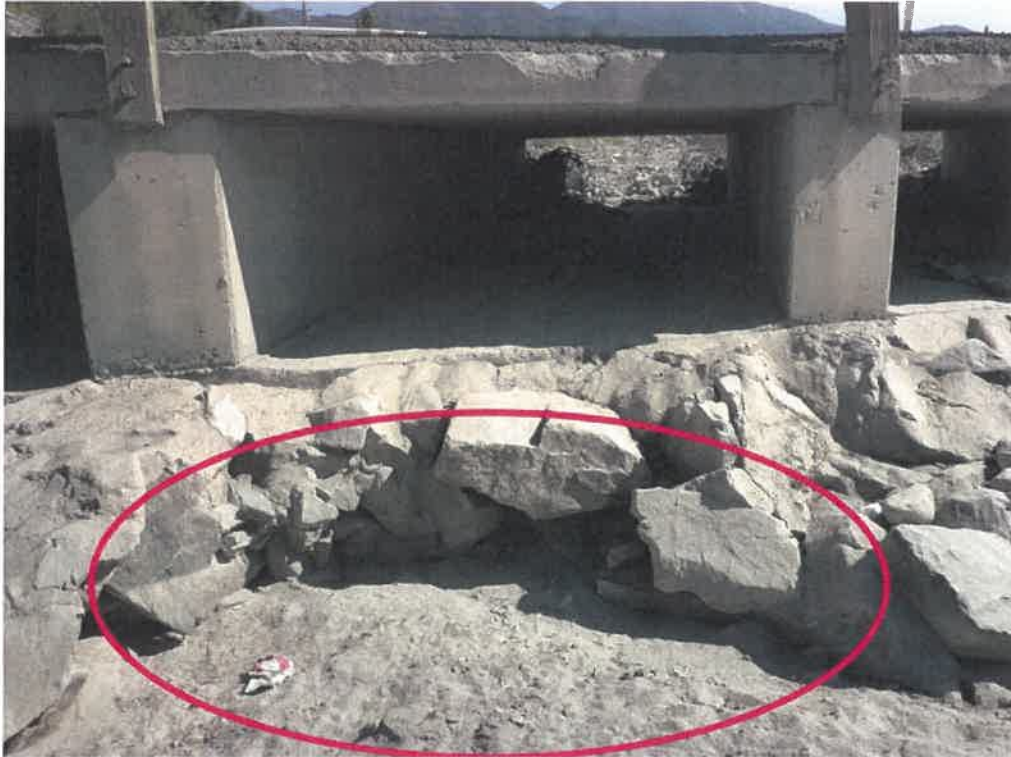
Photo No. 4

The downstream grouted riprap is degraded at the south side, and there are holes at the bottom of riprap is exposed about 1 foot at the following spans:

Span 4 a hole is 13 feet X 5 feet. (see the attached photo no. 4)

A hole 13 ft X 5 ft at the downstream side (south) of span 4.

Fill the riprap holes with proper material to prevent more damage to the riprap at the downstream side.

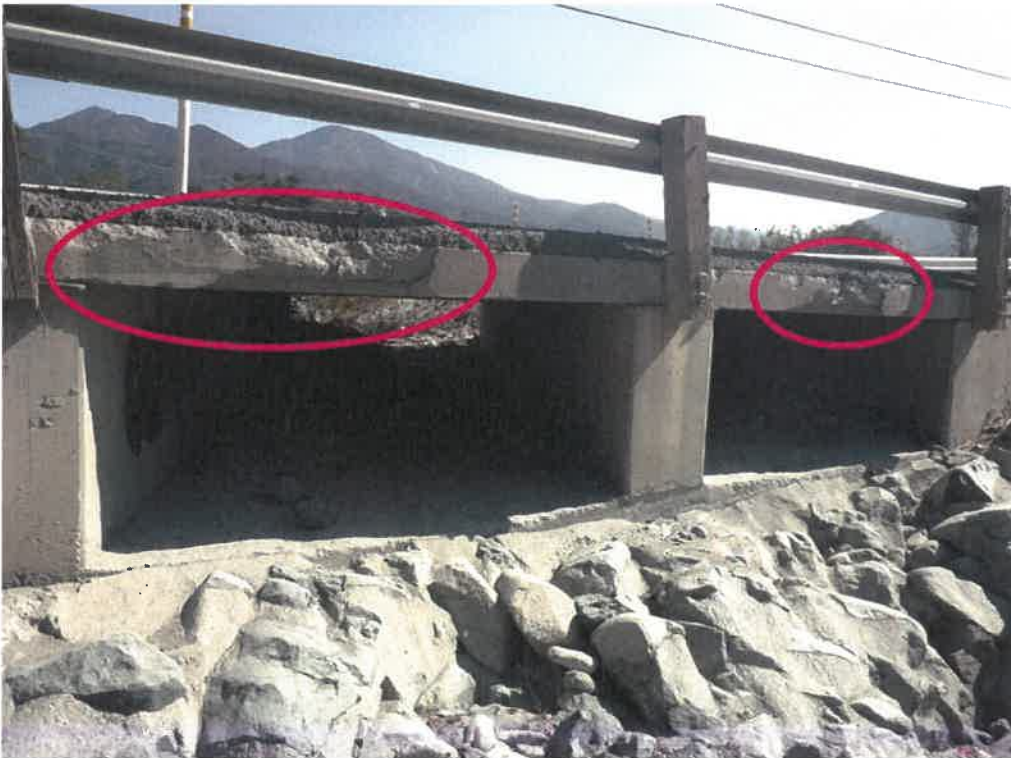
Photo No. 5

There are few spalls varied +/- 4 feet L X 10 inches W X 2 inches D at the south edge of the slab with corroded rebars, those spalls were mostly noticed at Spans 5 and 6; and scattered spalls +/- 12 inches L X 8 inches W X 1 inch at spans 1 to 4. (see the attached photos no. 5 & 6)

Slab has large spalls at the south side at Spans 5 and 6.

Repair the two spalls 4 feet L X 10 inches H X 3 inches D with exposed rebars at the south edge of the deck in spans #5 and #6.

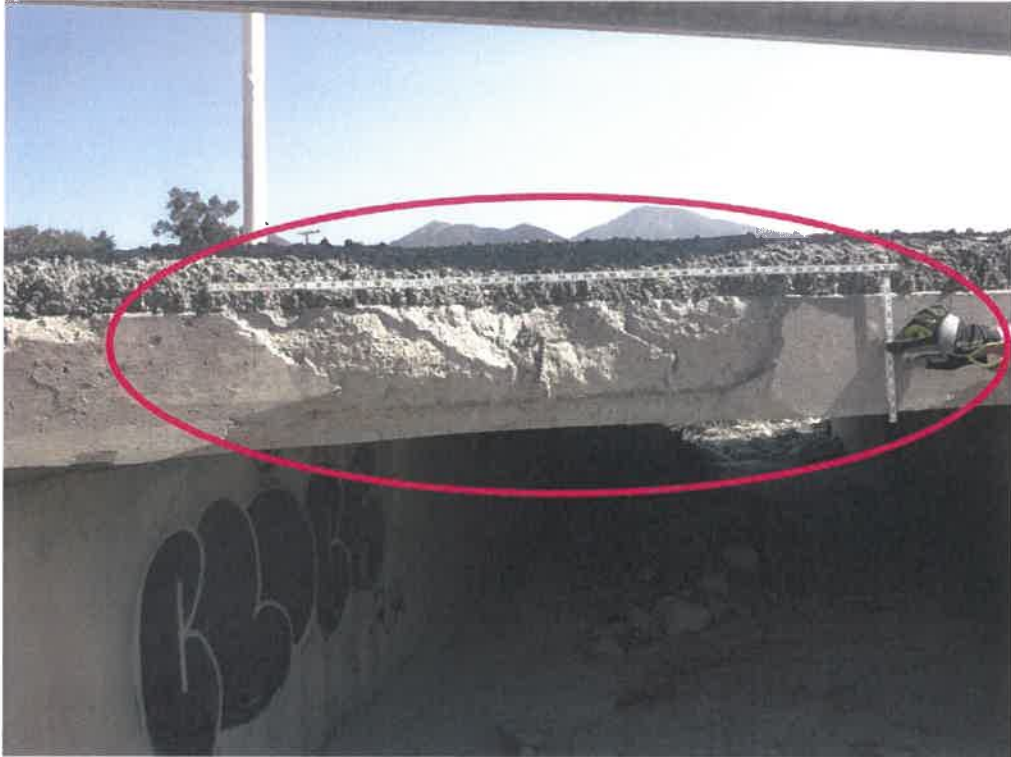
Photo No. 6

Slab has large spalls at the south side at Spans 5 and 6.

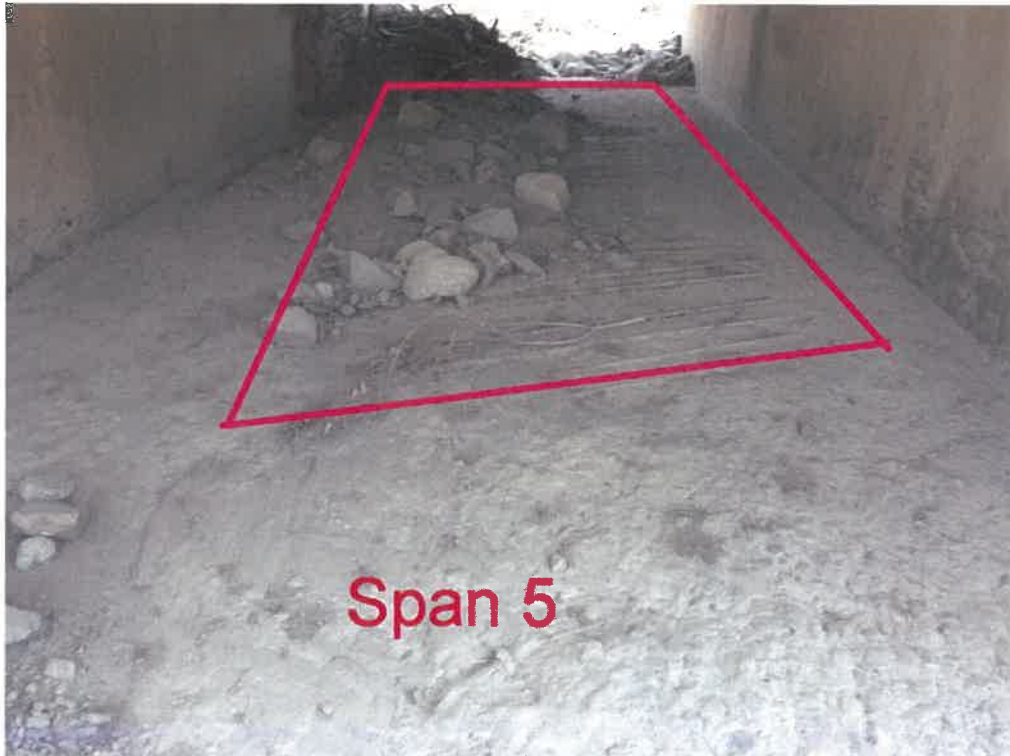
Photo No. 7

The spread footing which invert slab is exposed and has an eroded concrete area with exposed and rusted rebars. In Span 5, the eroded area is 17 feet X 8 feet at the middle, and in Span 6 the eroded area is 2 feet X 1 foot at the south end. (see the attached photo no. 7)

Eroded concrete with exposed rebar at the spread footing at Span 5.

Repair the eroded concrete at the spread footing at Spans 5 & 6 with exposed rebars of an area 17 feet X 8 feet in the middle of the spans.

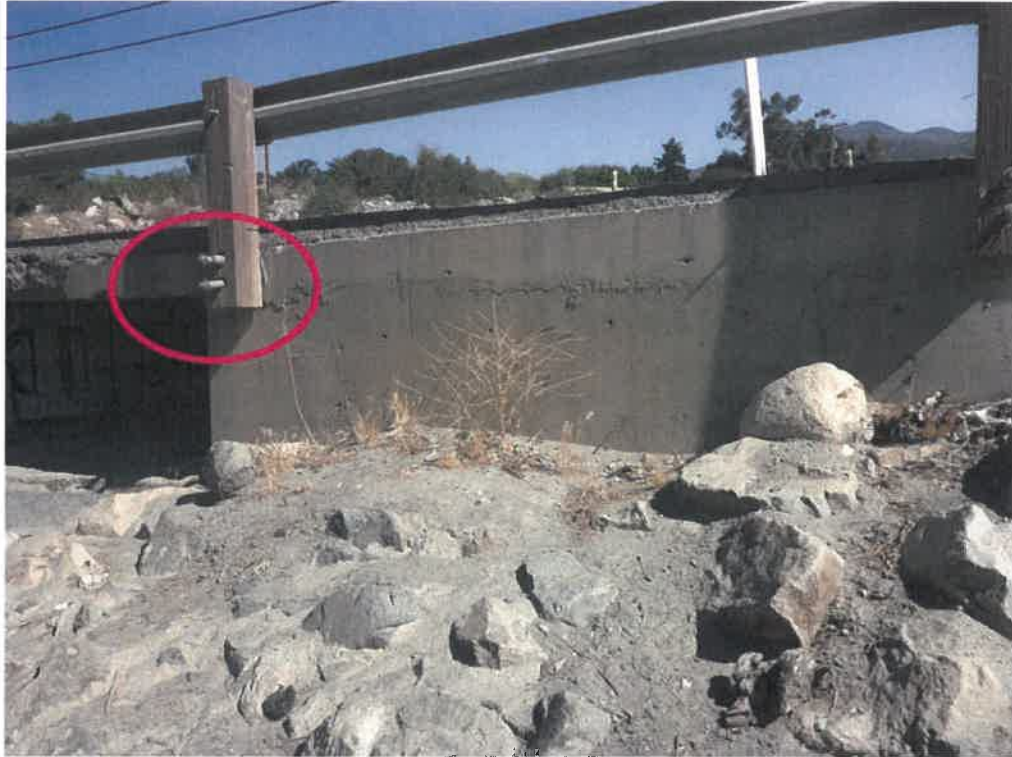
Photo No. 8

Some of the timber posts have loose nuts at the connection with the concrete slab. (see the attached photo no. 8)

Loose nuts at the timber posts.

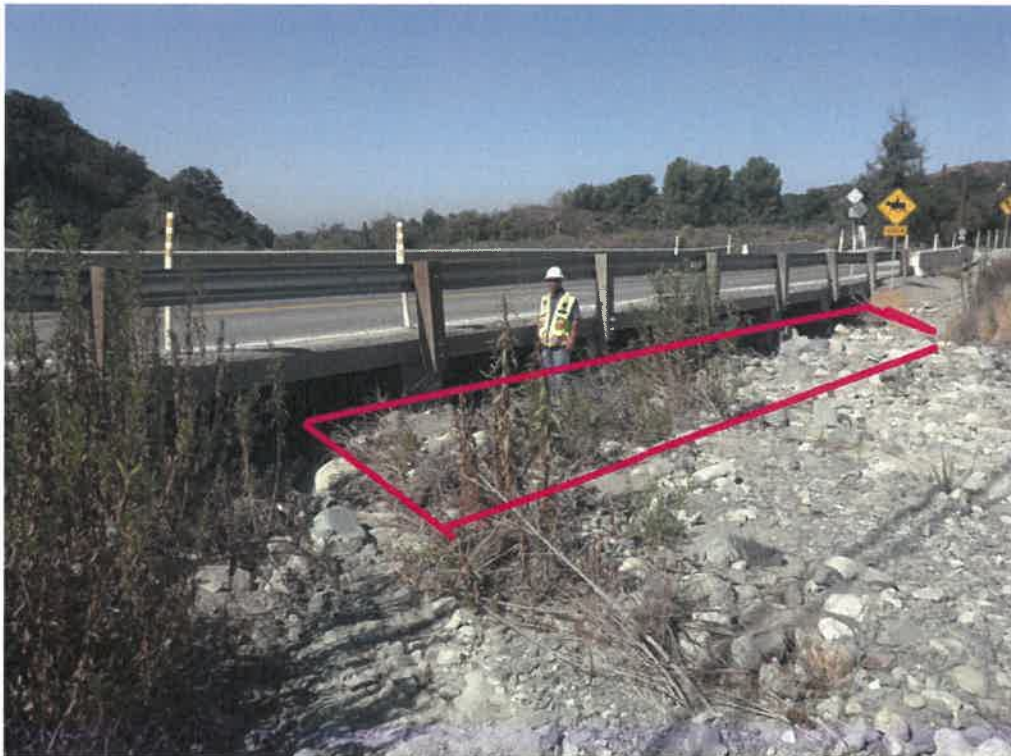
Photo No. 9

There is a high sediment up to 2 feet at the upstream side in front of the most spans. (see the attached photo no. 9)

2 feet sediment at the upstream side in front of most spans.

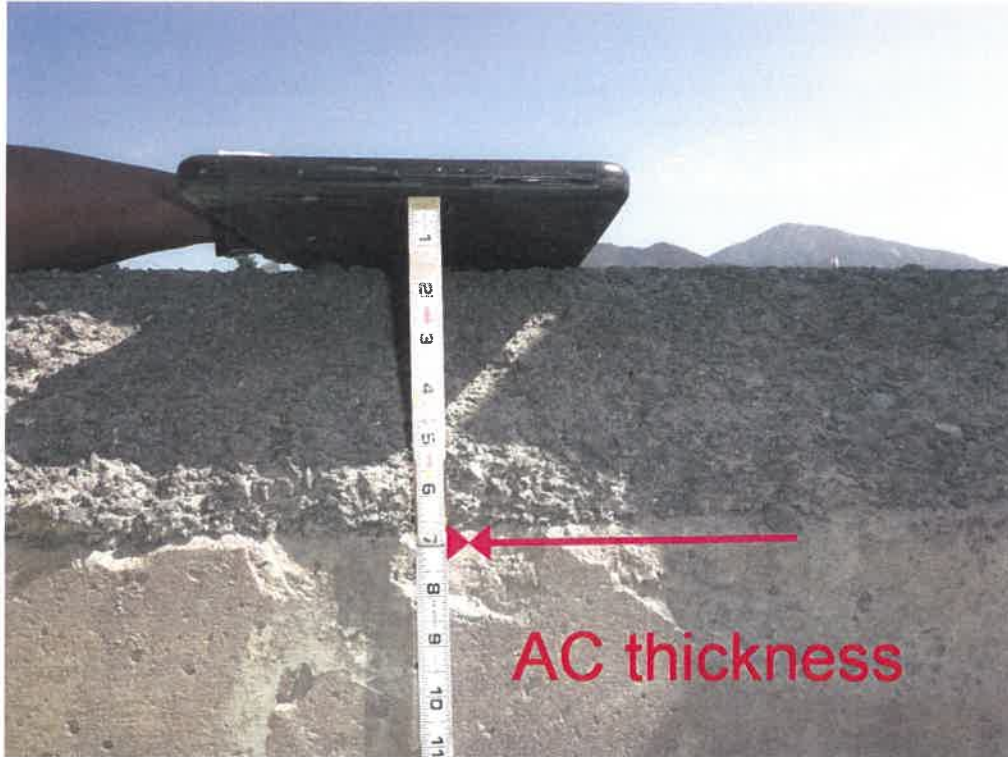
Photo No. 10

Average AC overlay on top of the bridge deck is measure in the field and it was 6.0 inches. (see the attached photo no. 10)

Ac Thickness at the south side.
