DEPARTMENT OF TRANSPORTATION
Structure Maintenance & Investigations

Bridge Number : 55C0017
Facility Carried: LINCOLN AVENUE
Location : 0.7 MI E/O ROUTE 57 FWY.
City :
Inspection Date : 12/31/2017

Bridge Inspection Report

STRUCTURE NAME: SANTA ANA RIVER CHANNEL

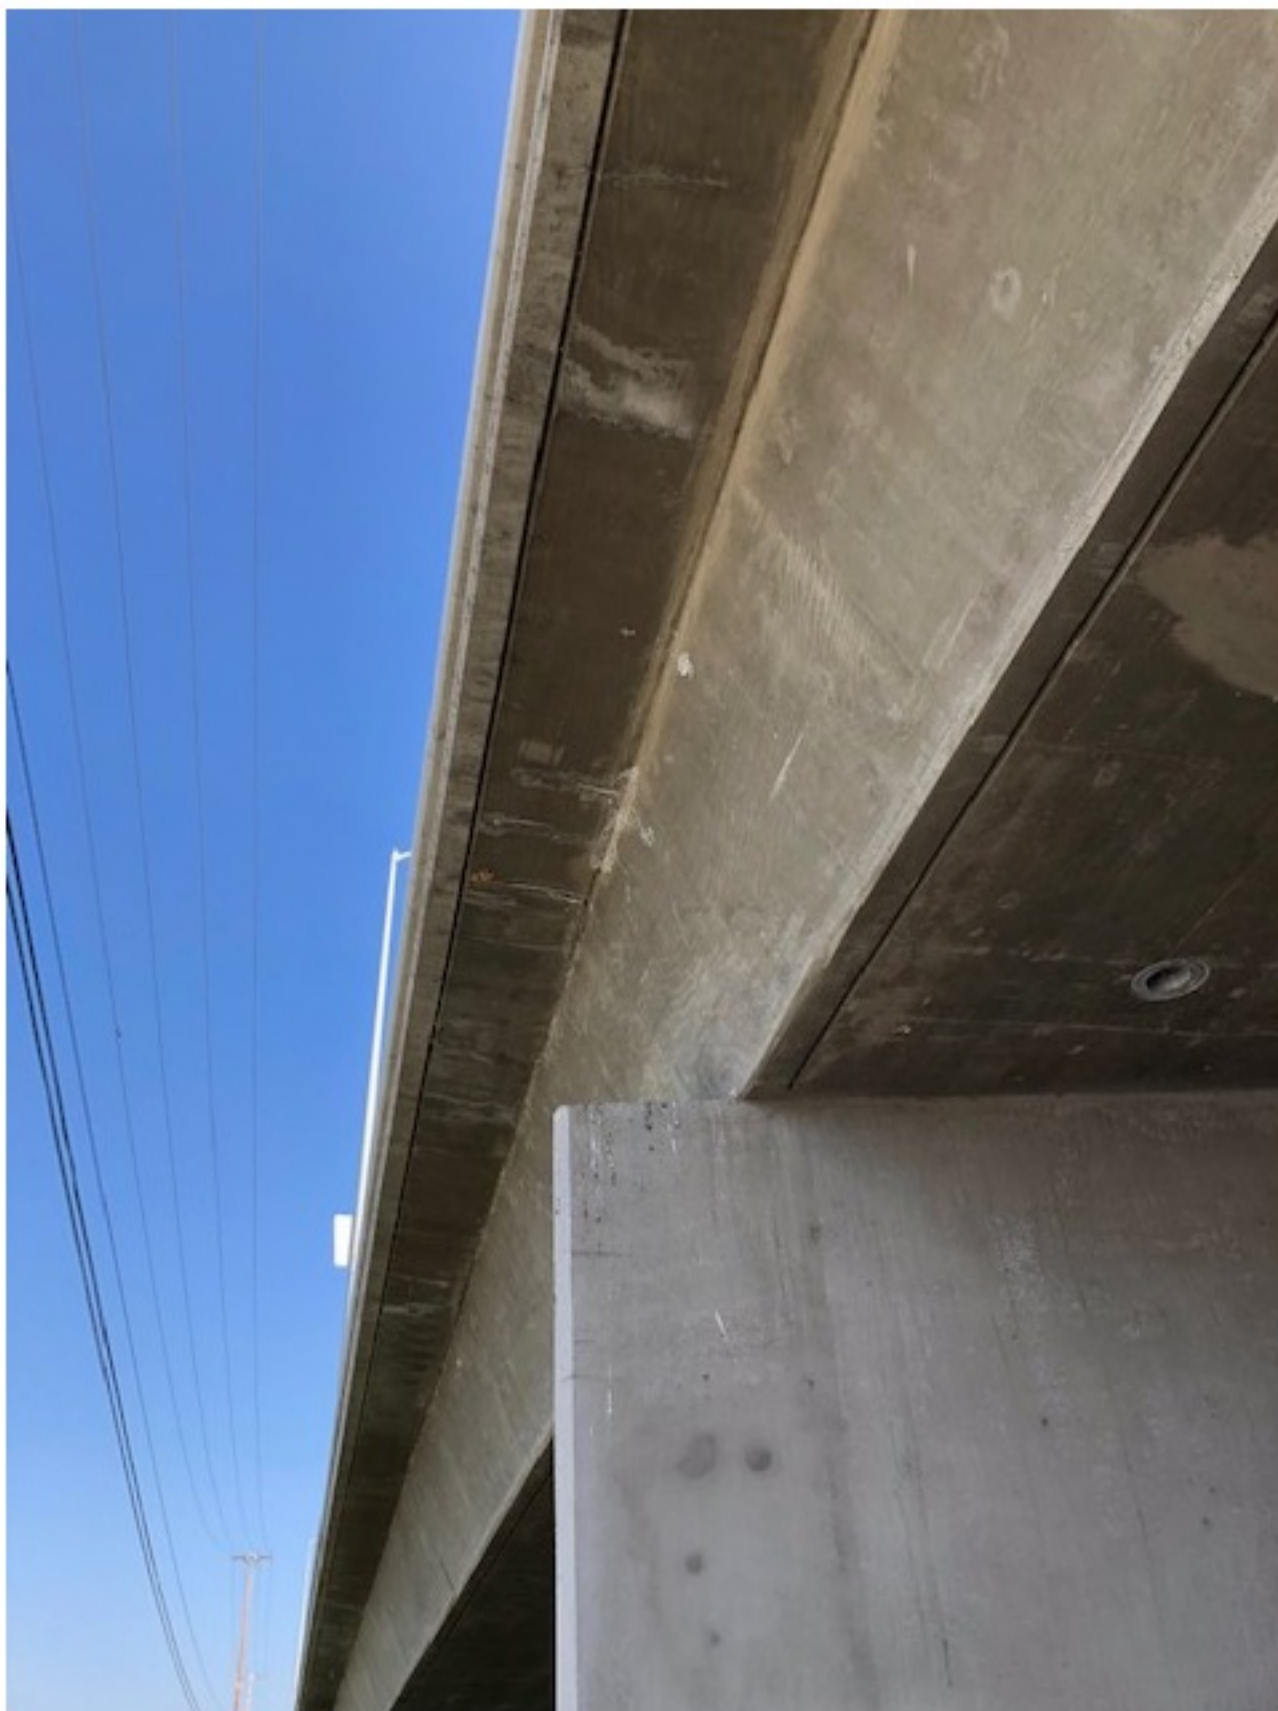
Photo No. 1

There are transverse cracks in the soffit in several bays in most spans with white efflorescence.

Deck overhang with transverse cracks with efflorescence

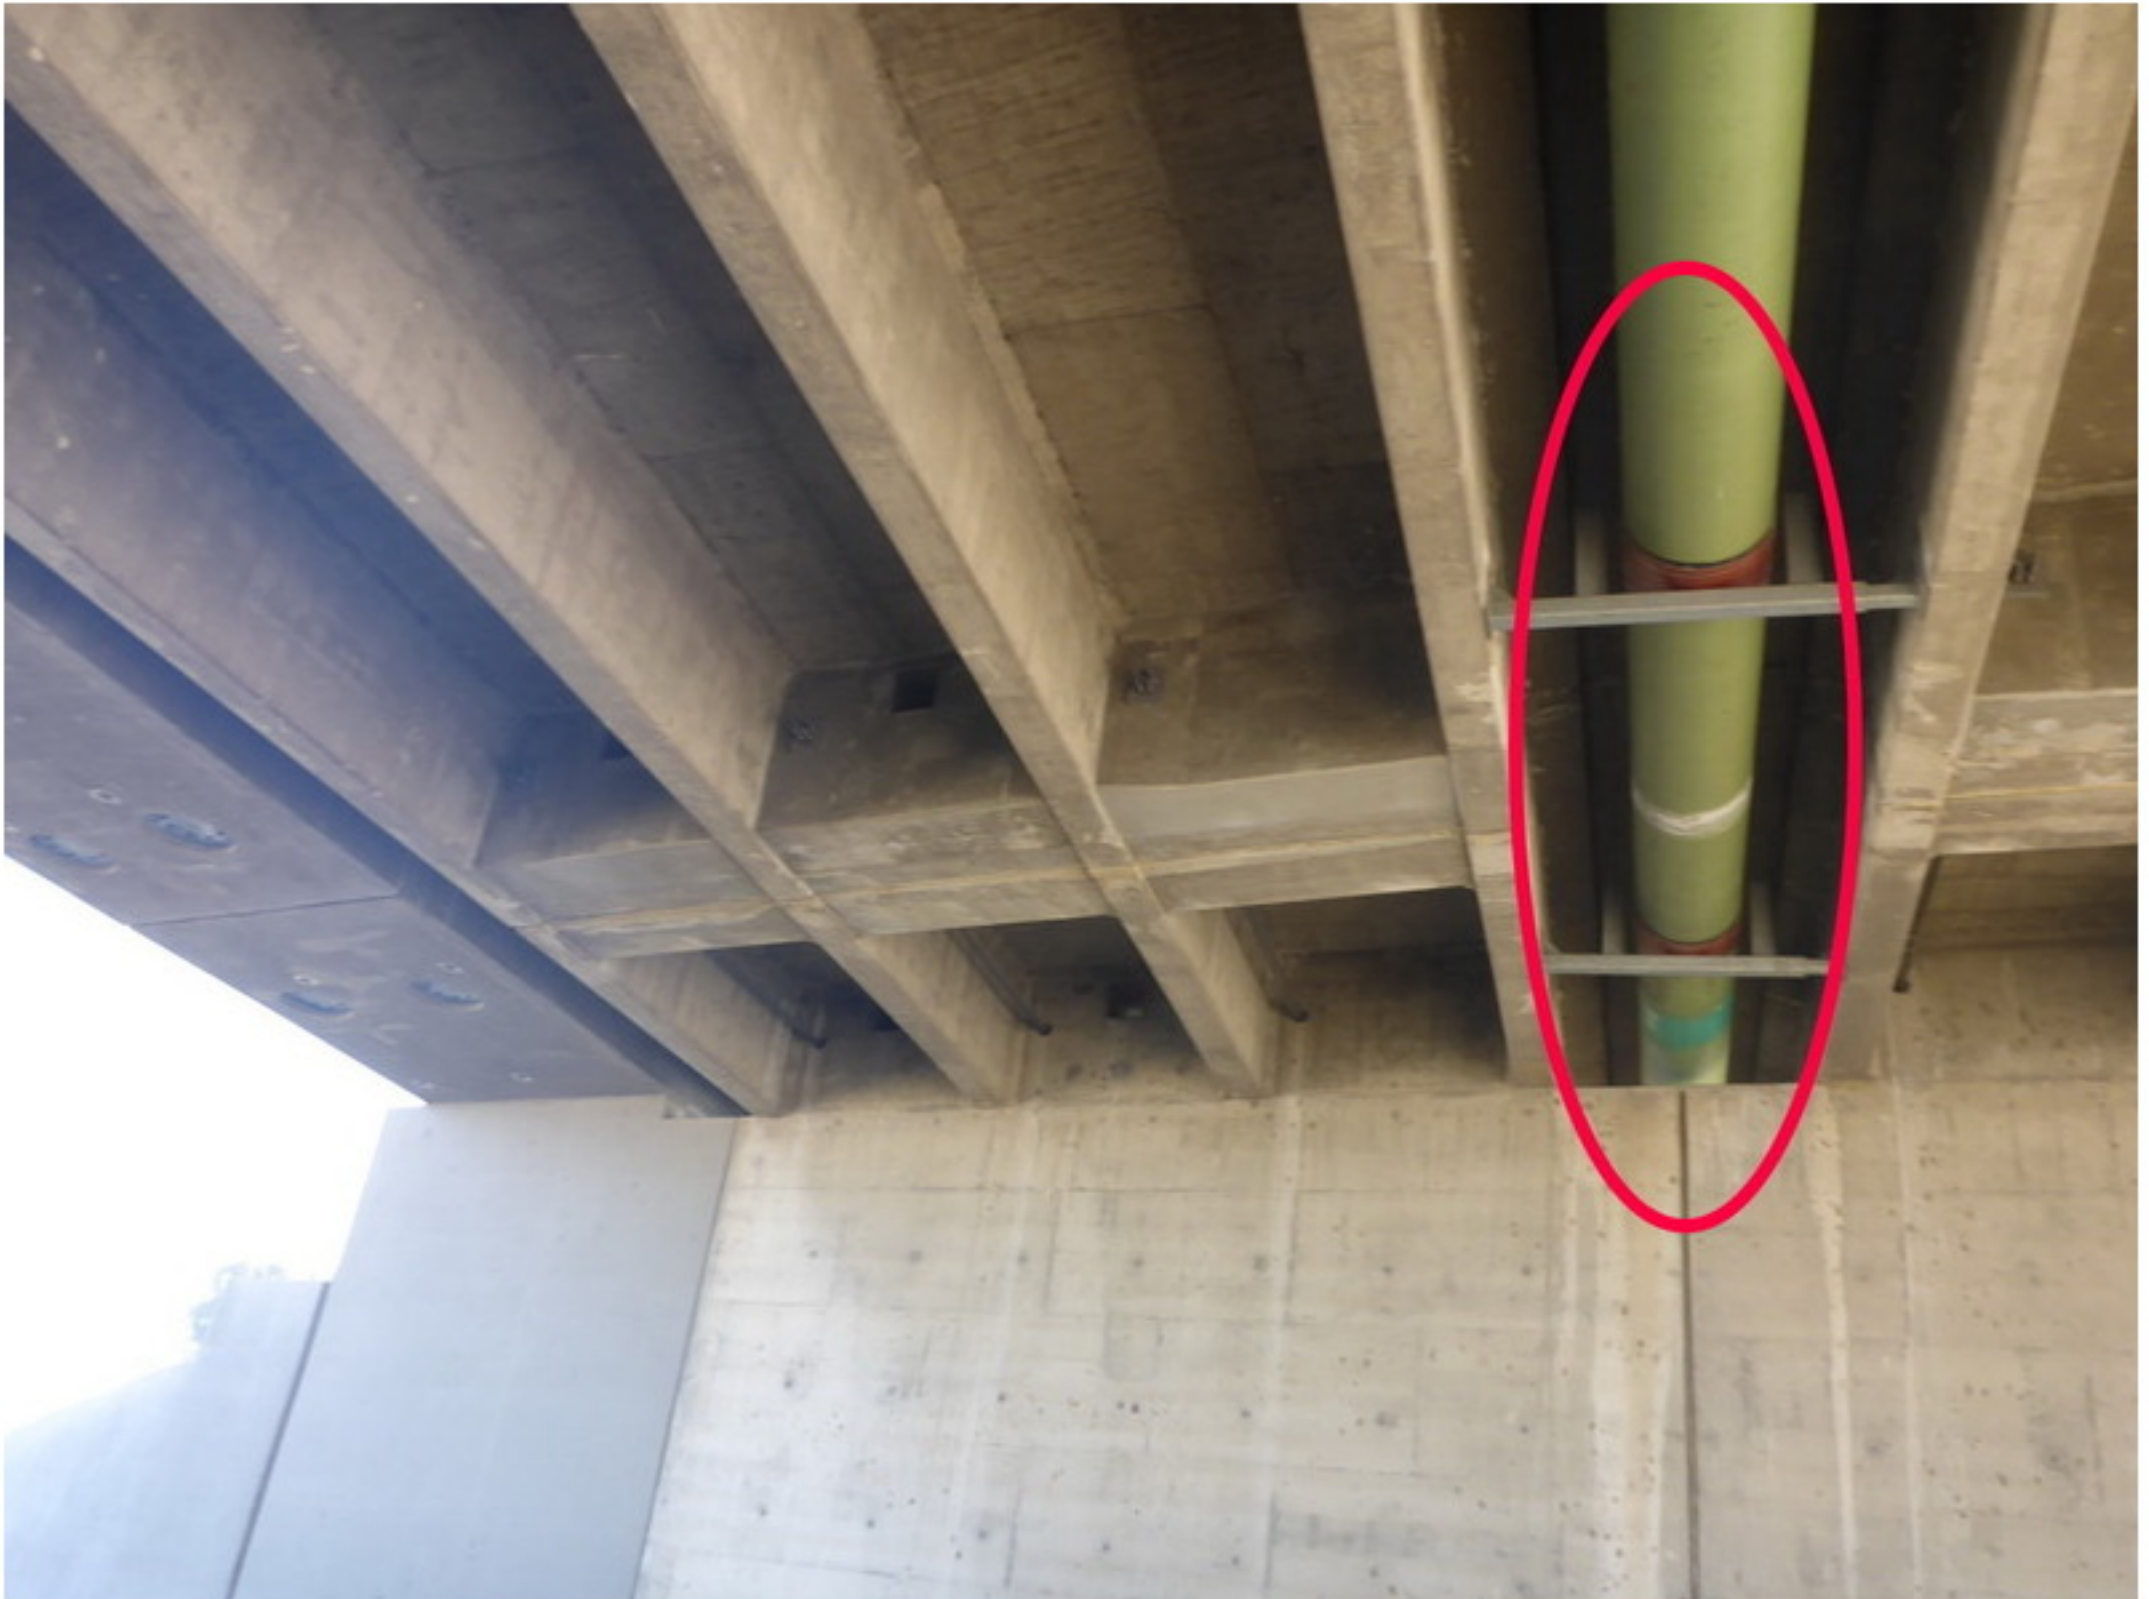
Photo No. 1

Steel pipe at the bridge centerline, hanged from he soffit.

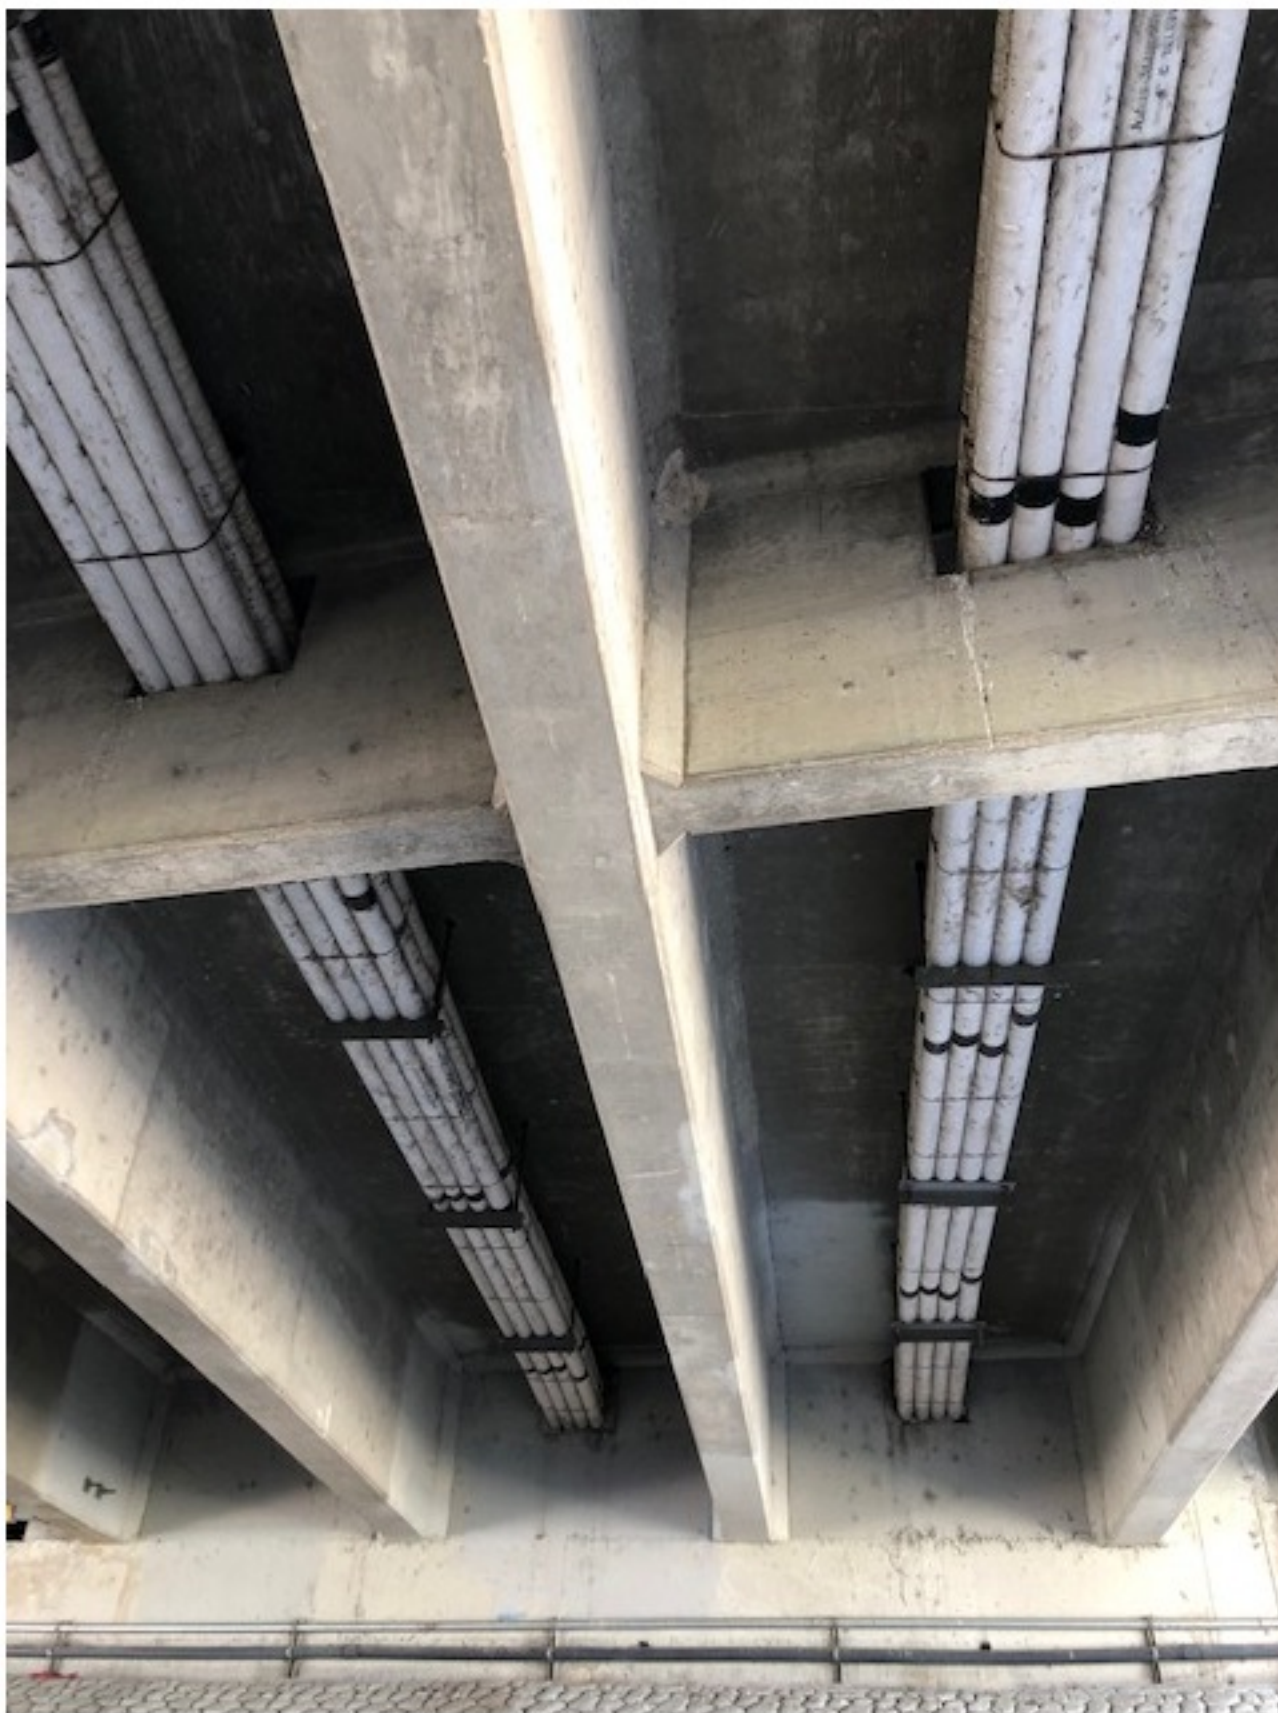
Photo No. 1

Encroachment inside bays, northerly side.

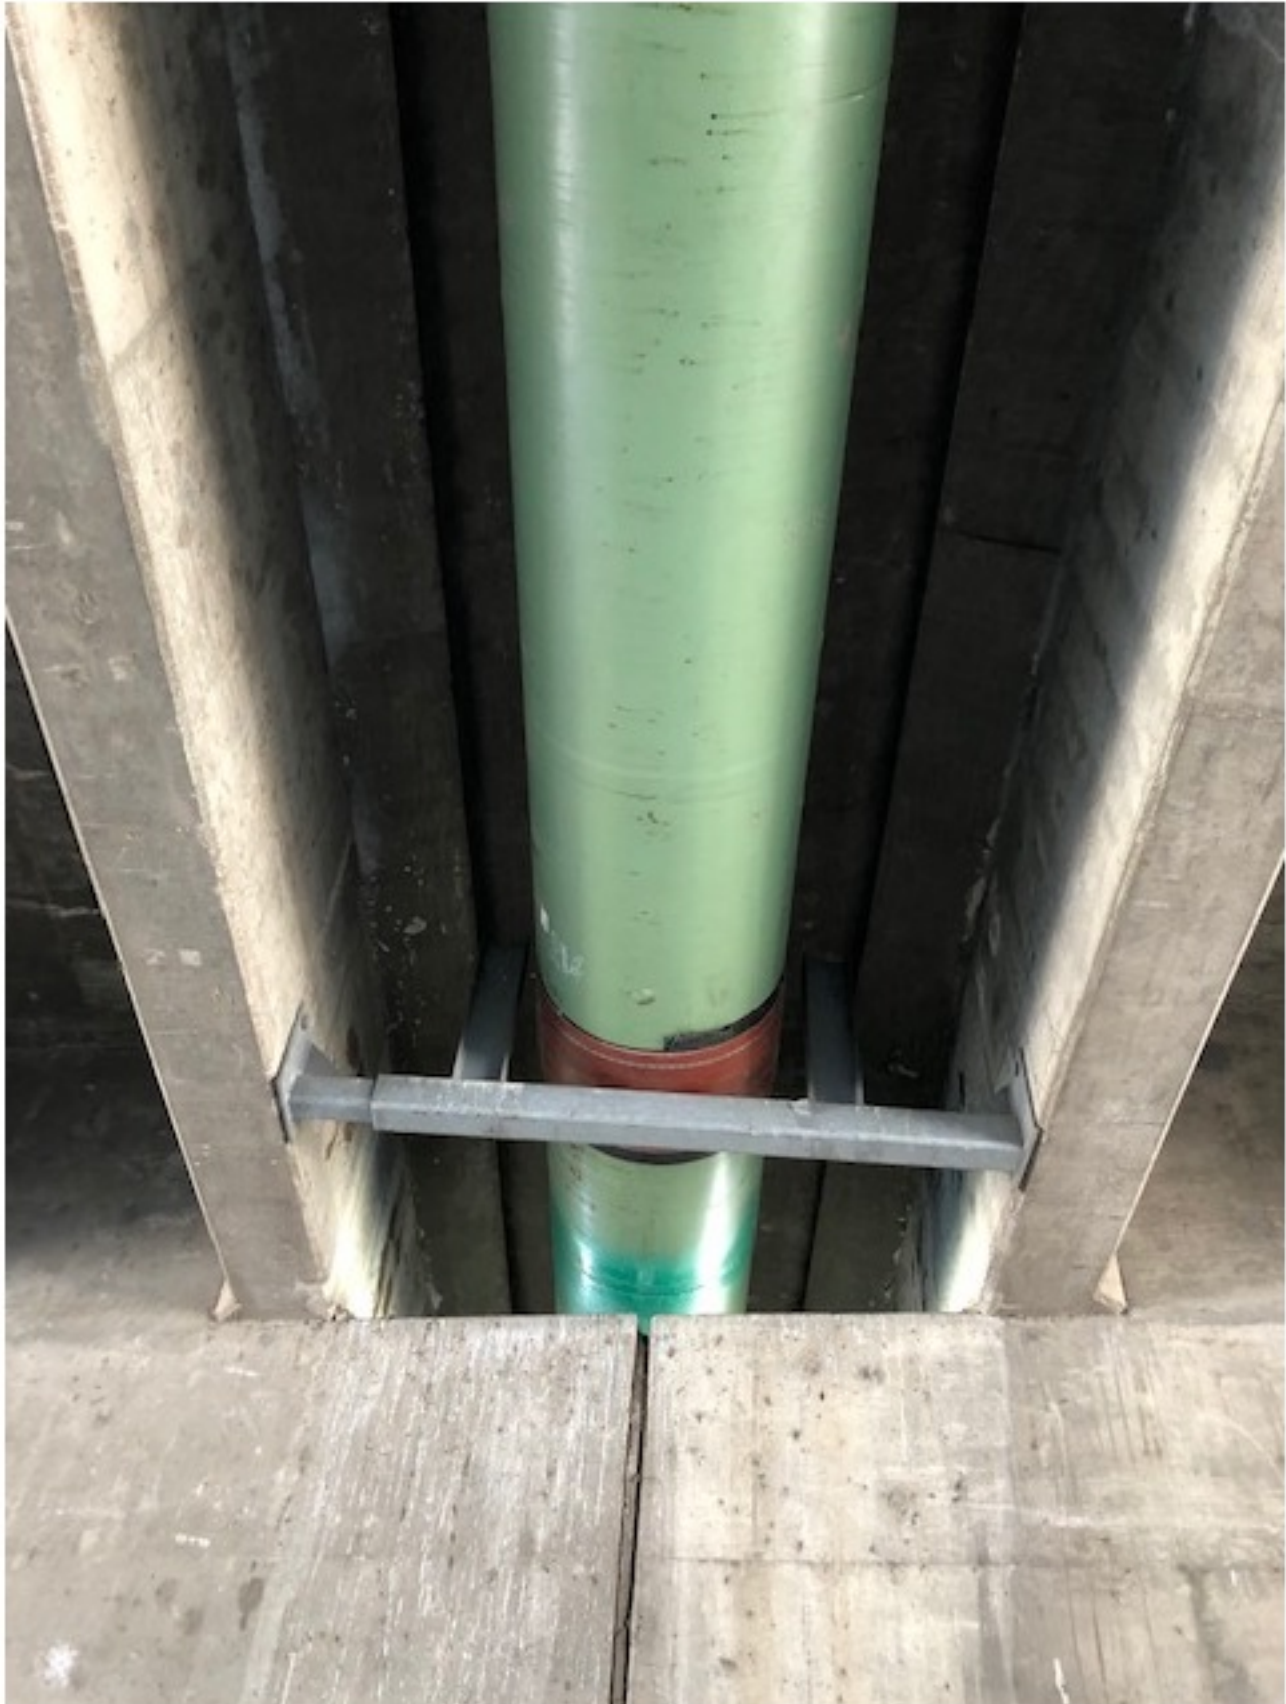
Photo No. 1
Encroachment in the middle of bridge

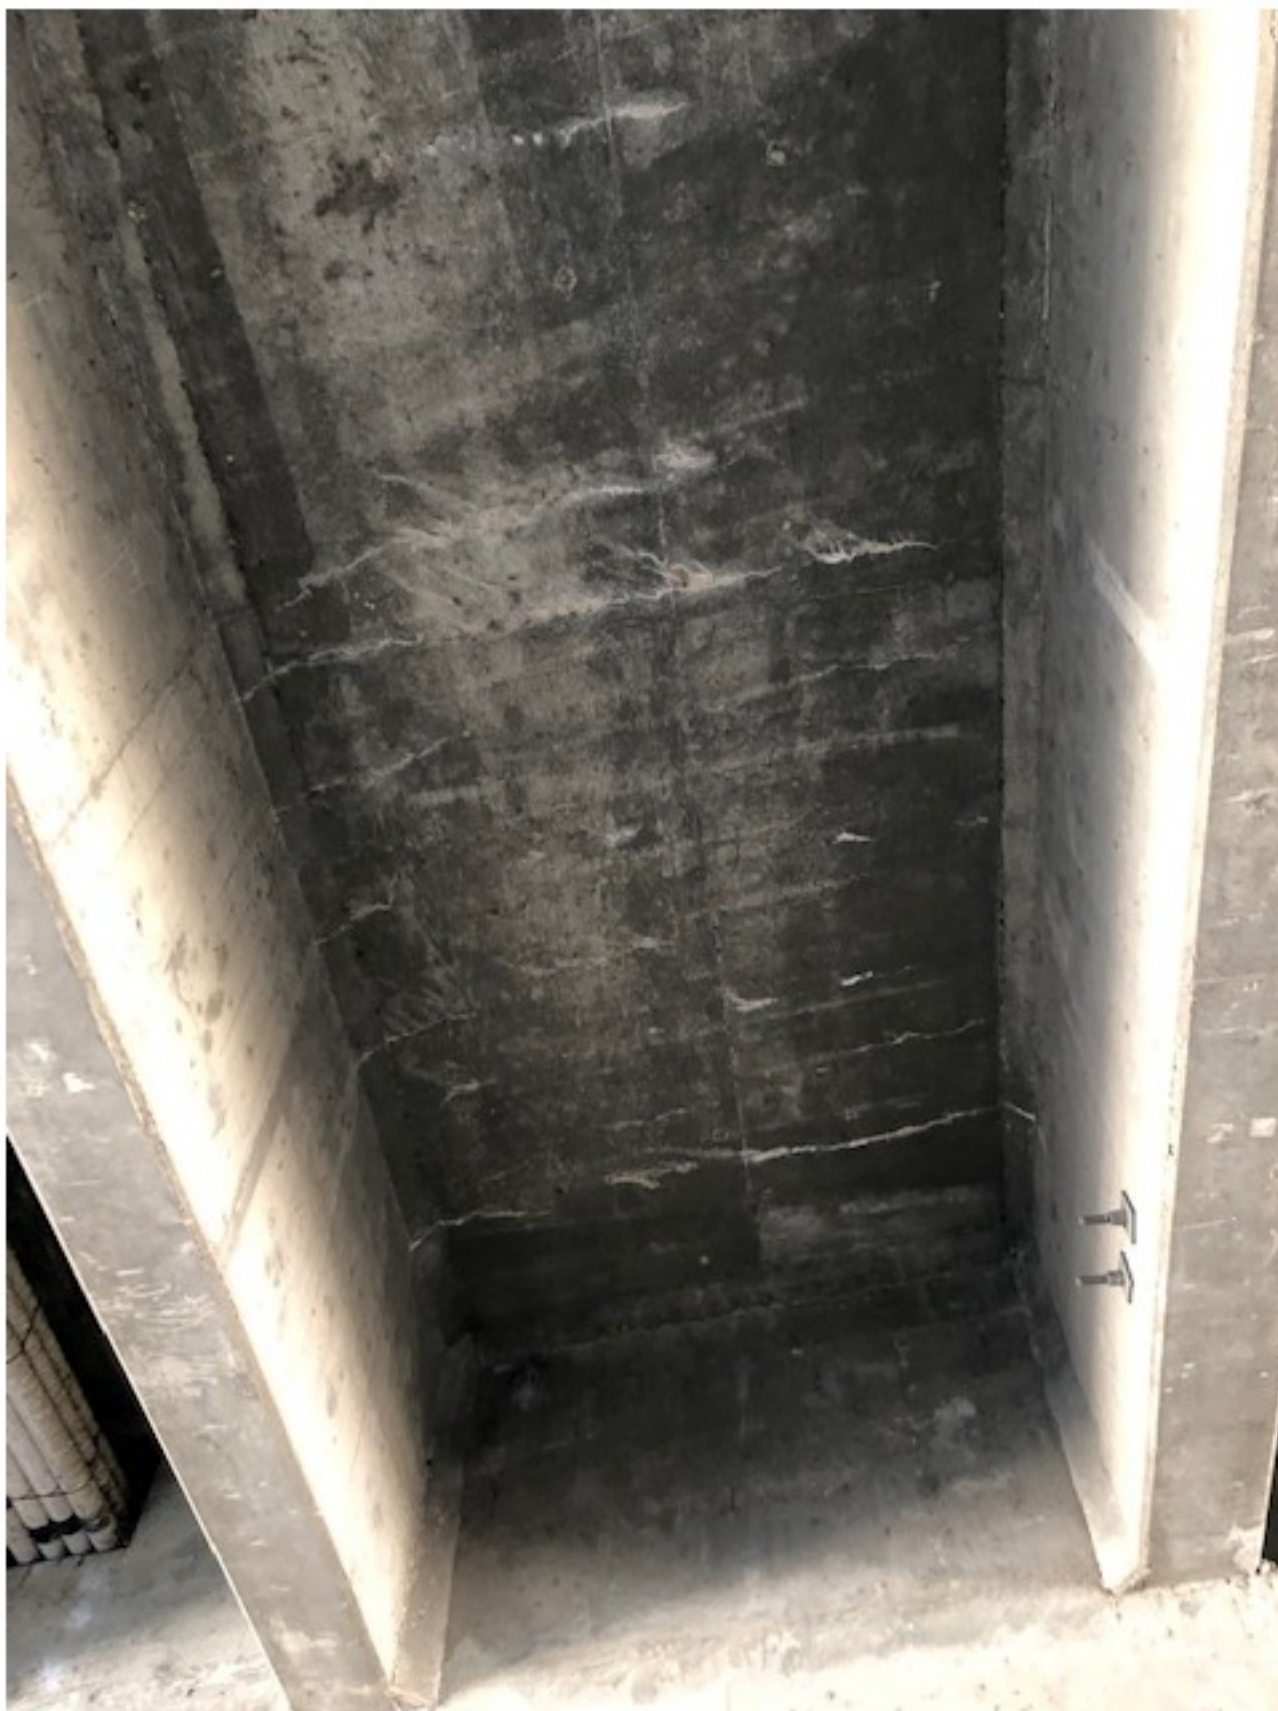
Photo No. 1

Transverse cracks with efflorescence

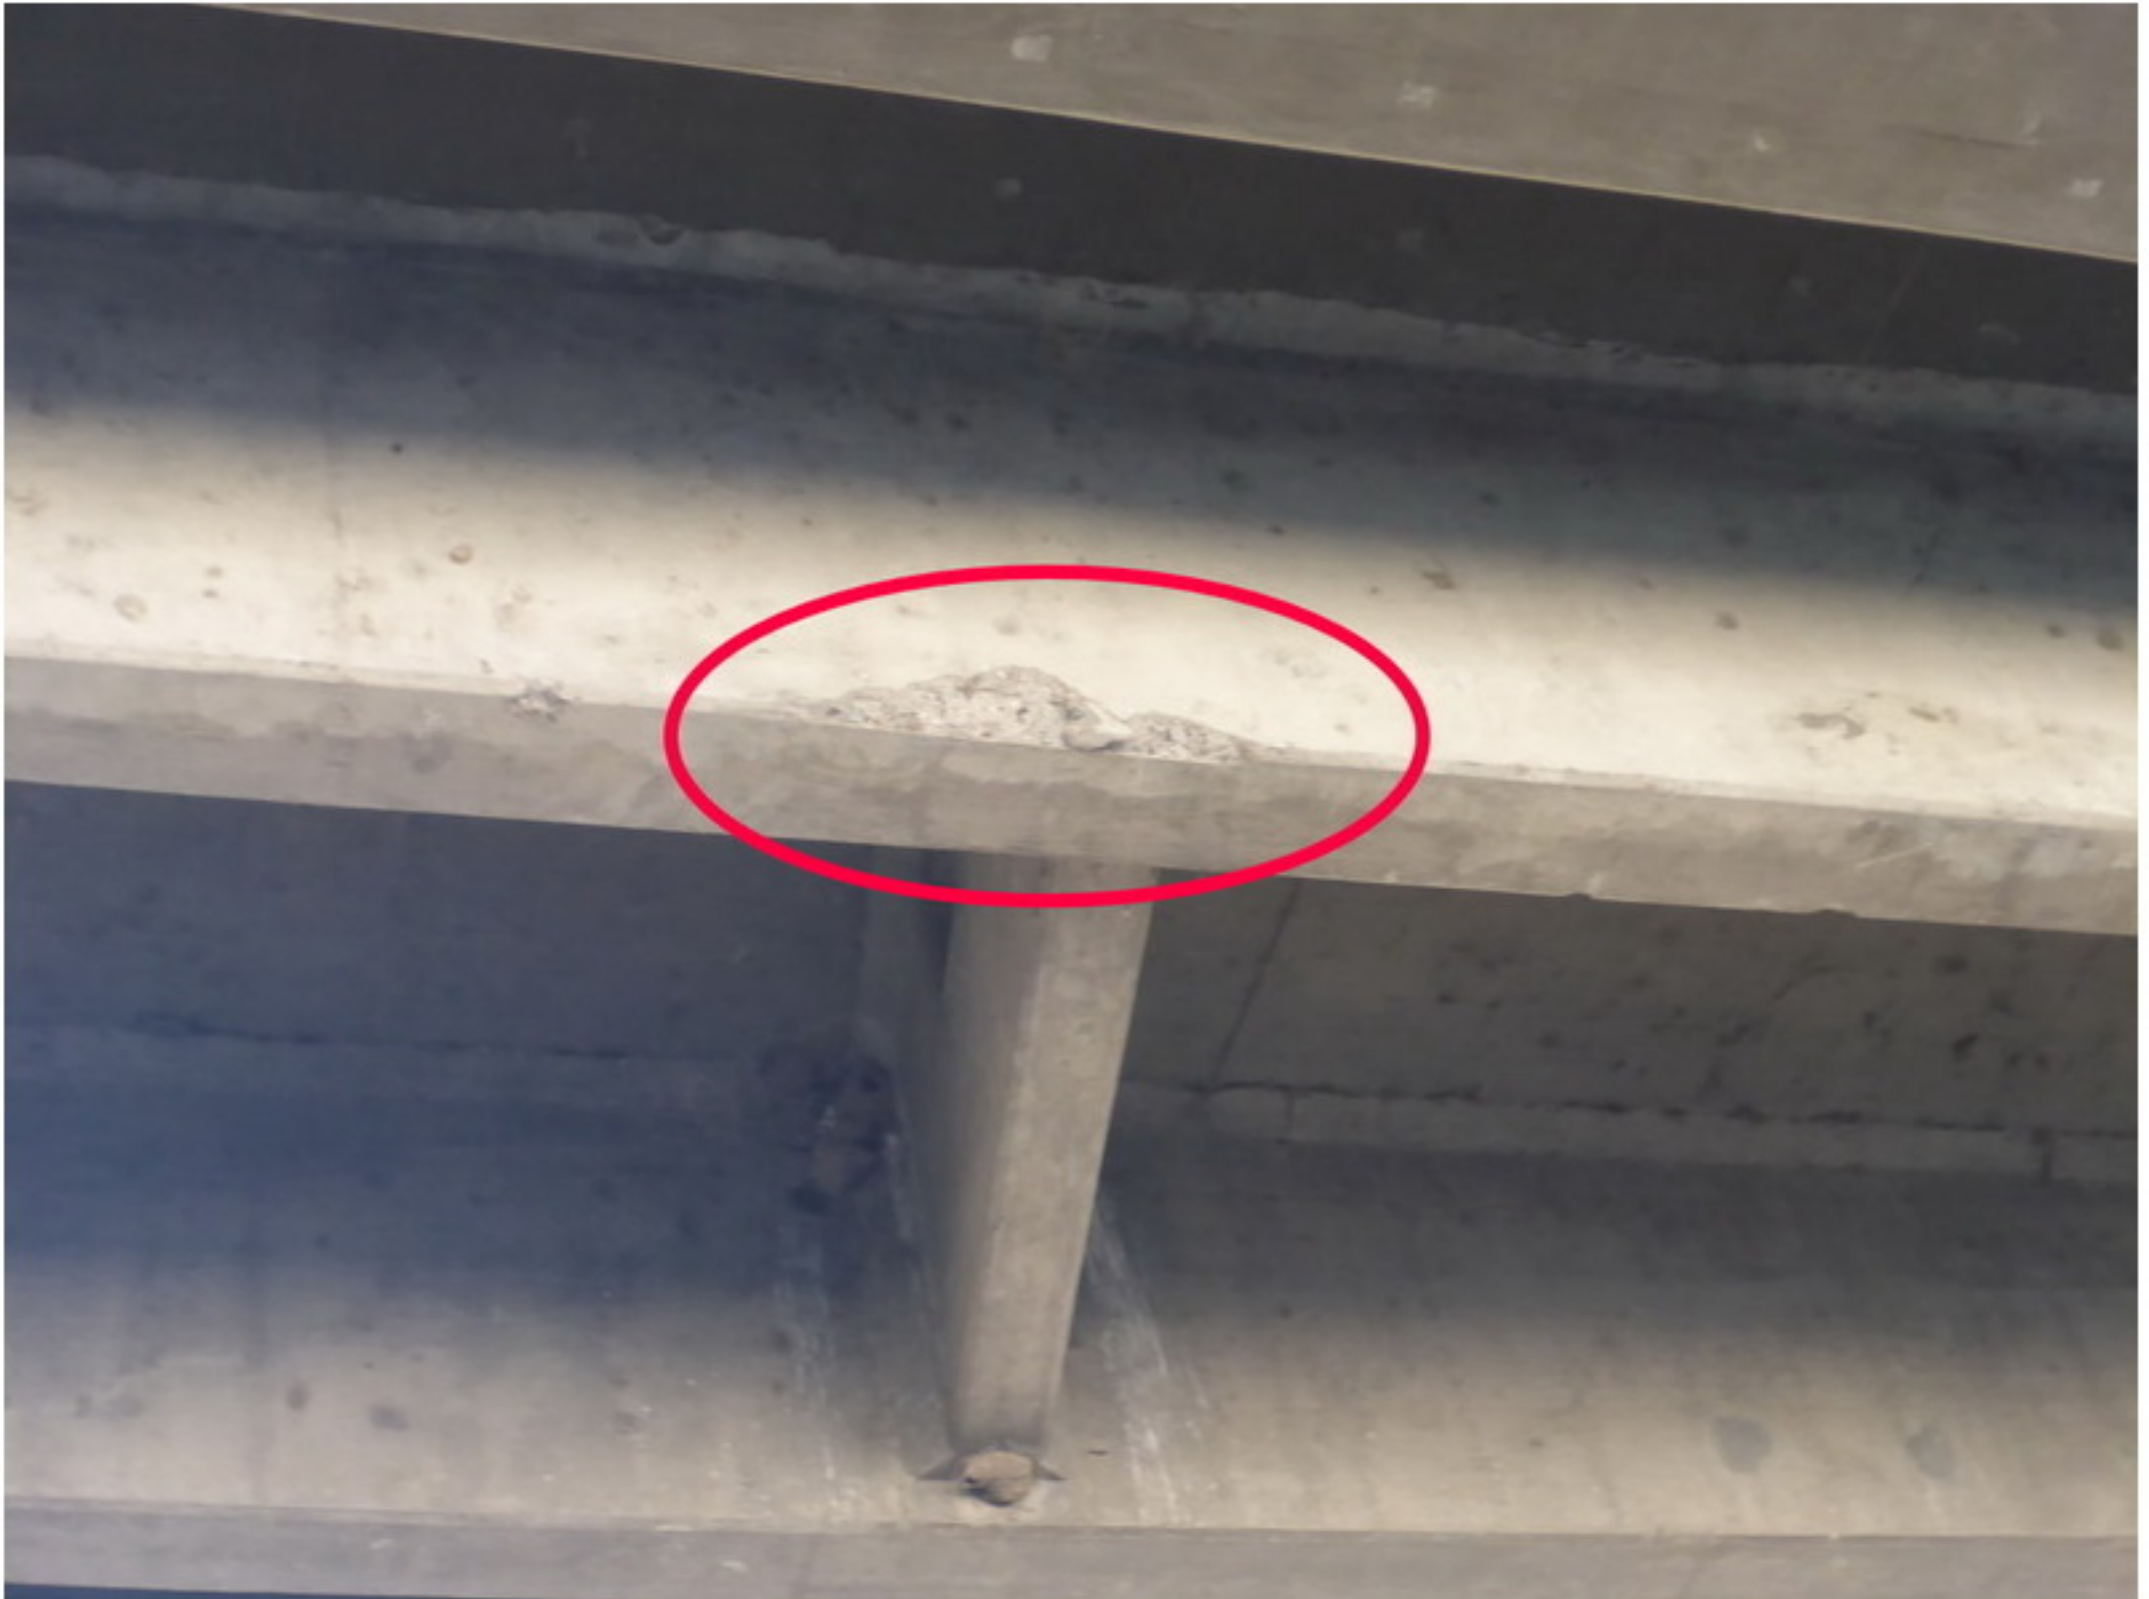
Photo No. 2

At span 2: girder #1 (original RC) has a spall 2.50 feet X 10 inches X 2 inches at mid-span. (see the attached photo no. 2)

Spall 2.5 ft X 10 in. X 2 in. at span 2, id-span of girder 1.

Action : Super-Patch spalls

Patch the spall at span 2, girder #1

(original RC) that has a spall 2.50 feet X 10 inches X 2 inches at mid-span. (see the attached photo no. 2)
