Bridge Number : 55C0017
Facility Carried: LINCOLN AVENUE
Location : 0.7 MI E/O ROUTE 57 FWY.
City
Inspection Date : 12/31/2017

Bridge Inspection Report

STRUCTURE NAME: SANTA ANA RIVER CHANNEL

Bridge Number : 55C0130
Facility Carried: GLASSELL STREET
Location : 0.3 MI S/O ROUTE 91 FWY
City :
Inspection Date : 12/31/2017

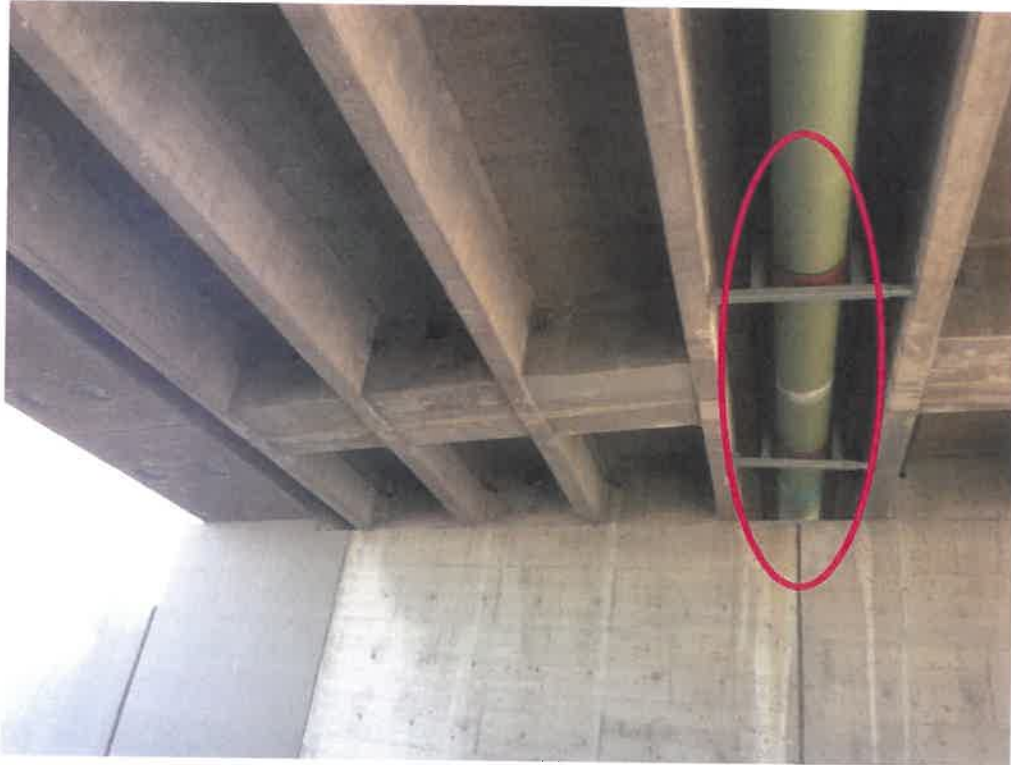
Photo No. 1

Steel pipe at the bridge centerline, hanged from the soffit.

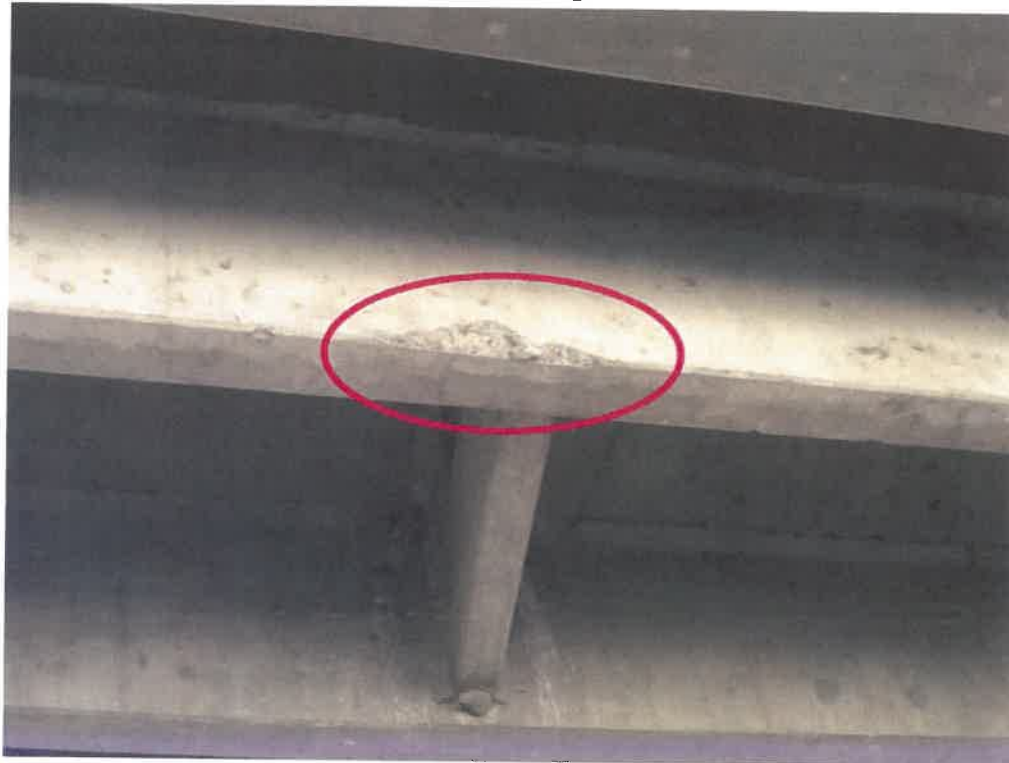
Photo No. 2

Spall 2.5 ft X 10 in. X 2 in. at span 2, id-span of girder 1.

Patch the spall at span 2, girder #1 (original RC) that has a spall 2.50 feet X 10 inches X 2 inches at mid-span. (see the attached photo no. 2)

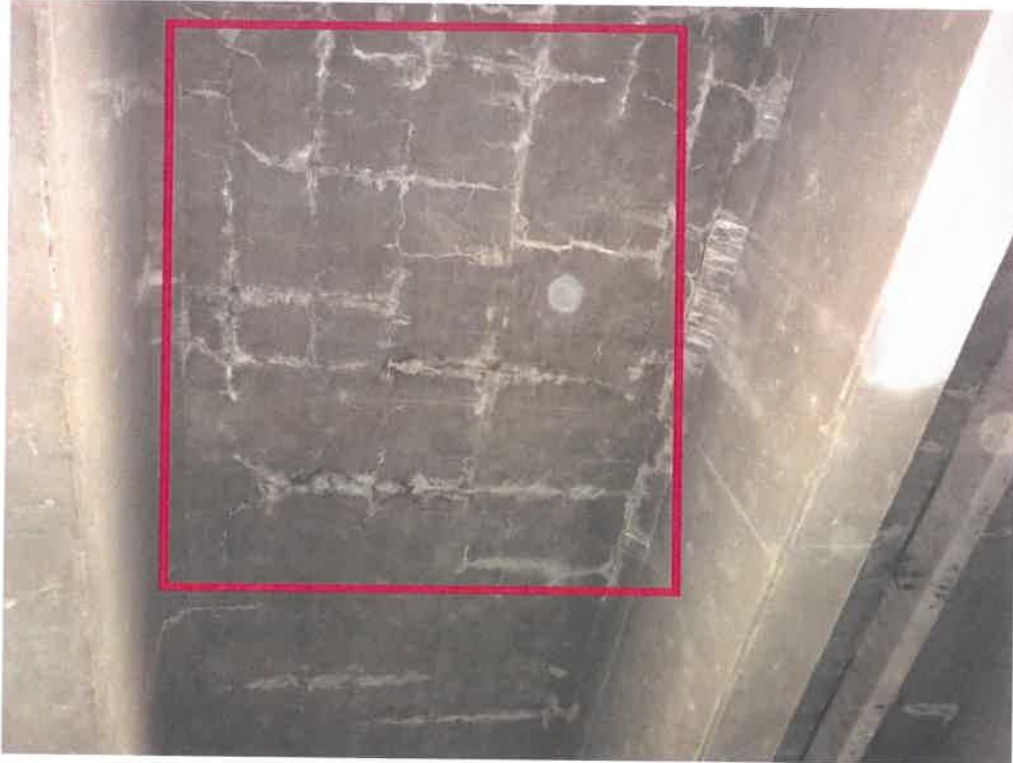
Photo No. 1

The soffit exhibits: (see the attached photo no. 1)

* span #1: all bays under the traffic lanes (original bridge) has several transverse cracks with heavy white efflorescence;

* span #2: all bays under the traffic lanes (original bridge) has several transverse cracks, up to 6 feet long with light white efflorescence mostly at south end; and

* at spans #8 to #18: few transverse cracks with light white efflorescence; these cracks mirror the deck cracks.

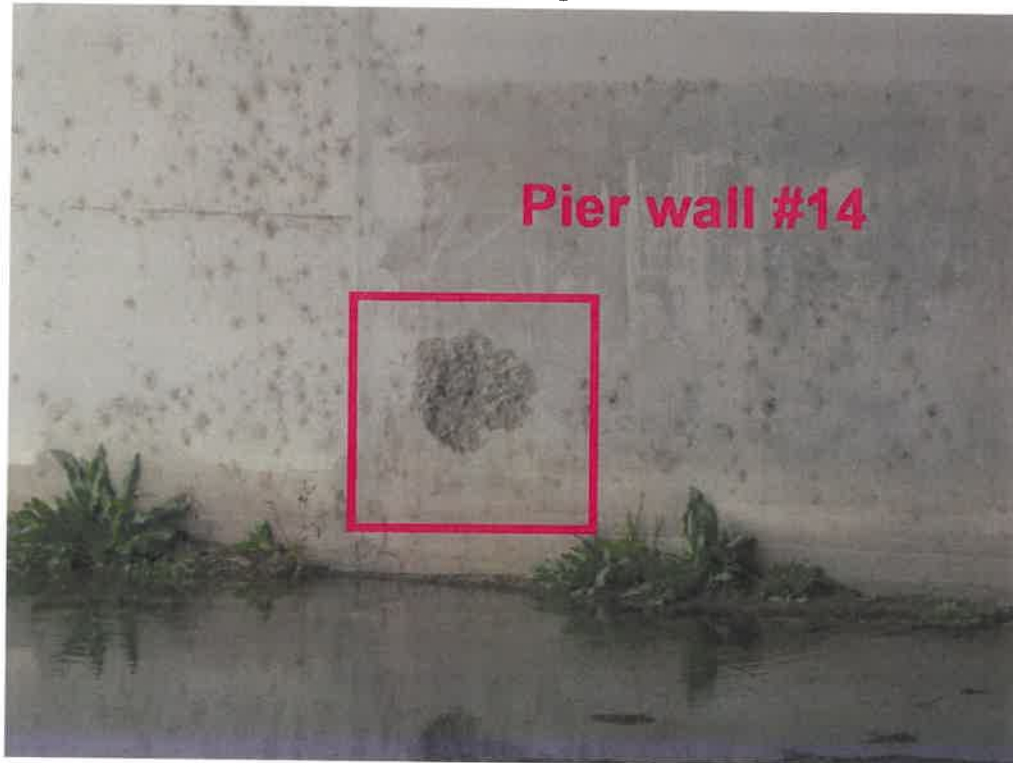
Photo No. 2

Pier wall #14 exhibits a spall 1.5 feet diameter X 2 inches at 15 feet from west end southerly face.

Spall 1.5 feet diameter X 2 inches deep at pier wall 14.

RecDate: 12/31/2017	EstCost:	Patch Pier wall #14 that has a spall 1.5
Action : Sub-Patch spalls	StrTarget: 2 YEARS	feet diameter X 2 inches at 15 feet from
Work By: LOCAL AGENCY	DistTarget:	west end southerly face. (see the
Status : PROPOSED	EA:	attached photo no. 2)

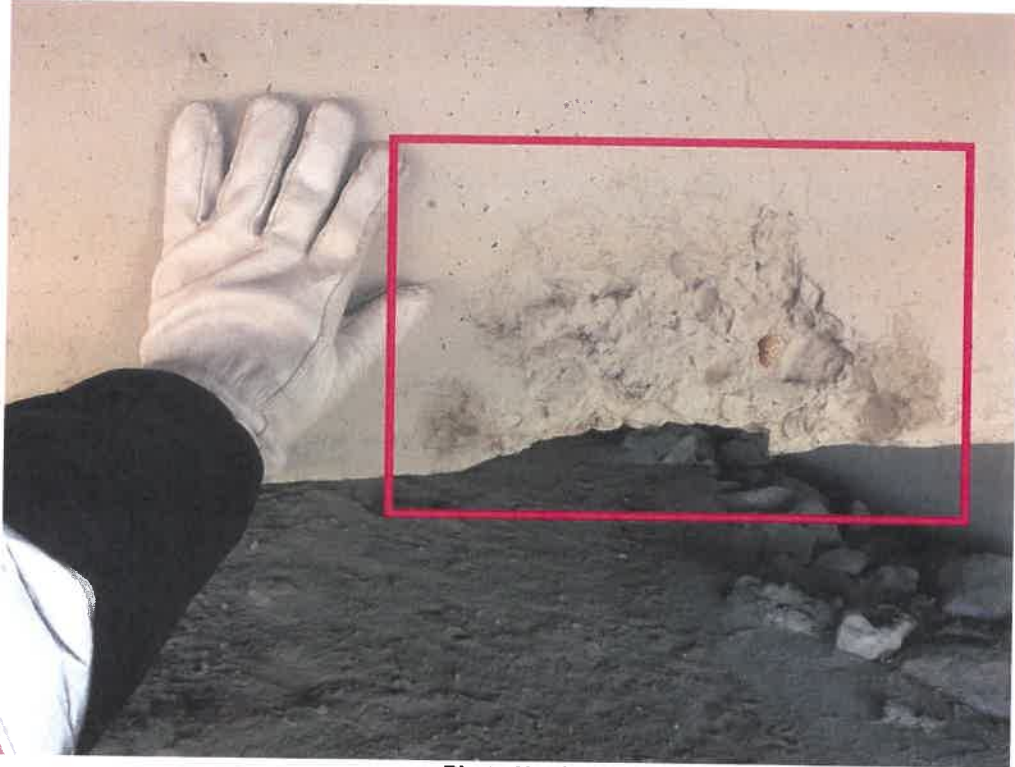
Photo No. 3

- girder 1 exhibits a spall 3 inches X 3 inches X 1 inch at west fascia at 15 feet from PW #10;
- girder 3 exhibits four spalls +/- 12 inches X 5 inches X 2 inch at west fascia; (see the attached photo no. 3)
- girder #9 exhibits two spalls 5 inches X 5 inches X 1 inch at 5 feet north from intermediate diaphragm at both faces; and
- girder #10 exhibits a spall 5 inches X 6 inches X 1 inch at 5 feet north from intermediate diaphragm at west face.

Spalls 12 in X 5 in. X 2 in.at G#9 at span 9.

RecDate: 12/31/2017	EstCost:	Patch all the spalls at the concrete
Action : Super-Patch spalls	StrTarget: 2 YEARS	girders at span #9 that have several
Work By: LOCAL AGENCY	DistTarget:	spalls +/- 12 inches X 5 inches X 2
Status : PROPOSED	EA:	inches. (see the attached photo no. 3)

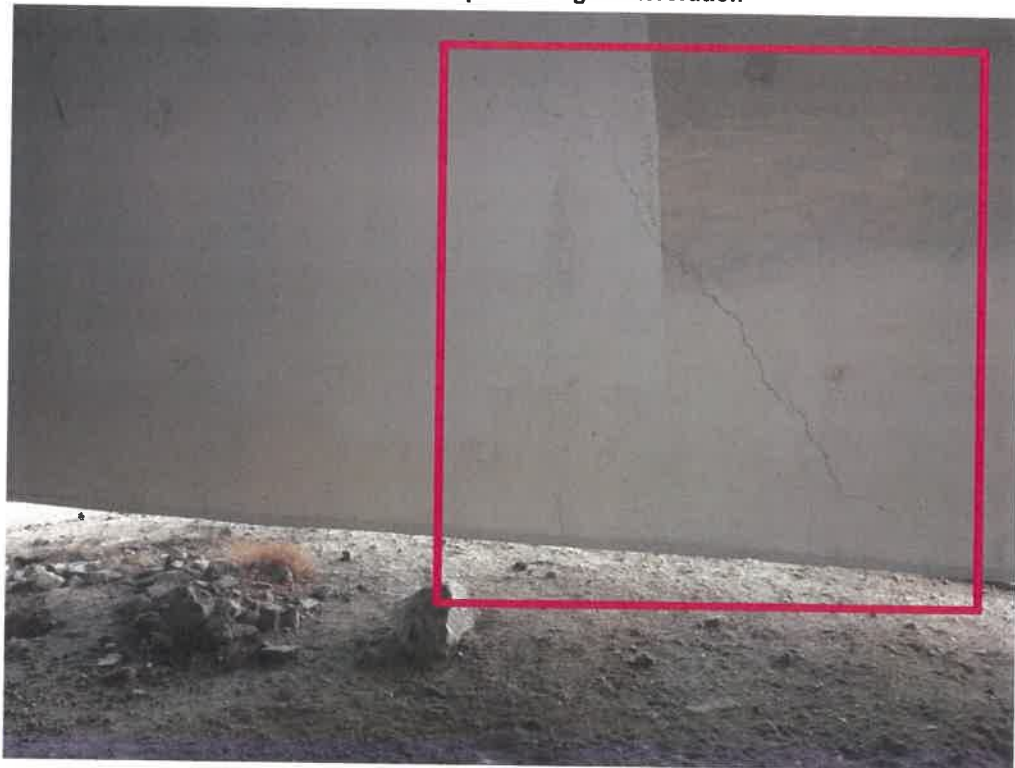
Photo No. 4

Diagonal cracks at the RC girders, up to 0.04 inches wide.
