DEPARTMENT OF TRANSPORTATION
Structure Maintenance & Investigations

Bridge Number : 55C0038
Facility Carried: SANTIAGO CNYN ROAD
Location : 0.2 MI W/O SILVERADO CYN
City :
Inspection Date : 05/06/2019

Bridge Inspection Report

STRUCTURE NAME: SANTIAGO CREEK

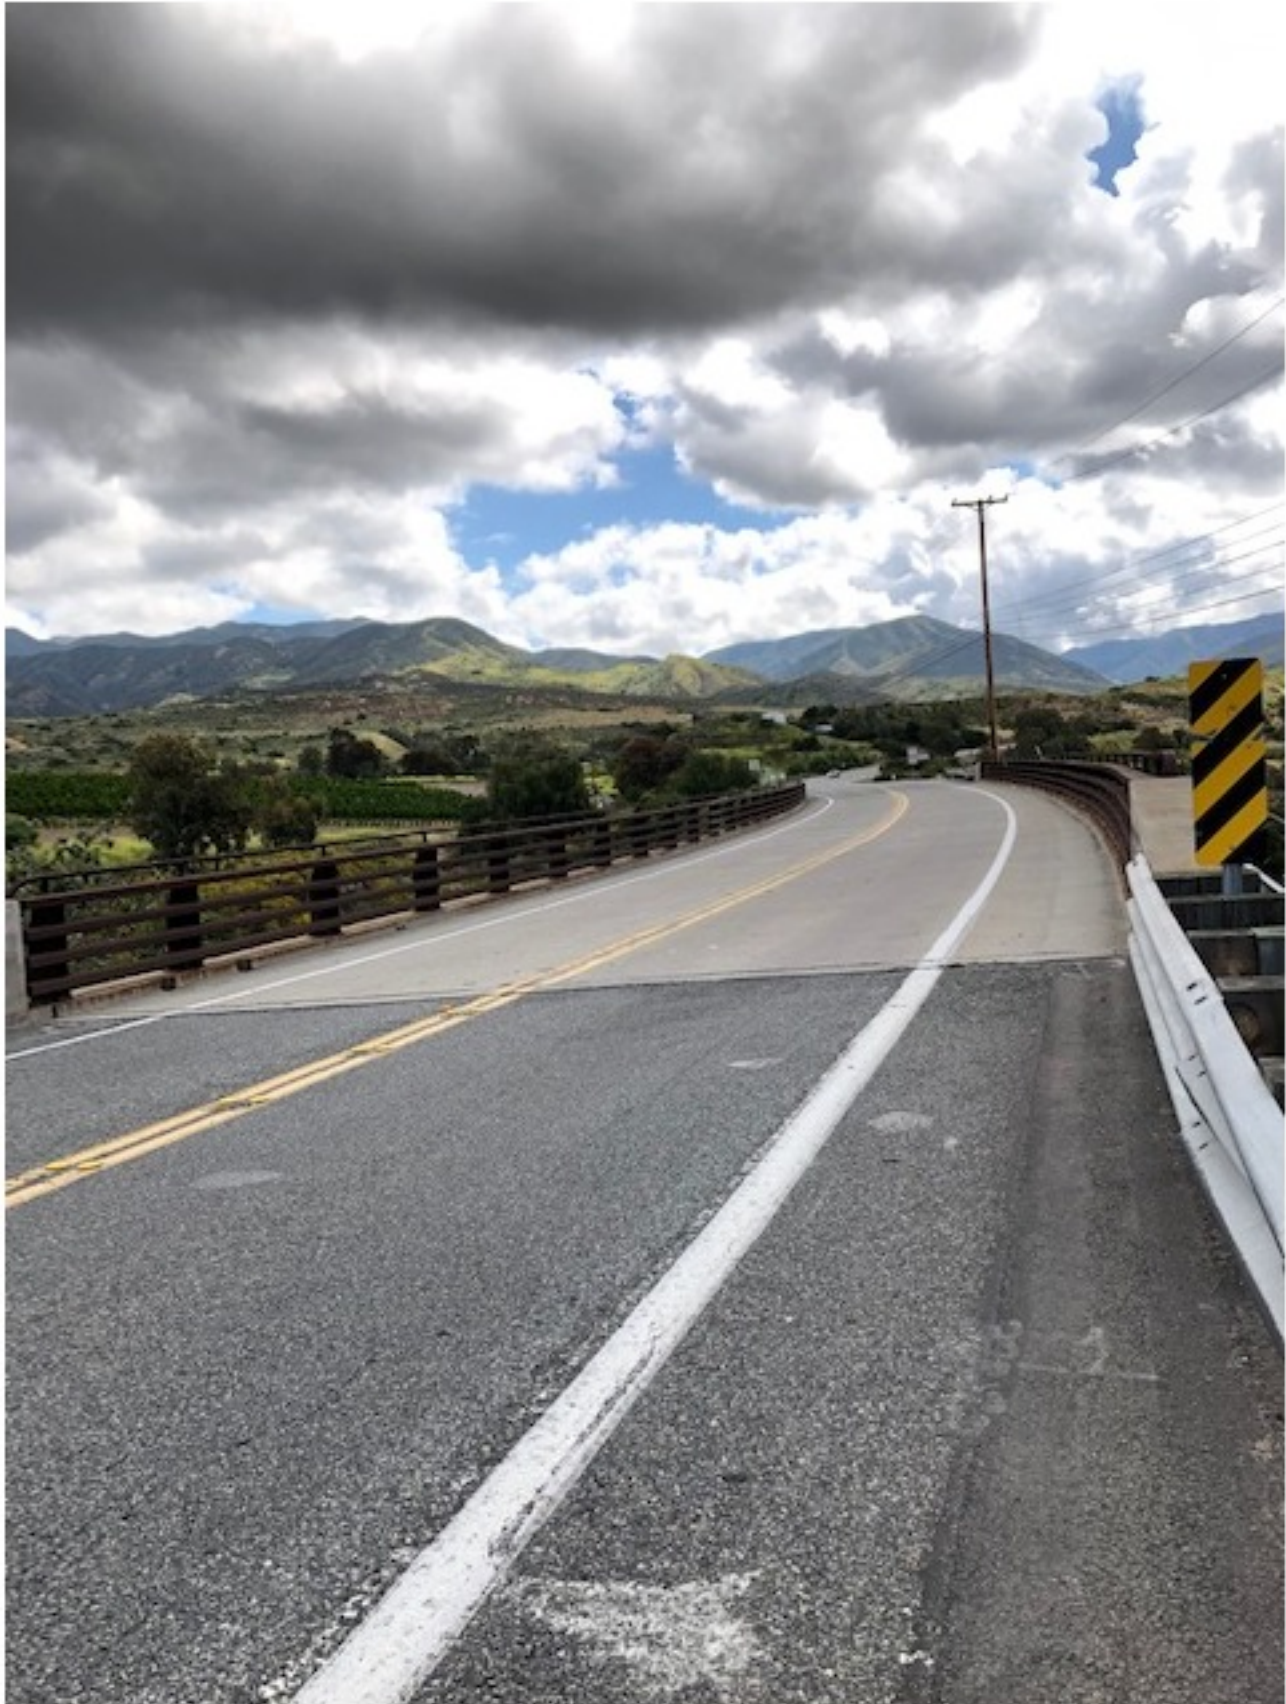
Photo No. 1
Deckview looking east

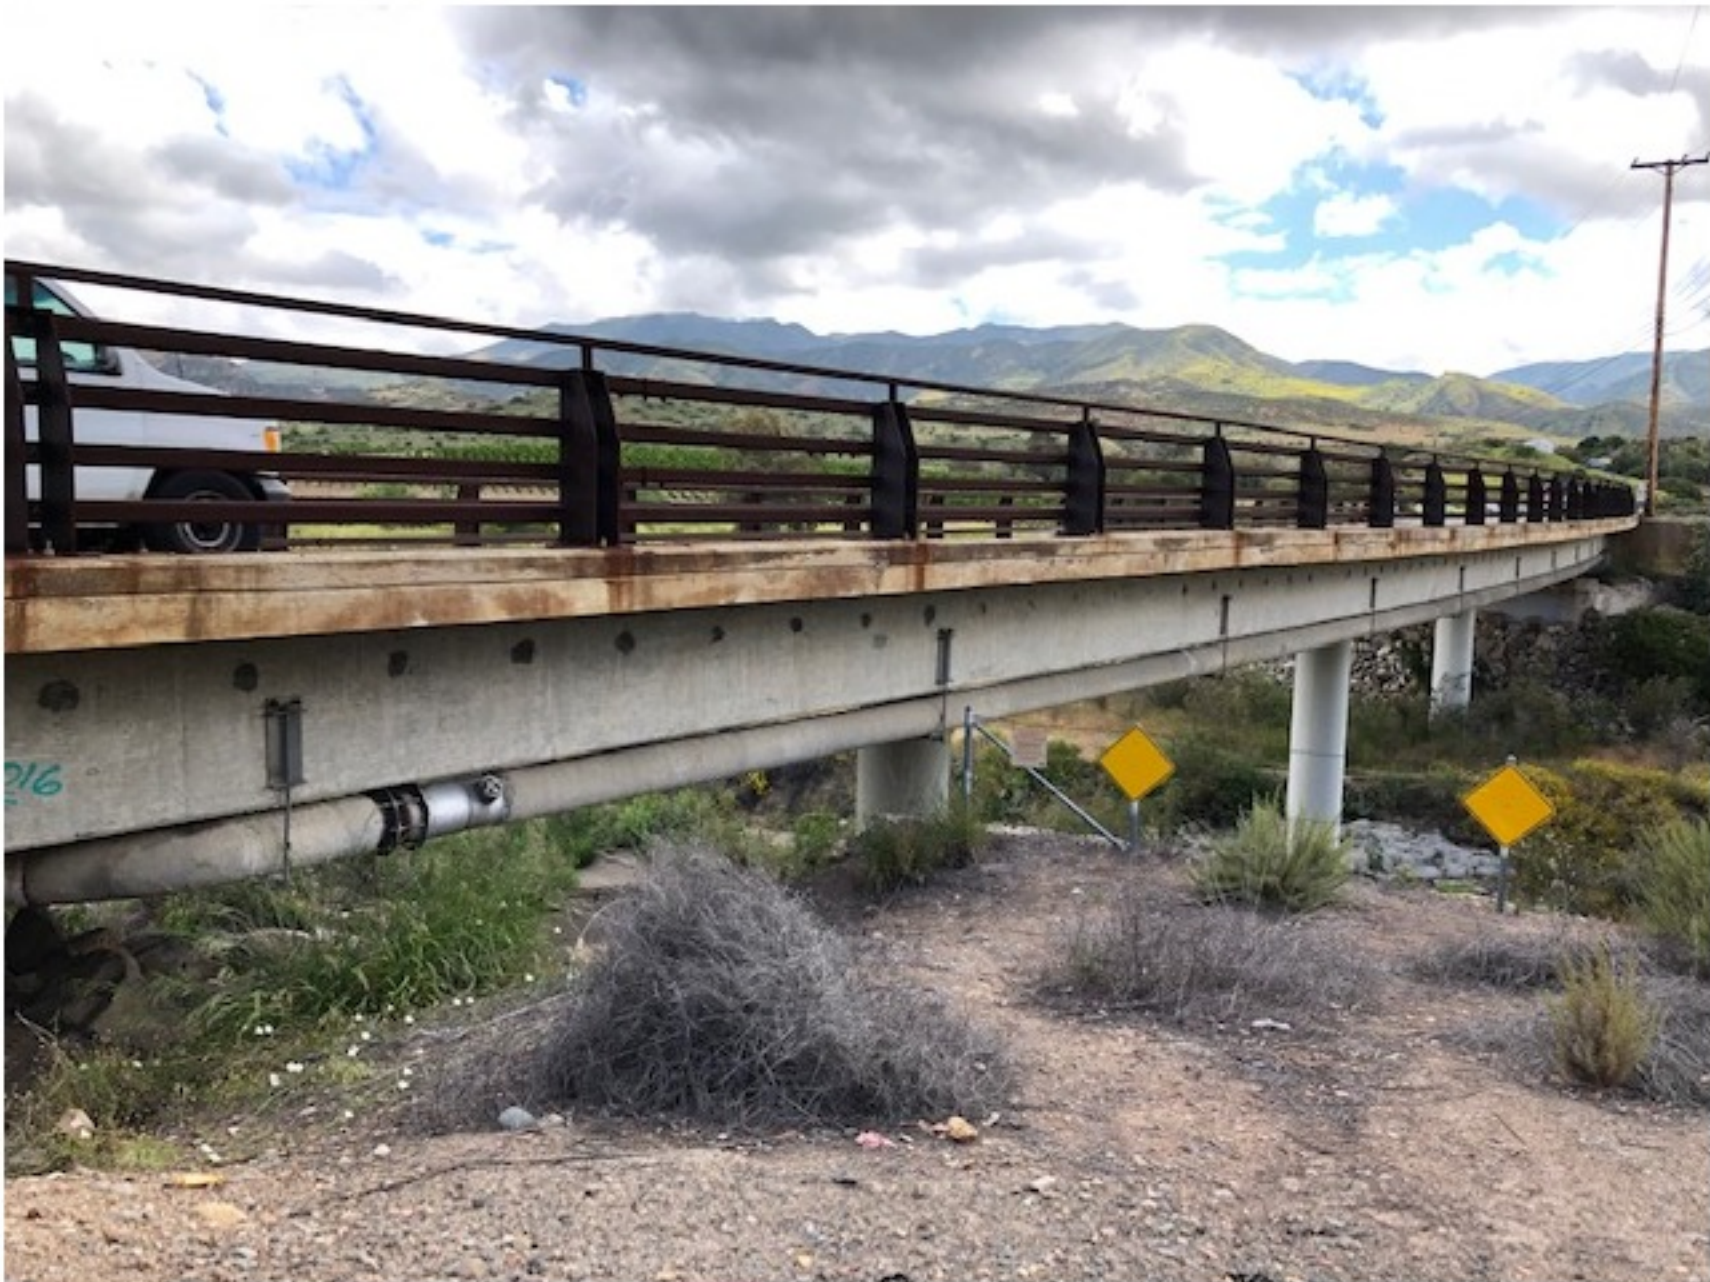
Photo No. 1

Elevation looking northeast, southerly rail

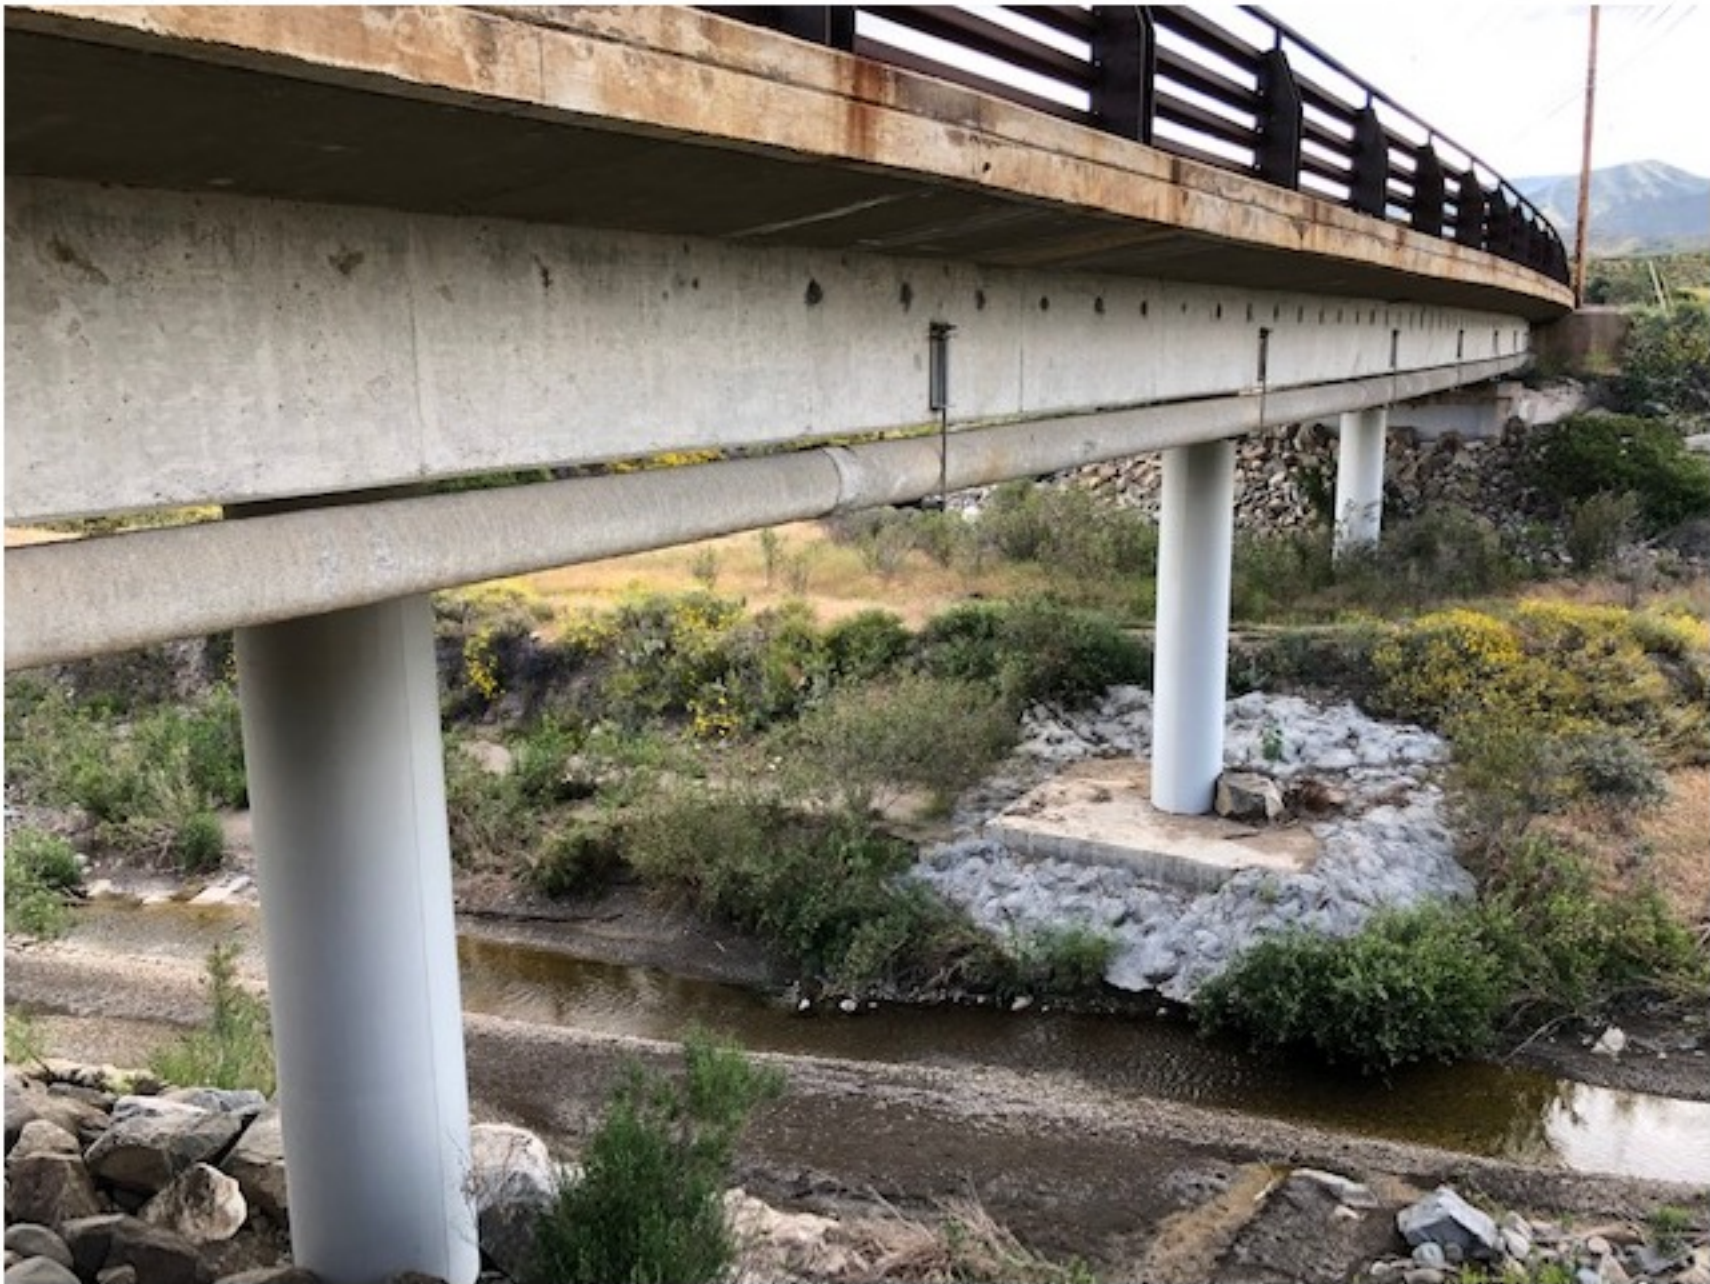
Photo No. 1

Elevation shows superstructure, substructure elements and upstream/downstream.

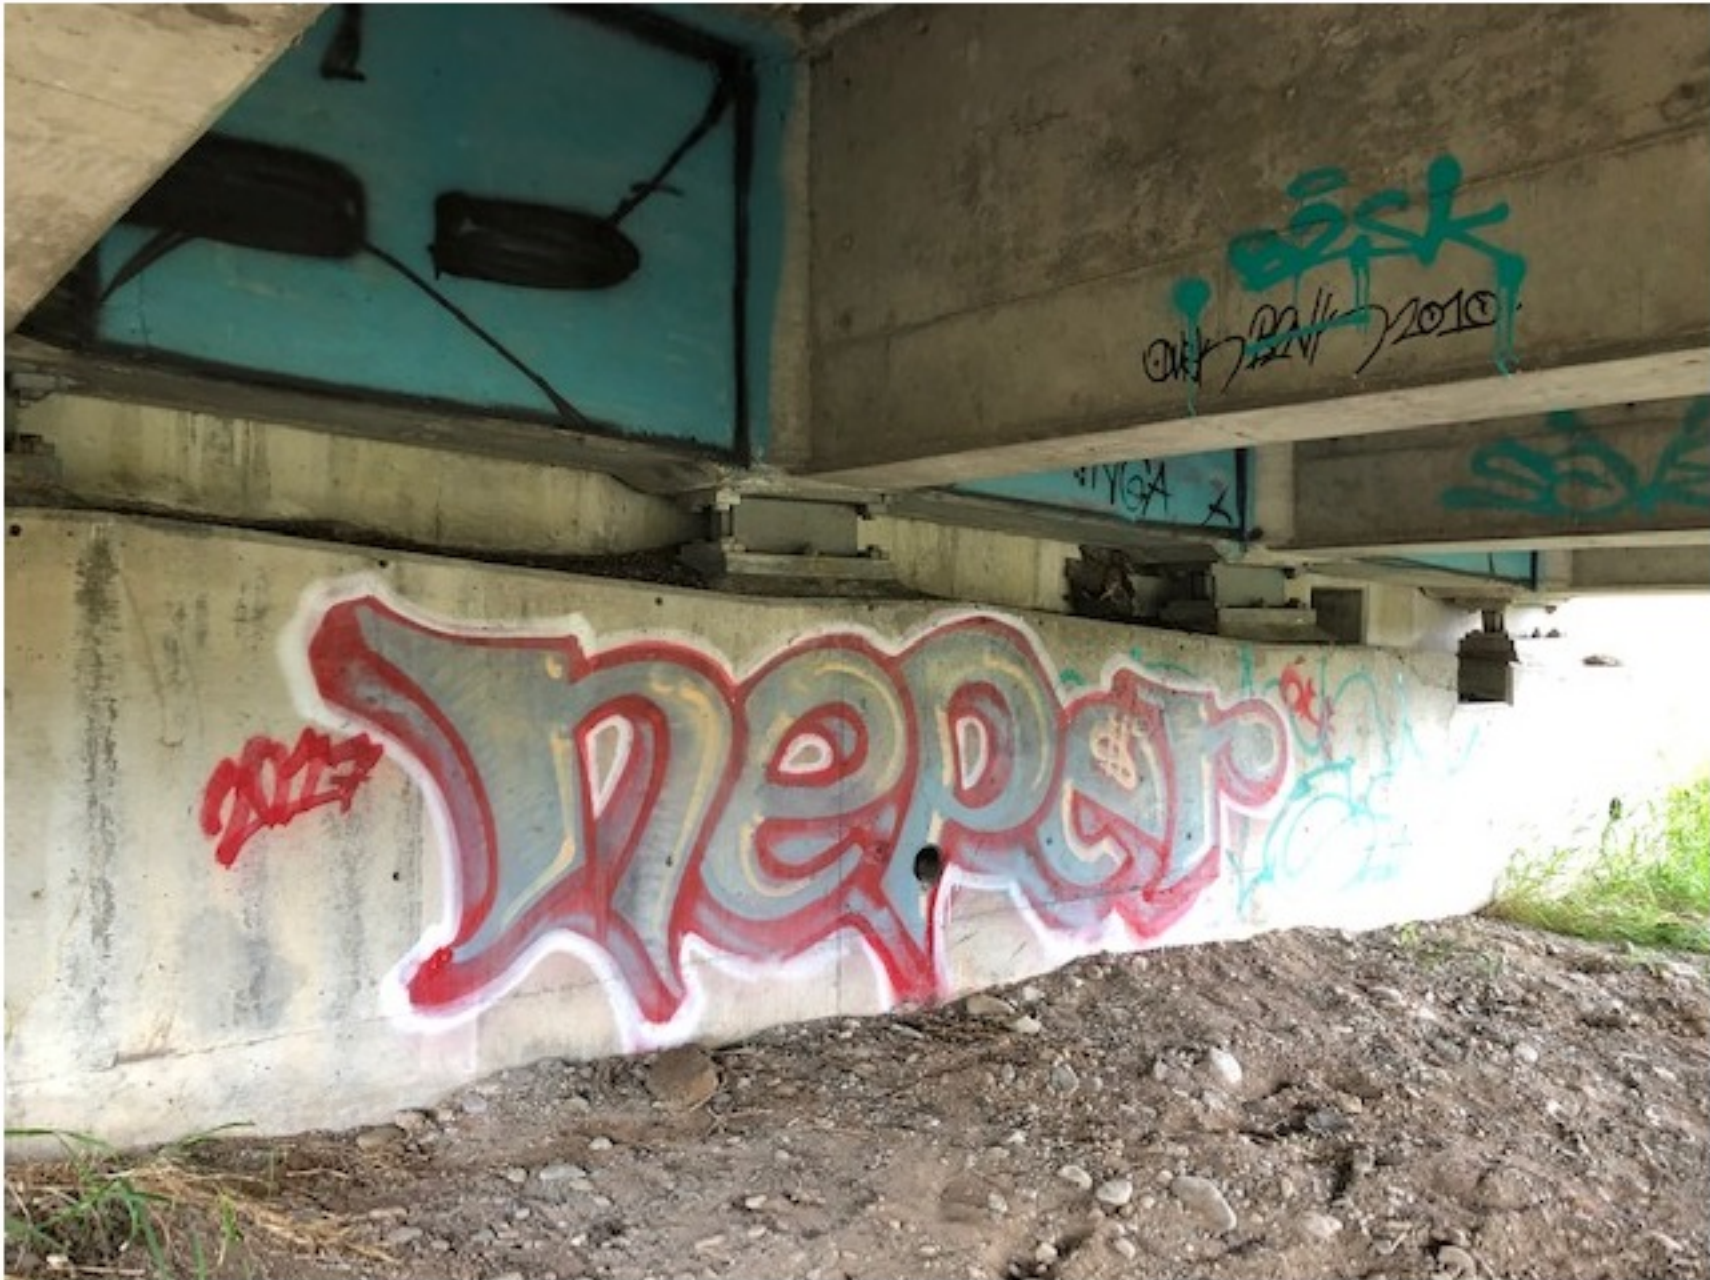
Photo No. 1
Westerly Abutment

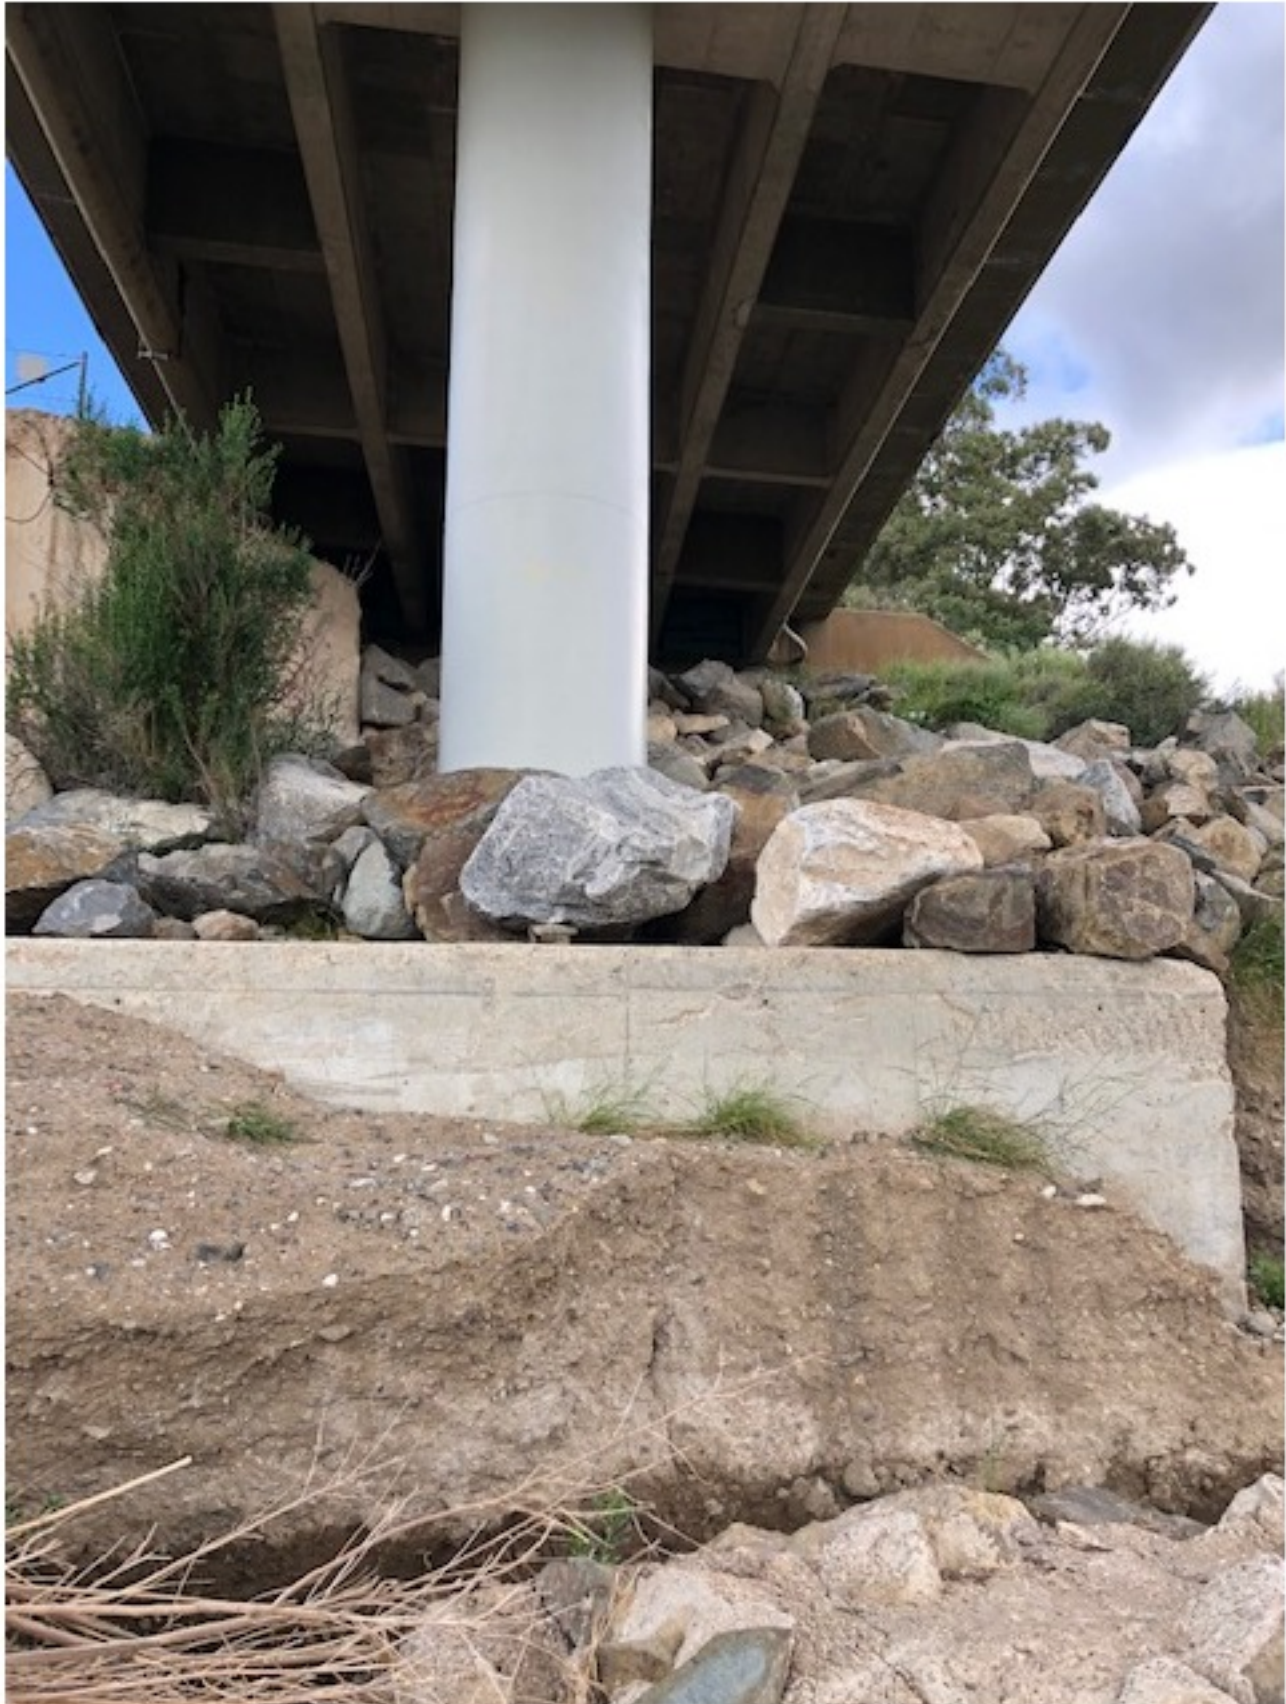
The footing under column #2 is exposed about 20.0 feet long and 30.0 inches deep, there are rocks around the footing (see the attached photo no. 3)

Photo No. 1
Bent #2 with a minor washout due to recent rain

Protect the channel bed and sides, around the columns from further degradation and scour.

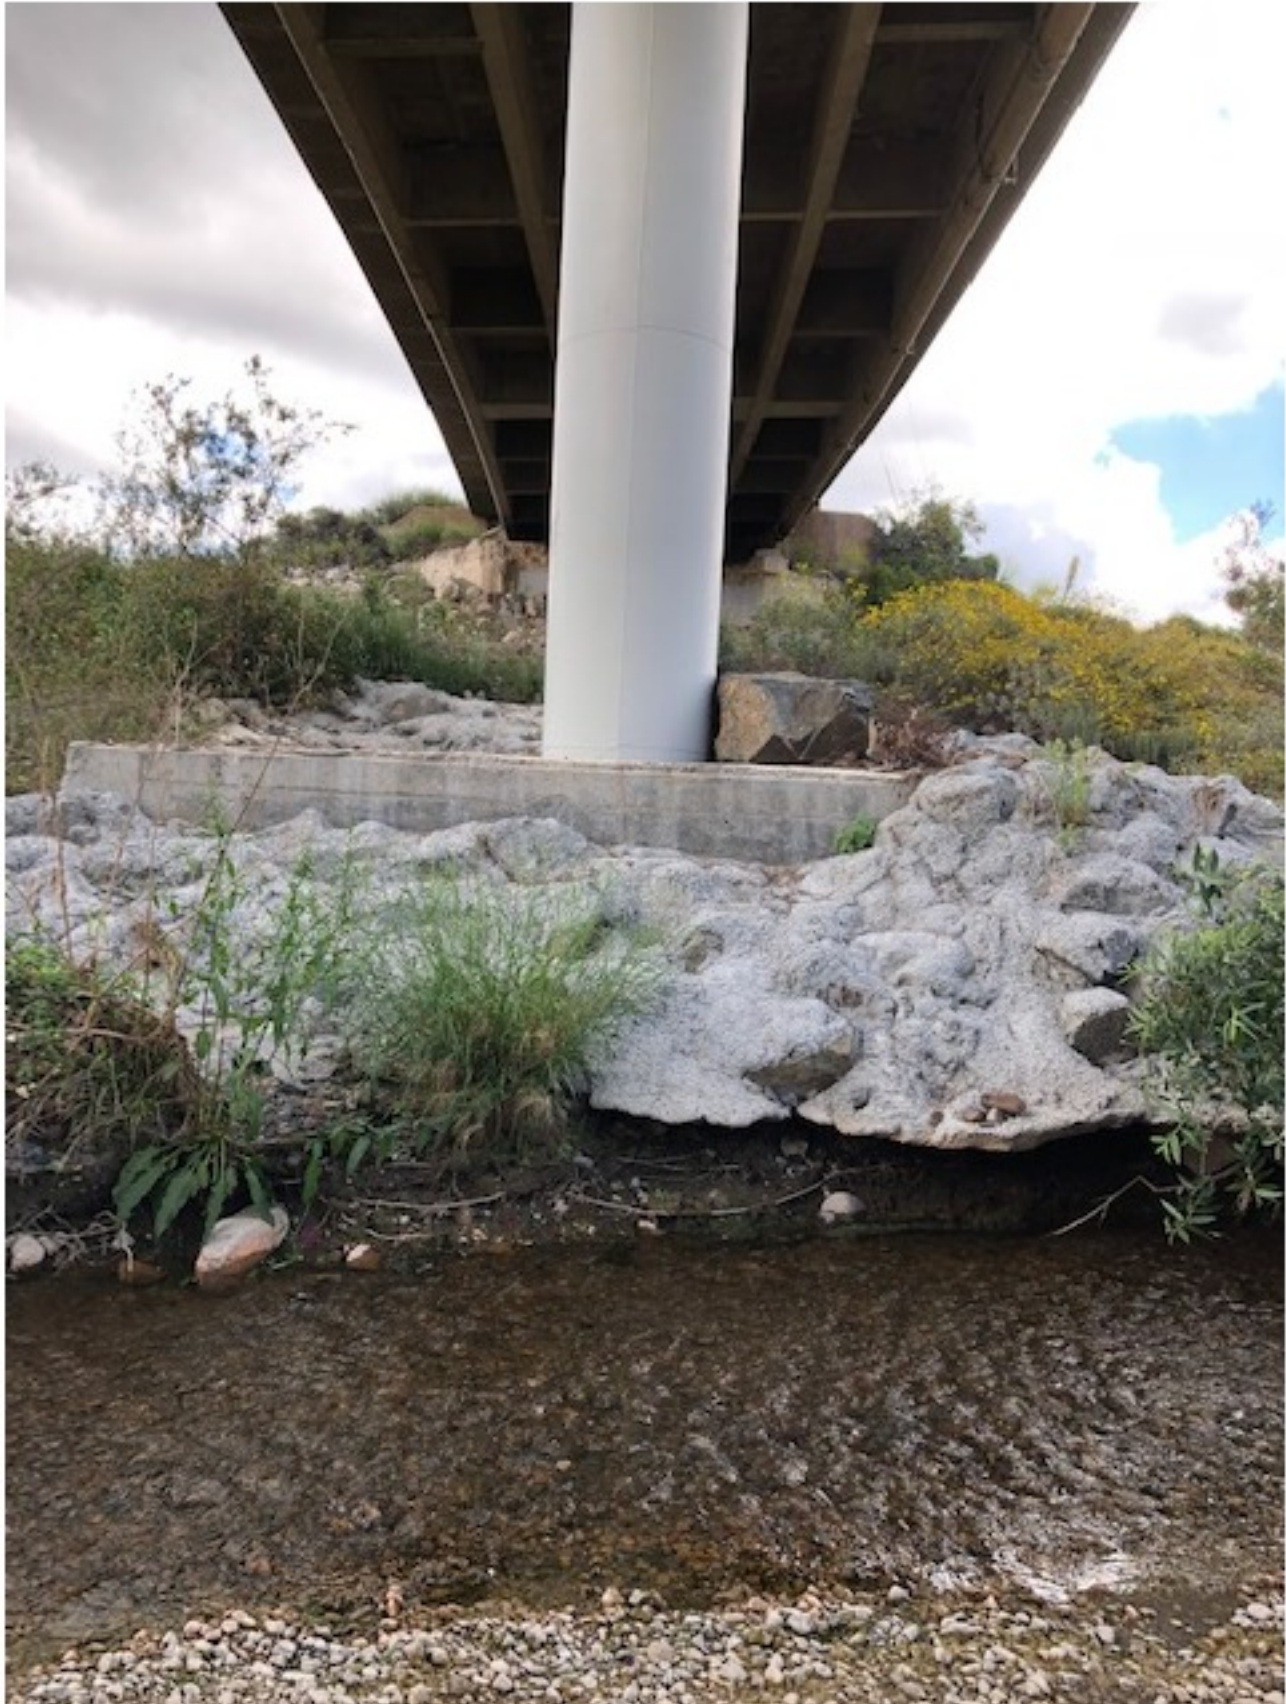
Photo No. 1

The footing under column #3 is exposed about 20.0 feet long and 18.0 inches deep; however there is a grouted riprap around the footing. In addition, there is an undermining at 15.0 inches at the upstream side, southerly side (see the attached photo no. 2).

Bent #3, footing is protected by concrete apron but it has a minor washout in BIR.

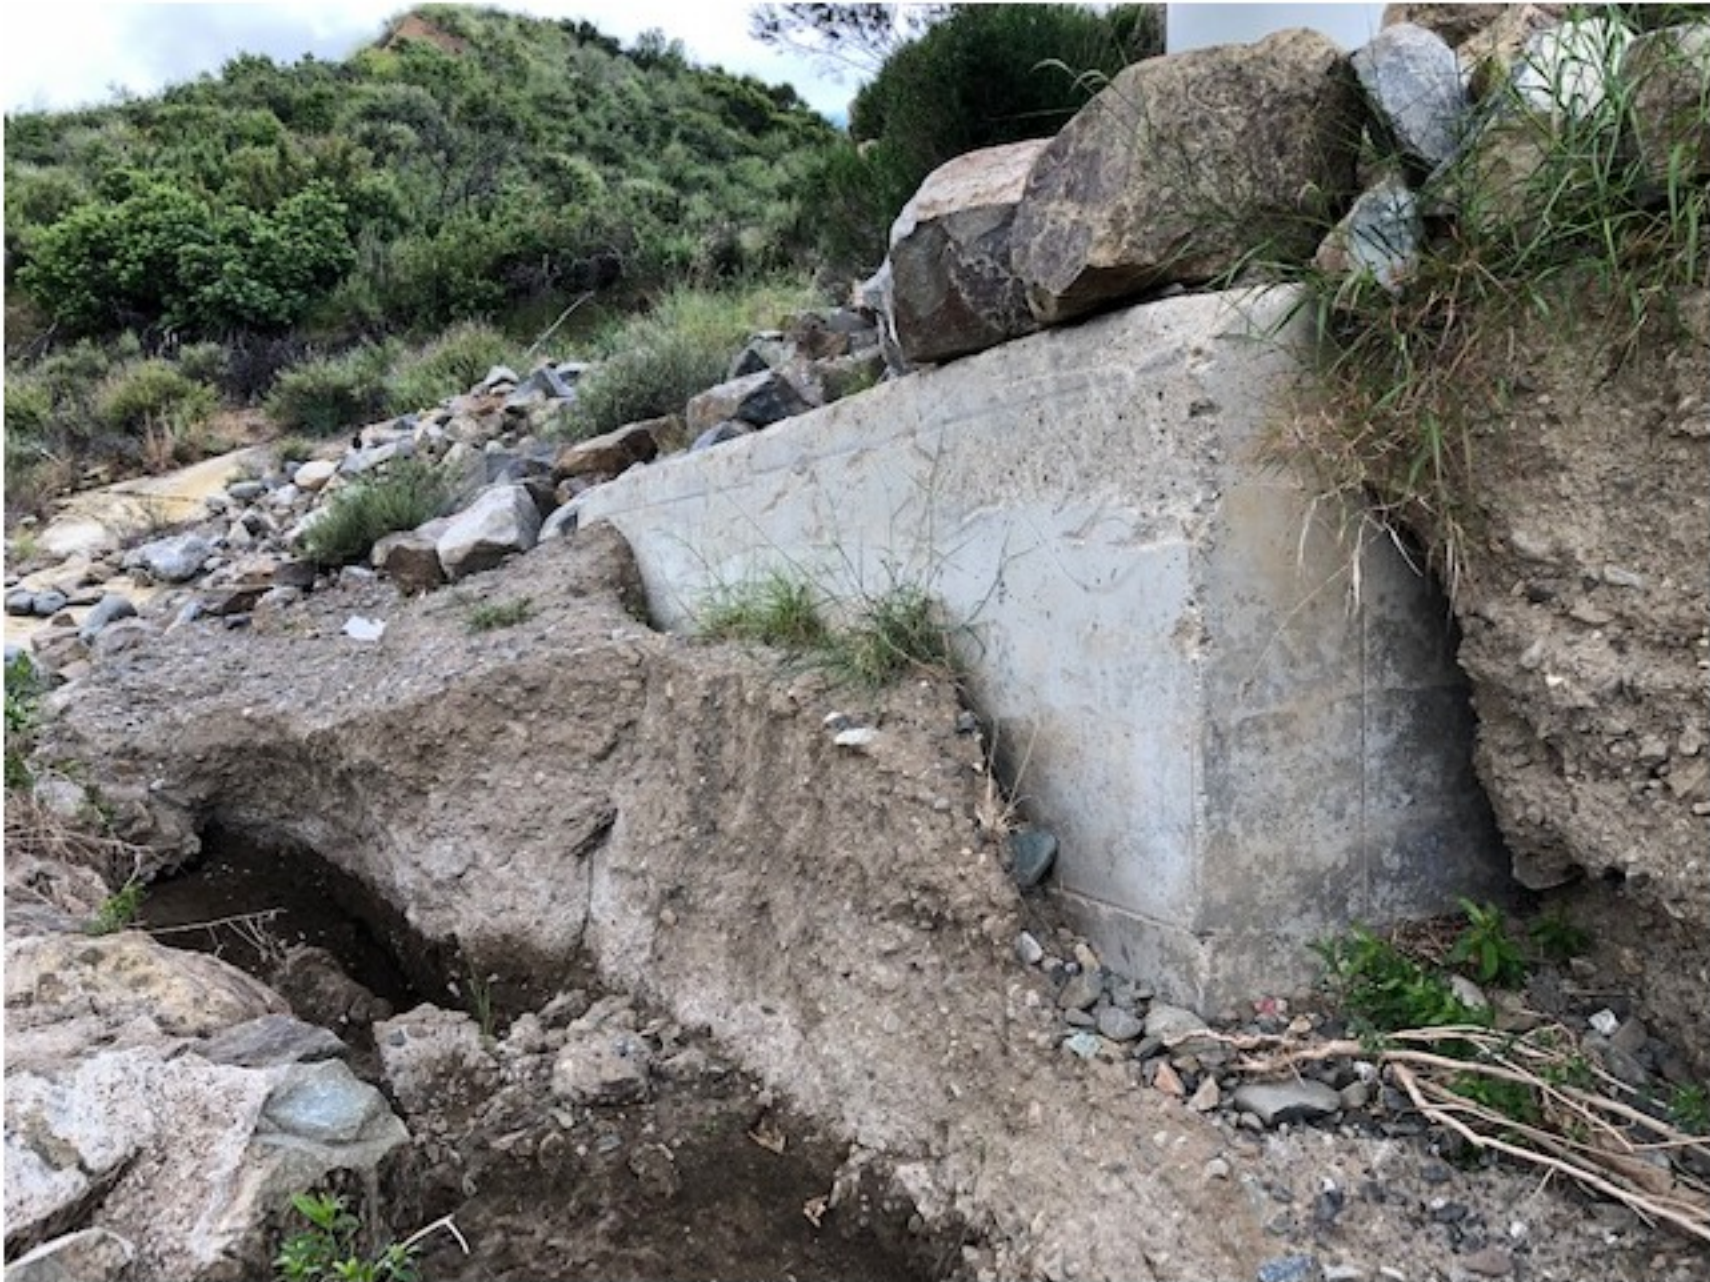
Photo No. 1

Bent #2 with a minor washout due to recent rain

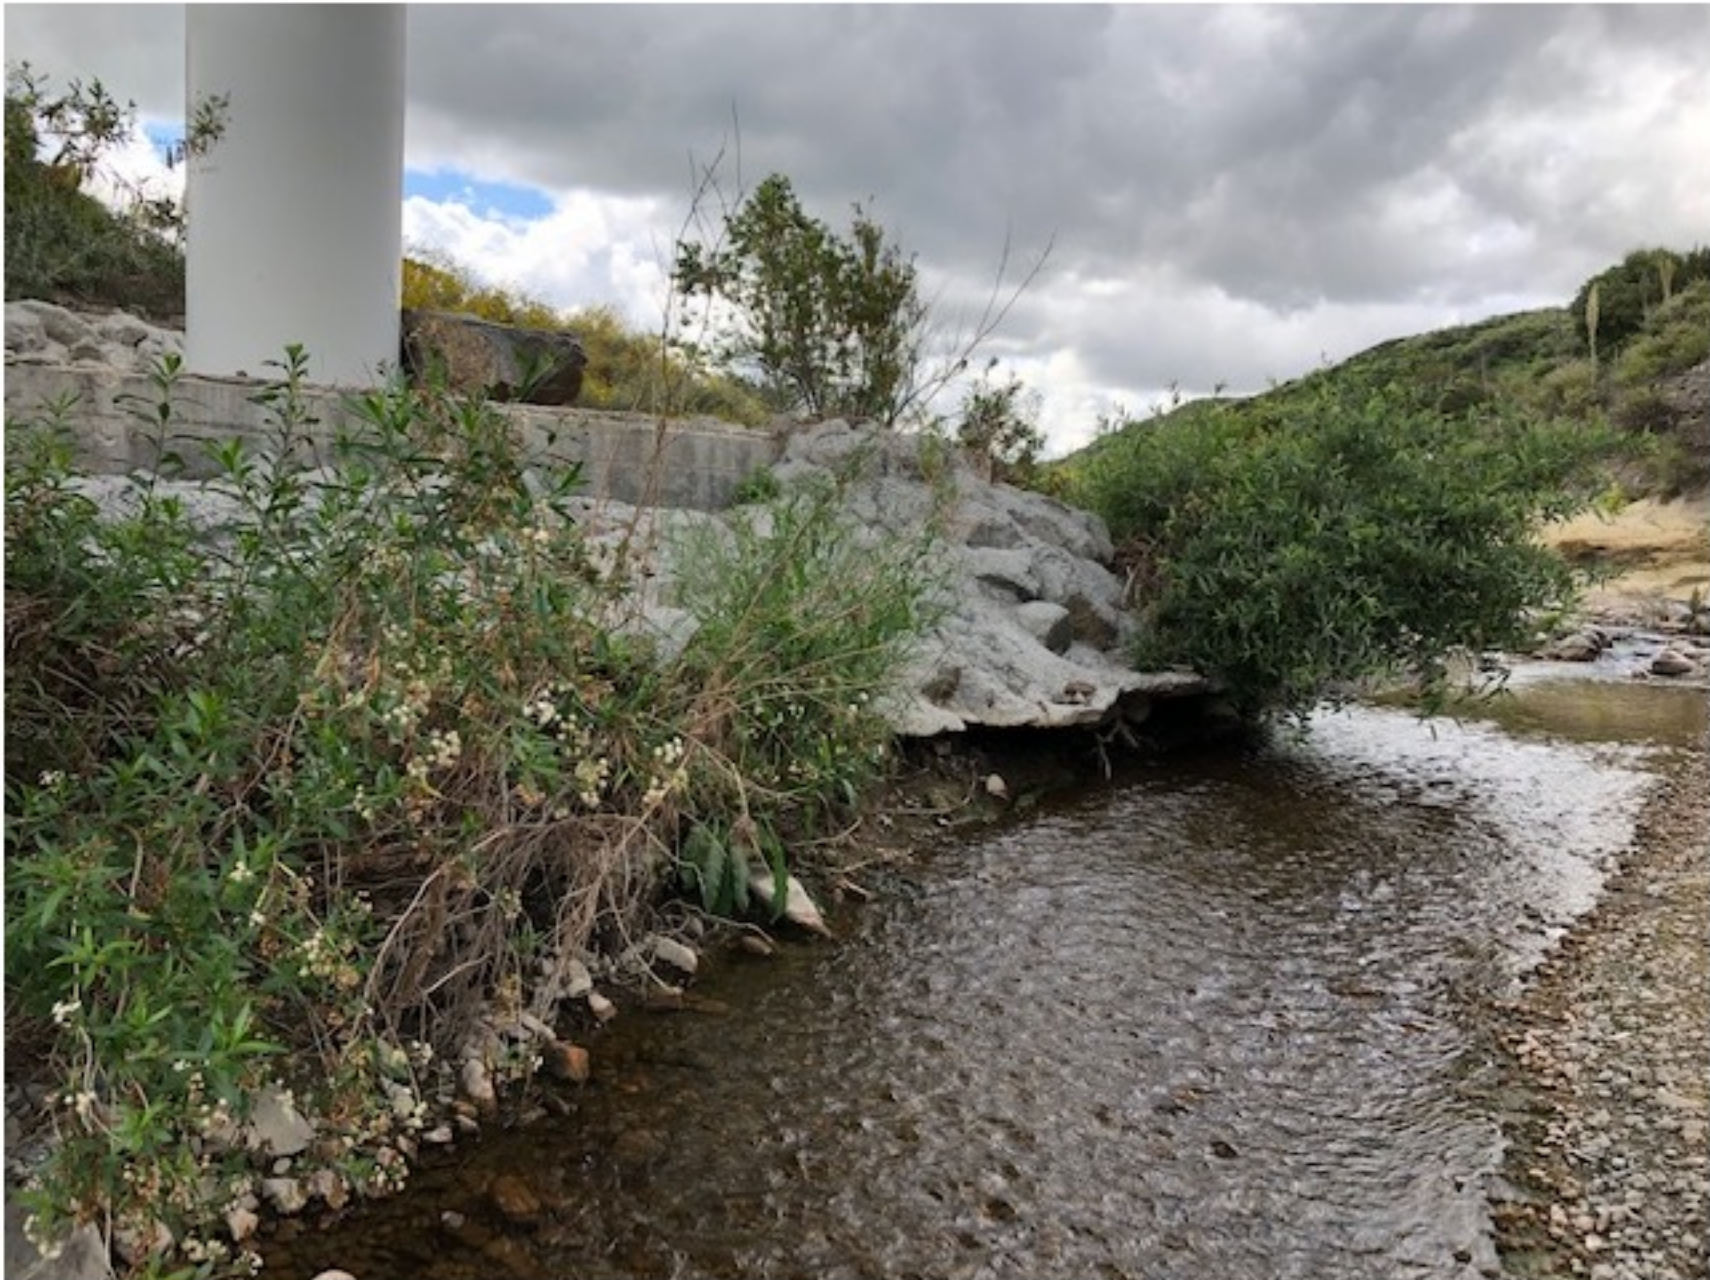
Photo No. 1

Looking Upstream (South) at the Bent #3 with a minor washout that has been noticed in BIR

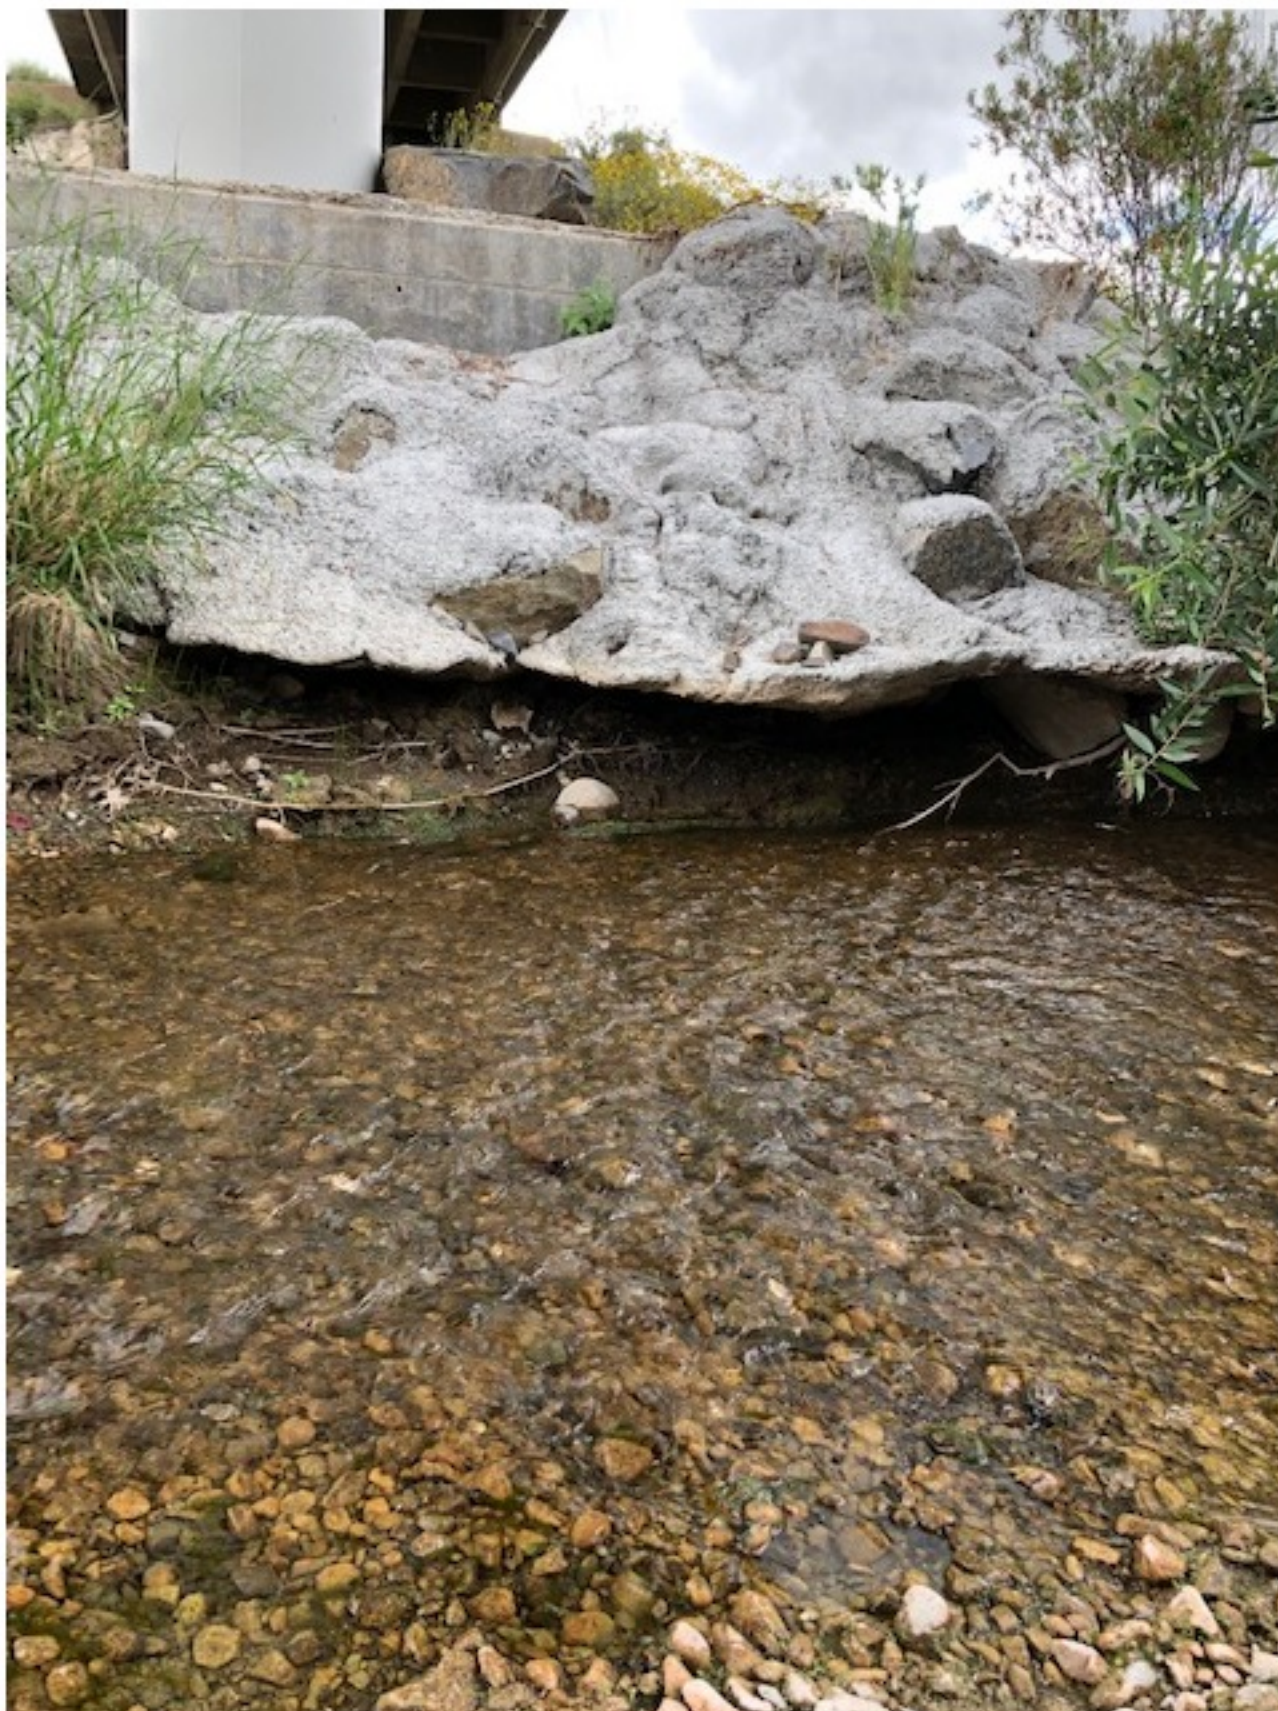
Photo No. 1
Bent #3, looking southeast

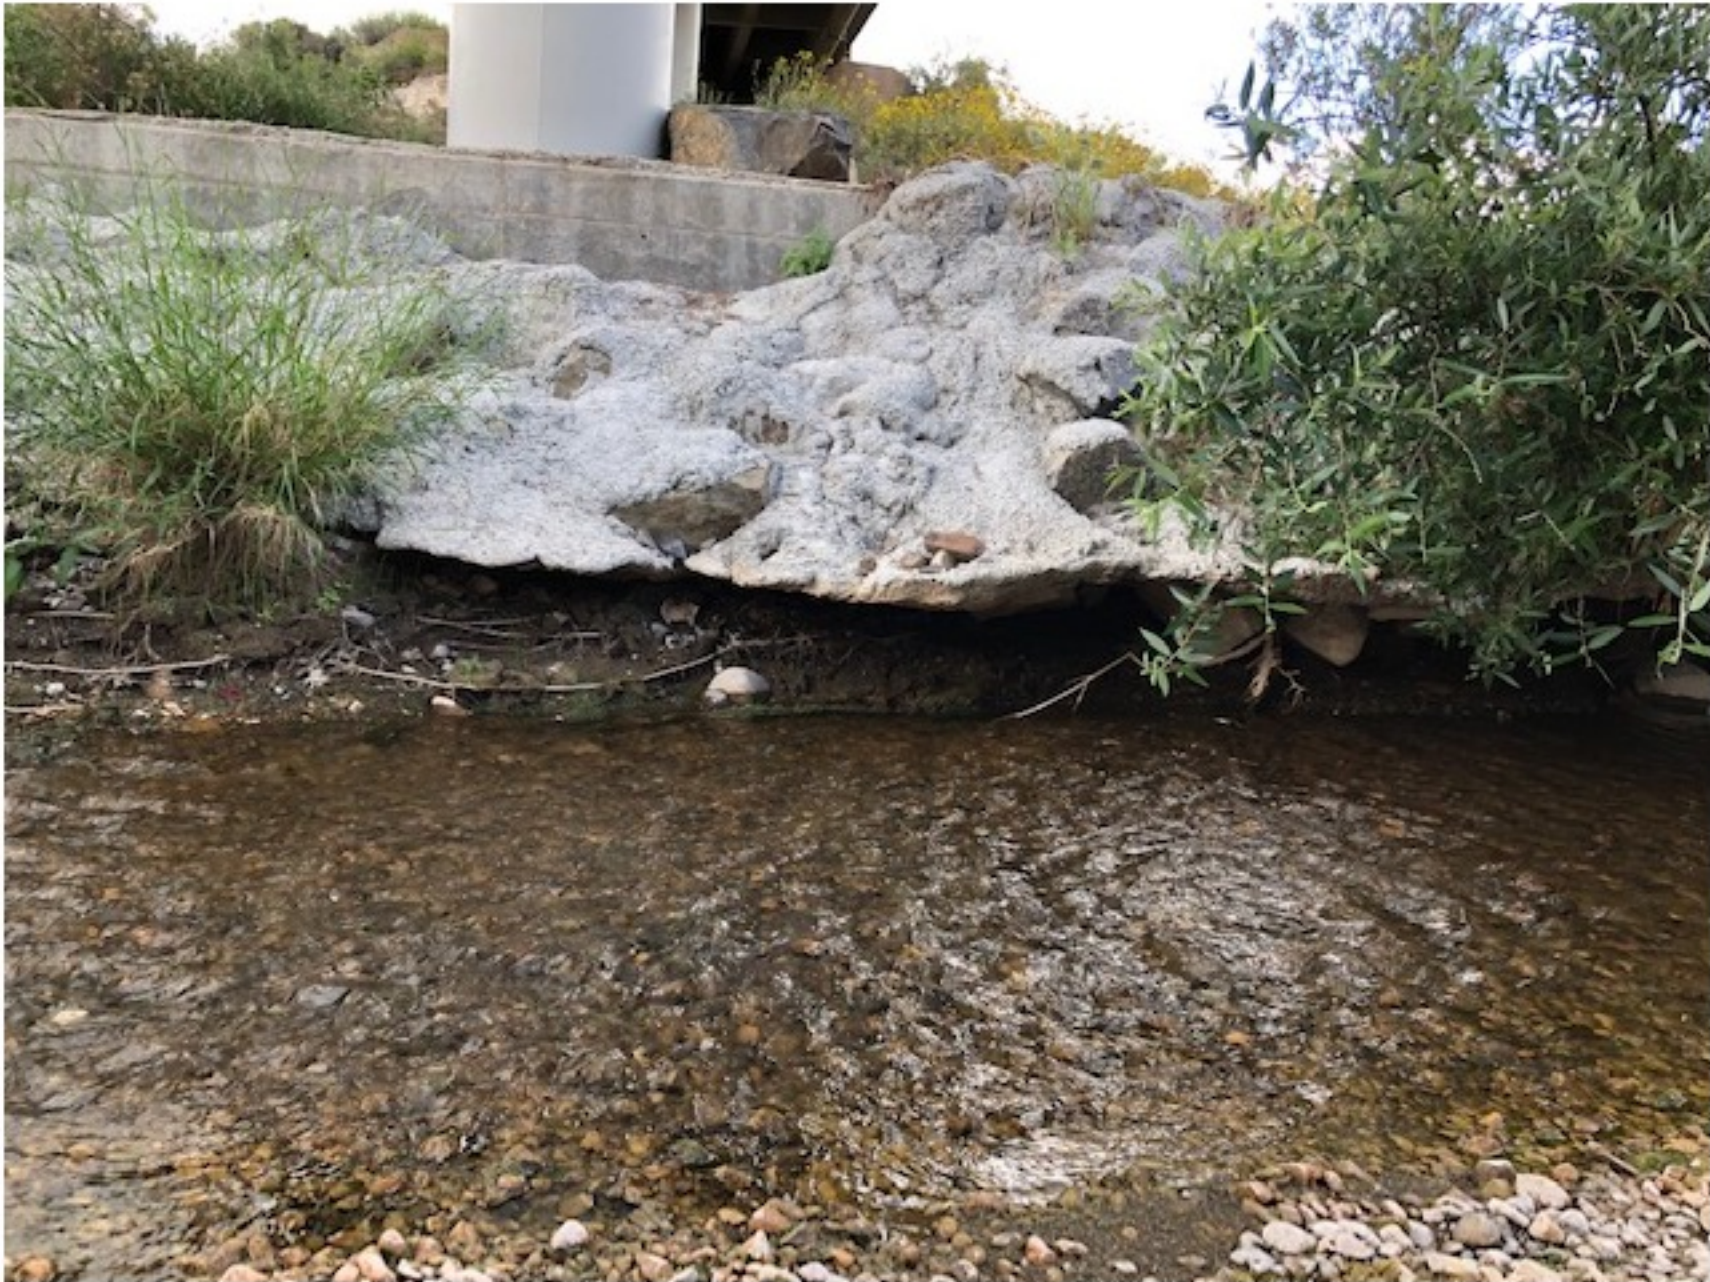
Photo No. 1

Bent #3, footing is protected by concrete apron but it has a minor washout in BIR.
