April 5, 2018

Bridge Number : 55C0038
Facility Carried: SANTIAGO CNYN ROAD
Location : 0.2 MI W/O SILVERADO CYN
City :
Inspection Date : 09/07/2017

Bridge Inspection Report

STRUCTURE NAME: SANTIAGO CREEK

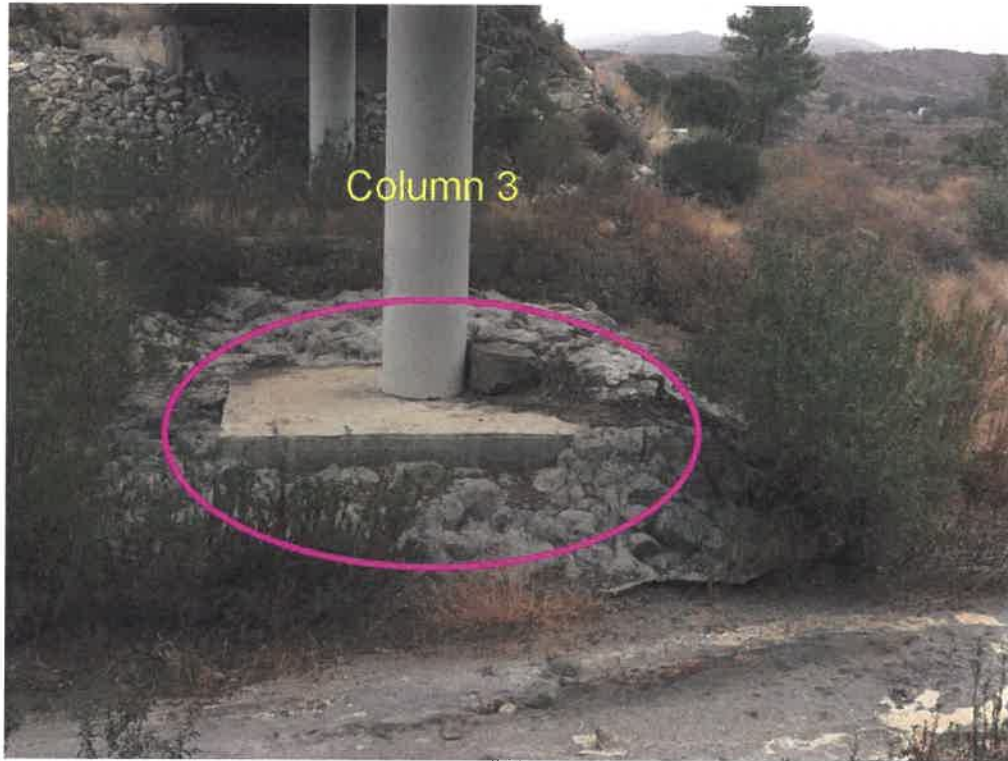
Photo No. 2

A scour is noticed at Bents 2 and 3, and the spread footing is exposed. A request #7983 was sent the hydraulic department on 03/05/2018 to re-assess the current hydraulic condition.

(215)									
There were no significant defects noted.									
(215-1130)									
The west Abutment has a vertical crack, 0.05 inches wide under girder 3.									
220		Pile Cap/Footing-RC	2	12	m	0	12	0	0
6000		Scour	2	12		0	12	0	0
(220-6000)									
The spread footing under the columns is exposed as follows:									
The footing under column 2 is exposed 20 feet long and 30 inches deep, there are rocks around the footing. (see the attached photo no. 3)									
The footing under column 3 is exposed 20 feet long and 18 inches deep, however there is grouted riprap around the footing and there is undermining 15 inches at the upstream side (south side). (see the attached photo no. 2)									
234		Pier Cap-RC	2	27	m	27	0	0	0

Footing is exposed under column 3.

Protect the channel bed and sides, around the columns from further degradation and scour.

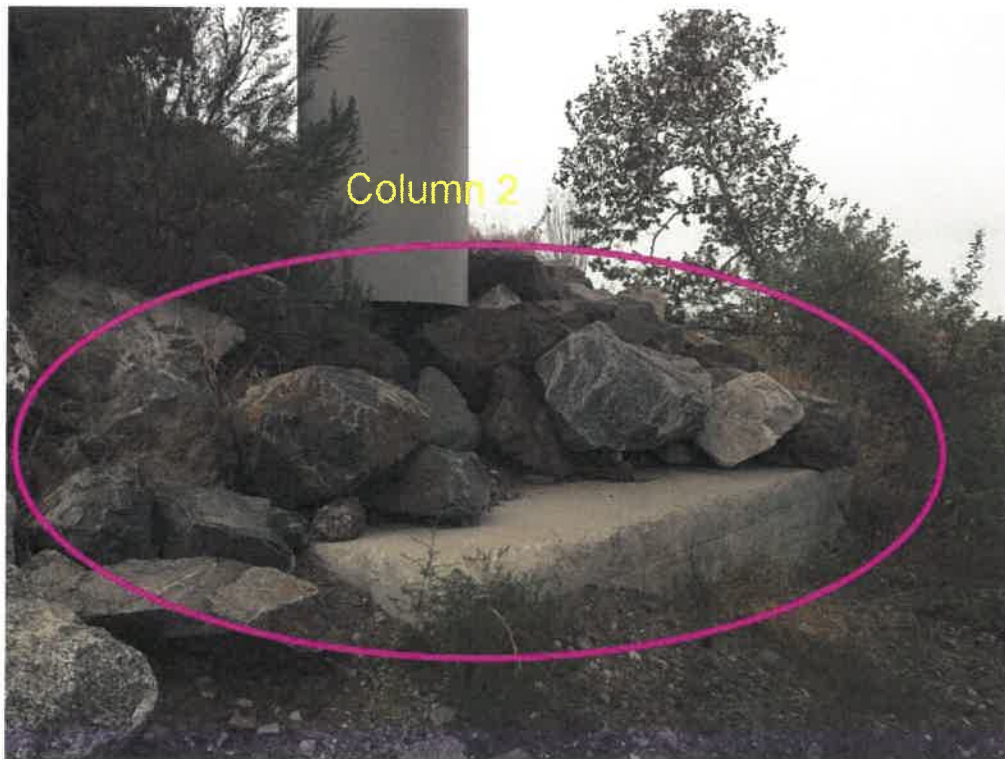
Photo No. 3

Footing is exposed under column 2.

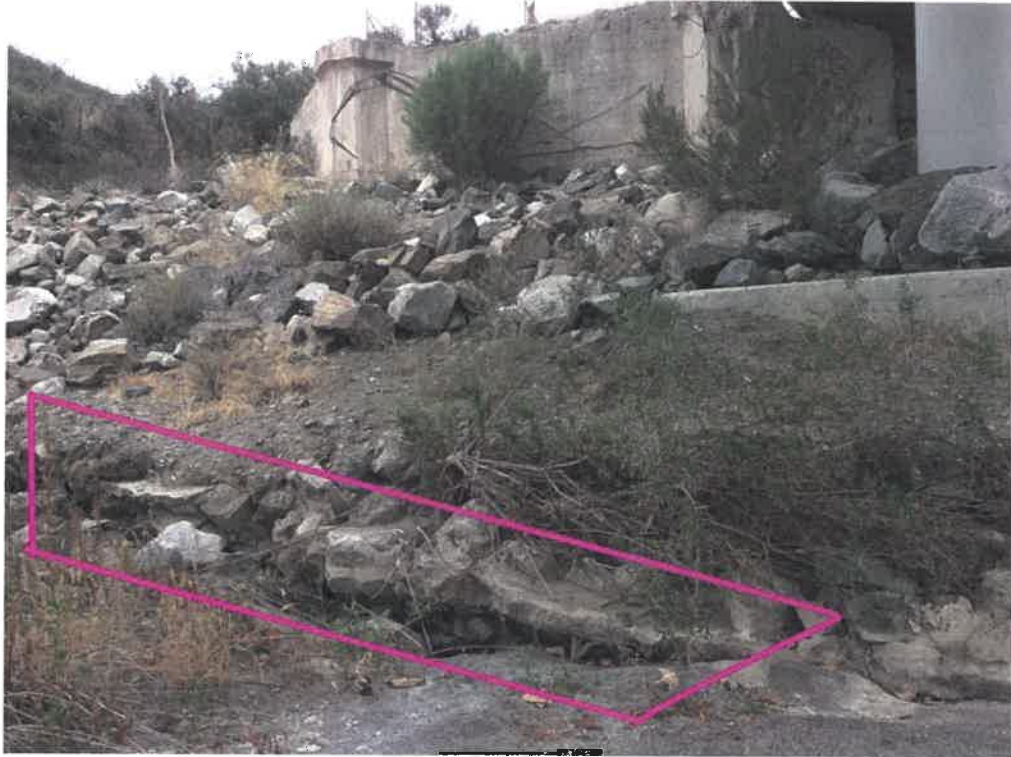
Photo No. 4

The west channel slope is undermined 40 feet long and 2 feet deep at the upstream side (south side). (see the attached photos no. 4 & 5)

Channel degraded with undermining at the south side.

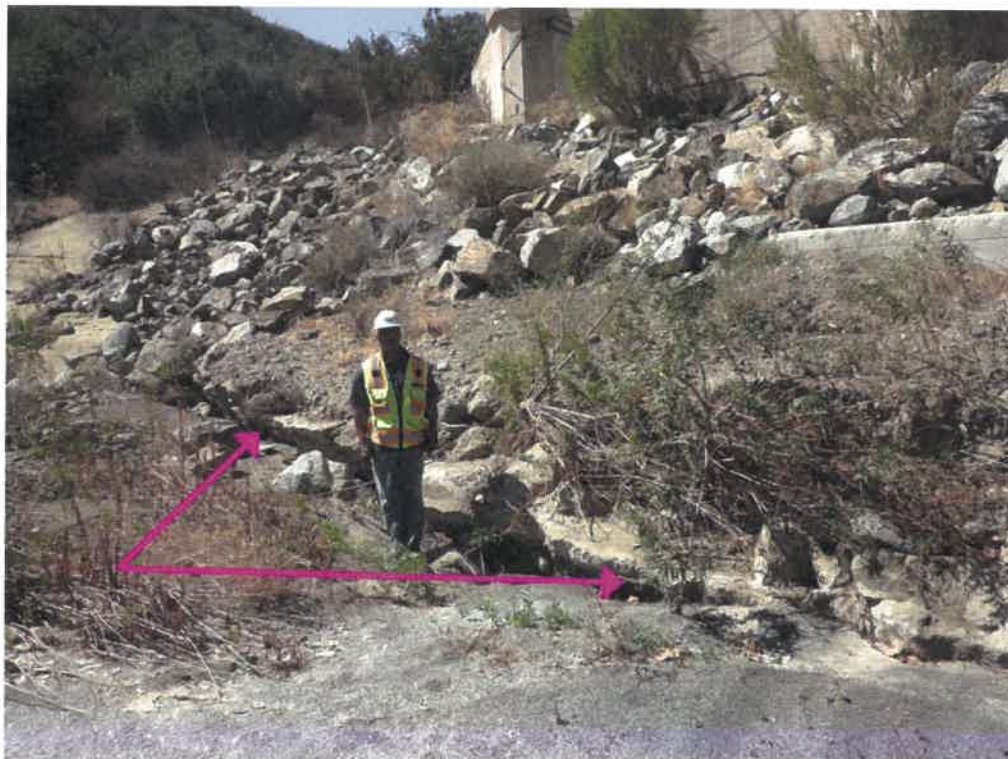
Photo No. 5

Channel degraded with undermining at the south side.

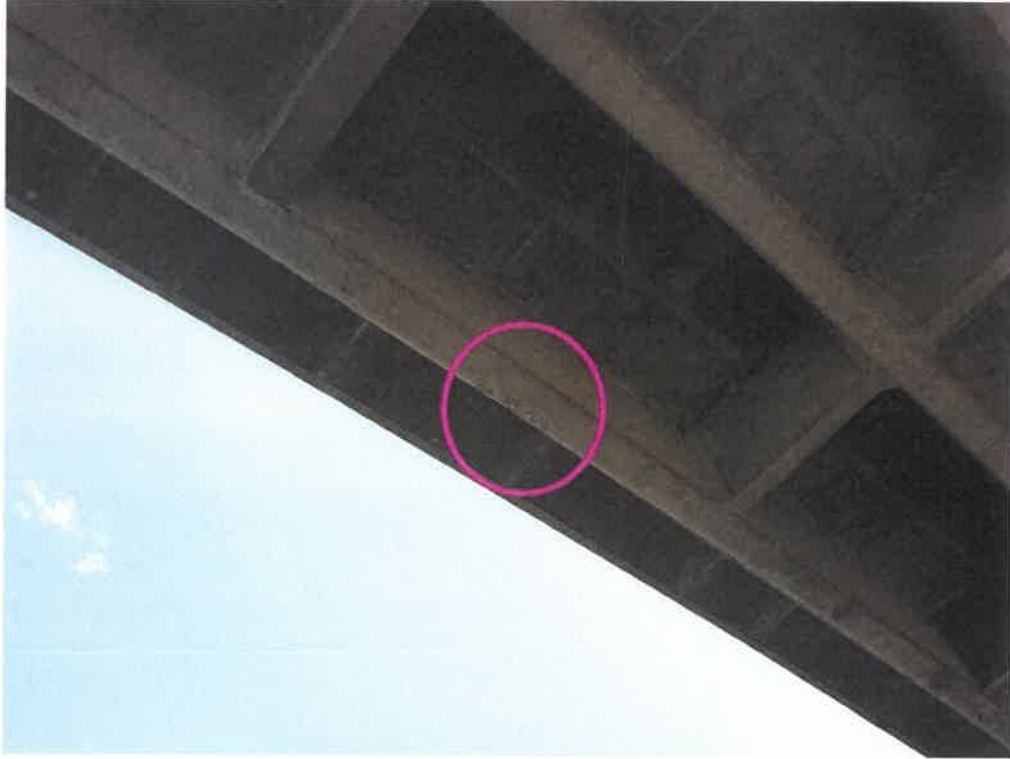
Photo No. 6

Elem No.	Defect /Prot	Element Description	Env	Total Qty	Units	Qty in each Condition State			
						St. 1	St. 2	St. 3	St. 4
1080		Delamination/Spall/Patched Area	2	1		0	0	1	0
1130		Cracking (RC and Other)	2	15		0	15	0	0
(110-1080)									
The bottom face of the north girder has a spall 2 feet X 4 inches X 1 inch at 25 feet from column 3 at Span 3. (see the attached photo no. 6)									
(110-1130)									
The concrete girders have few vertical and diagonal cracks, up to 2.5 feet long and up to 0.04 inches wide most noticed near the supports.									
215		Abutment-RC	2	28	m	27	1	0	0
1130		Cracking (RC and Other)	2	1		0	1	0	0

Spall at the girder 1 (north) at Span 2.

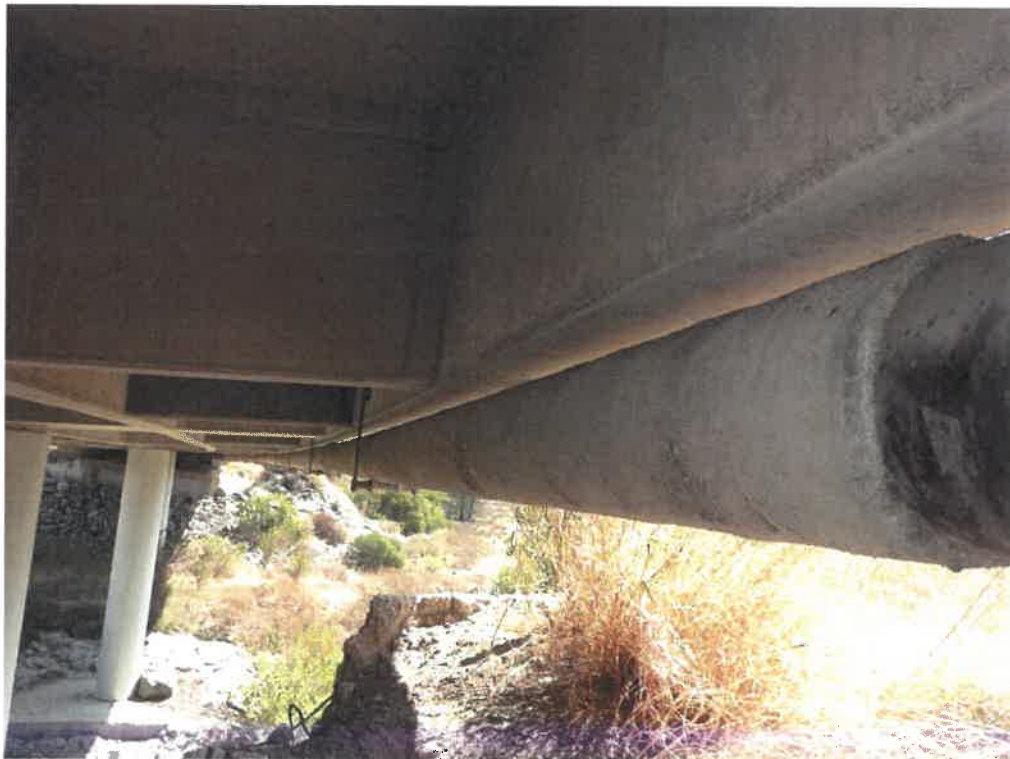
Photo No. 7

Pipe attached under girder 5.

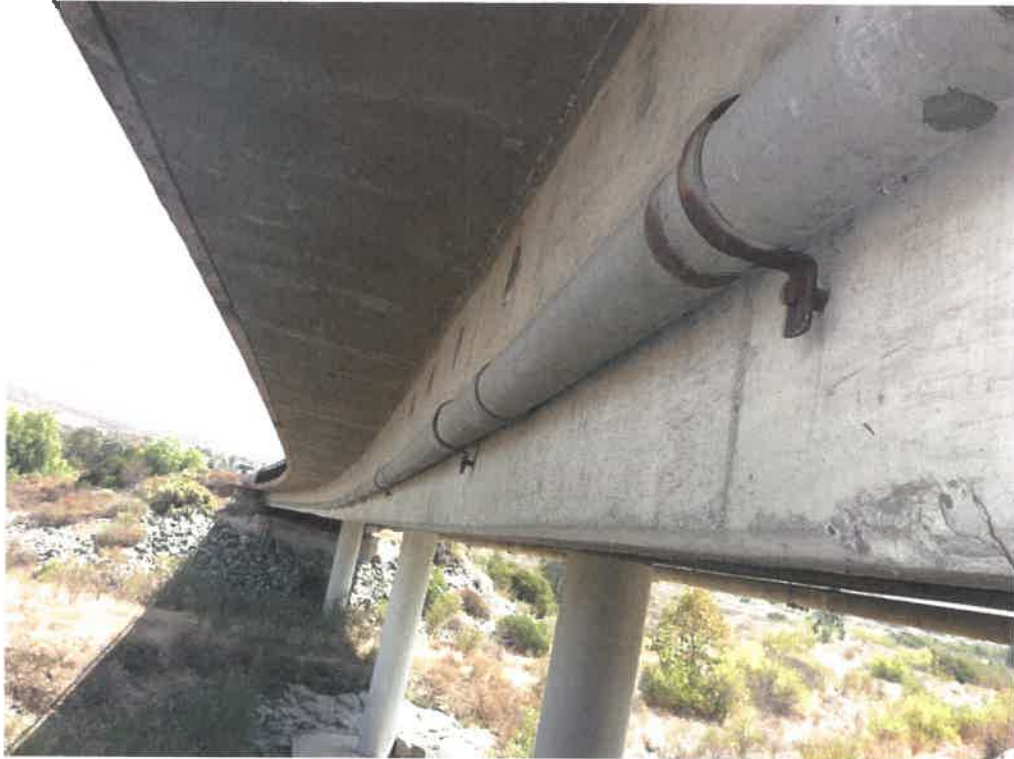
Photo No. 8

Pipe attached to the nor face of the north girder.
