**Bridge Number** : 55C0065  
**Facility Carried**: SANTIAGO CNYN ROAD  
**Location** : 4.4 mi se/o JAMBOREE RD.  
**City** :  
**Inspection Date** : 09/13/2017

**Bridge Inspection Report**

**STRUCTURE NAME:** LIMESTONE CANYON

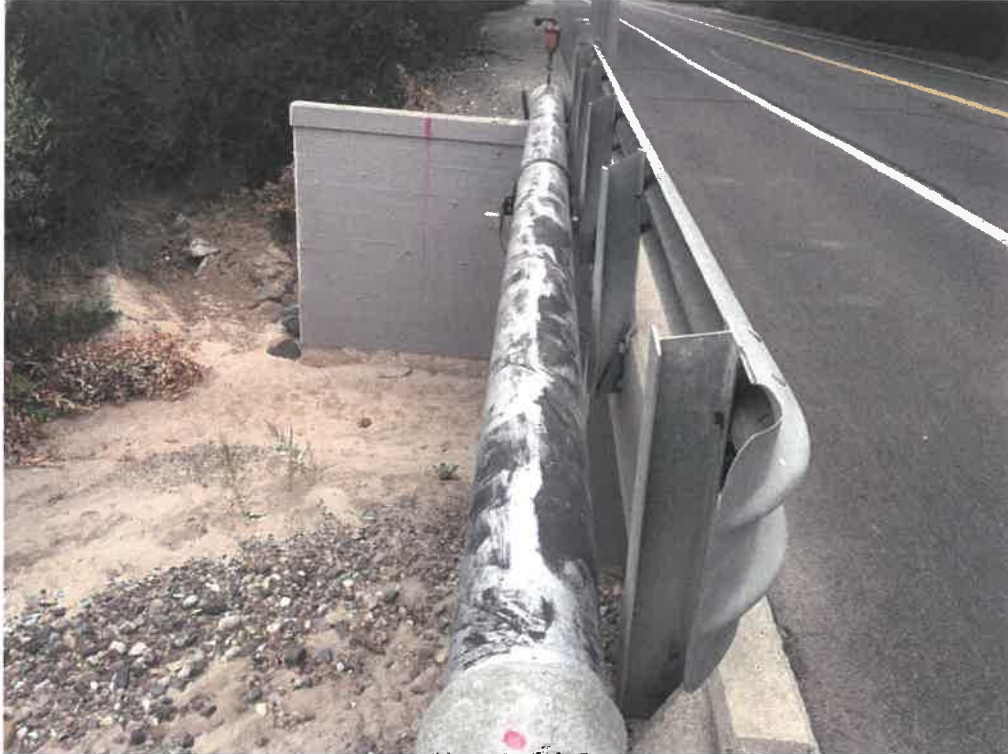
Photo No. 2

Pipe attached at the south side.

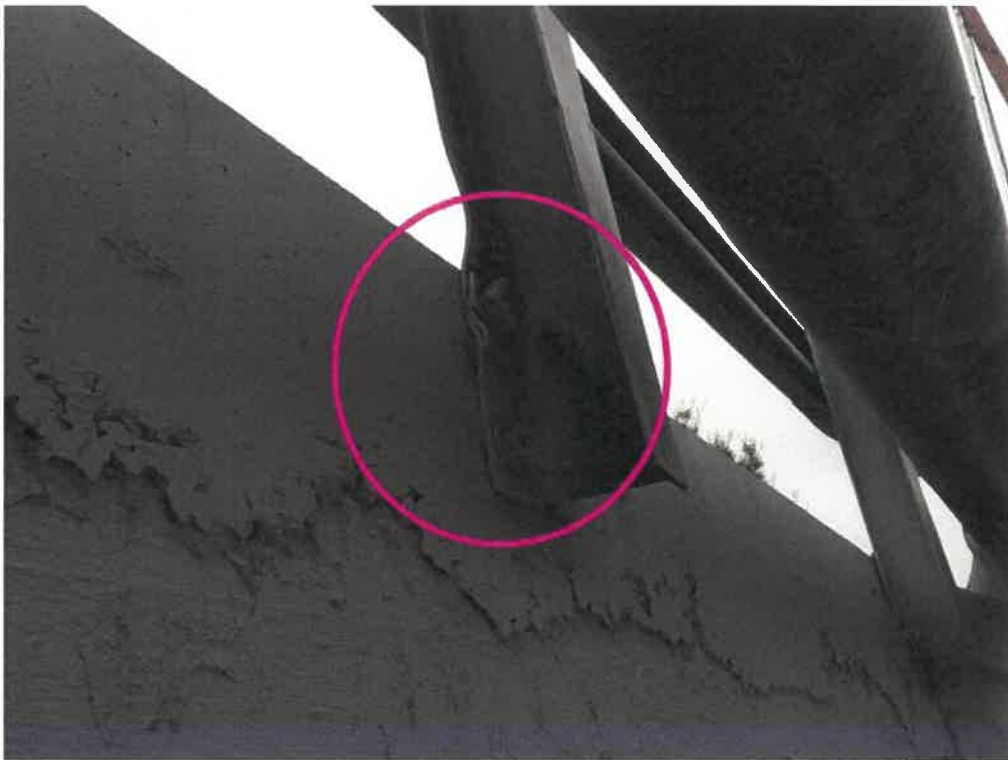
Photo No. 3

The steel post 4 is deformed and bent at the bottom connection with the culvert top slab. (see the attached photo no. 3)

Steel post 4 is bent at the south rail.

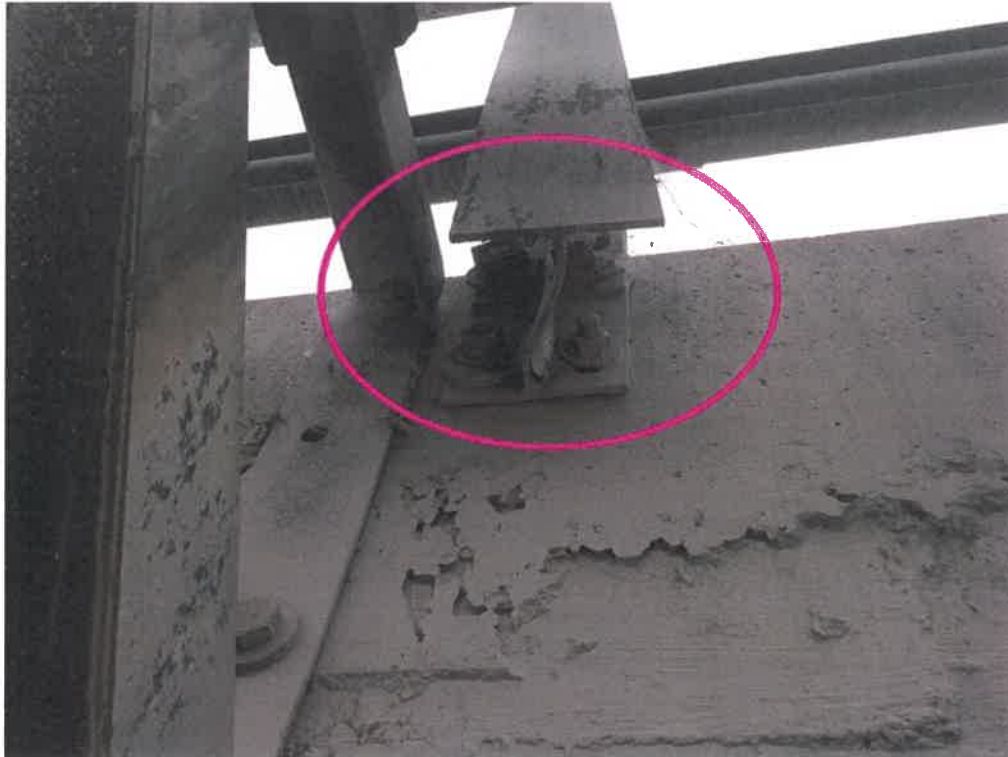
Photo No. 4

The web of the steel post 3 is deformed and bent at the south rail. (see the attached photo no. 4)

Steel post 3 is deformed at the south rail.
