# Bridge Inspection Records Information System

Bridge Number : 55C0103  
Facility Carried: HAMILTON-VICTORIA  
Location : 0.15 MI E BROOKHURST ST  
City :  
Inspection Date : 13-AUG-01

**Bridge Inspection Report**

**Name : SANTA ANA RIVER**

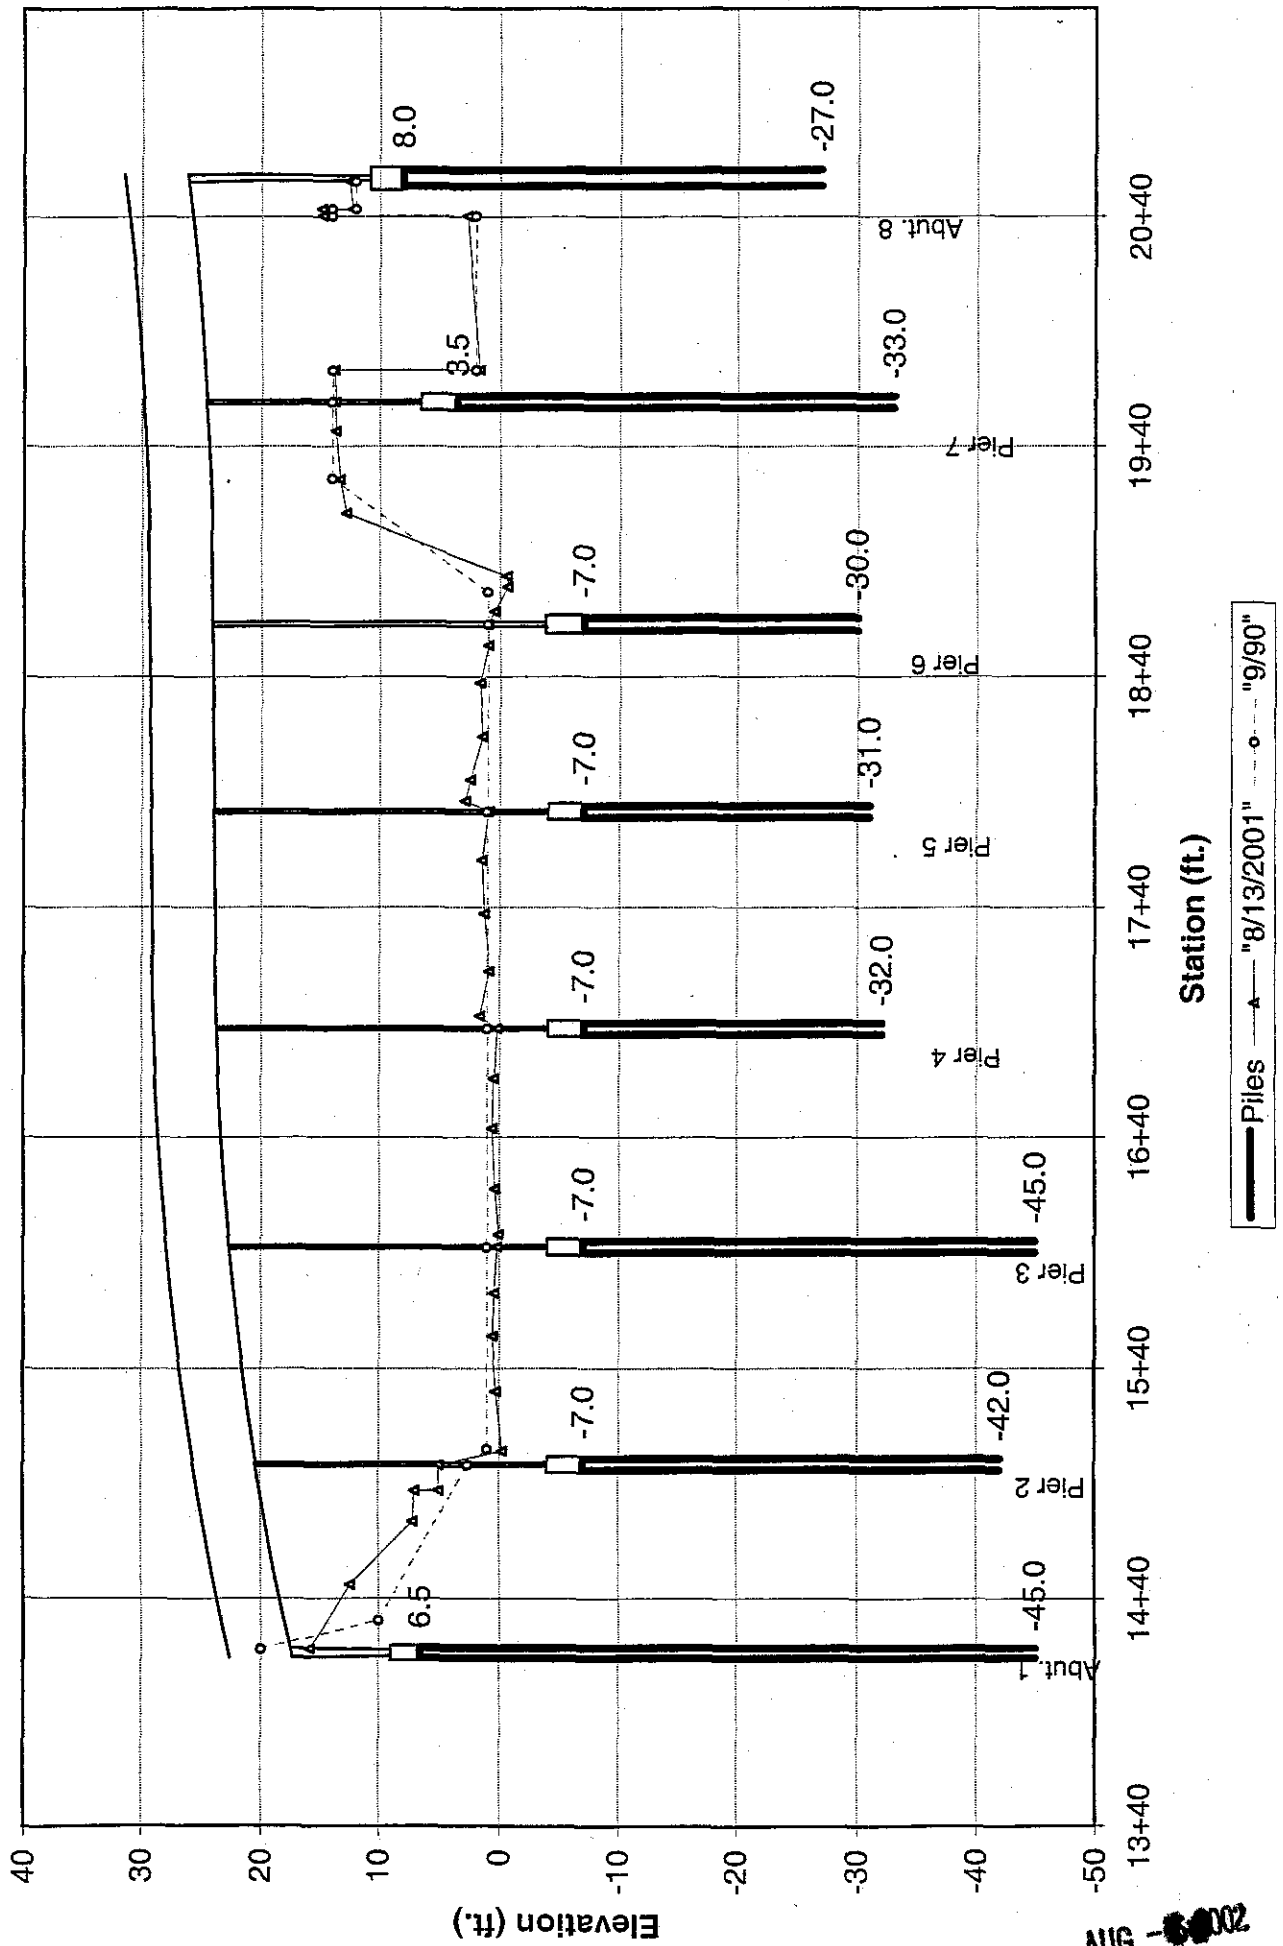
# Santa Ana River - Upstream

A field investigation was conducted at the time of this report in which a channel cross-section was taken. During this time, there was water flowing in the sandy channel. Grouted rock slope protection at Abutment 1 was noted. There is a flood control structure under Span 7. Rock slope protection at the flood control structural wall near Pier 7 was observed. The flood control structure is separated from the Santa Ana River, therefore Pier 7 can be treated as an abutment for hydraulic analysis. No hydraulic skew or obvious signs of scour were observed. The result of the hydraulic analysis revealed this structure is NOT SCOUR CRITICAL.
