# Bridge Inspection Records Information System

Bridge Number : 55C0114  
Facility Carried: TUSTIN AVE  
Location : 200' S ORANGETHORPE AVE  
City :  
Inspection Date : 31-OCT-01

**Bridge Inspection Report**

**Name : ATWOOD CHANNEL**

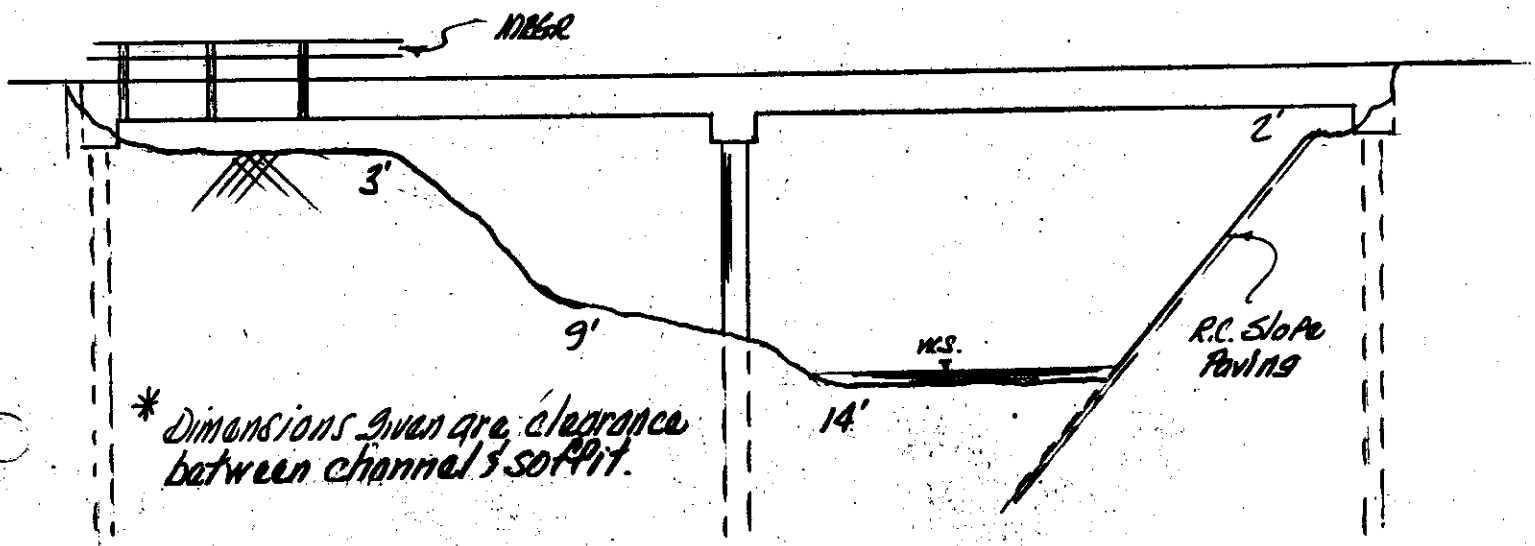
CHANNEL PROFILE

LOOKING EAST
