DEPARTMENT OF TRANSPORTATION
Structure Maintenance & Investigations

Bridge Number : 55C0119
Facility Carried: TONNER CANYON ROAD
Location : 400' S/O BREA CANYON BLV
City :
Inspection Date : 11/01/2017

Bridge Inspection Report

STRUCTURE NAME: BREA CANYON CHANNEL

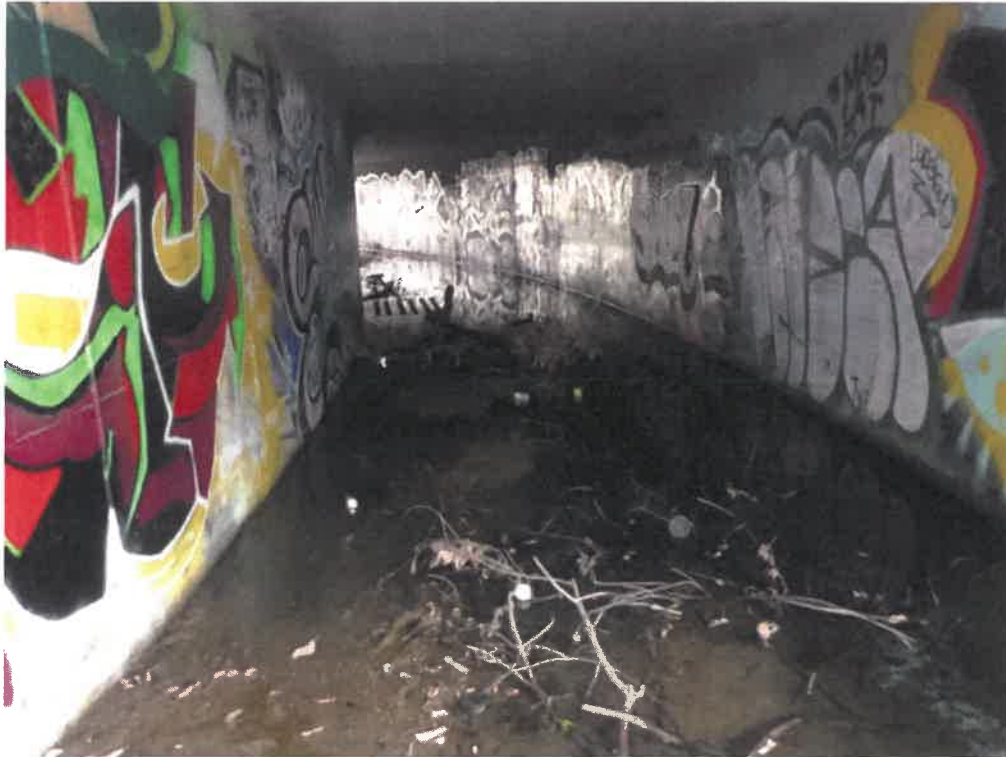
Photo No. 2

Underside View looking North. barrel 1

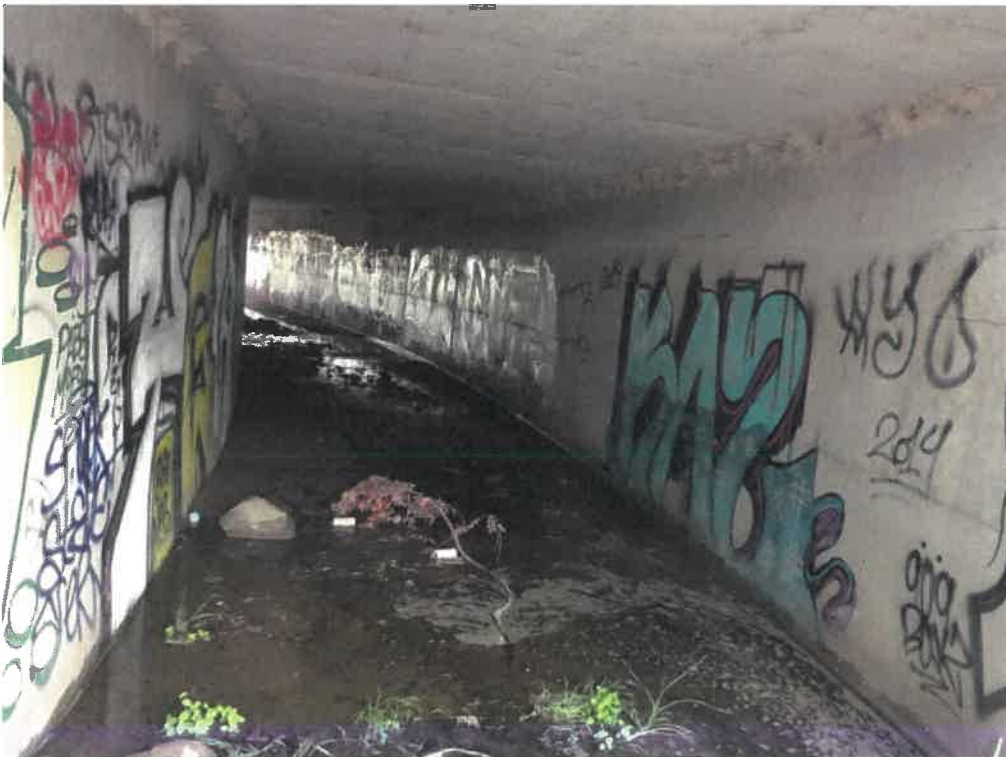
Photo No. 3

Underside View looking North. barrel 2

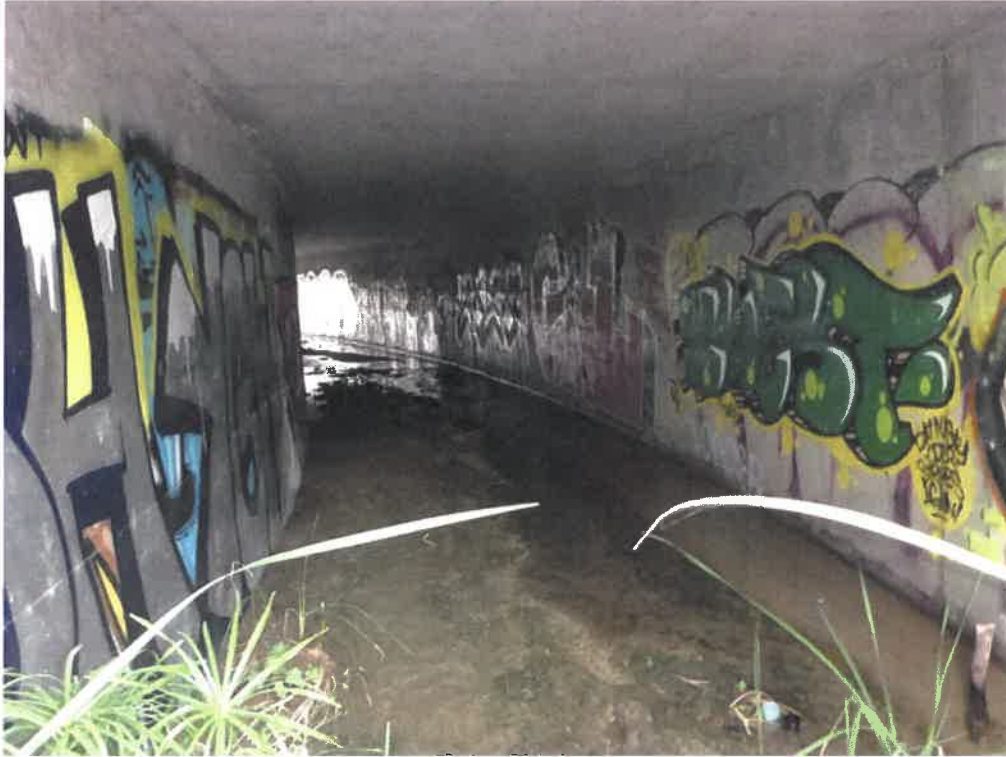
Photo No. 4

Underside View looking North. barrel 3

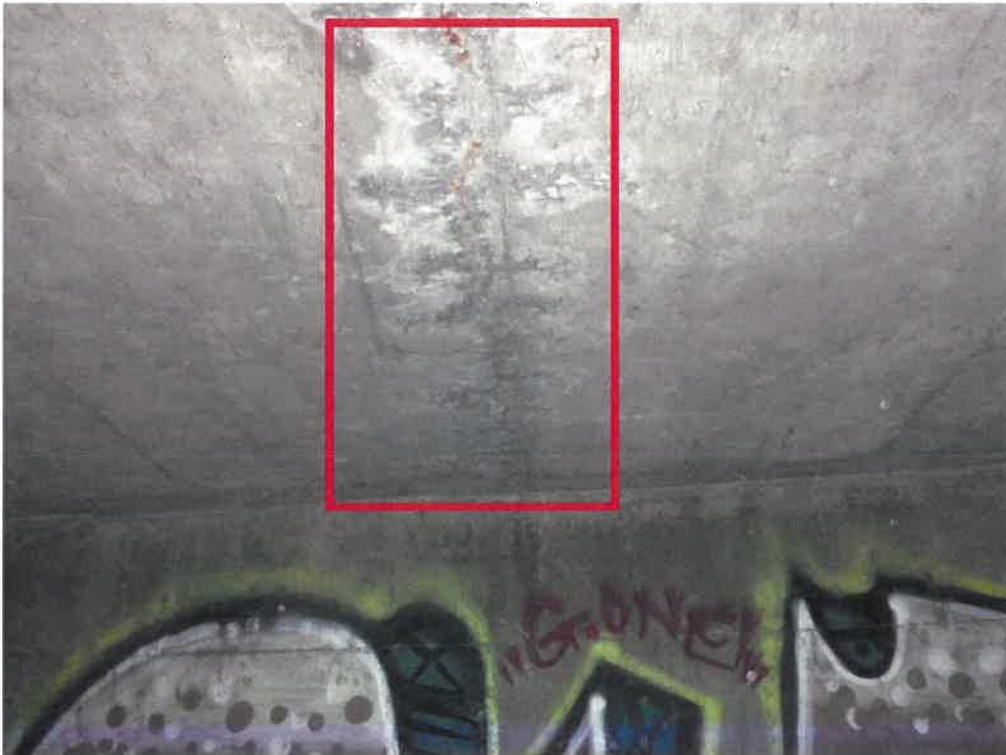
Photo No. 5

The soffit of the culvert at all barrels has up to three longitudinal cracks with white and brown efflorescence. (see the attached photo no. 5)

Longitudinal cracks with white and brown efflorescence in all barrels.

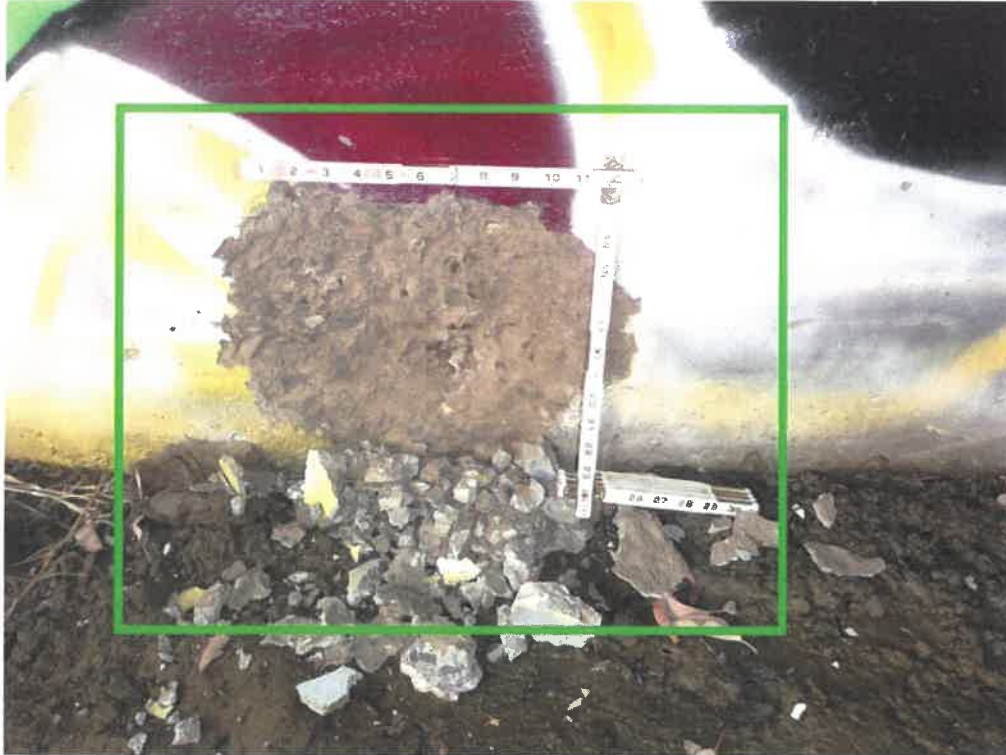
Photo No. 6

Culvert wall 1 has a spall 12 inches X 12 inches X 2 inches at 10 feet from the south end. (see the attached photo no. 6)

Culvert wall 1 has a spall 1 ft X 1 ft X 2 inches at 10 feet from the south end.

RecDate: 11/01/2017	EstCost:	Patch the spall 12 inches X 12 inches X 2
Action : Sub-Patch spalls	StrTarget: 2 YEARS	inches at culvert wall 1 at 10 feet from
Work By: LOCAL AGENCY	DistTarget:	the south end. (see the attached photo
Status : PROPOSED	EA:	no. 6)
RecDate: 06/05/2001	EstCost:	Remove the bushes and trees from the
Action : Remove Vegetation	StrTarget: 2 YEARS	channel bed within 30 meters of the
Work By: LOCAL AGENCY	DistTarget:	bridge to allow the water to flow
Status : PROPOSED	EA:	properly.
		It is growing back.
