**DEPARTMENT OF TRANSPORTATION**  
Structure Maintenance & Investigations

**Bridge Number** : 55C0121  
**Facility Carried**: BREA CANYON BLVD.  
**Location** : 0.4 MI N/O CENTRAL AVENUE  
**City** :  
**Inspection Date** : 07/15/2019

**Bridge Inspection Report**

**STRUCTURE NAME:** BREA CANYON CHANNEL

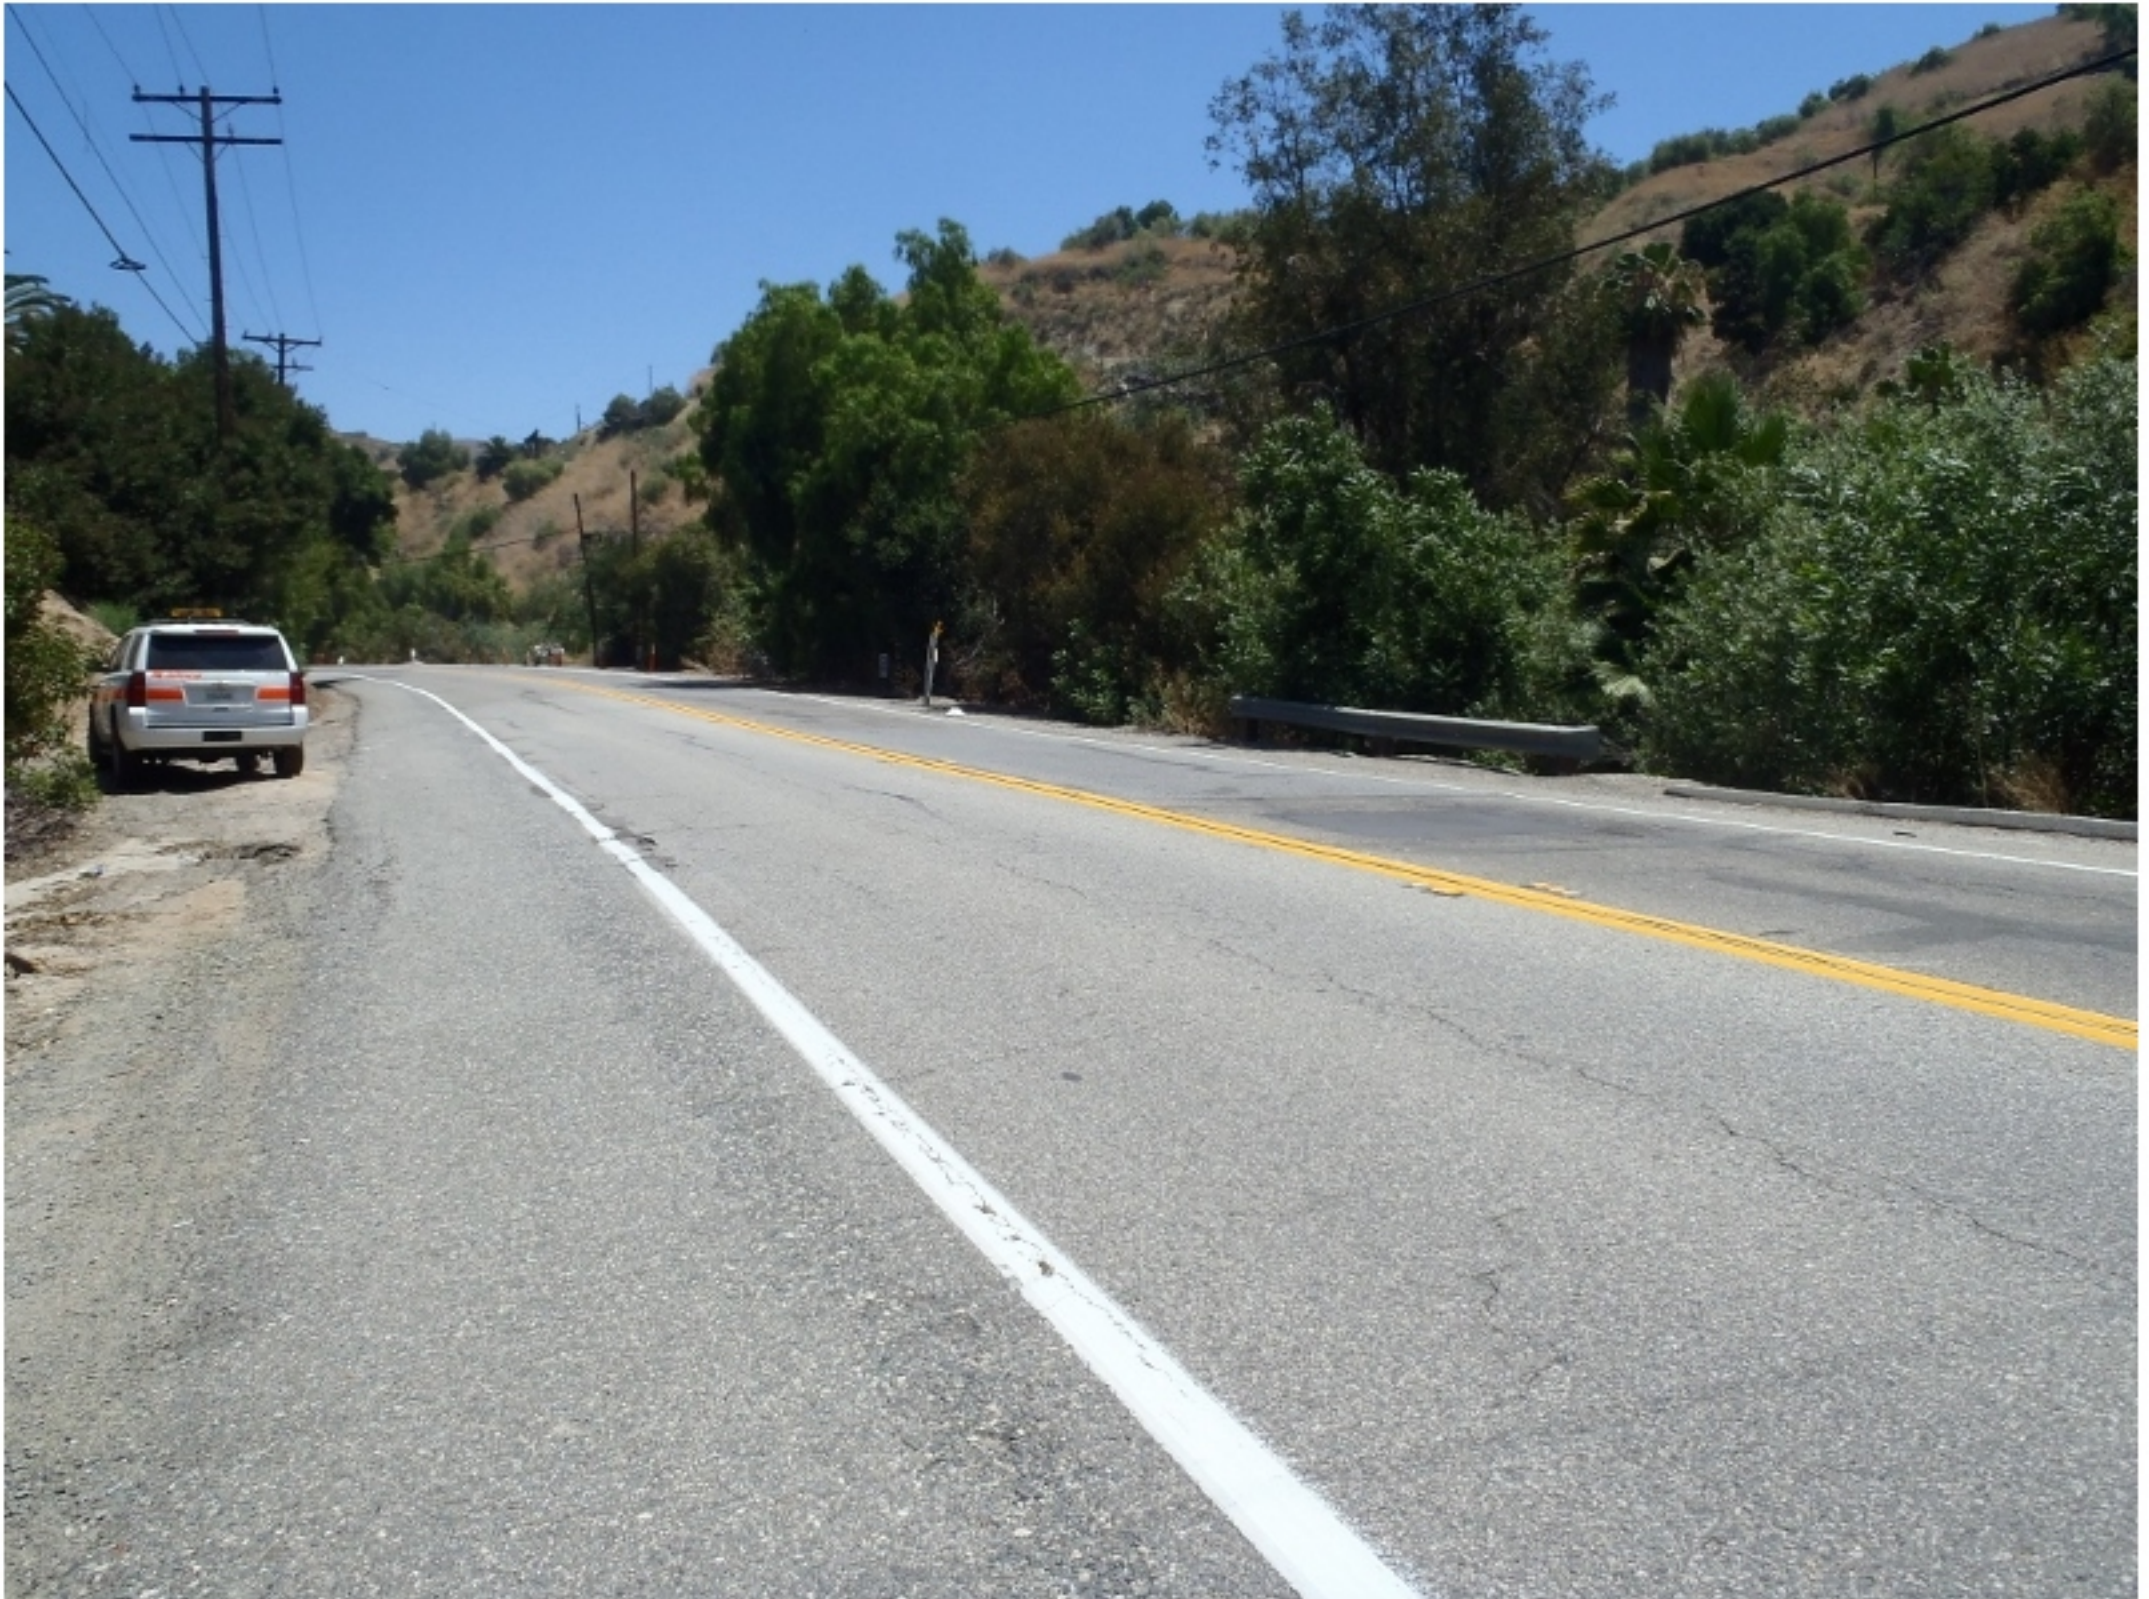
Photo No. 1  
ROADWAY VIEW LOOKING NORTHEAST

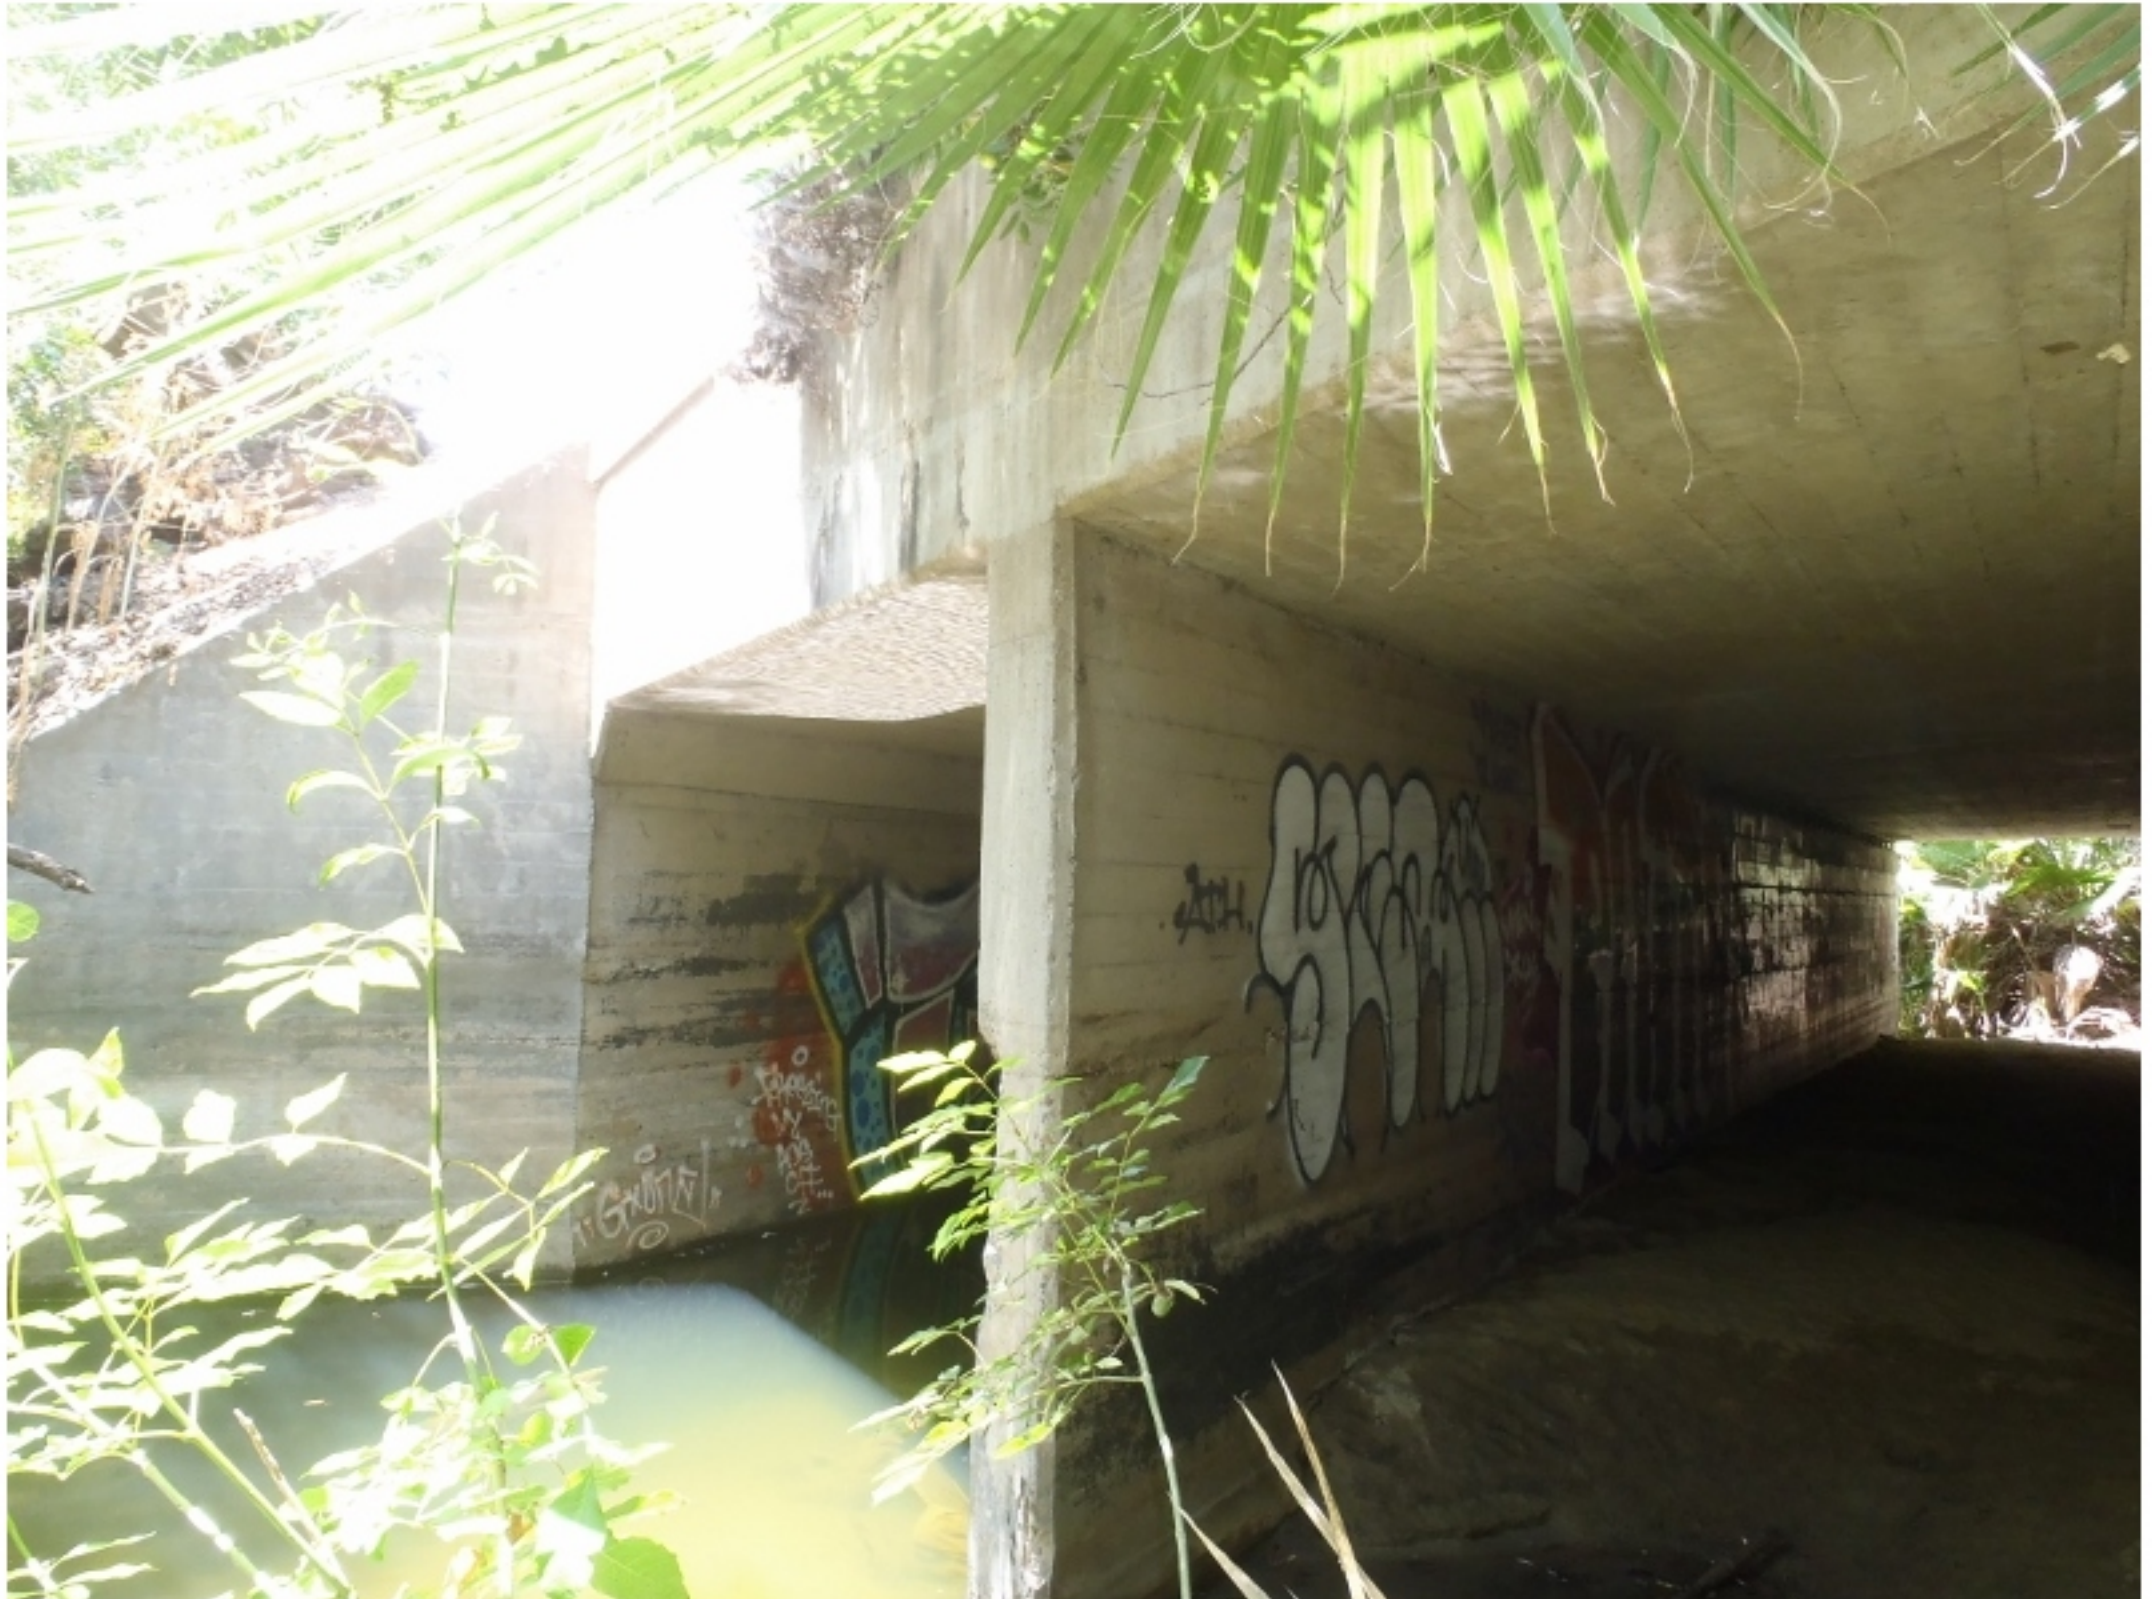
Photo No. 1  
SIDE VIEW LOOKING WEST

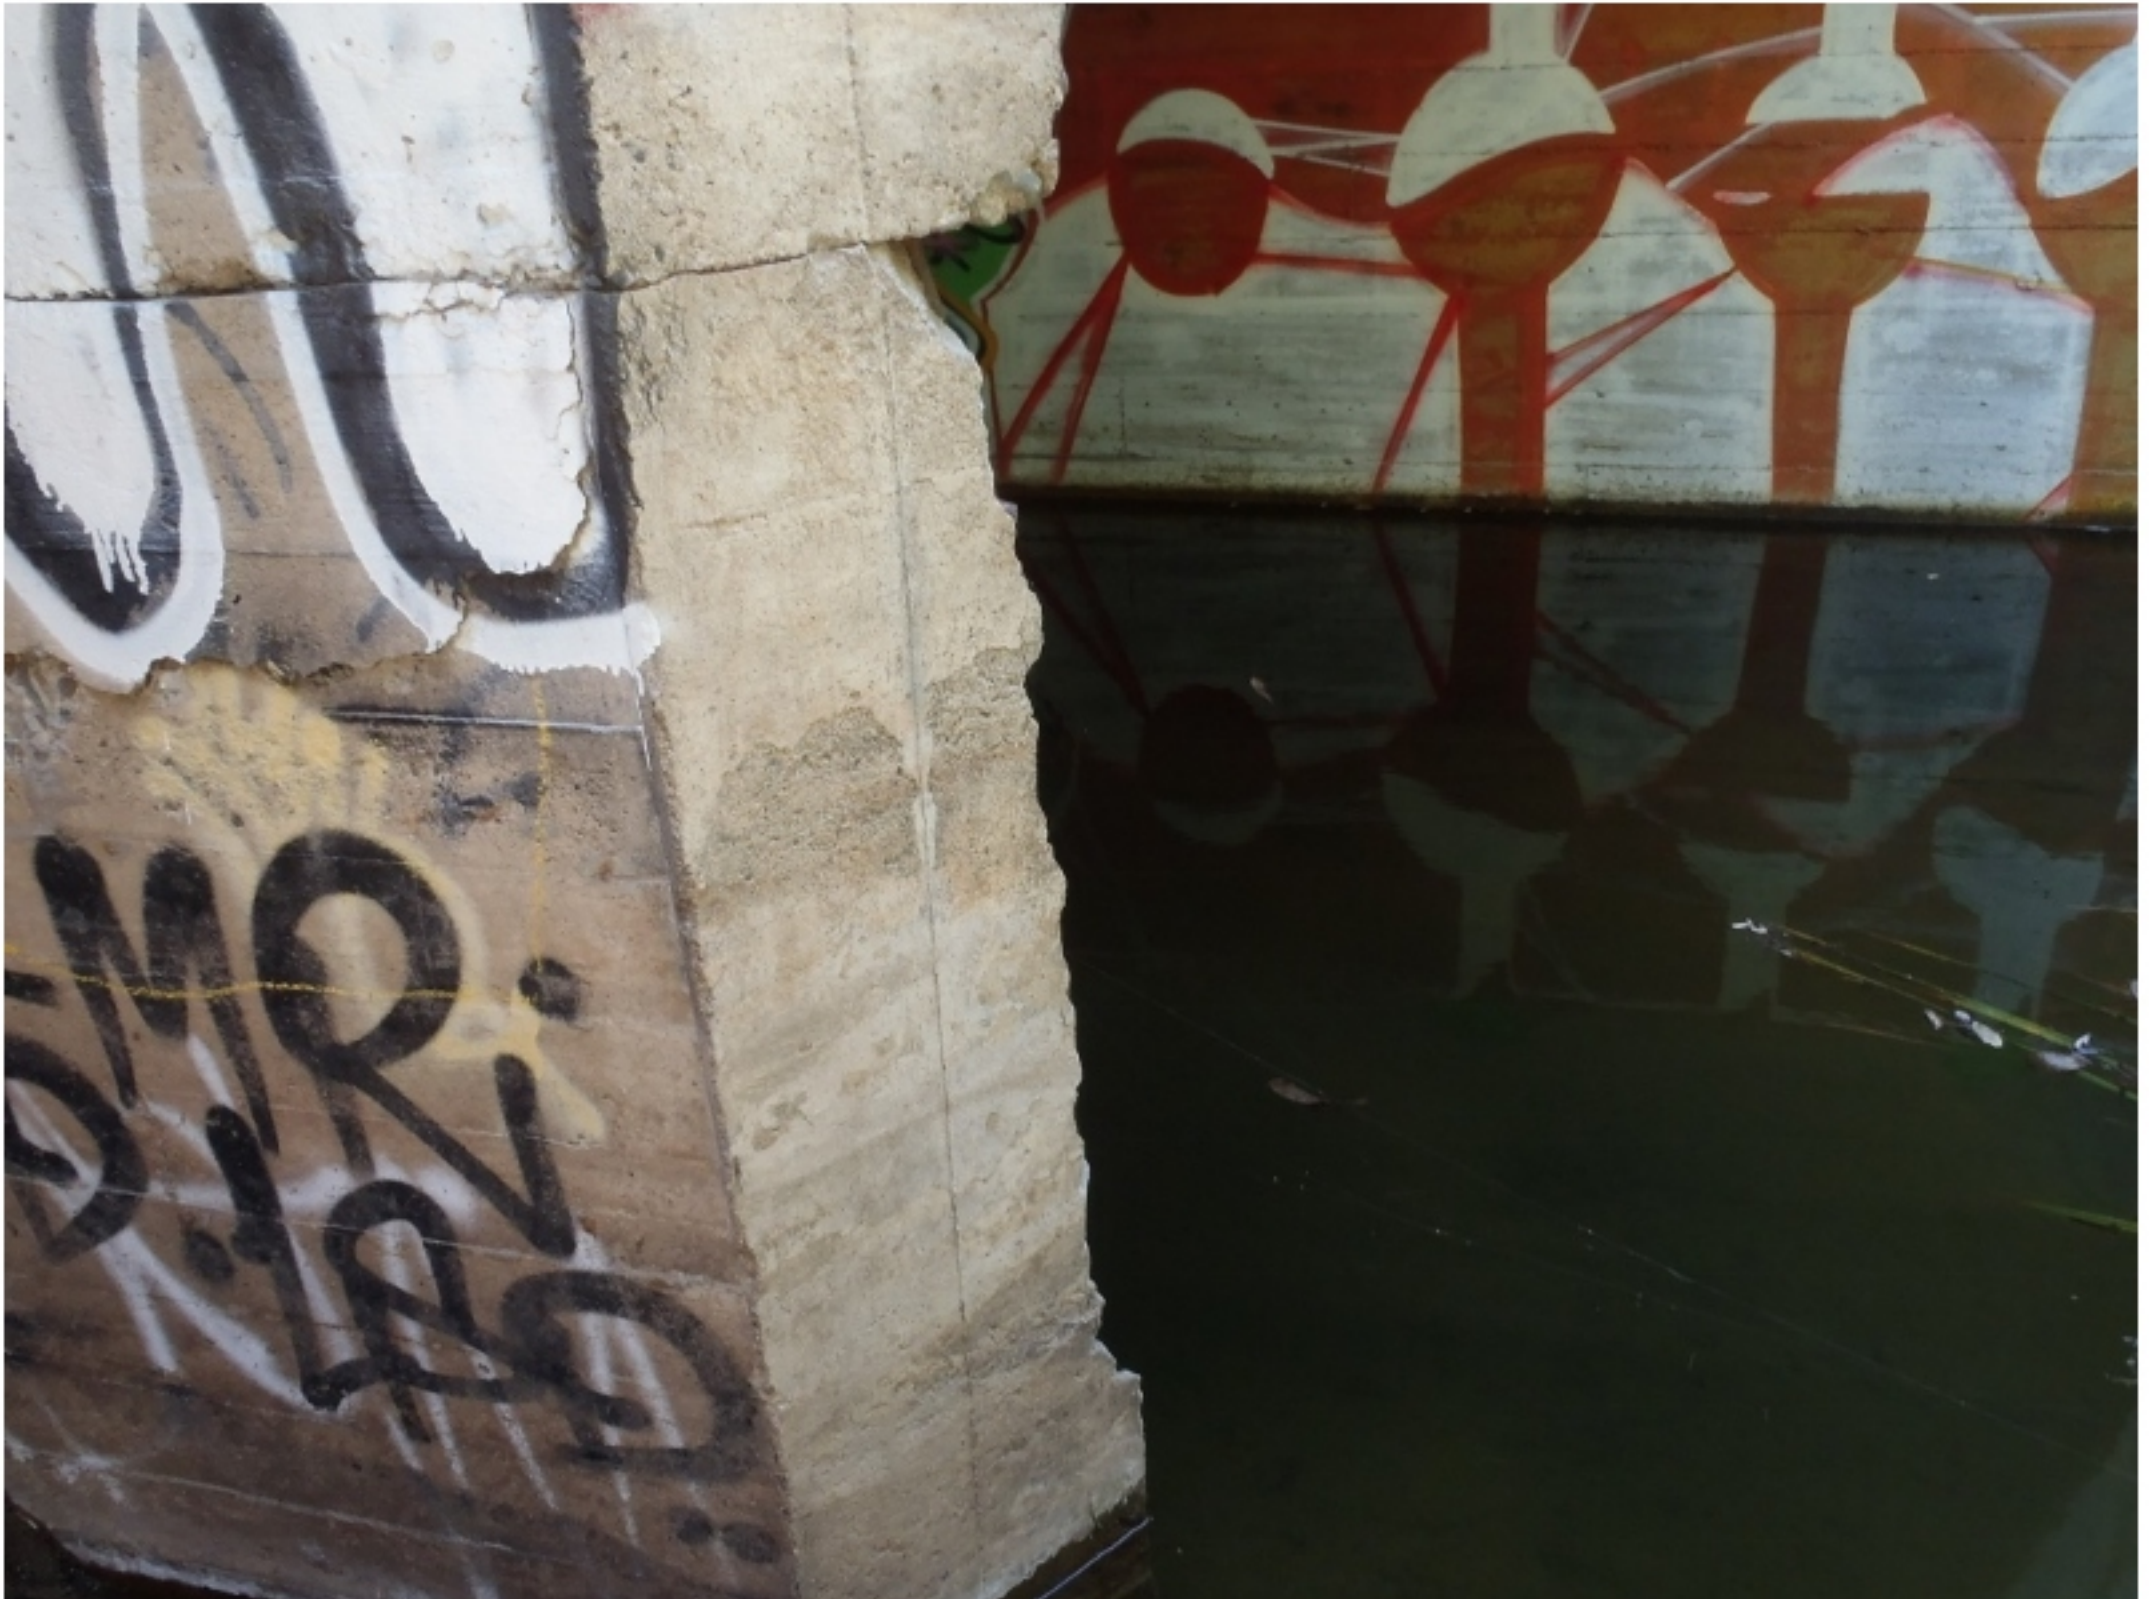
(38)									
There were no significant defects noted. (under 5 feet of fill)									
210			Pier Wall-RC	2	20	m	13	4	3 0
1080			Delamination/Spall/Patched Area	2	6		0	3	3 0
1130			Cracking (RC and Other)	2	1		0	1	0 0
(210-1080)									
There are the following defects at the Bent 2 pier wall:									
a spall 18 inch H x 12 inch W x 2 inch D with rusted rebars exposed at the west end,									
a spall 30 inch H x 20 inch W x 2 inch D with rusted rebars exposed at the east end southern face,									
an unsound concrete area 18 inch H x 6 inch W at 15 feet from east side on the northern face,									
a spall with unsound concrete area with combined size 10 feet L x 18 inch H x 2 inch D at west end.									
(210-1130)									
There are 2 vertical cracks on the middle pier wall, up to 0.05 inches wide.									
215			Abutment-RC	2	40	m	40	0	0 0

Photo No. 1  
A SPALL ON THE MIDDLE PIER WALL AT WESTERN SIDE

Locate the pier wall spalls with rusted

exposed rebars at both ends, remove all

rests on the exposed rebars, clean and

patch the spalled areas. Update on

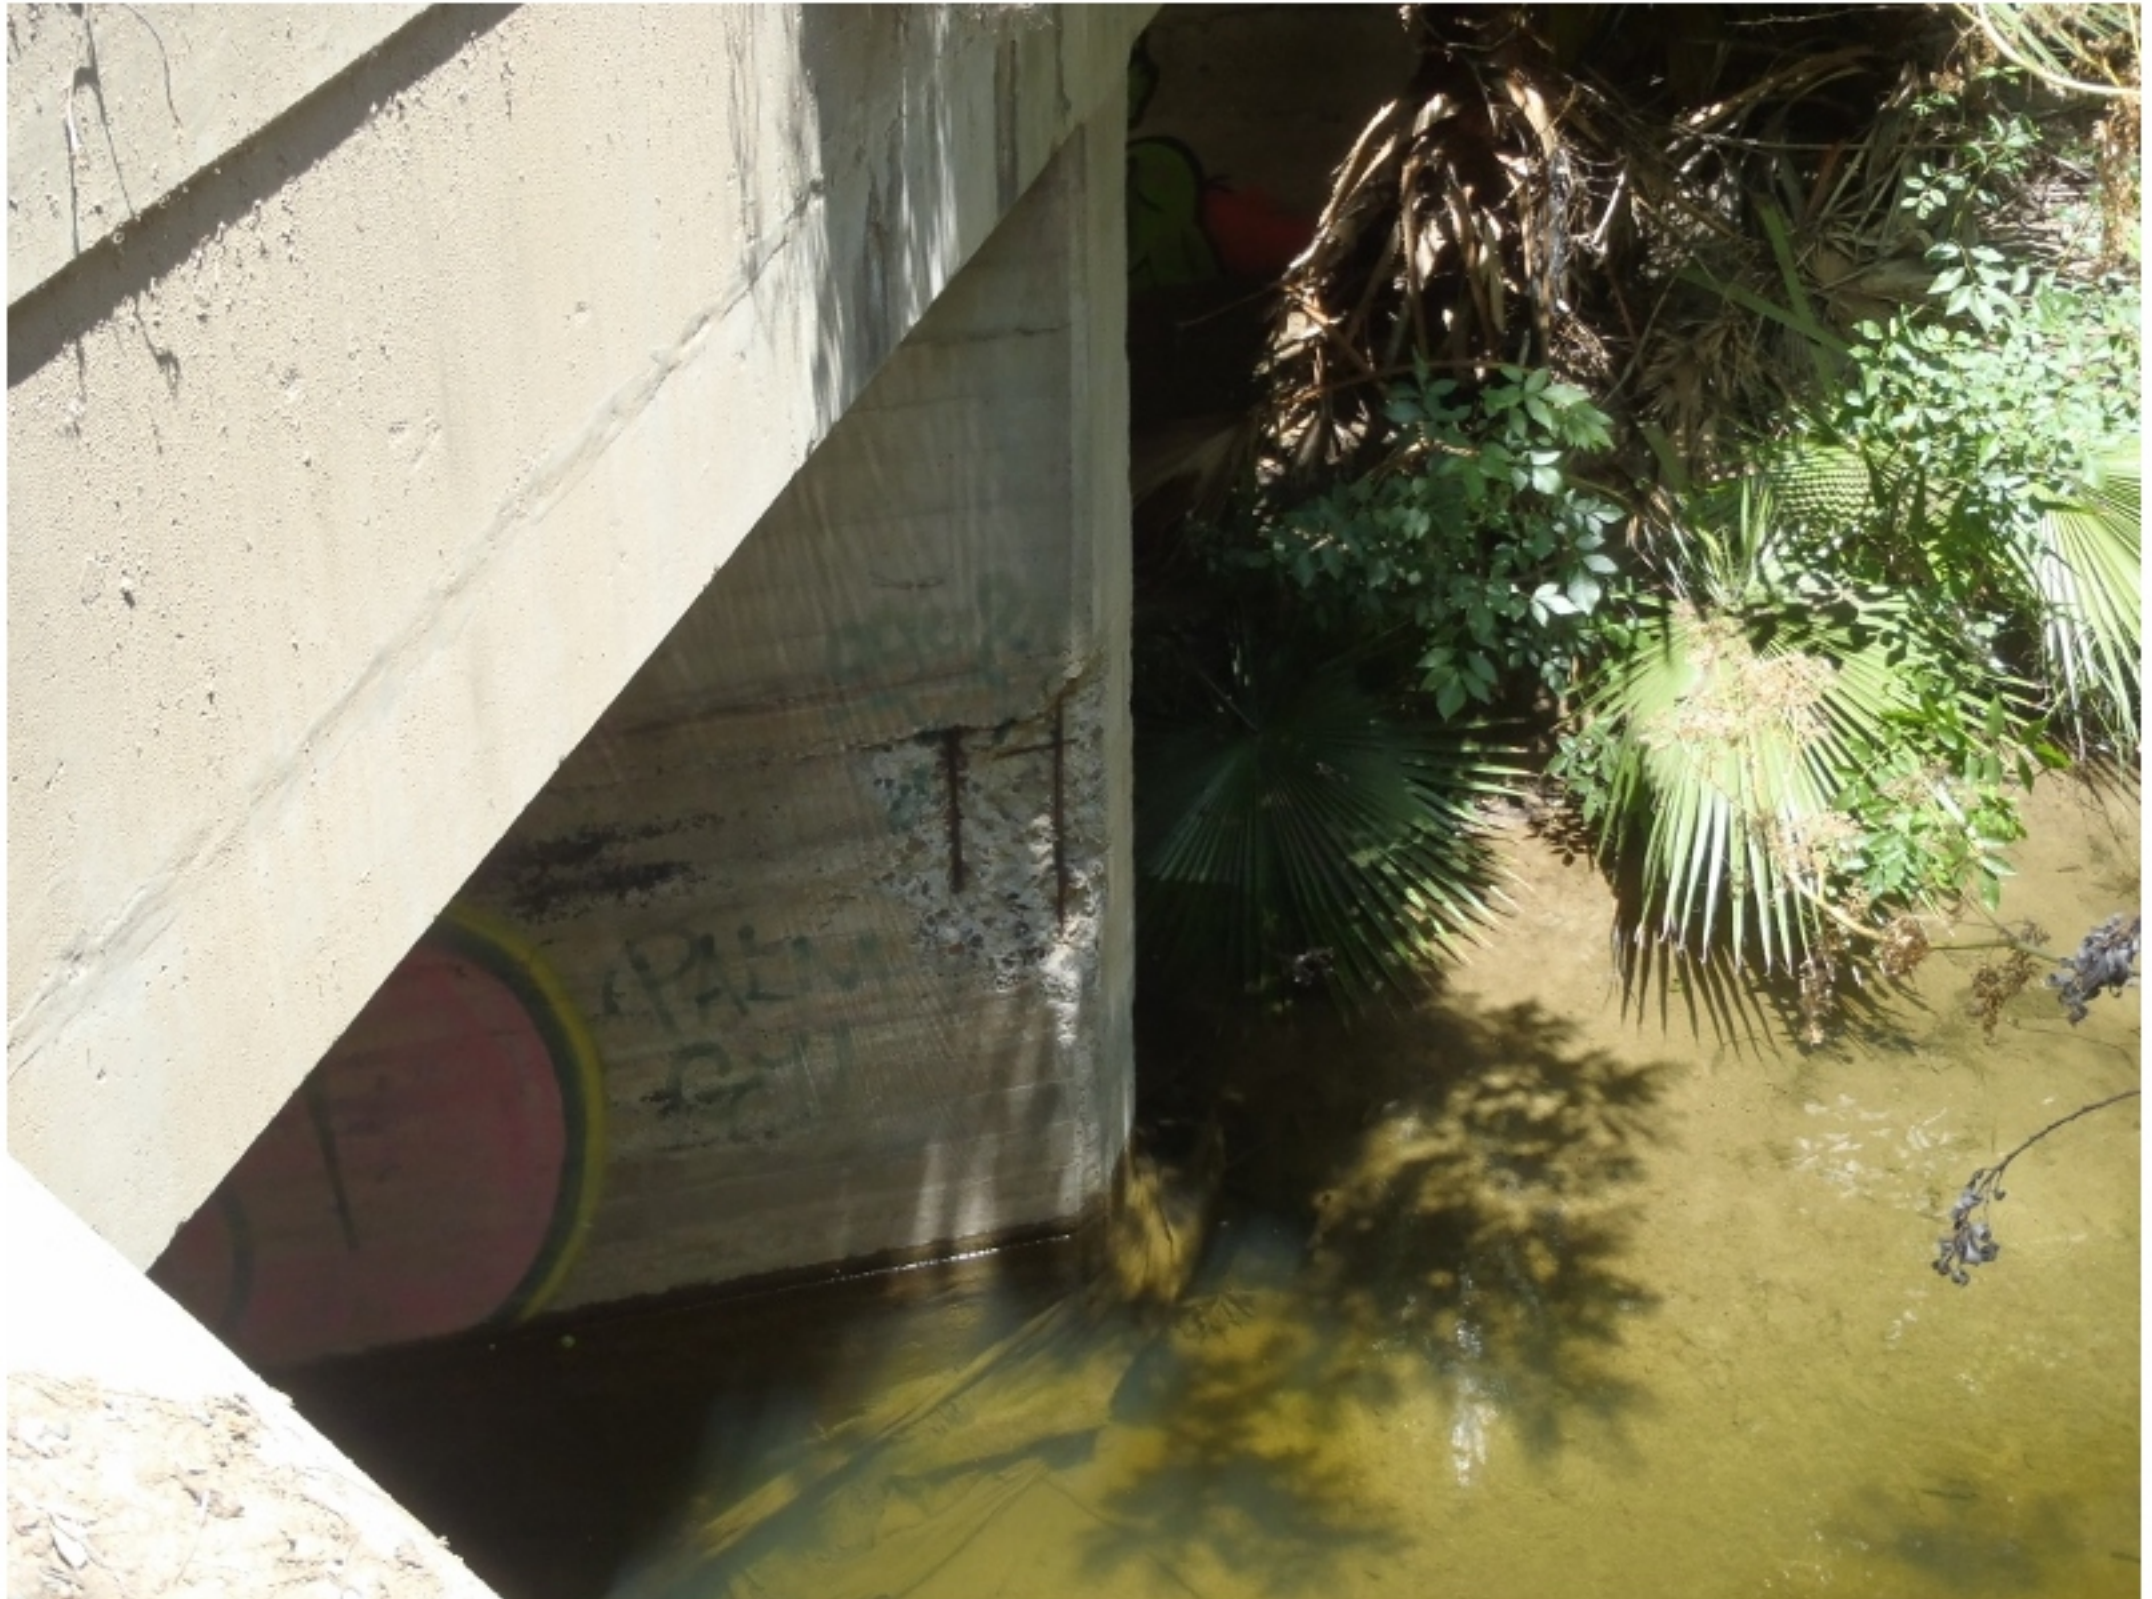
Photo No. 1

A SPALL ON THE MIDDLE PIER WALL AT EASTERN SIDE WITH REBARS EXPOSED

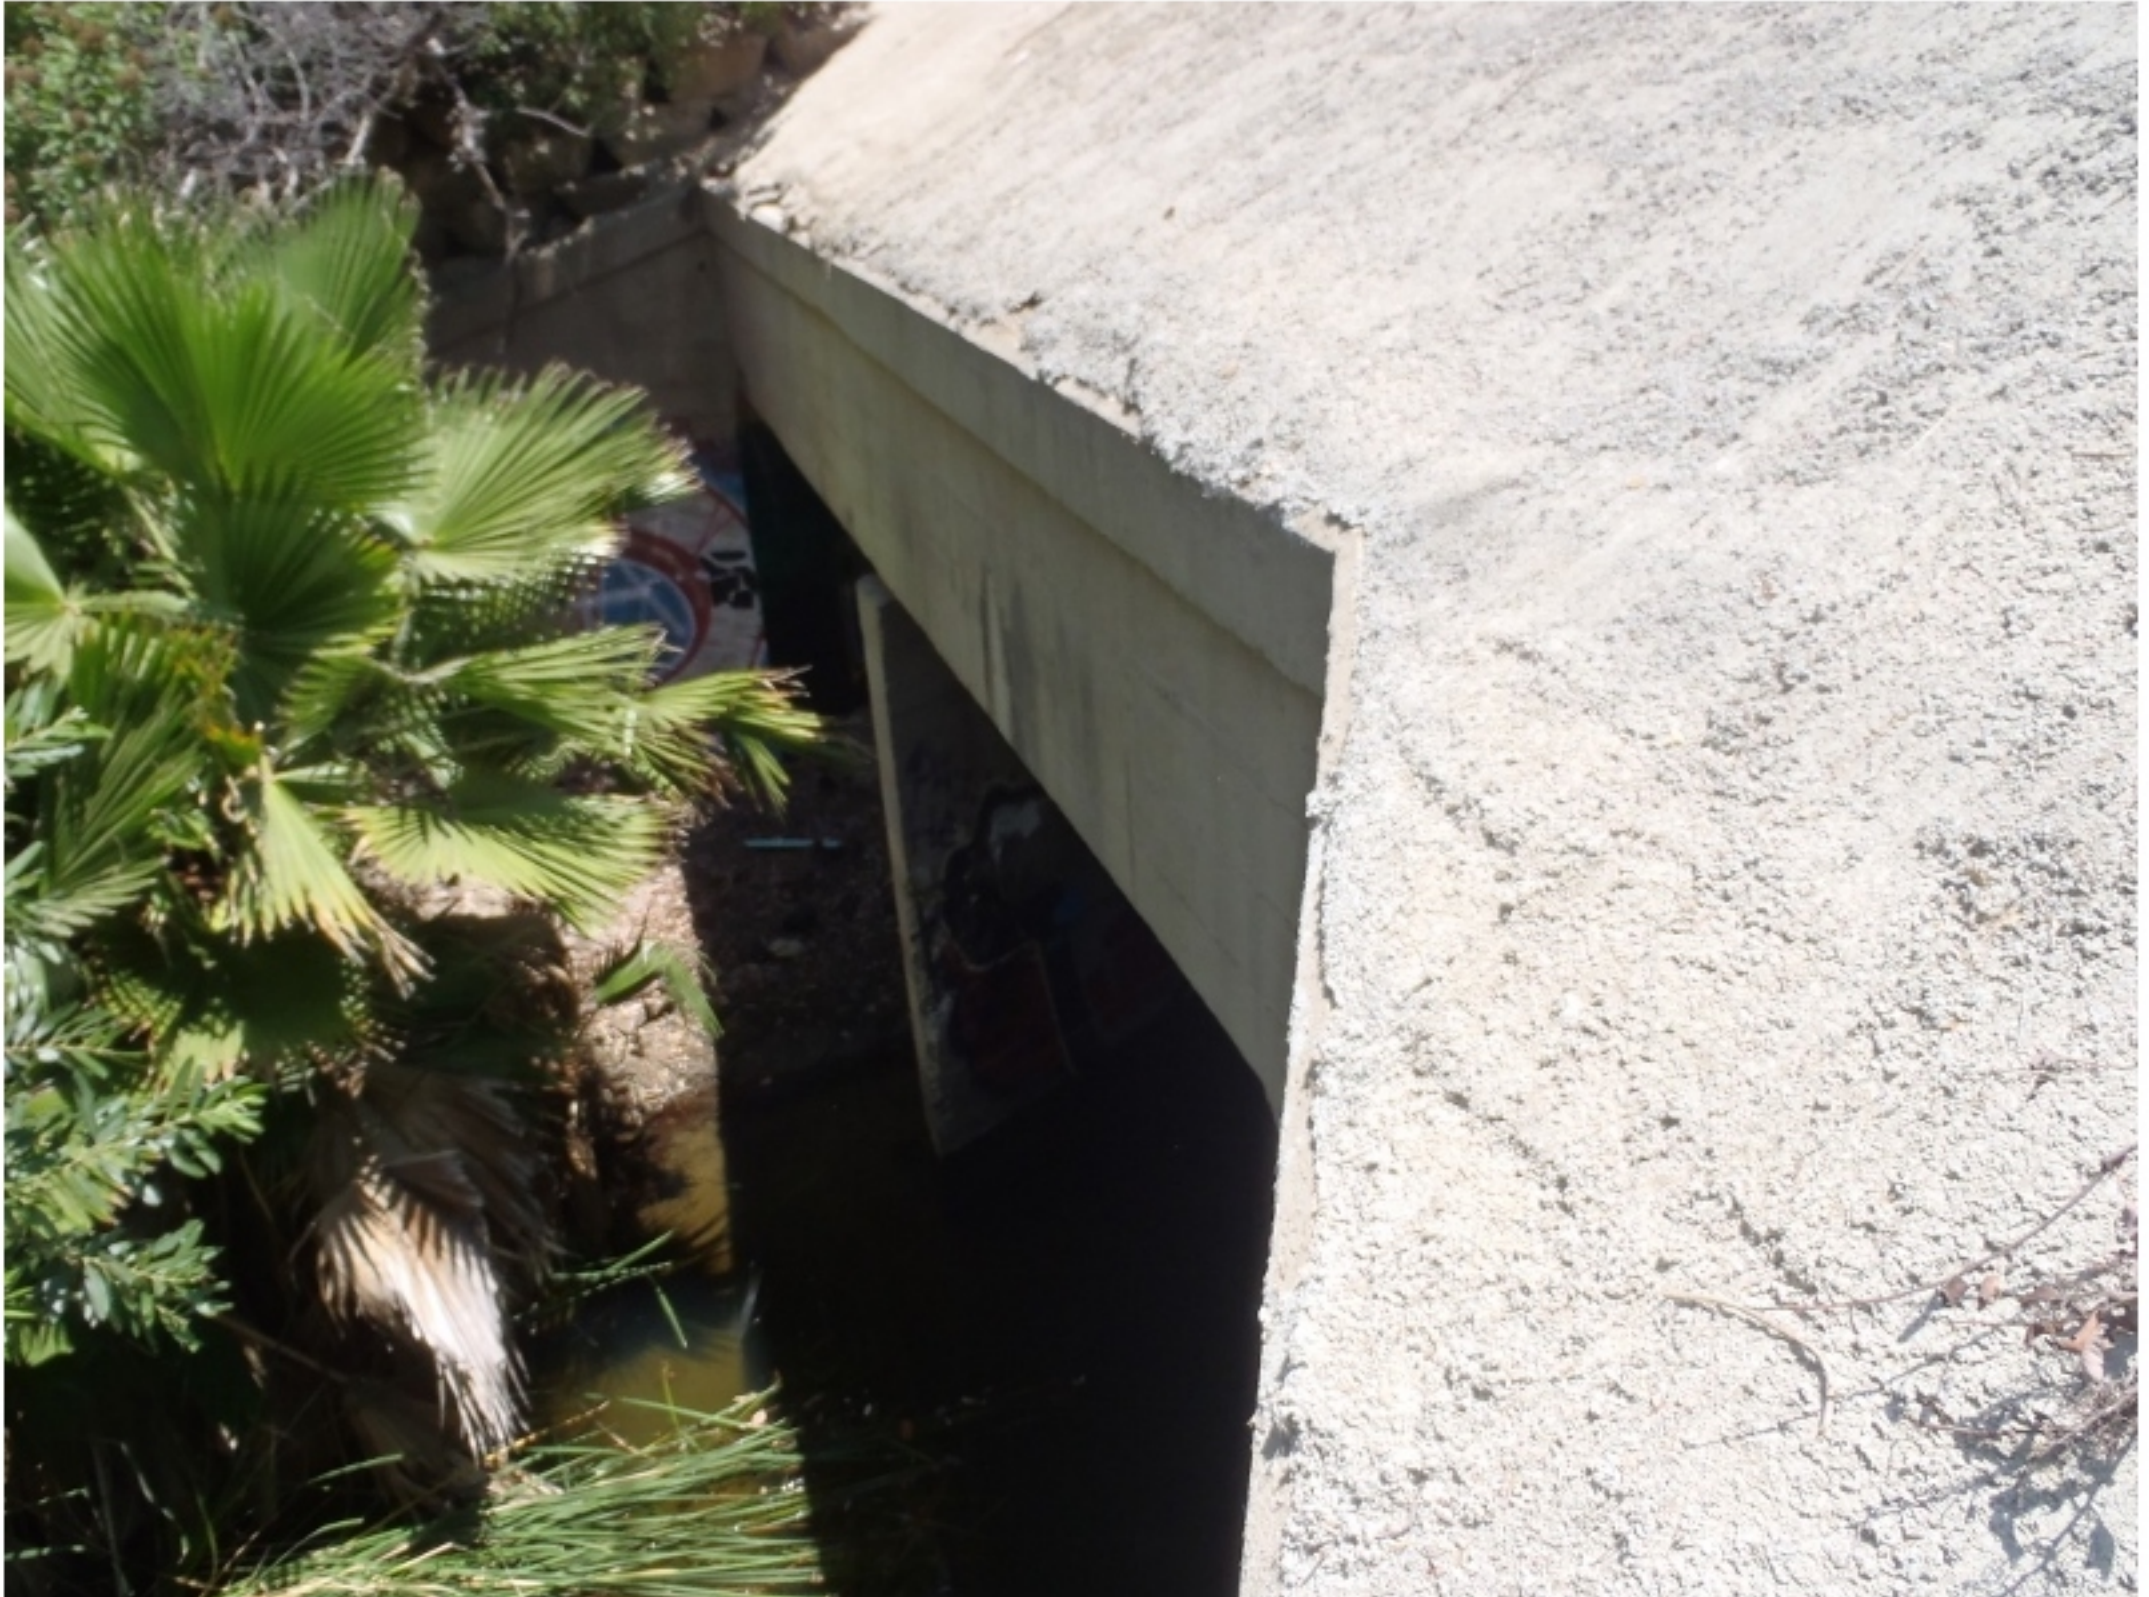
Photo No. 1  
A SPALL ON THE MIDDLE PIER WALL AT WESTERN SIDE WITH REBARS EXPOSED

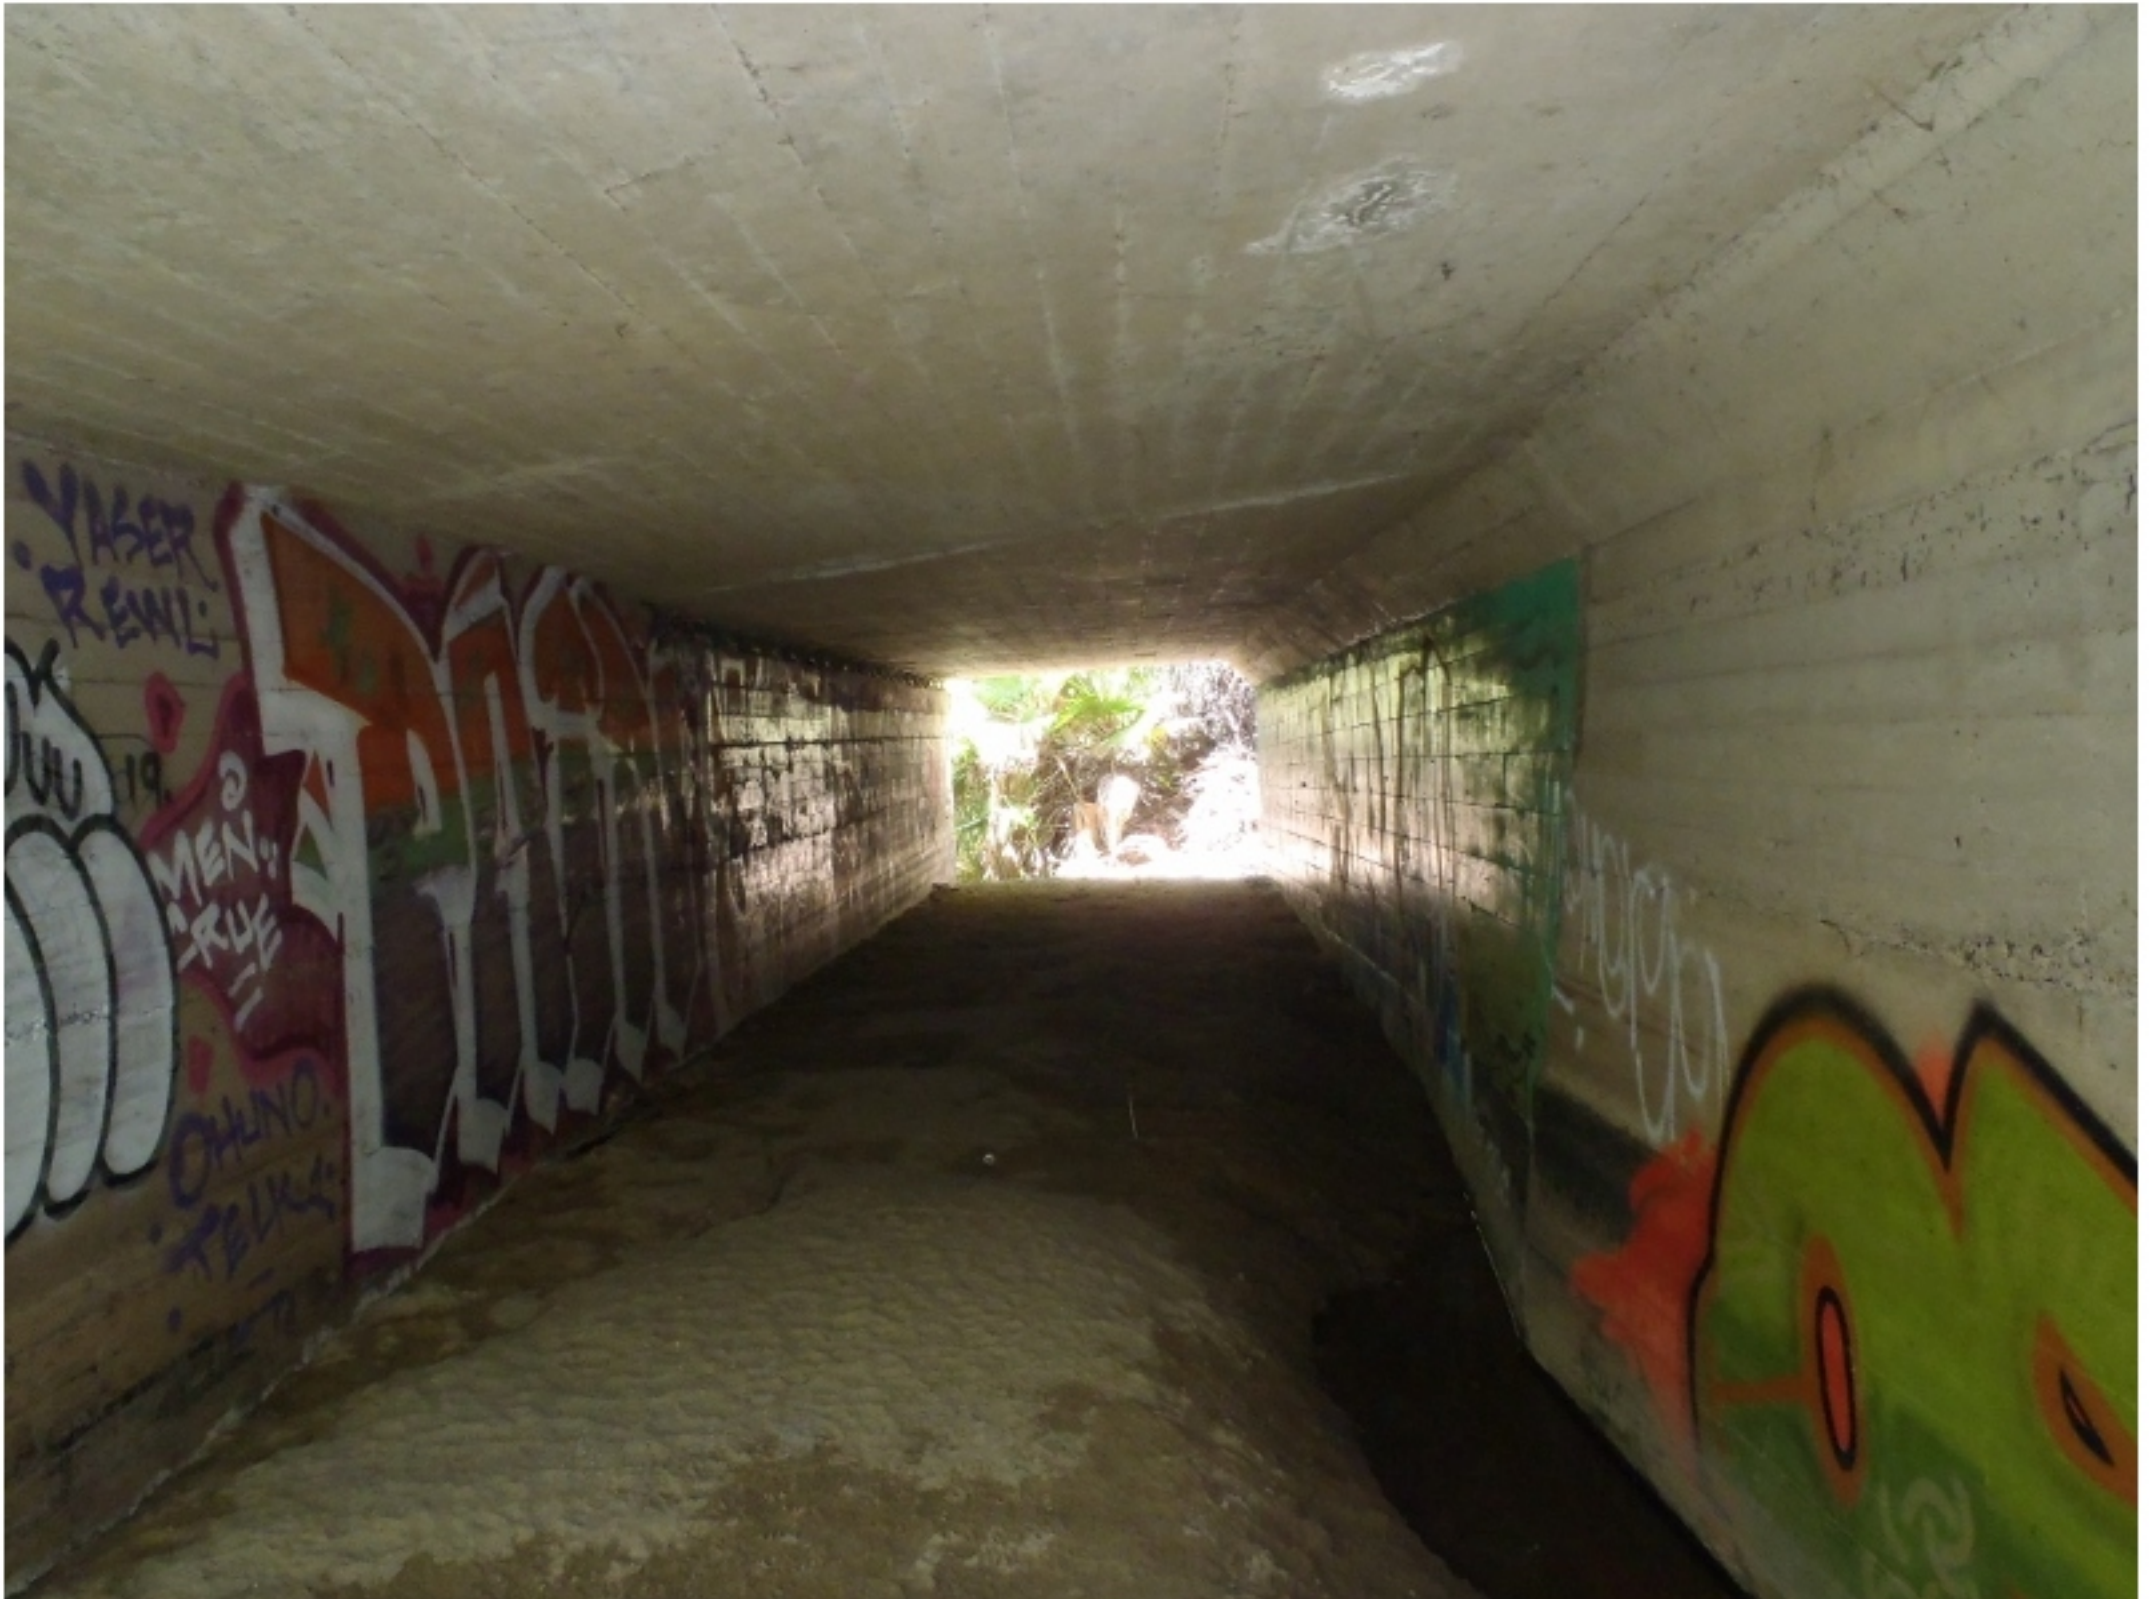
Photo No. 1

UNDER VIEW LOOKING WEST IN NORTHERN SPAN
