**DEPARTMENT OF TRANSPORTATION**  
Structure Maintenance & Investigations

**Bridge Number** : 55C0121  
**Facility Carried**: BREA CANYON BLVD.  
**Location** : 0.4 MI N/O CENTRAL AVENUE  
**City** :  
**Inspection Date** : 07/15/2019

**Bridge Inspection Report**

**STRUCTURE NAME:** BREA CANYON CHANNEL

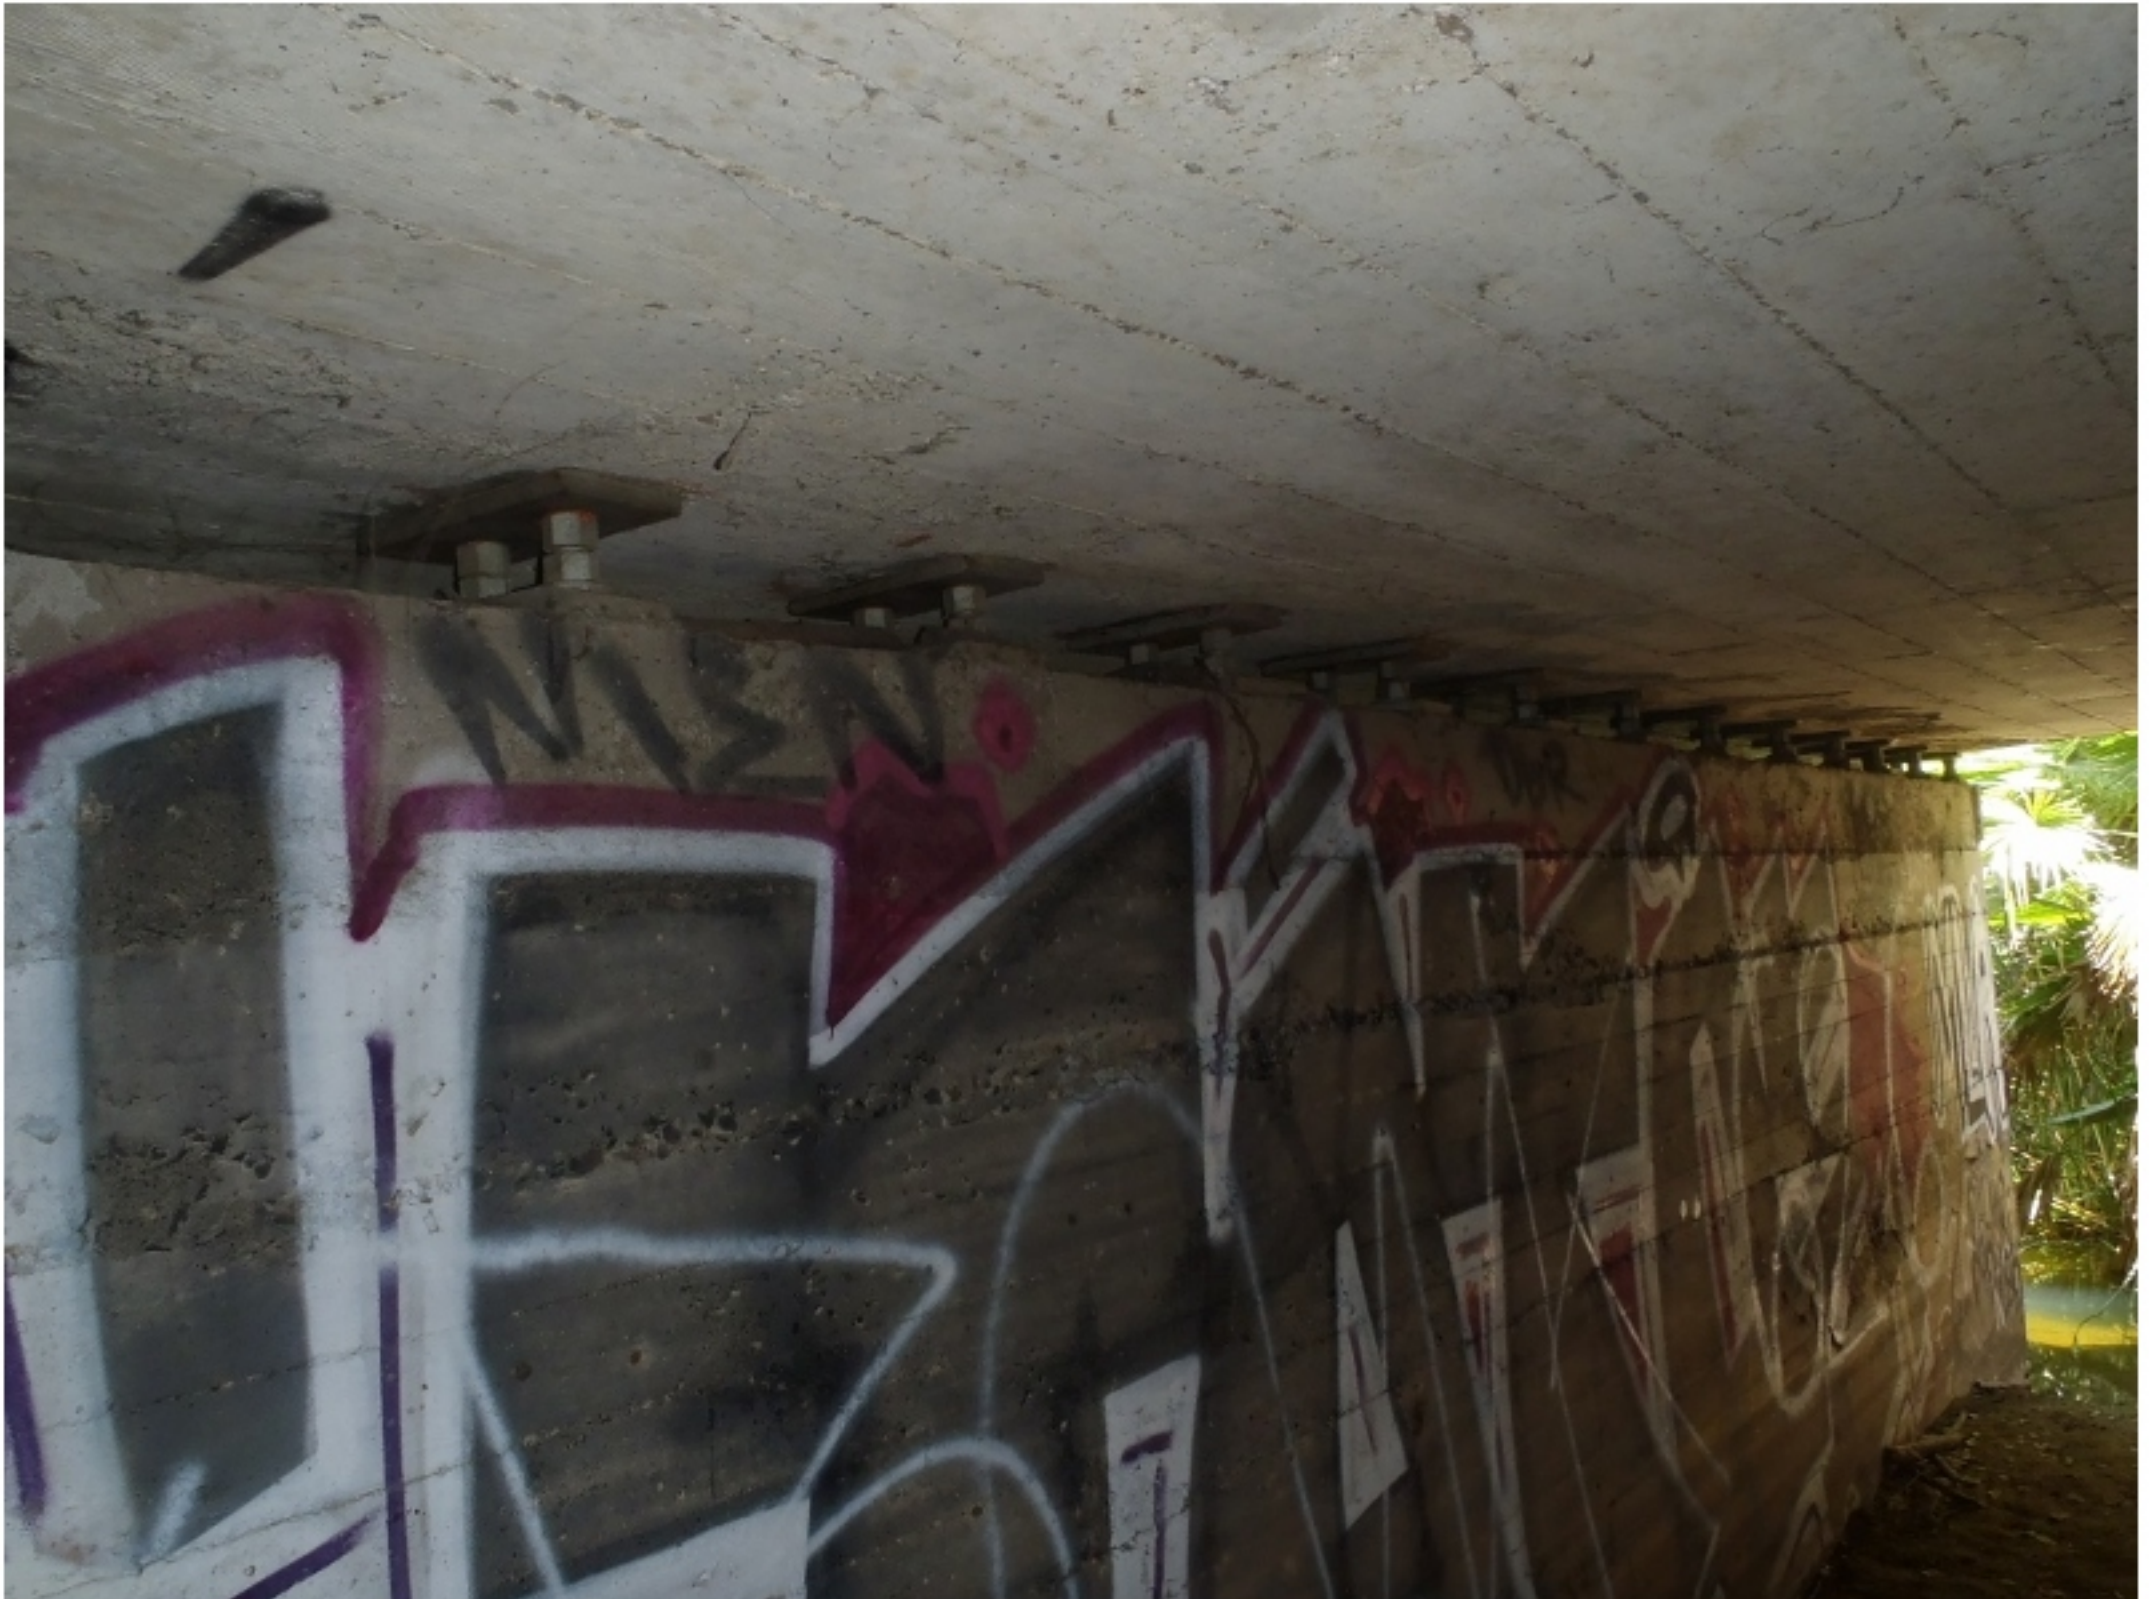
Photo No. 1

UNDER VIEW TOWARD THE MIDDLE PIER WALL
