DEPARTMENT OF TRANSPORTATION
Structure Maintenance & Investigations

Bridge Number : 55C0121
Facility Carried: BREA CANYON BLVD.
Location : 0.4 MI N/O CENTRAL AVENUE
City :
Inspection Date : 11/01/2017

Bridge Inspection Report

STRUCTURE NAME: BREA CANYON CHANNEL

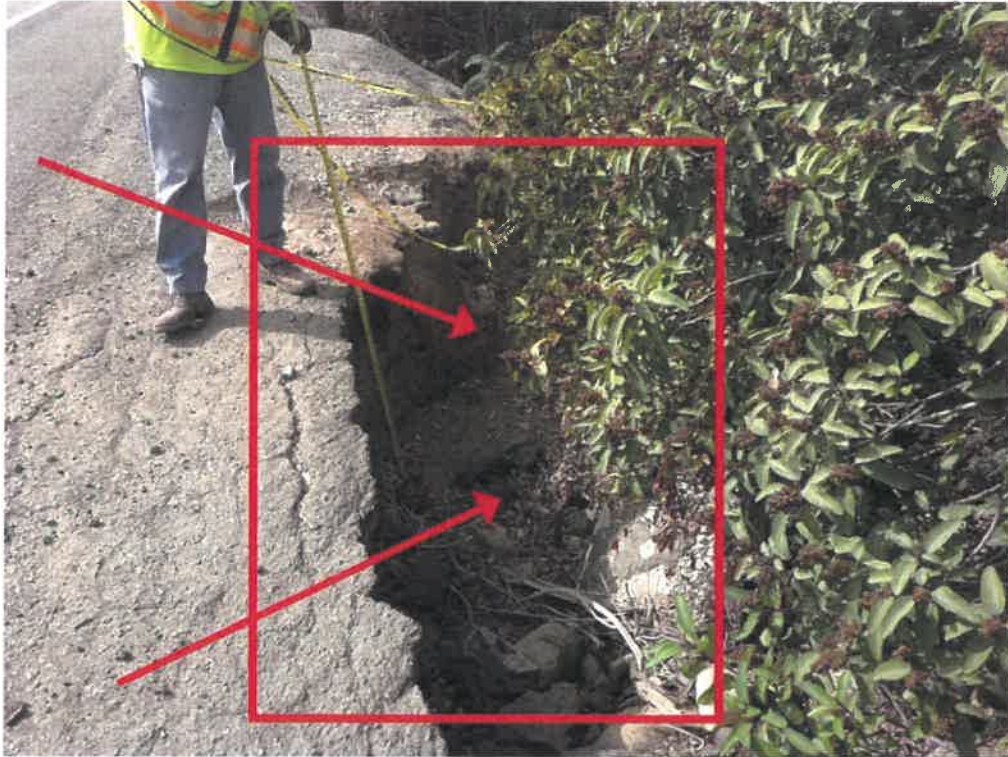
Photo No. 2

Roadway erosion 12 feet long X 5 feet wide X 3 feet deep is noticed at the west shoulder at southbound lane. (see the attached photo no. 2)

Roadway erosion 12 ft X 5 ft X 3 ft at west shoulder of SB lane.

RecDate: 11/01/2017 EstCost: Repair the roadway erosion 12 feet long X 5 feet wide X 3 feet deep is noticed at the west shoulder at southbound lane.
 Action : Appr. Roadway-Repair StrTarget: 2 YEARS
 Work By: LOCAL AGENCY DistTarget:
 Status : PROPOSED EA:

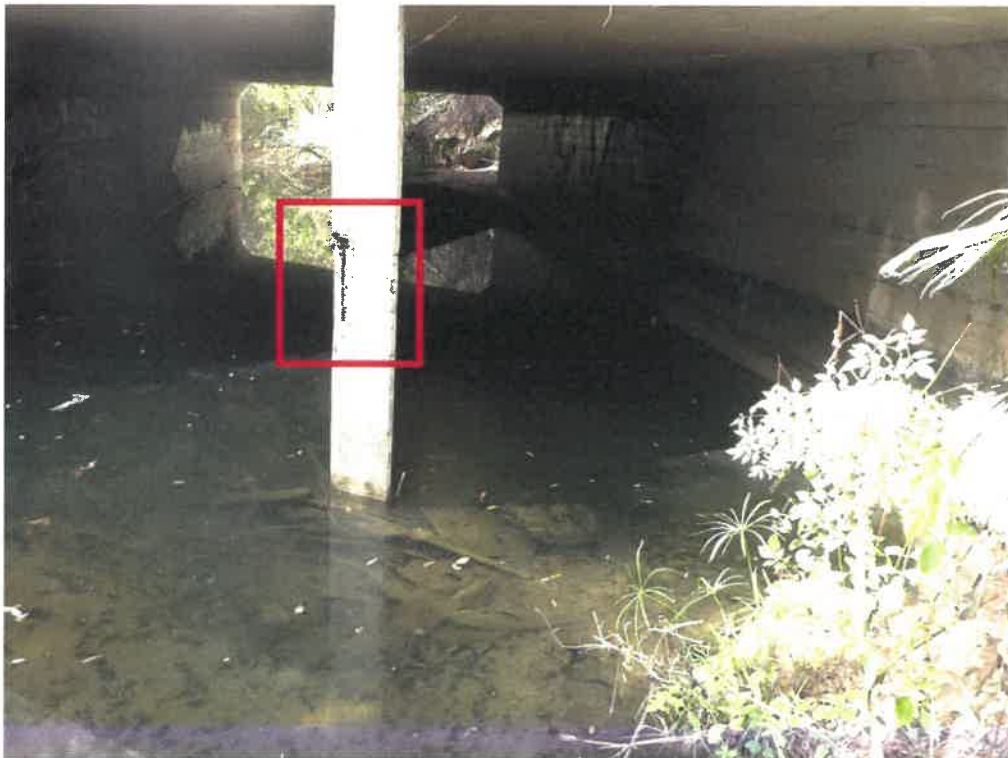
Photo No. 3

Spall at the west end of pier wall 2.

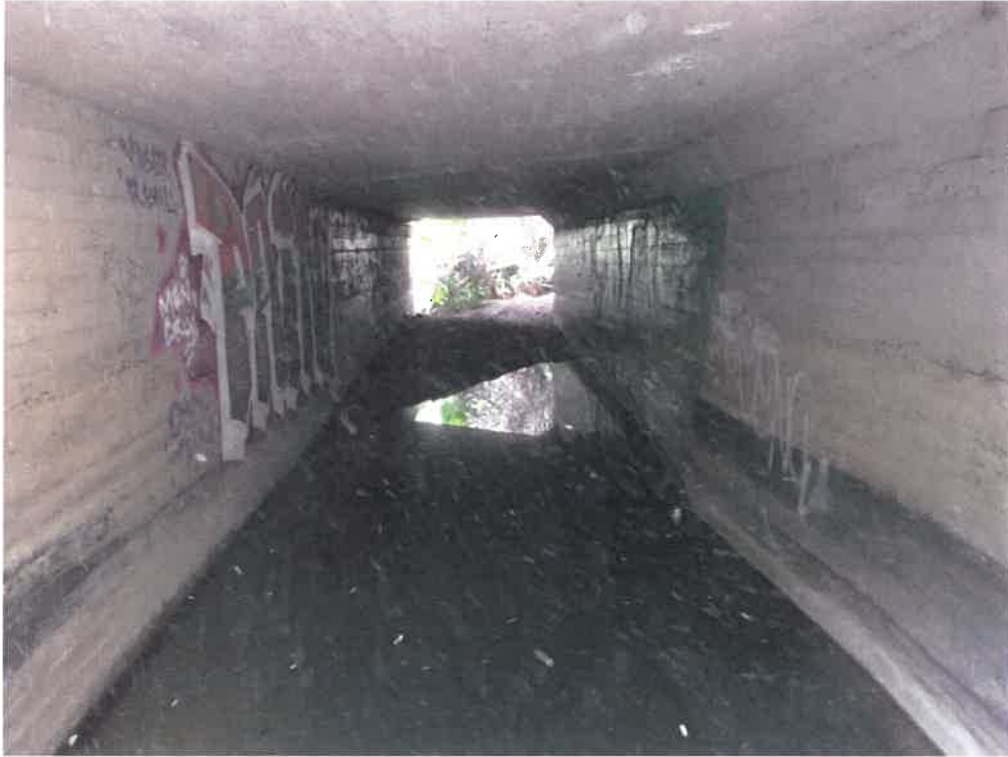
Photo No. 4

Underside View looking East. (north span)

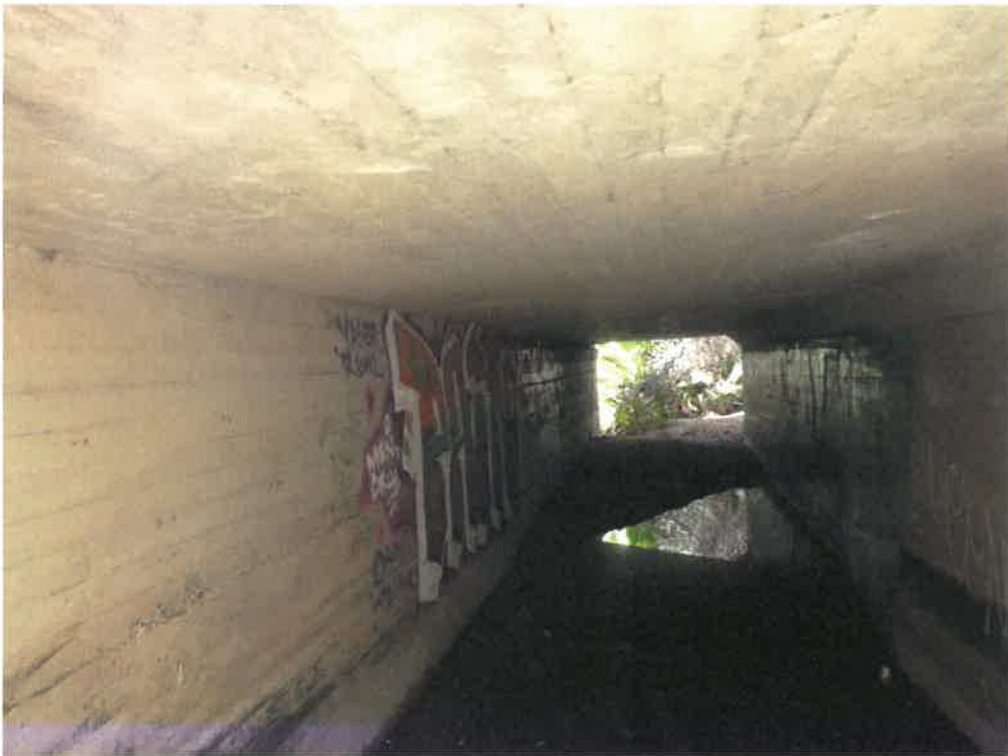
Photo No. 5

Underside View looking East. (south span)

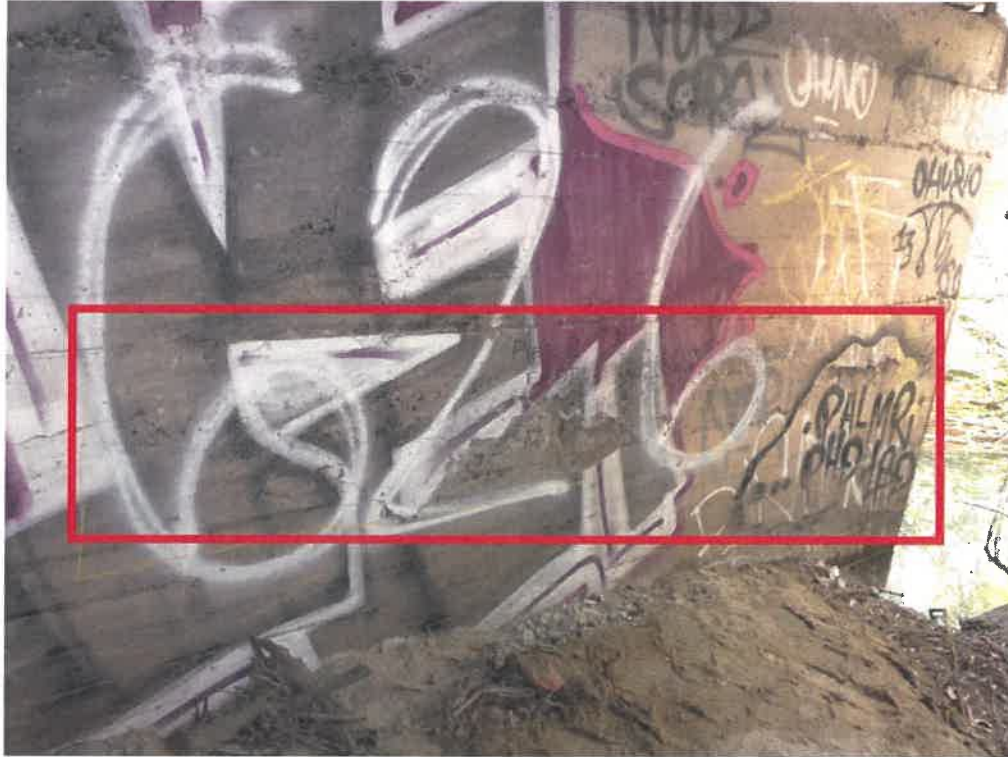
Photo No. 6

(38)										
There were no significant defects noted. (under 5 feet of fill)										
210			Pier Wall-RC	2	17	m	10	4	3	0
	1080		Delamination/Spall/Patched Area	2	6		0	3	3	0
	1130		Cracking (RC and Other)	2	1		0	1	0	0
(210-1080)										
Pie wall 2 has the following defects:										
At the west end , there is a spall 1.5 feet X 5 inches X 2 inches with exposed rebar at the west end. (see the attached photo no. 2)										
At the southerly face, there is a spall 2 feet high X 5 inches wide X 2 inches deep at East end.										
At the northerly face, there is an unsound concrete area 1.5 feet high X 6 inches wide at 15 feet from the east end.										
At the northerly face, there is spall with unsound concrete area combined size is 10 feet long X 1.5 feet wide X 2 inches at the west end. (see the attached photo no. 6)										
(210-1130)										
Pierwall 2 has two vertical cracks, up to 0.05 inches wide.

Spall and delamination 10 ft X 1.5 ft X 2 in. at north face , westerly end.

RecDate: 05/18/2012 EstCost: Repair Pier wall 2 that has a spall with unsound concrete area combined size is 10 feet long X 1.5 feet wide X 2 inches at the west end.
 Action : Sub-Patch spalls StrTarget: 2 YEARS
 Work By: LOCAL AGENCY DistTarget:
 Status : PROPOSED EA:

Remove unsound concrete and patch the delamination area of Pier wall 2. Revised by A. Shenouda 05/06/2018
