Bridge Inspection Records Information System

State of California
Department of Transportation

Bridge Number : 55C0121
Facility Carried: BREA BLVD
Location : 0.4 MI N CENTRAL AVE
City :
Inspection Date : 05-JUN-01

Bridge Inspection Report**Name : BREA CANYON CHANNEL****CONSTRUCTION INFORMATION**

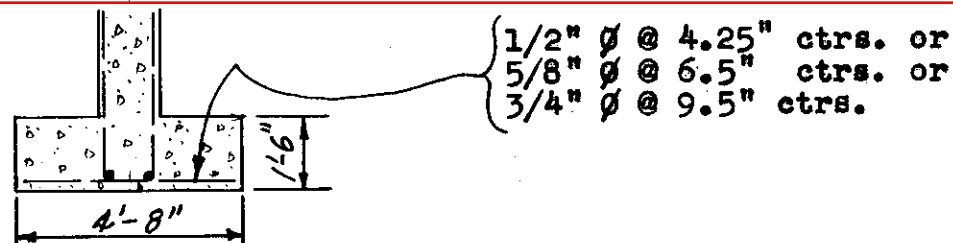
When excavating for the footings it was found that the material upon which it is proposed to support the bridge consists of fairly fine sand mixed with some rotary mud. The latter material apparently was deposited in the channel from nearby oil well workings. The material is inundated under normal conditions and it is necessary to pump water from the excavations in order to carry on the work.

1. Due to the nature of the foundation material the following changes in the pier and abutment footings will be made:
