DEPARTMENT OF TRANSPORTATION
Structure Maintenance & Investigations

Bridge Number : 55C0122
Facility Carried: BREA CANYON BLVD.
Location : 0.6 MI N/O CENTRAL AVENUE
City :
Inspection Date : 07/15/2019

Bridge Inspection Report

STRUCTURE NAME: BREA CANYON CHANNEL

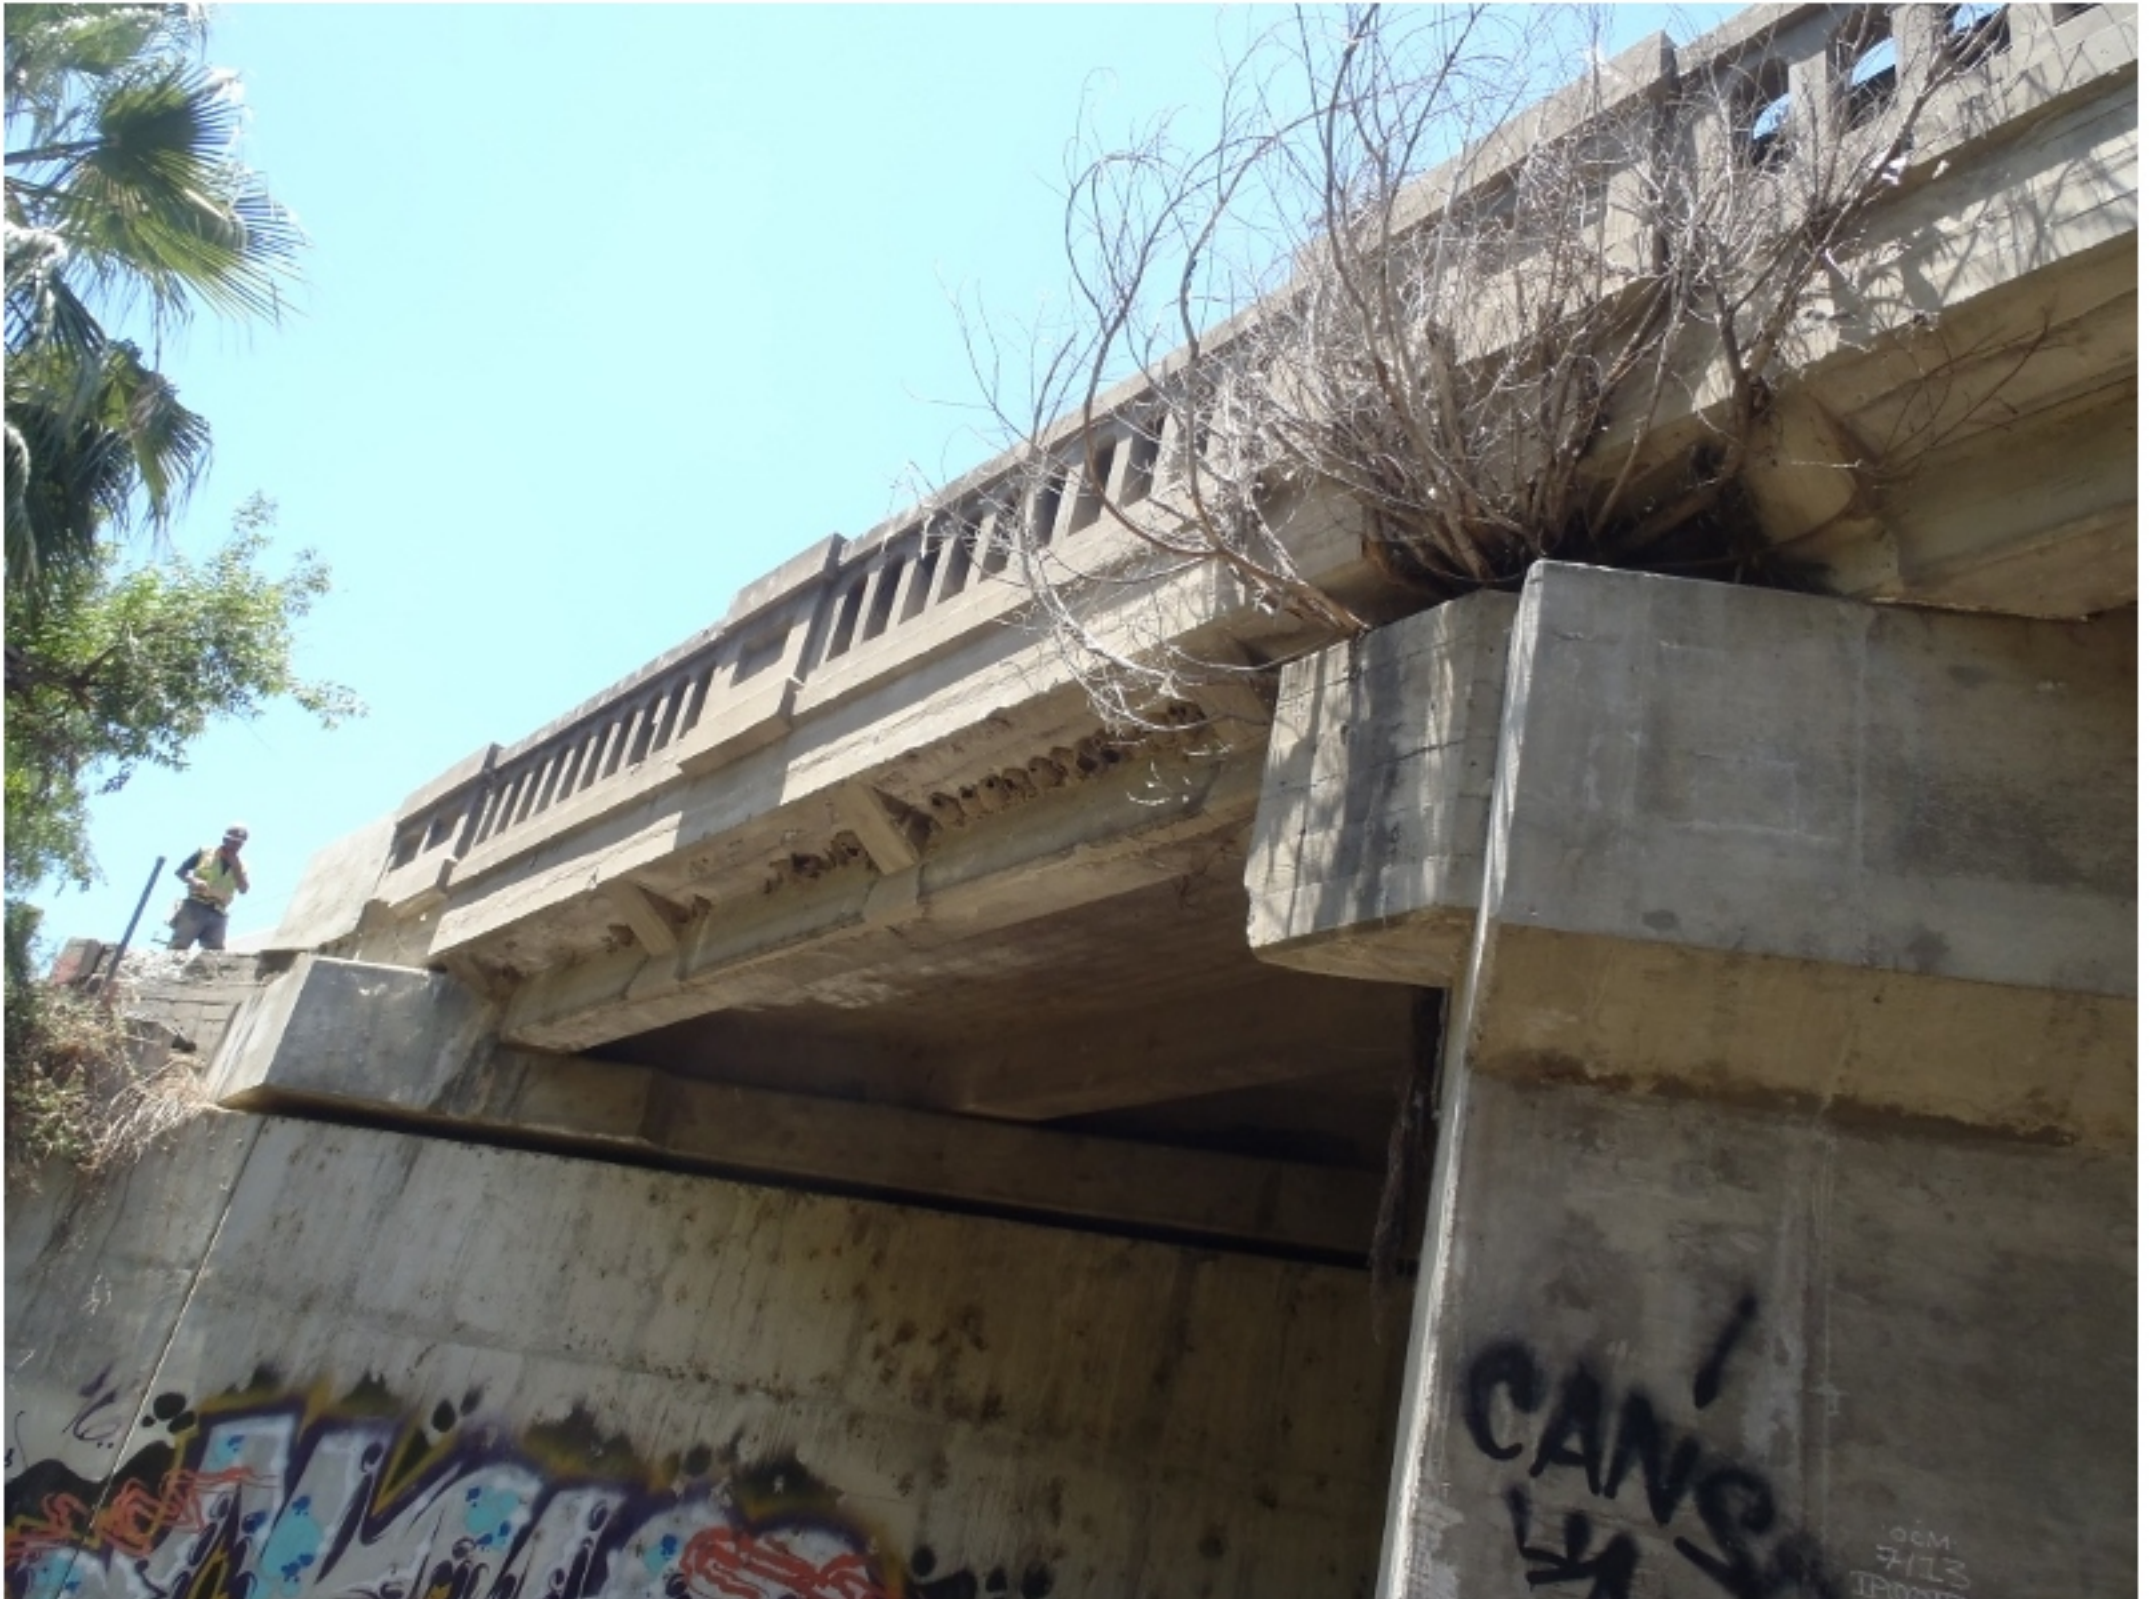
Photo No. 1

There was a tree growing at the top of the south side of pier wall 2.

SIDE VIEW LOOKING SOUTHWEST , NOTE THE PLANT GROWING ON THE TOP OF THE MIDDLE PIER
