DEPARTMENT OF TRANSPORTATION
Structure Maintenance & Investigations

Bridge Number : 55C0122
Facility Carried: BREA CANYON BLVD.
Location : 0.6 MI N/O CENTRAL AVENUE
City :
Inspection Date : 11/01/2017

Bridge Inspection Report

STRUCTURE NAME: BREA CANYON CHANNEL

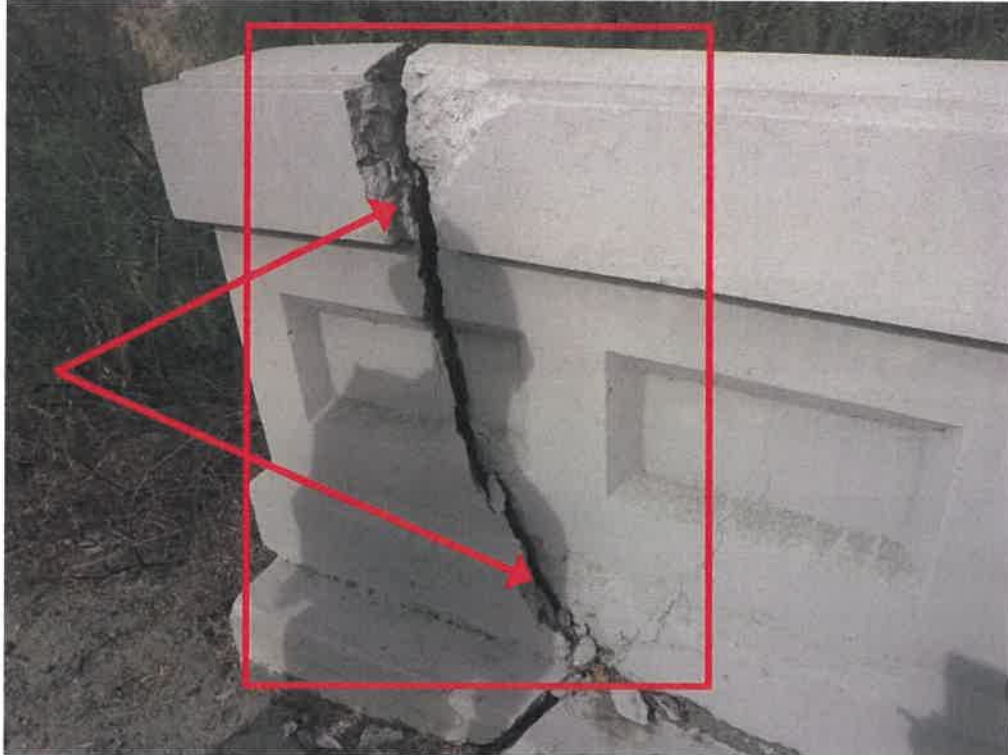
Photo No. 2

(215)										
There were no significant defects noted.										
227			Pile-RC	2	1	ea.	1	0	0	0
(227)										
The pile element is included to indicate the presence of piles on this structure. The piles were not exposed for visual inspection. No indication of pile distress was noted in any substructure element.										
331			Railing-RC	2	29	m	9	10	9	1
1080			Delamination/Spall/Patched Area	2	20		0	10	9	1
(331-1080)										
The concrete balusters at both rails have been cracked or spalled +/- 15 inches X 3 inches X 1 inch in many locations.										
The west end of the north concrete rail is broken and a crack 1 inch is noticed; and there is a spall 2 feet X 1.5 feet X 5 inches at the exterior face of the north rail westerly end. (see the attached photos no. 2 & 3)

North rail wsterly end has a crack 1 inch wide.

RecDate: 05/06/2010	EstCost:	Repair the spalls +/- 15 inches X 3
Action : Railing-Repair	StrTarget: 2 YEARS	inches X 1 inch in both concrete baluster
Work By: LOCAL AGENCY	DistTarget:	railings.
Status : PROPOSED	EA:	
RecDate: 05/30/2007	EstCost:	Repair the damaged rail.
Action : Railing-Repair	StrTarget: 2 YEARS	The west end post of north rail is
Work By: LOCAL AGENCY	DistTarget:	damaged and cracked; there is 1 inch wide
Status : PROPOSED	EA:	vertical cracks from top to the bottom of
		footing.

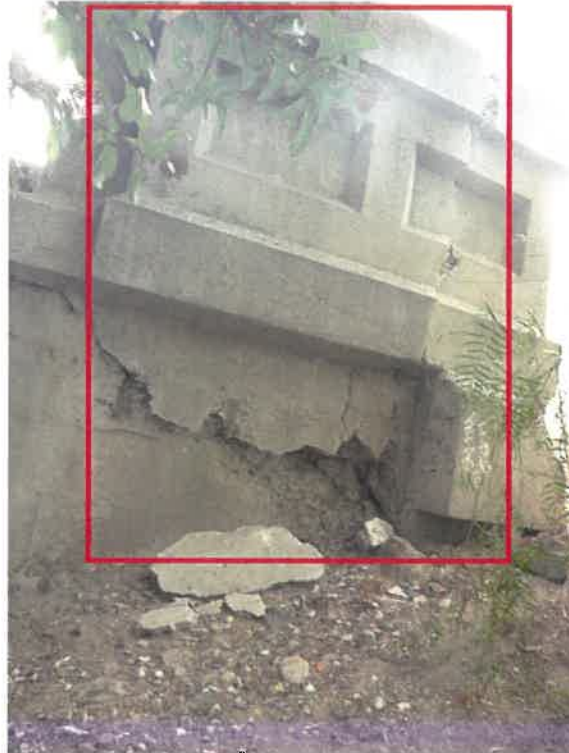
Photo No. 3

Exterior face of the north rail, westerly end has a spall 2 feet X 1.5 feet X 5 inches.

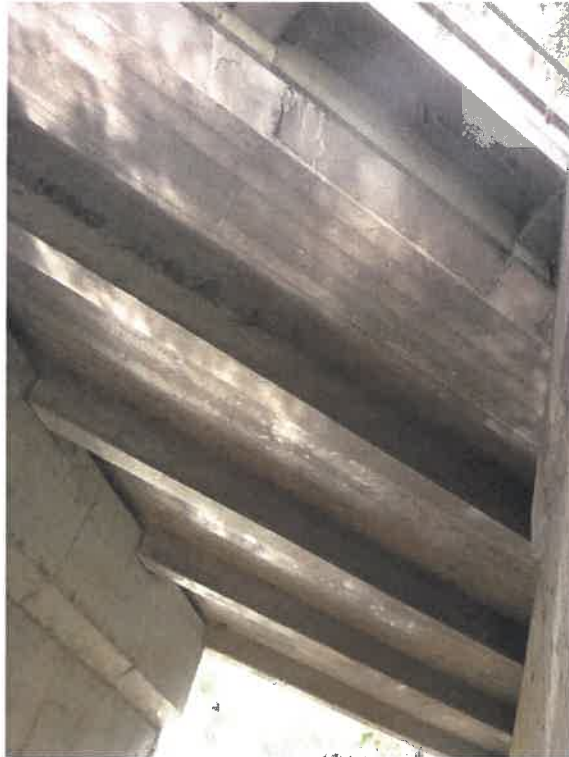
Photo No. 4

Ten year routine underside photograph was taken during this inspection and is included with this report. (see the attached photo no. 4)

Underside View looking South. (Span 1)

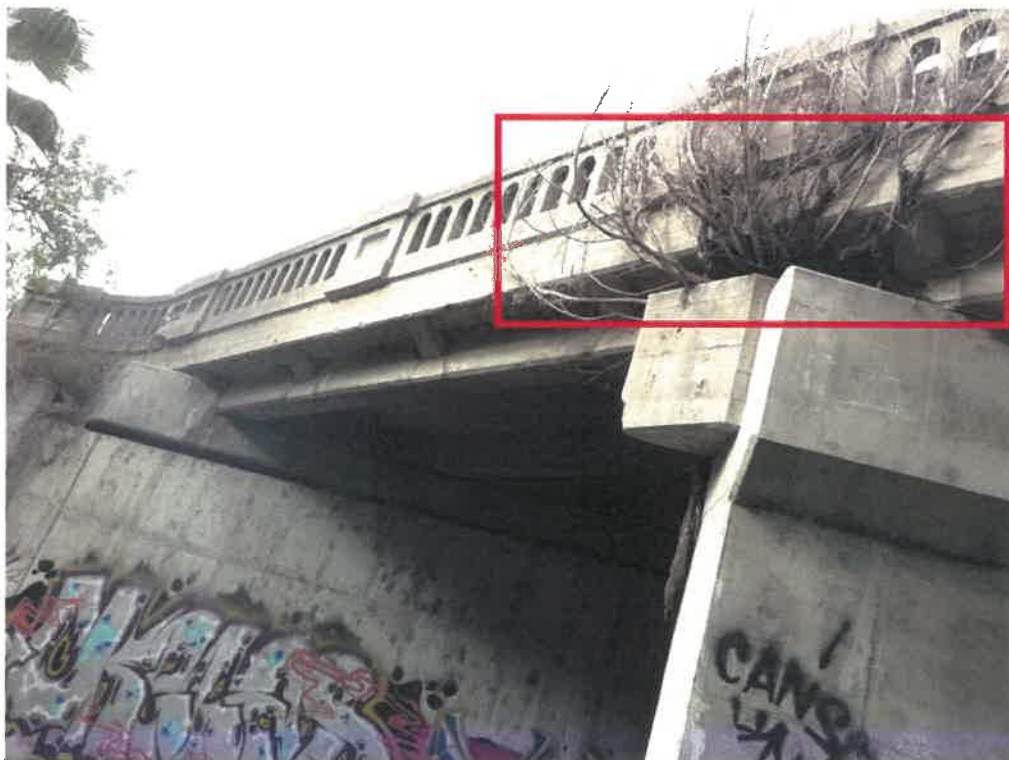
Photo No. 5

There was a tree growing at the top of the south side of pier wall 2. (see the attached photo no. 5)

Tree is growing at the top of pierwall 2 , southerly end.

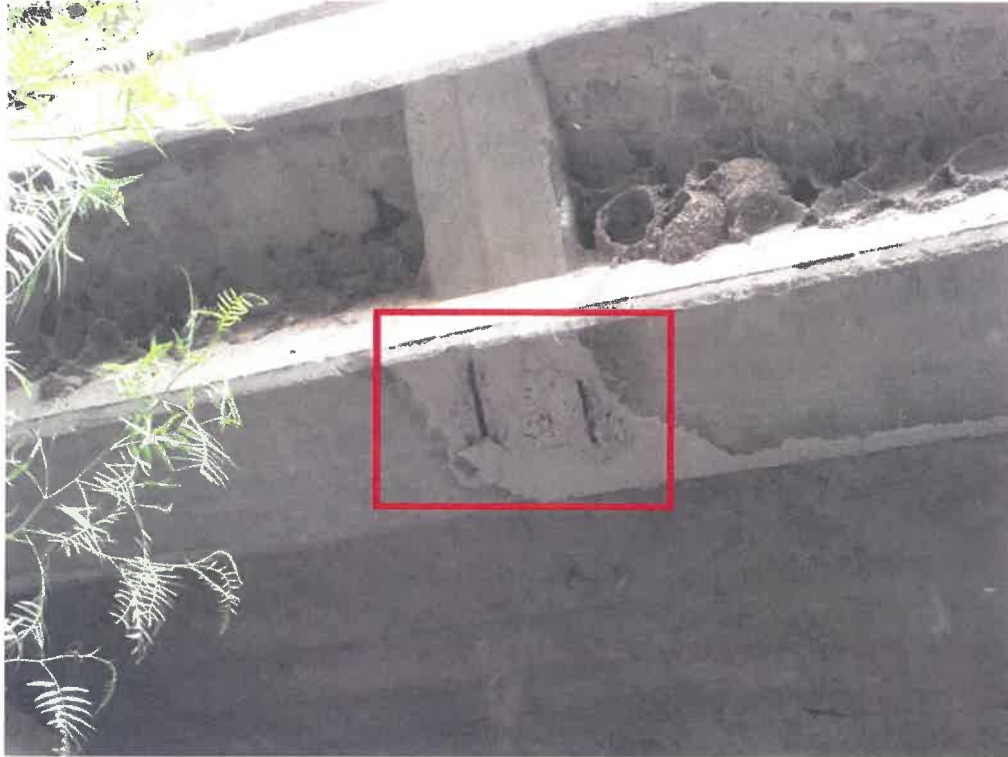
Photo No. 6

(16)										
There were no significant defects noted.										
(16-1080)										
The elevation o the top flange has few spalls and incipient spalls +/- 6 inches X 6 inches x 1 inch mostly at the south elevation.										
(16-510-3220)										
There are two transverse cracks, 0.5 inches wide and a longitudinal crack 20 feet long and 0.50 inches wide.										
110			Girder/Beam-RC	2	95	m	93	1	1	0
	1080		Delamination/Spall/Patched Area	2	2		0	1	1	0
(110-1080)										
The concrete girders have few spalls at the bottom face at the north girder at both spans. (see the attached photo no. 6)										
210			Pier Wall-RC	2	14	m	13	1	0	0

Spall with exposed rebar at the bottom of the north girder.
