# Bridge Inspection Records Information System

Bridge Number : 55C0122  
Facility Carried: BREA BLVD  
Location : 0.6 MI N CENTRAL AVE  
City :  
Inspection Date : 05-JUN-01

**Bridge Inspection Report**

**Name : BREA CANYON CHANNEL**

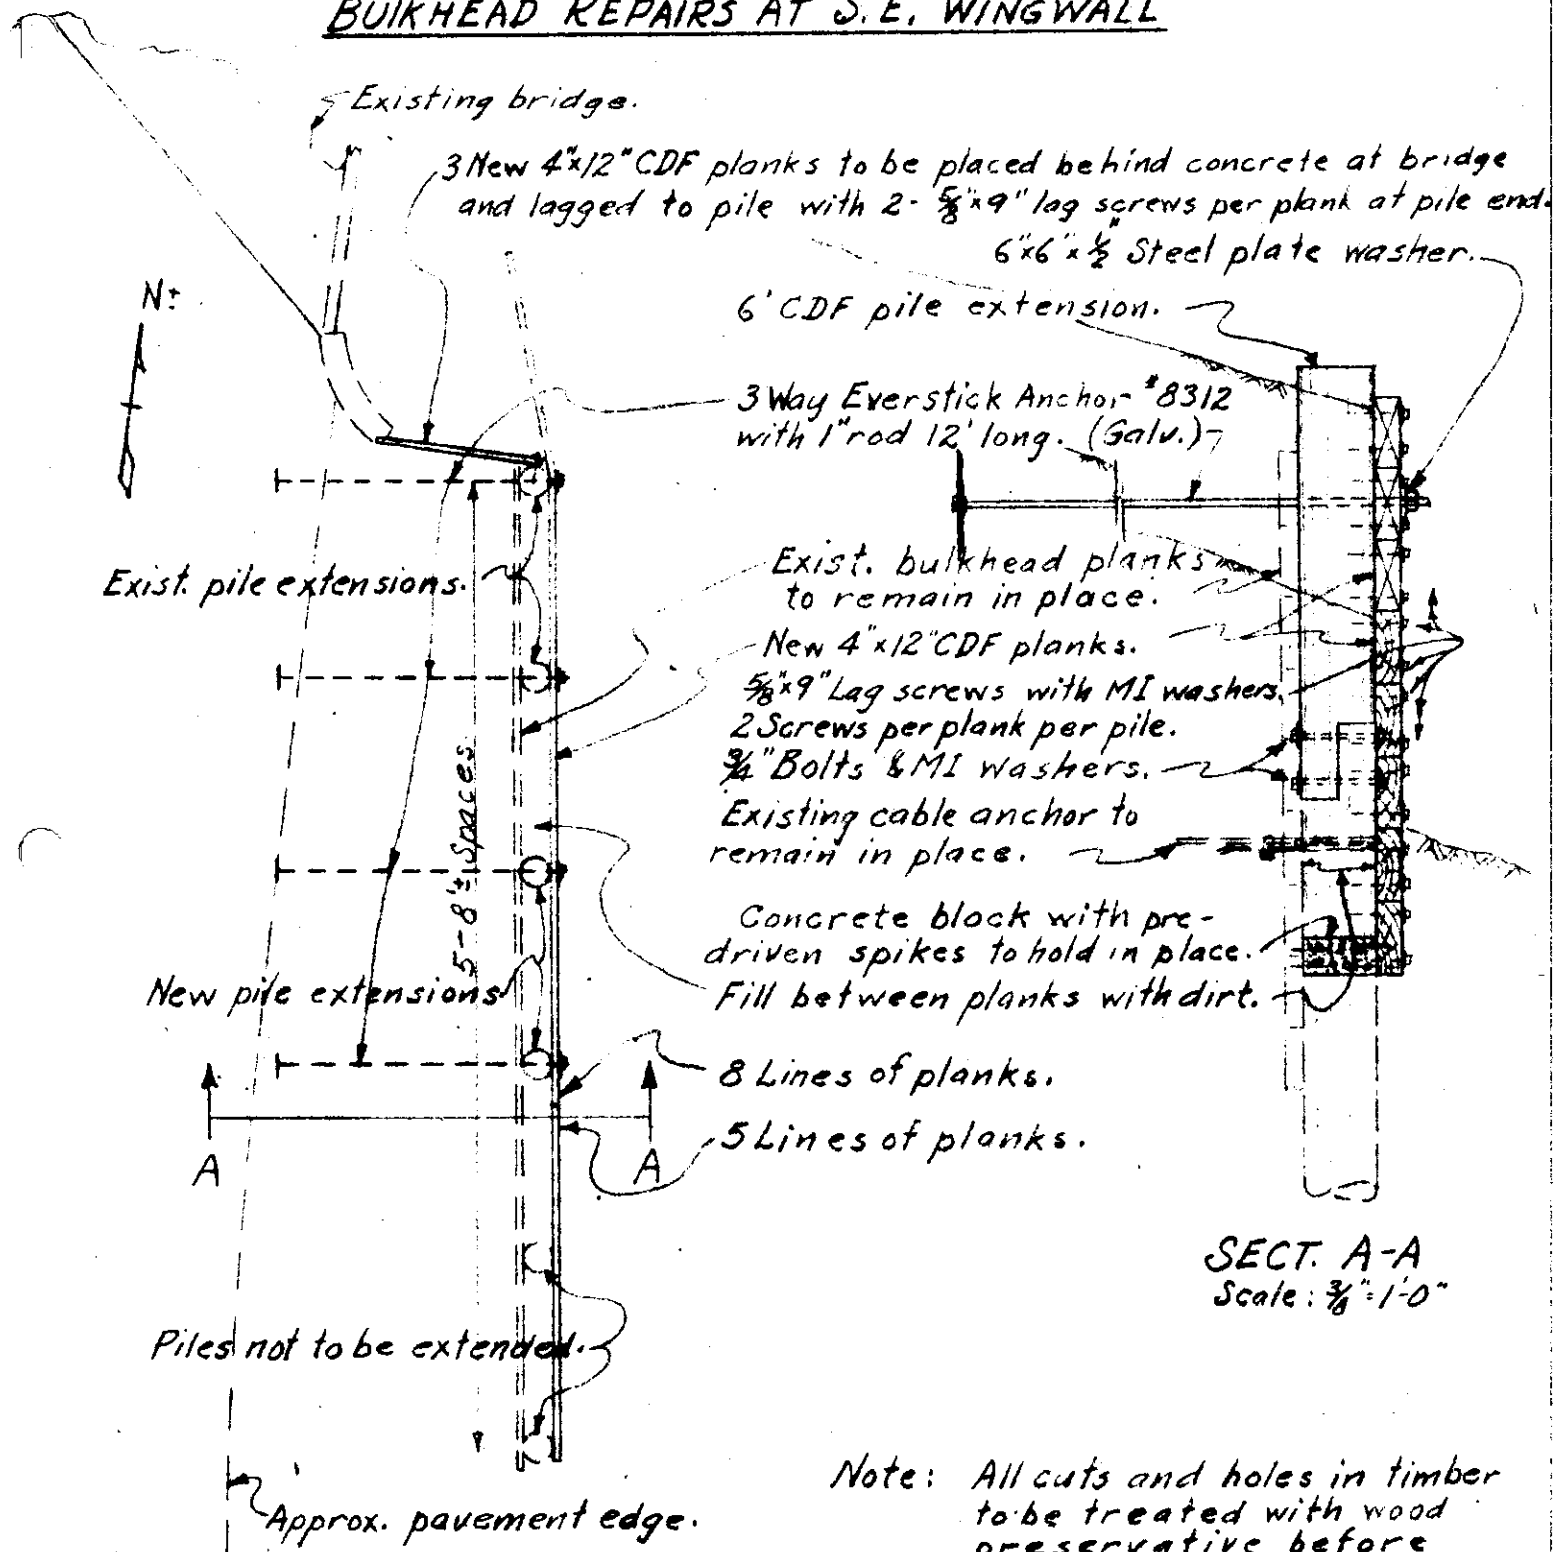
BULKHEAD REPAIRS AT S. E. WINGWALL

An erosion gully exists at the southeast return wall. The top plank is broken in the timber bulkhead at this same location. The broken plank is not detrimental.

1. Divert runoff water from the bridge by constructing an AC dike from the southeast return wall to downdrain located approximately 15' south of the structure. The dike should parallel the metal beam approach rail. Backfill the gully at the southeast return wall with AC.
2. Repair concrete spalls on the outside of the southerly rail posts by removing any unsound concrete, cleaning the spalled areas, and patching with epoxy bonded concrete.
