**DEPARTMENT OF TRANSPORTATION**  
Structure Maintenance & Investigations

**Bridge Number** : 55C0123  
**Facility Carried**: BREA CANYON BLVD.  
**Location** : 0.8 MI N/O CENTRAL AVENUE  
**City** :  
**Inspection Date** : 07/15/2019

**Bridge Inspection Report**

**STRUCTURE NAME:** BREA CANYON CHANNEL

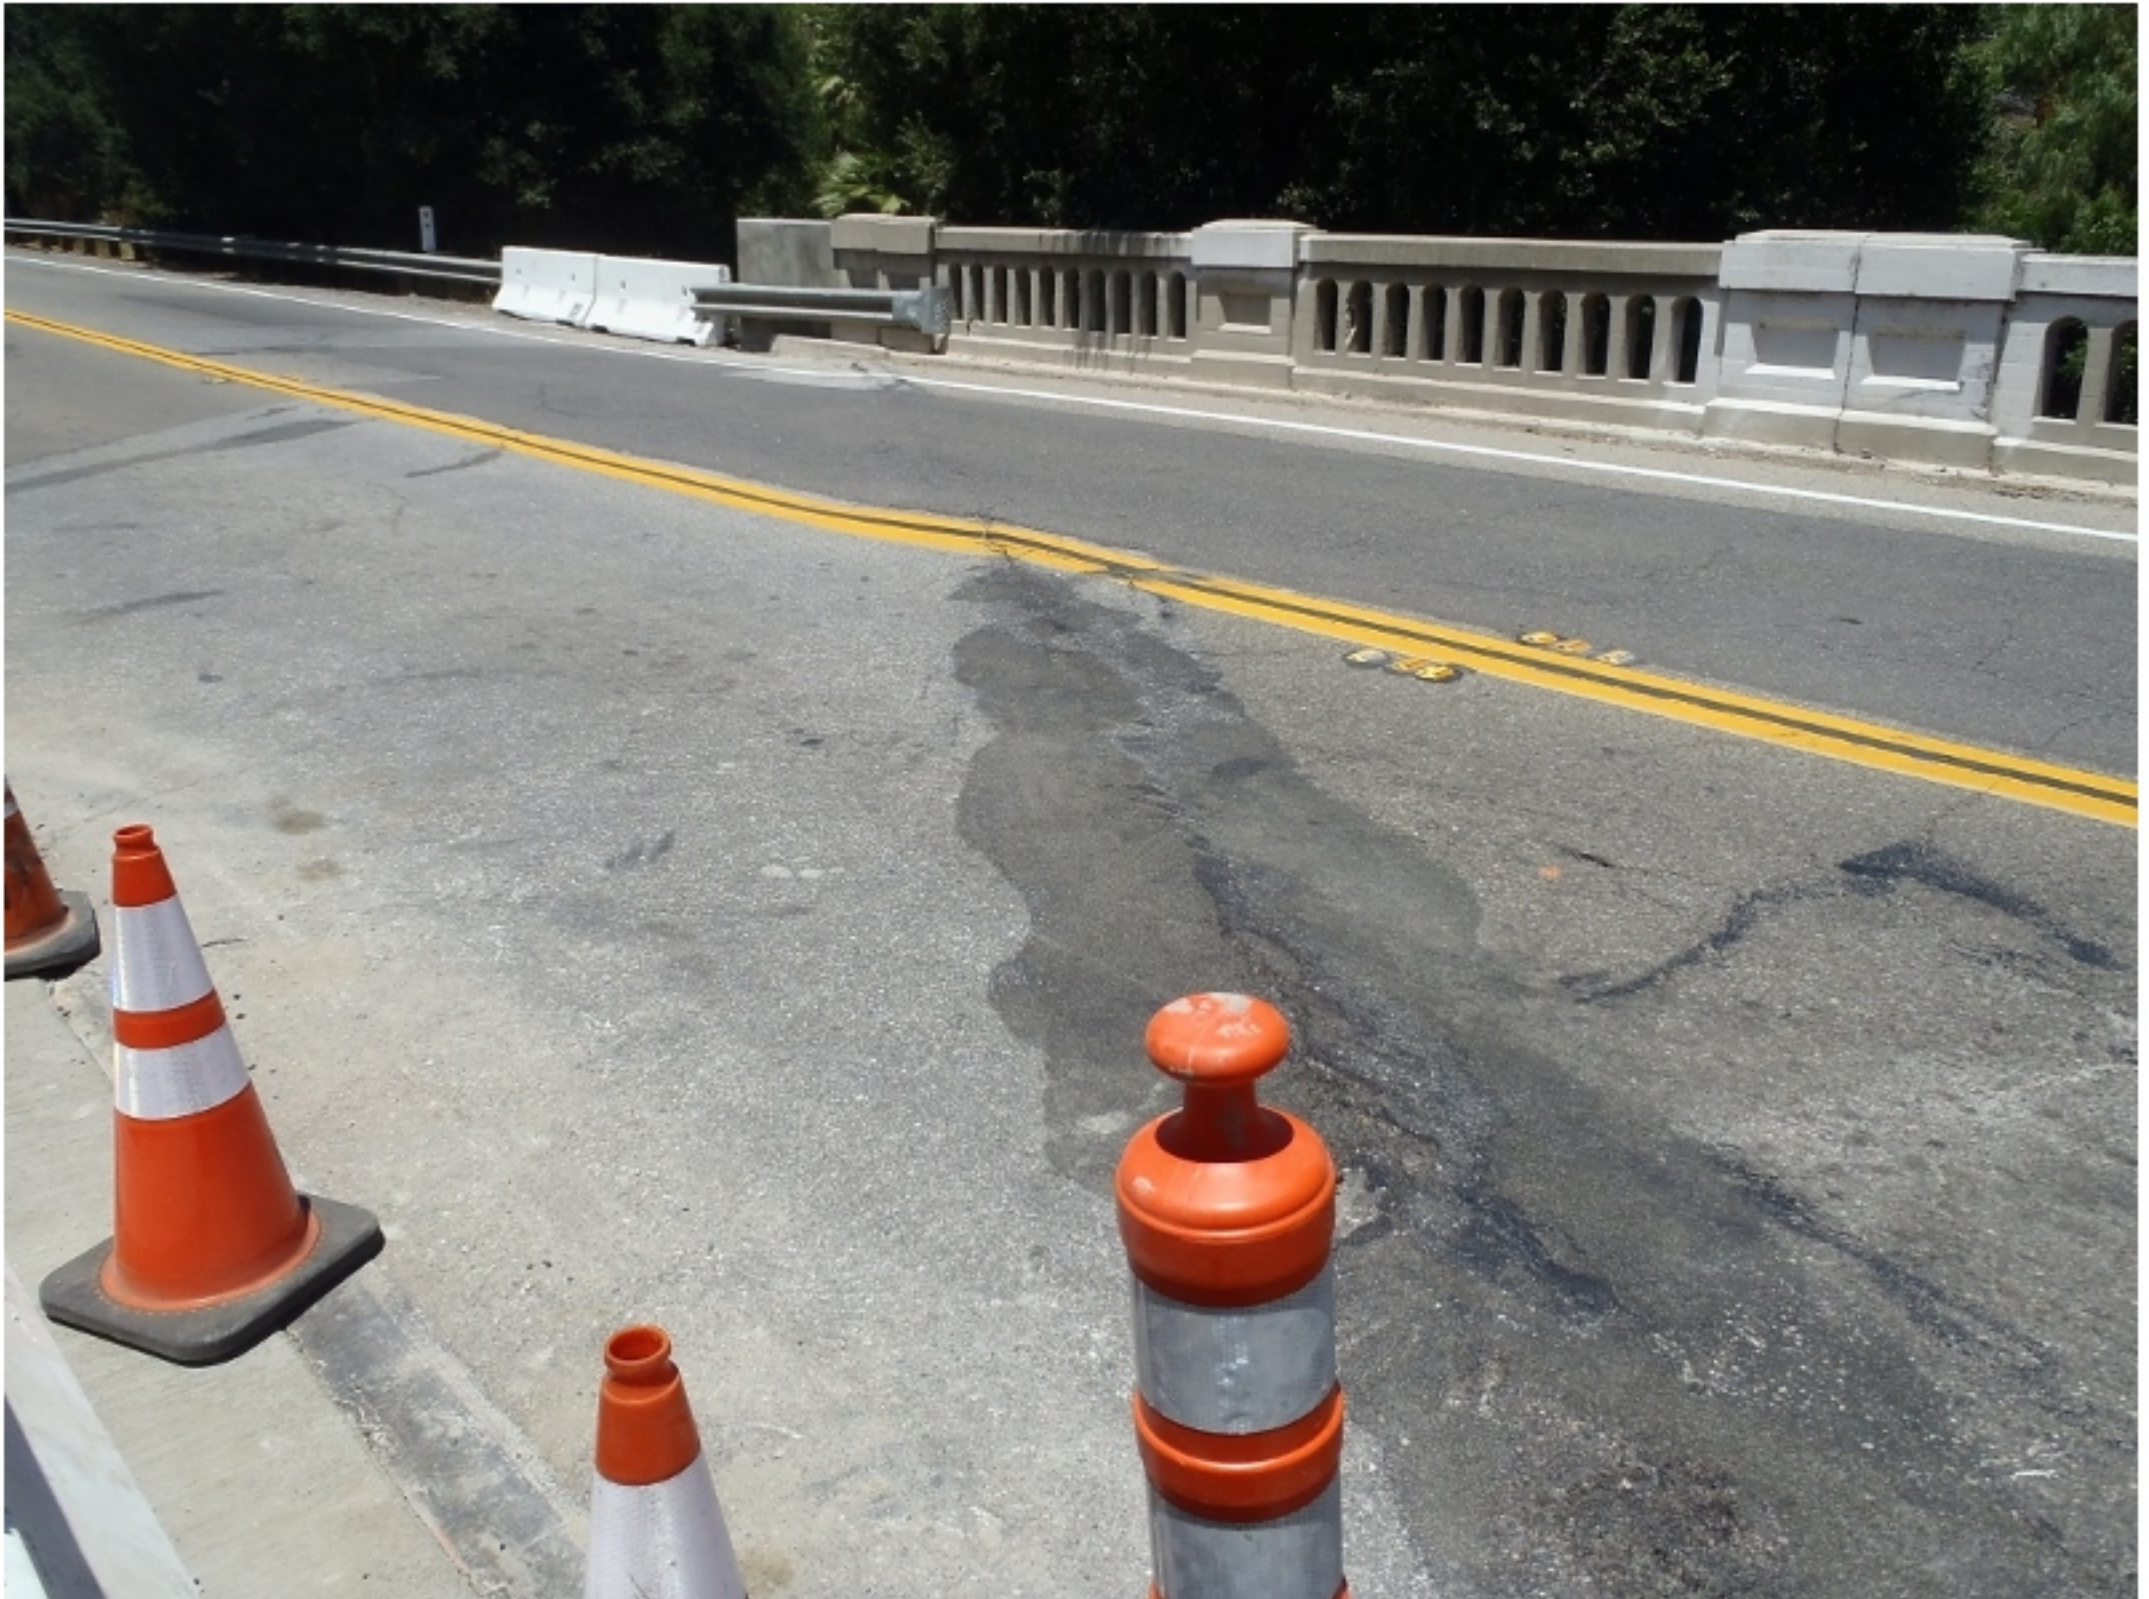
Photo No. 1  
JOINT CONDITION AT WESTERN ABUTMENT

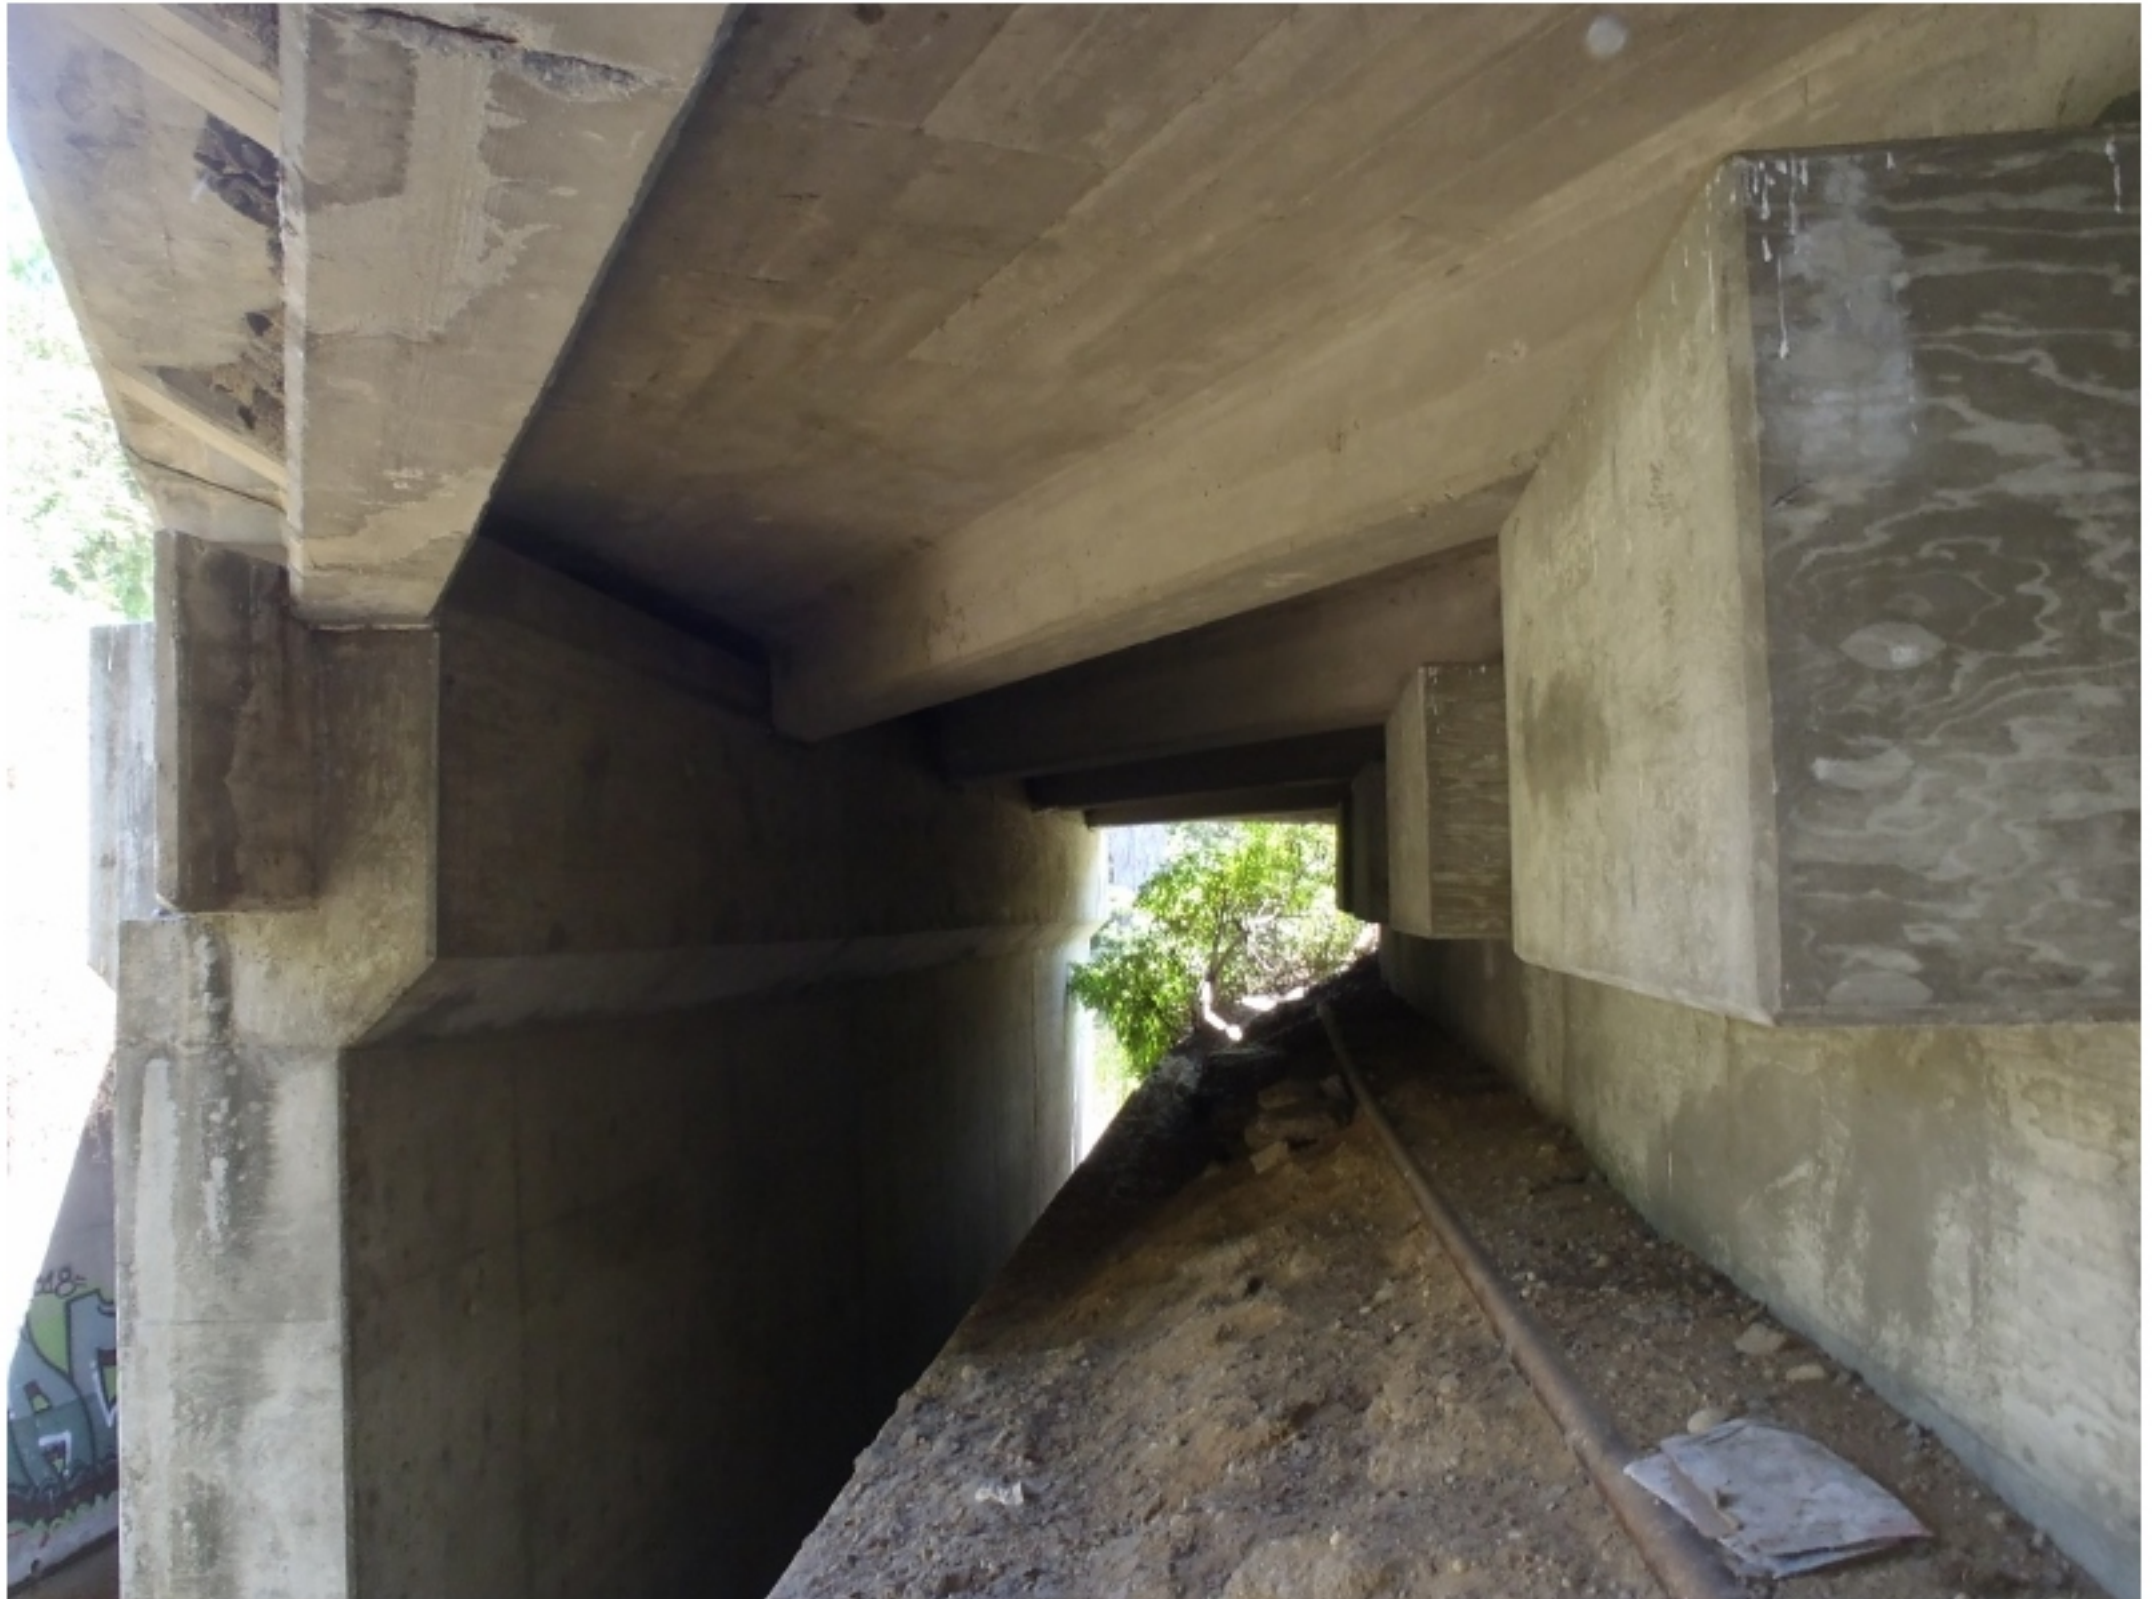
Girder 1 in Span 1, 2 spalls up to 12 inch x 4 inch x 1.5 inch,										
Girder 1 in Span 2, 4 spalls from 4 inch x 4 inch x 1.5 inch to 12 inch x 6 inch x 1.5 inch,										
Girder 1 in Span 3, 18 inch x 12 inch x 2 inch.

Photo No. 1  
UNDER VIEW IN SPAN 1, LOOKING SOUTHEAST
