DEPARTMENT OF TRANSPORTATION
Structure Maintenance & Investigations

Bridge Number : 55C0123
Facility Carried: BREA CANYON BLVD.
Location : 0.8 MI N/O CENTRAL AVENUE
City :
Inspection Date : 11/01/2017
Inspection Type
Routine ☒ FC ☐ Underwater ☐ Special ☐ Other ☐

Bridge Inspection Report

STRUCTURE NAME: BREA CANYON CHANNEL

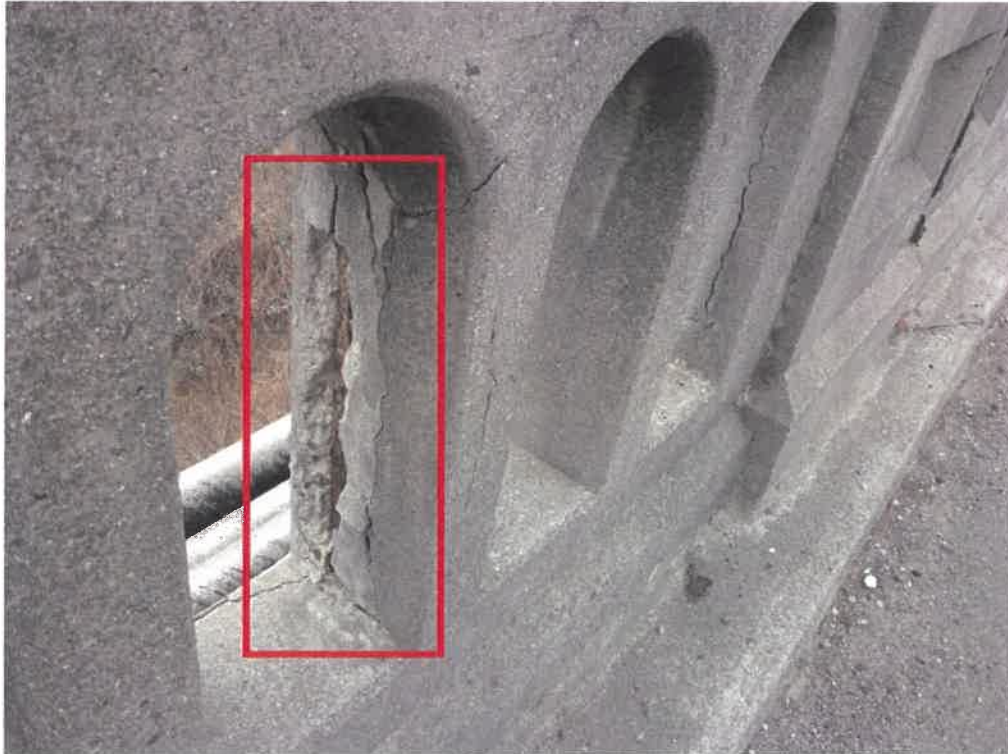
Photo No. 2

The concrete balusters at both rails have been cracked or spalled +/- 15 inches X 3 inches X 1 inch in many locations.

119 - PHOTO-Rail-Damage/Deterioration

Spalls at the concrete balusters.

Repair the spalls +/- 15 inches X 3 inches X 1 inch in both concrete baluster railings. Revised by A. Shenouda 5/9/2018

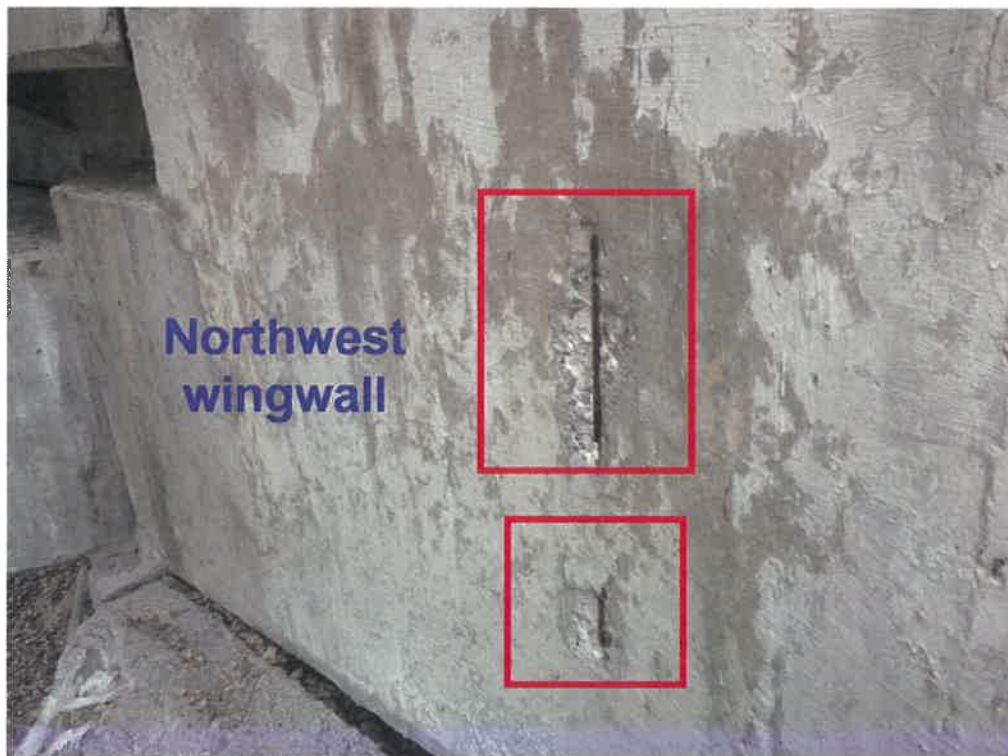
Photo No. 3

There were two spalls sized +/- 12 inches X 3 inches X 1 inch with exposed rebars at the northwest wing wall. (see the attached photo no. 3)

Nothwest has two spalls with exposed rebar.

Repair the three spalls +/- 12 inches X 3 inches X 1 inch with exposed rebars at the northwest wing wall.

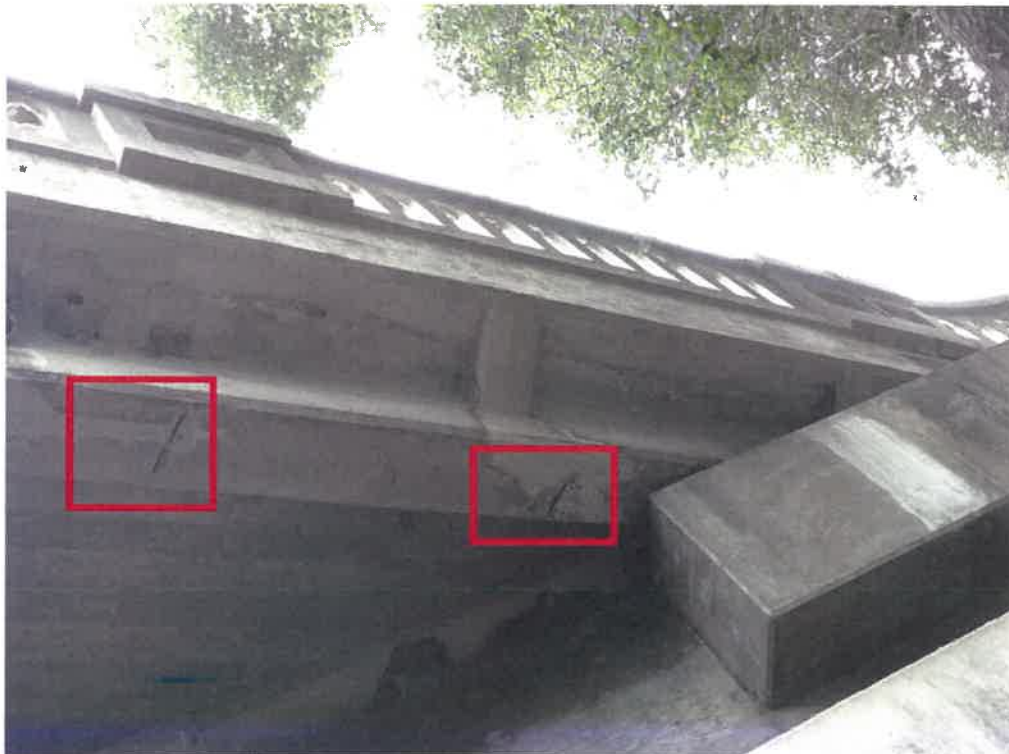
Photo No. 5

Elem No.	Defect /Prot	Defect	Element Description	Env	Total Qty	Units	Qty in each Condition State	St. 1	St. 2	St. 3	St. 4
16			Top Flange-RC	2	283	sq.m	278	2	3	0	0
	1080		Delamination/Spall/Patched Area	2	5		0	2	3	0	0
	510		Deck Wearing Surface-Asphalt	2	255	sq.m	240	15	0	0	0
	3220		Cracking-AC (WS)	2	15		0	15	0	0	0
(16-1080)											
There are ten spalls at the north edge of the deck with exposed rusted rebars mostly at spans 2 and 3, the average size was 8 inches x 6 inches x 1 inch. (see the attached photos no. 7 & 8)											
(16-510-3220)											
AC overlay exhibits Longitudinal crack 30 feet long and 0.5 inches wide at eastbound lane.											
110			Girder/Beam-RC	2	140	m	136	0	4	0	0
	1080		Delamination/Spall/Patched Area	2	4		0	0	4	0	0
(110-1080)											
There was four spalls 16 inches X 10 inches X 1 inch with exposed rebars at the bottom of both exterior girders at spans 1 and 3 and at span 2 north exterior girder. (see the attached photos no. 4 & 5)

Spalls with exposed rebars at the bottom face of the exterior girders.

Repair and patch the four spalls 16 inches X 10 inches X 1 inch with exposed rebars at the bottom of both exterior girders at spans 1 and 3 and at span 2 north exterior girder.

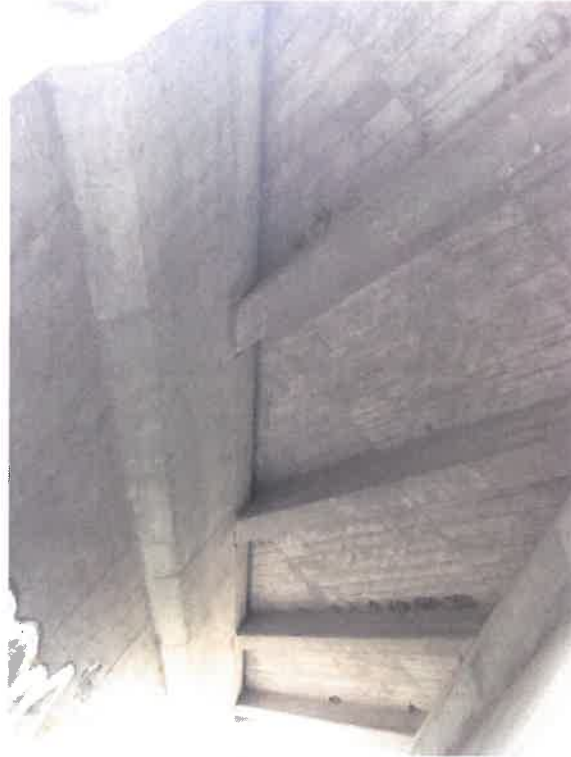
Ten year routine underside photograph was taken during this inspection and is included with this report. (see the attached photo no. 6)

Photo No. 6
Underside View looking South.

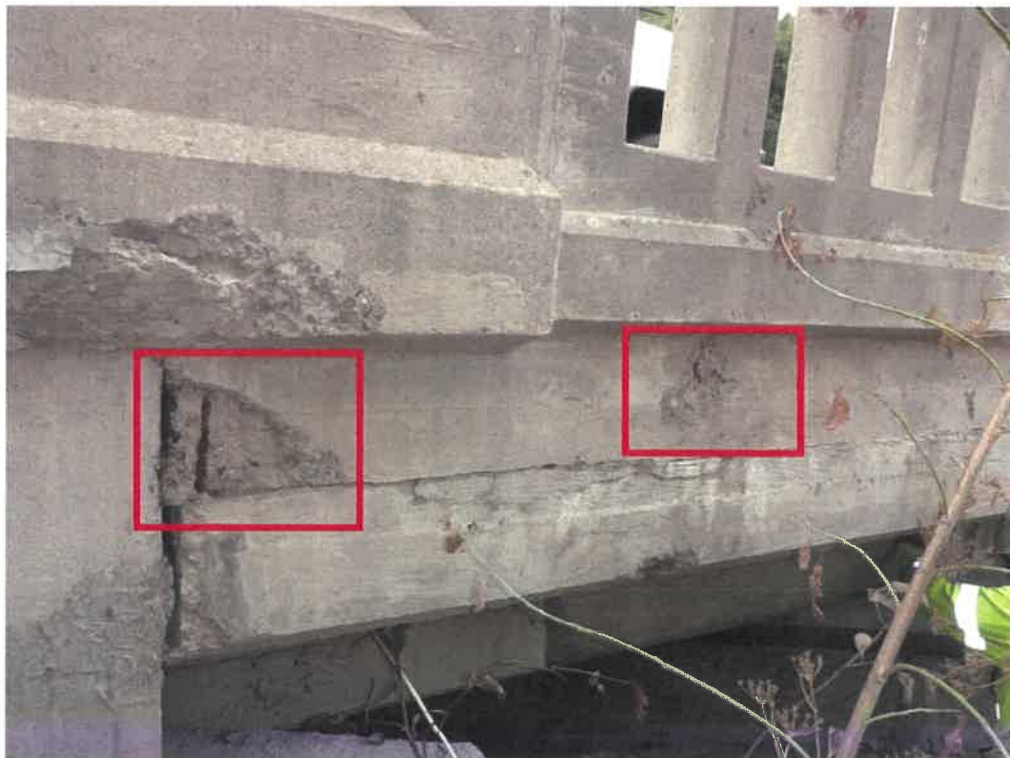
Photo No. 7
North deck elevations has 10 spalls with exposed rebars mainly in spans 2 and 3.

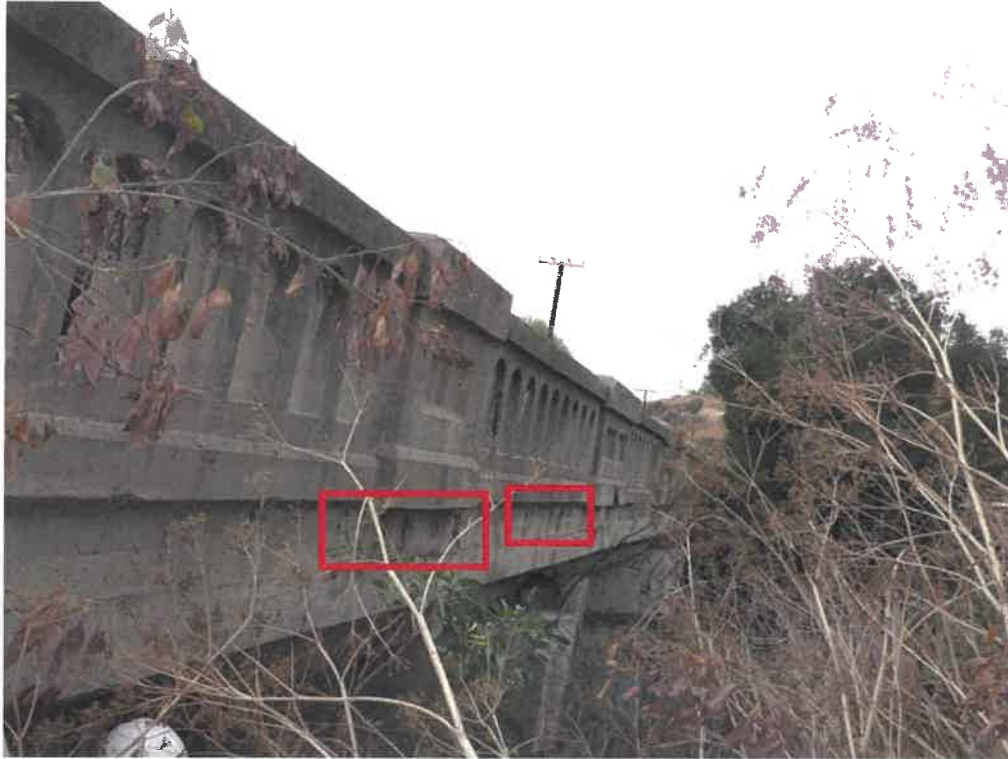
Photo No. 8

North deck elevations has 10 spalls with exposed rebars mainly in spans 2 and 3.
