Bridge Inspection Records Information System

Bridge Number : 55C0123
Facility Carried: BREA BOULEVARD
Location : 0.8 MI N CENTRAL AVE
City :
Inspection Date : 05-JUN-01

Bridge Inspection Report

Name : BREA CANYON CHANNEL

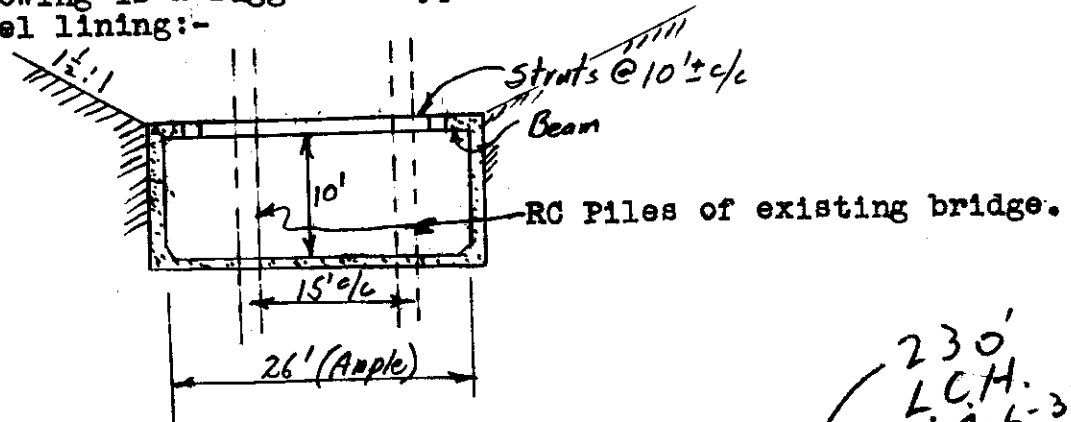
Channel has apparently scoured down about 5' since bridge was built. During the extreme highwater of 1938, parts of the bulkheads upstream from the bridge failed, and part of the roadway fill washed out. This damage has been temporarily repaired. The creosoted Douglas fir piles of the bulkheads are tied back with cables to deadmen, and are in fairly good condition except that the deadmen have failed on the north upstream wing and allowed piles to tip outward. Considerable of the redwood bulkhead planking has decayed and failed throughout entire lengths of bulkheads.

The following is a suggested typical cross section of the proposed channel lining:-

Channel to be lined for total distance of about 180' with a channel lining constructed along the above lines, but not larger in internal dimensions. Cut off walls will be necessary at each end, extending at least 8' below flow line. Wing walls may be necessary. Lining must be curved on upstream end, and backfilled where there is no existing backfill. Existing timber bulkheads may be buried in fill.
