# Bridge Inspection Records Information System

Bridge Number : 55C0125  
Facility Carried: NEWPORT BLVD  
Location : 1.0 MI S CHAPMAN AVE  
City :  
Inspection Date : 05-JUN-01

**Bridge Inspection Report**

**Name : HIGHCLIFF DR POC**

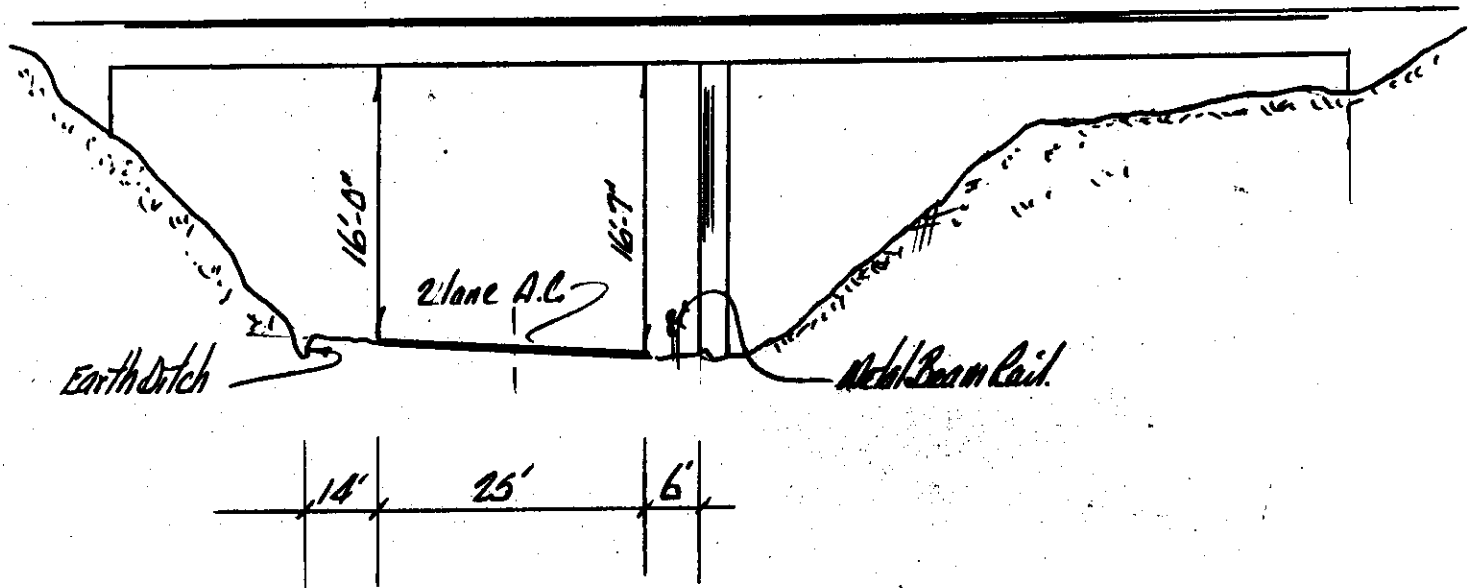
CLEARANCE DIAGRAM.

HIGHCLIFF DRIVE OC.

LOOKING NORTH ON NEWPORT AVENUE.
