DEPARTMENT OF TRANSPORTATION
Structure Maintenance & Investigations

Bridge Number : 55C0130
Facility Carried: GLASSELL STREET
Location : 0.3 MI S/O ROUTE 91 FWY
City :
Inspection Date : 12/31/2017

Bridge Inspection Report

STRUCTURE NAME: SANTA ANA RIVER CHANNEL

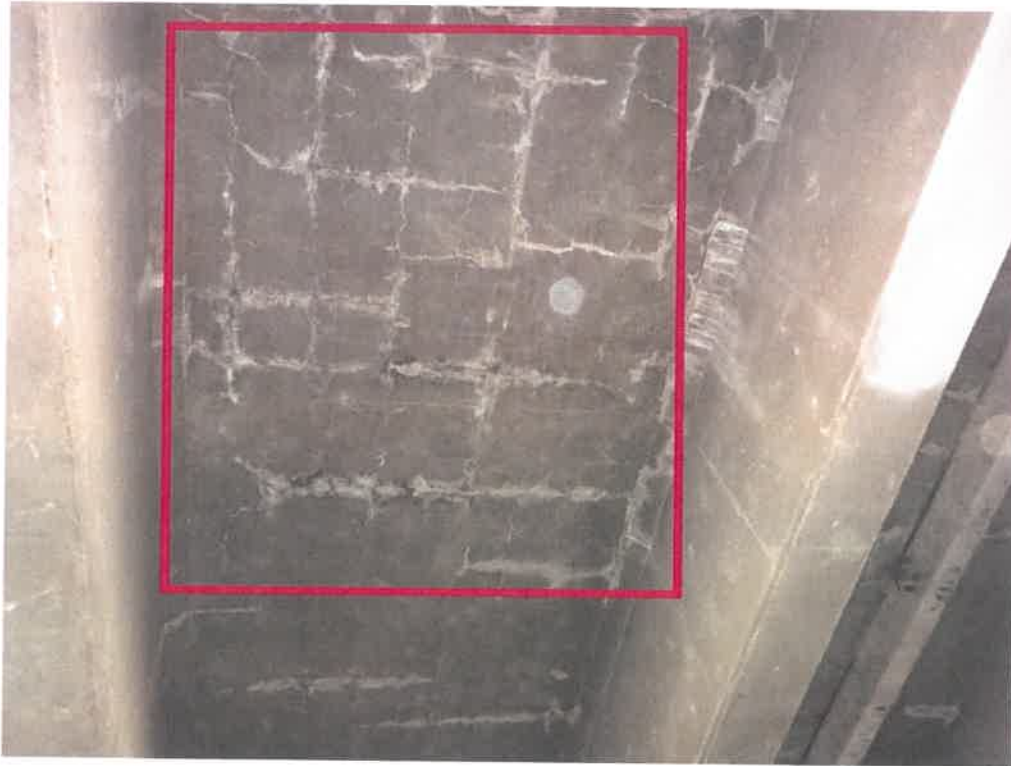
Photo No. 1

The soffit exhibits: (see the attached photo no. 1)

* span #1: all bays under the traffic lanes (original bridge) has several transverse cracks with heavy white efflorescence;

* span #2: all bays under the traffic lanes (original bridge) has several transverse cracks, up to 6 feet long with light white efflorescence mostly at south end; and

* at spans #8 to #18: few transverse cracks with light white efflorescence; these cracks mirror the deck cracks.

102 - PHOTO-Deck-Damage/Deterioration

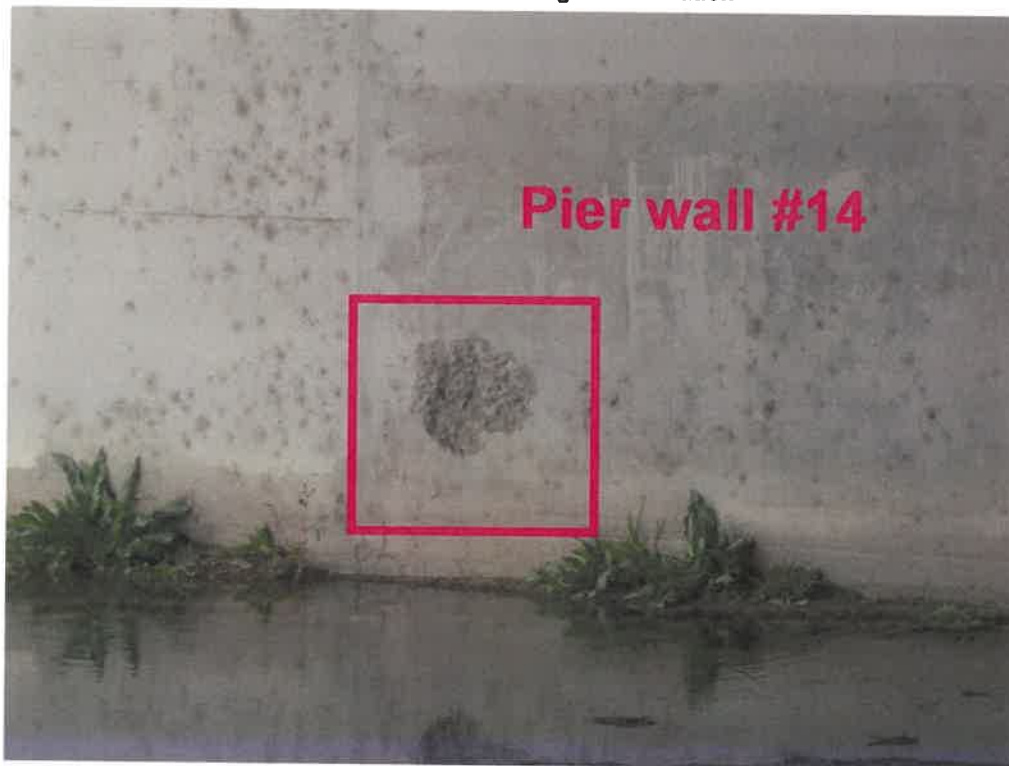
Photo No. 2

Pier wall #14 exhibits a spall 1.5 feet diameter X 2 inches at 15 feet from west end southerly face.

Spall 1.5 feet diameter X 2 inches deep at pier wall 14.

RecDate: 12/31/2017	EstCost:	Patch Pier wall #14 that has a spall 1.5
Action : Sub-Patch spalls	StrTarget: 2 YEARS	feet diameter X 2 inches at 15 feet from
Work By: LOCAL AGENCY	DistTarget:	west end southerly face. (see the
Status : PROPOSED	EA:	attached photo no. 2)

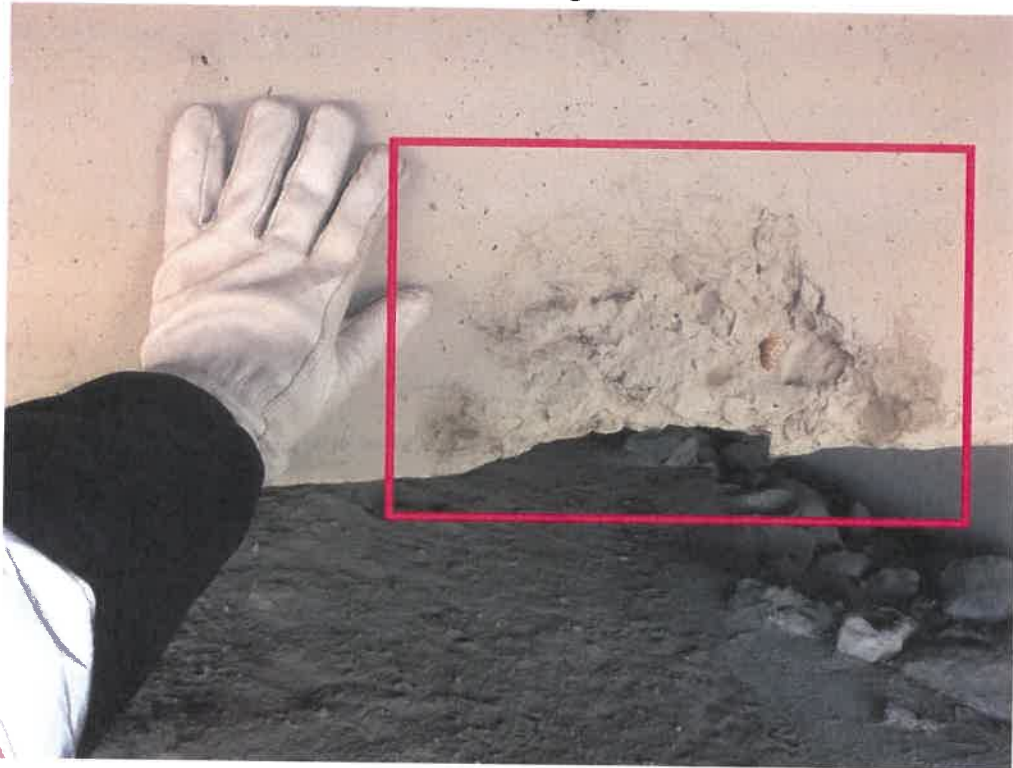
Photo No. 3

- girder 1 exhibits a spall 3 inches X 3 inches X 1 inch at west fascia at 15 feet from PW #10;
- girder 3 exhibits four spalls +/- 12 inches X 5 inches X 2 inch at west fascia; (see the attached photo no. 3)
- girder #9 exhibits two spalls 5 inches X 5 inches X 1 inch at 5 feet north from intermediate diaphragm at both faces; and
- girder #10 exhibits a spall 5 inches X 6 inches X 1 inch at 5 feet north from intermediate diaphragm at west face.

Spalls 12 in X 5 in. X 2 in.at G#9 at span 9.

RecDate: 12/31/2017	EstCost:	Patch all the spalls at the concrete
Action : Super-Patch spalls	StrTarget: 2 YEARS	girders at span #9 that have several
Work By: LOCAL AGENCY	DistTarget:	spalls +/- 12 inches X 5 inches X 2
Status : PROPOSED	EA:	inches. (see the attached photo no. 3)

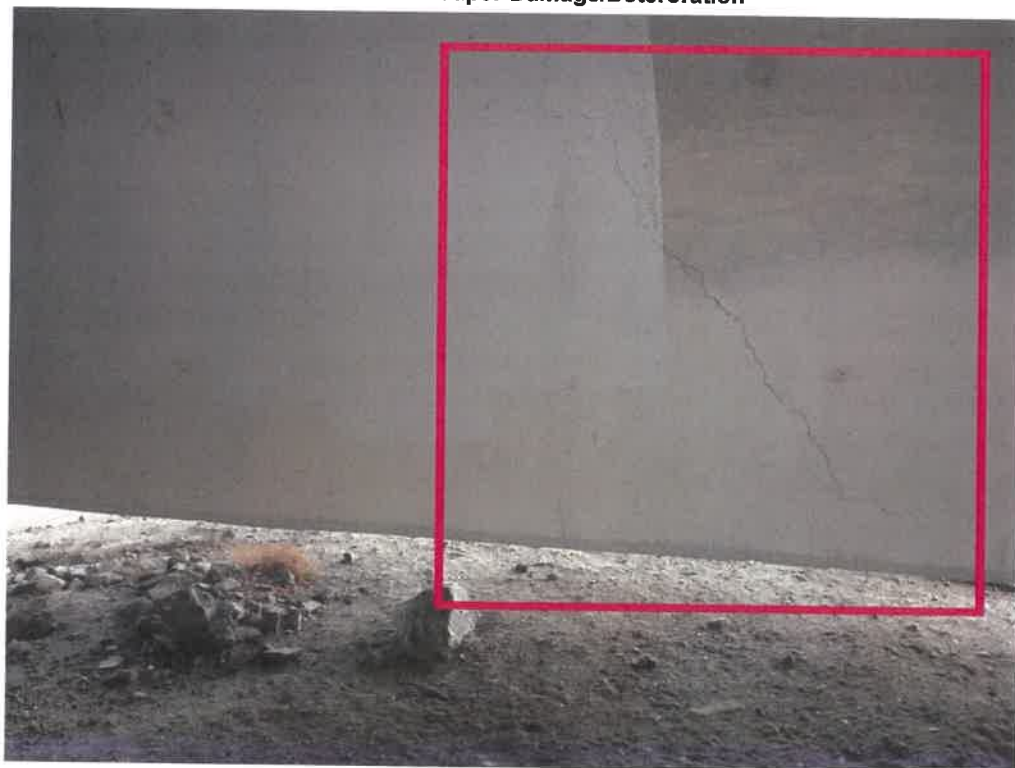
Photo No. 4

The concrete girders exhibit: (see the attached photo no. 4)

* in span 2: most original girders (south end) have few shear cracks (2 cracks at each girder) 0.04 inches wide;

* in span 9:

- 4 shear cracks (at each end) at each original girder , up to 0.04 inches wide;

* in span 10: girders 7, 8, 9 and 10 each has eight vertical cracks, up to 0.04 inches wide and 2.5 feet spaced apart mostly at the middle 2/3rd of the span.

* most original girders exhibit few shear cracks up to 0.03 inches wide at both ends.

Diagonal cracks at the RC girders, up to 0.04 inches wide.
