**DEPARTMENT OF TRANSPORTATION**  
Structure Maintenance & Investigations

Bridge Number : 55C0148  
Facility Carried: WARNER AVENUE  
Location : 0.1 MI W/O HARBOR BLVD  
City :  
Inspection Date : 06/28/2017

**Bridge Inspection Report**

**STRUCTURE NAME:** SANTA ANA RIVER CHANNEL (WARNER AVE)

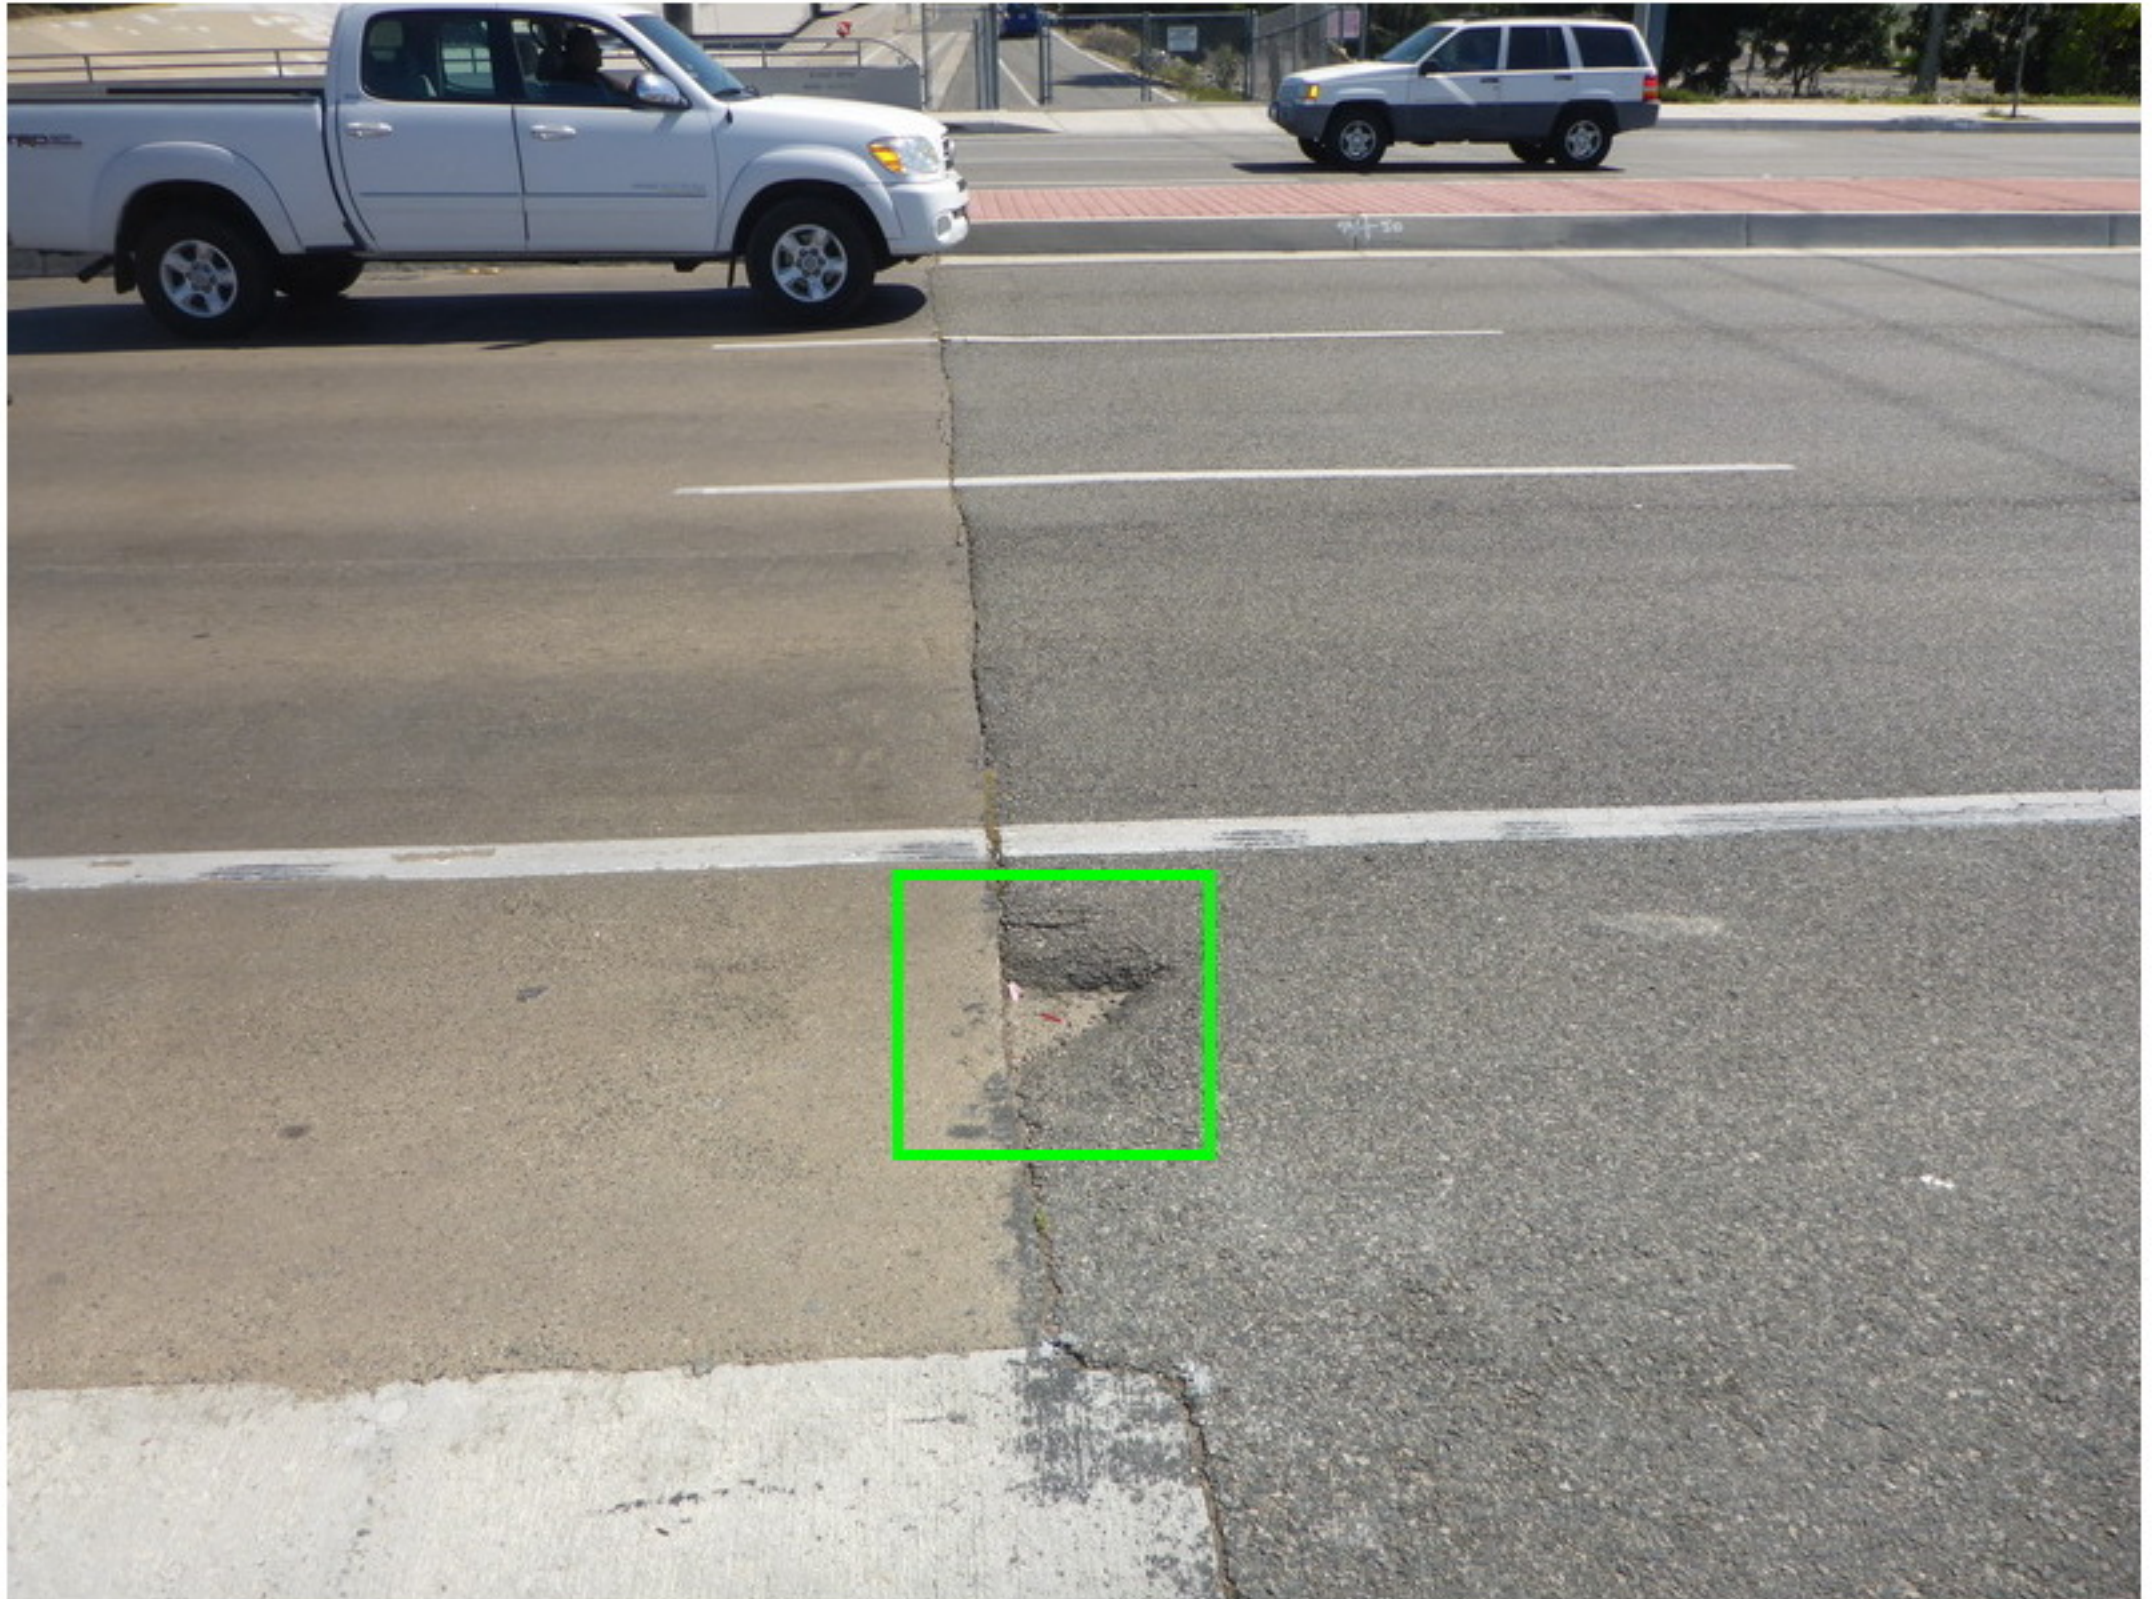
Photo No. 1

The roadway at the east side roadway of eastbound lanes has a pothole 1.5 feet X 1 foot X 3 inches at the south shoulder. (see the attached photos no. 1 to 3)

AC roadway at the outh shoulder EB llanes has a pothole 1.5 ft X 1 ft X 3 inches.

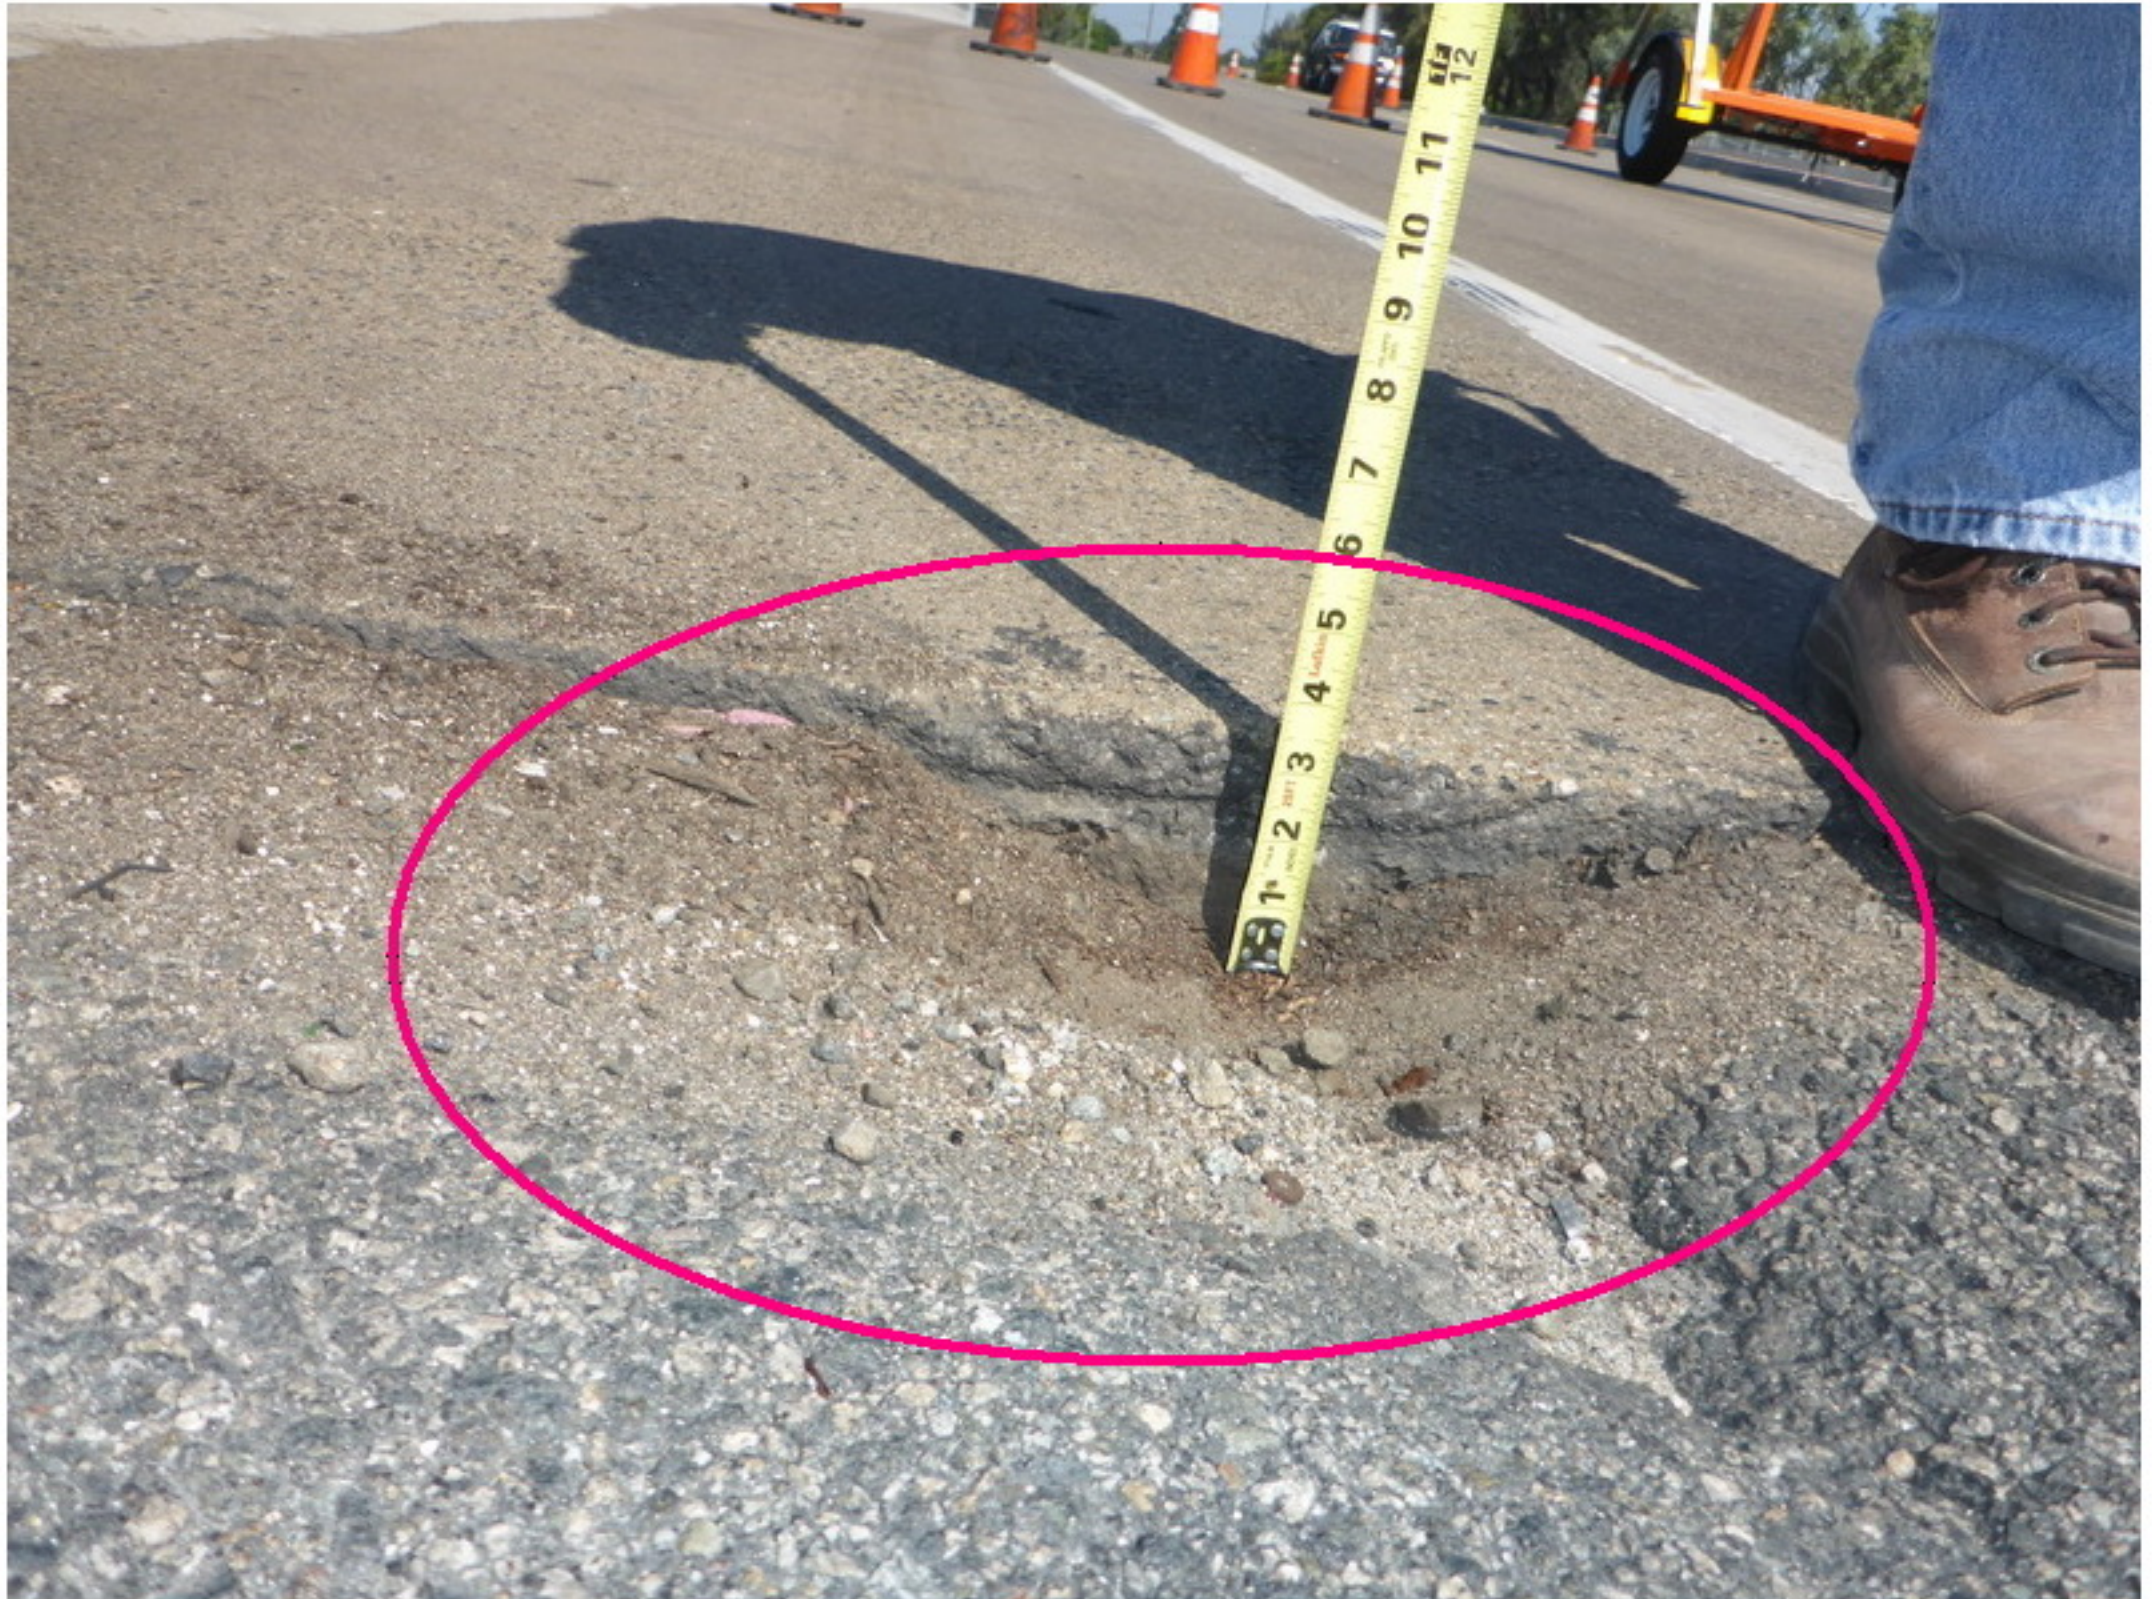
Photo No. 2

AC roadway at the outh shoulder EB llanes has a pothole 1.5 ft X 1 ft X 3 inches.

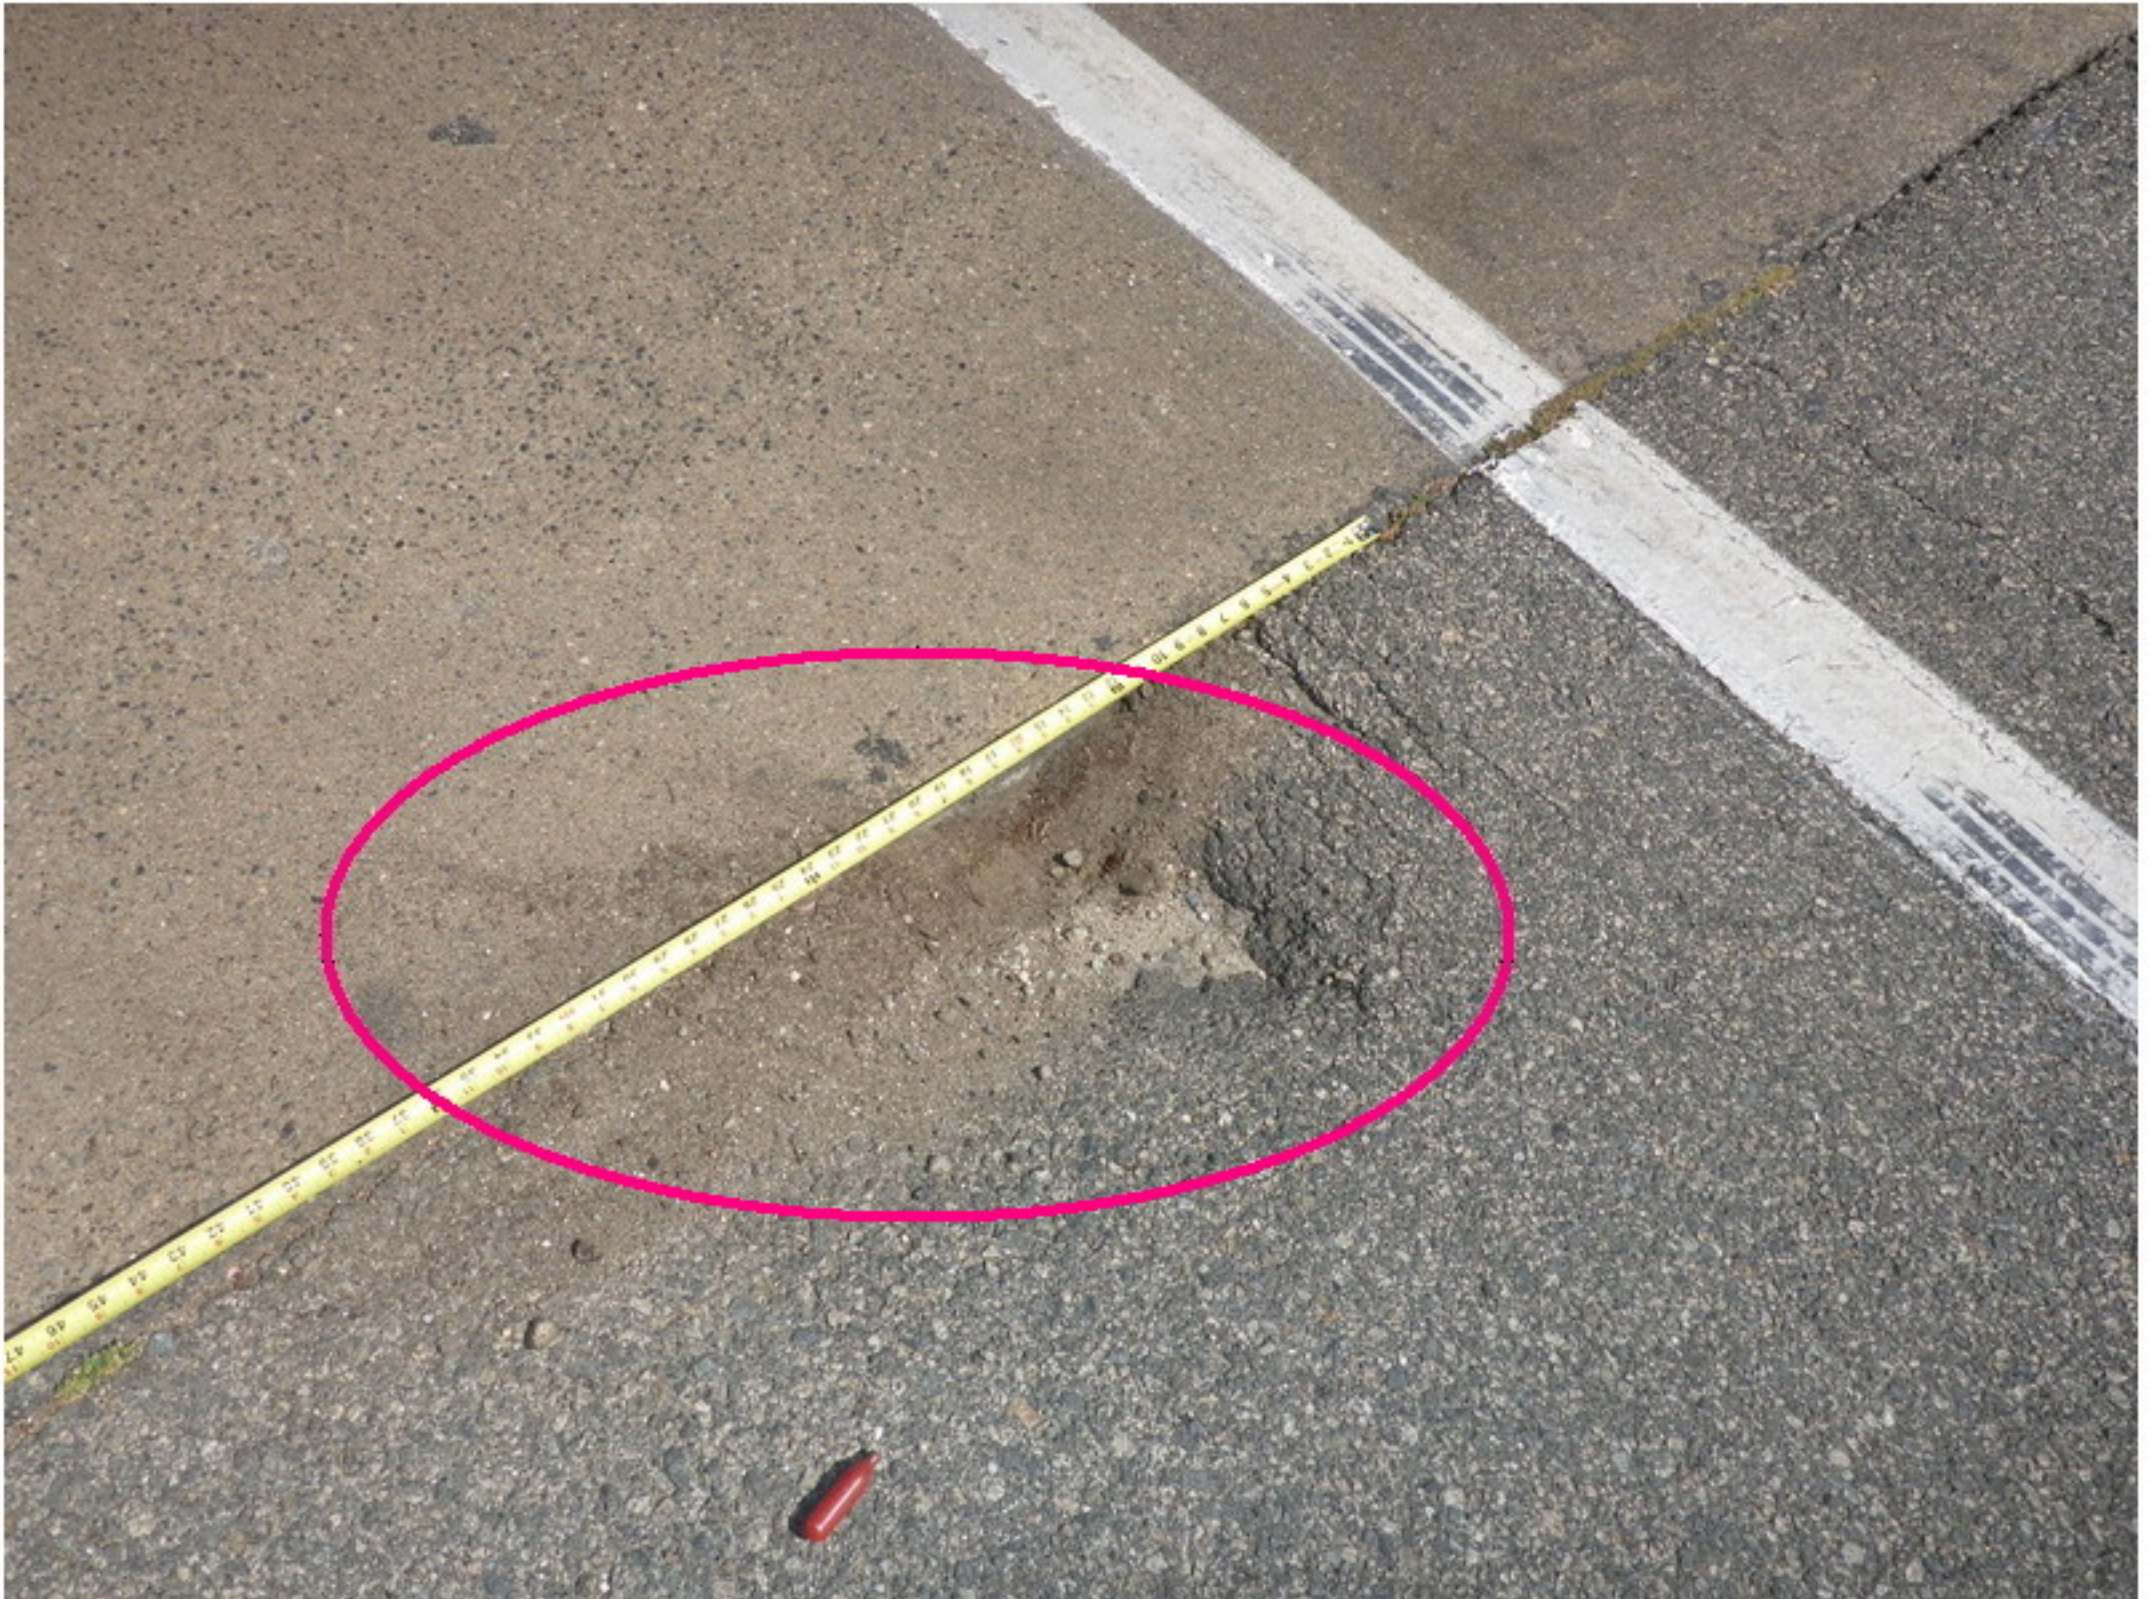
Photo No. 3

AC roadway at the outh shoulder EB lanes has a pothole 1.5 ft X 1 ft X 3 inches.

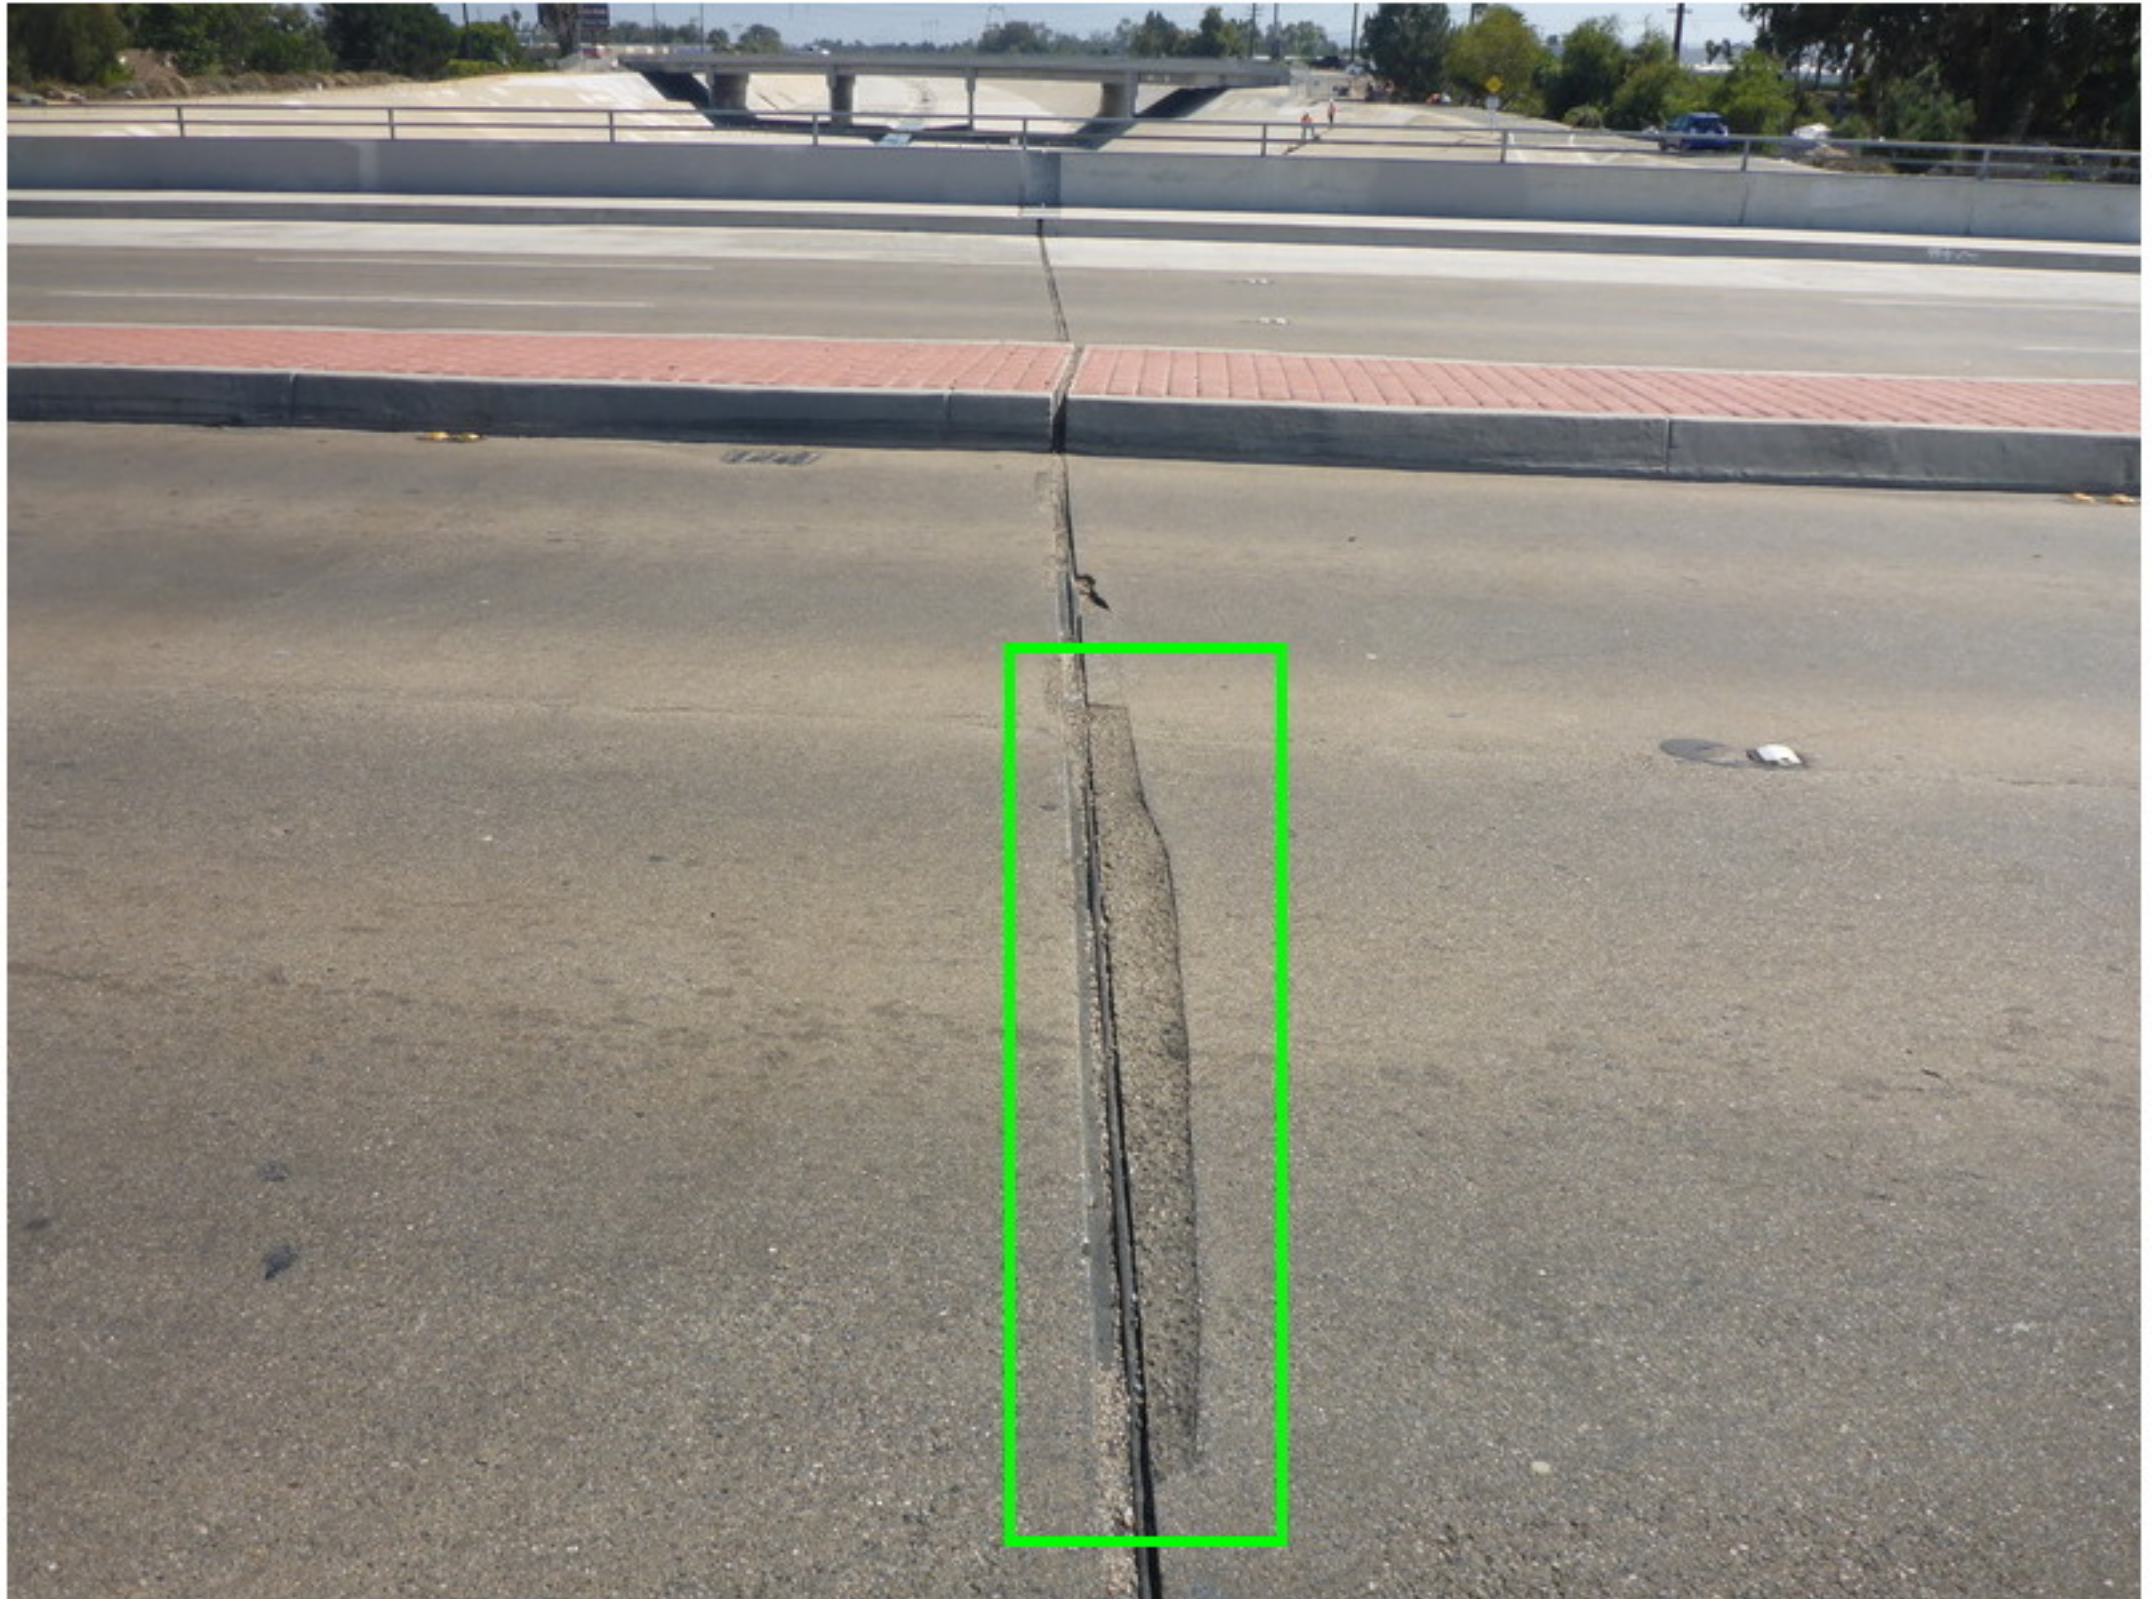
Photo No. 4  
Polyester spall at joint 5.

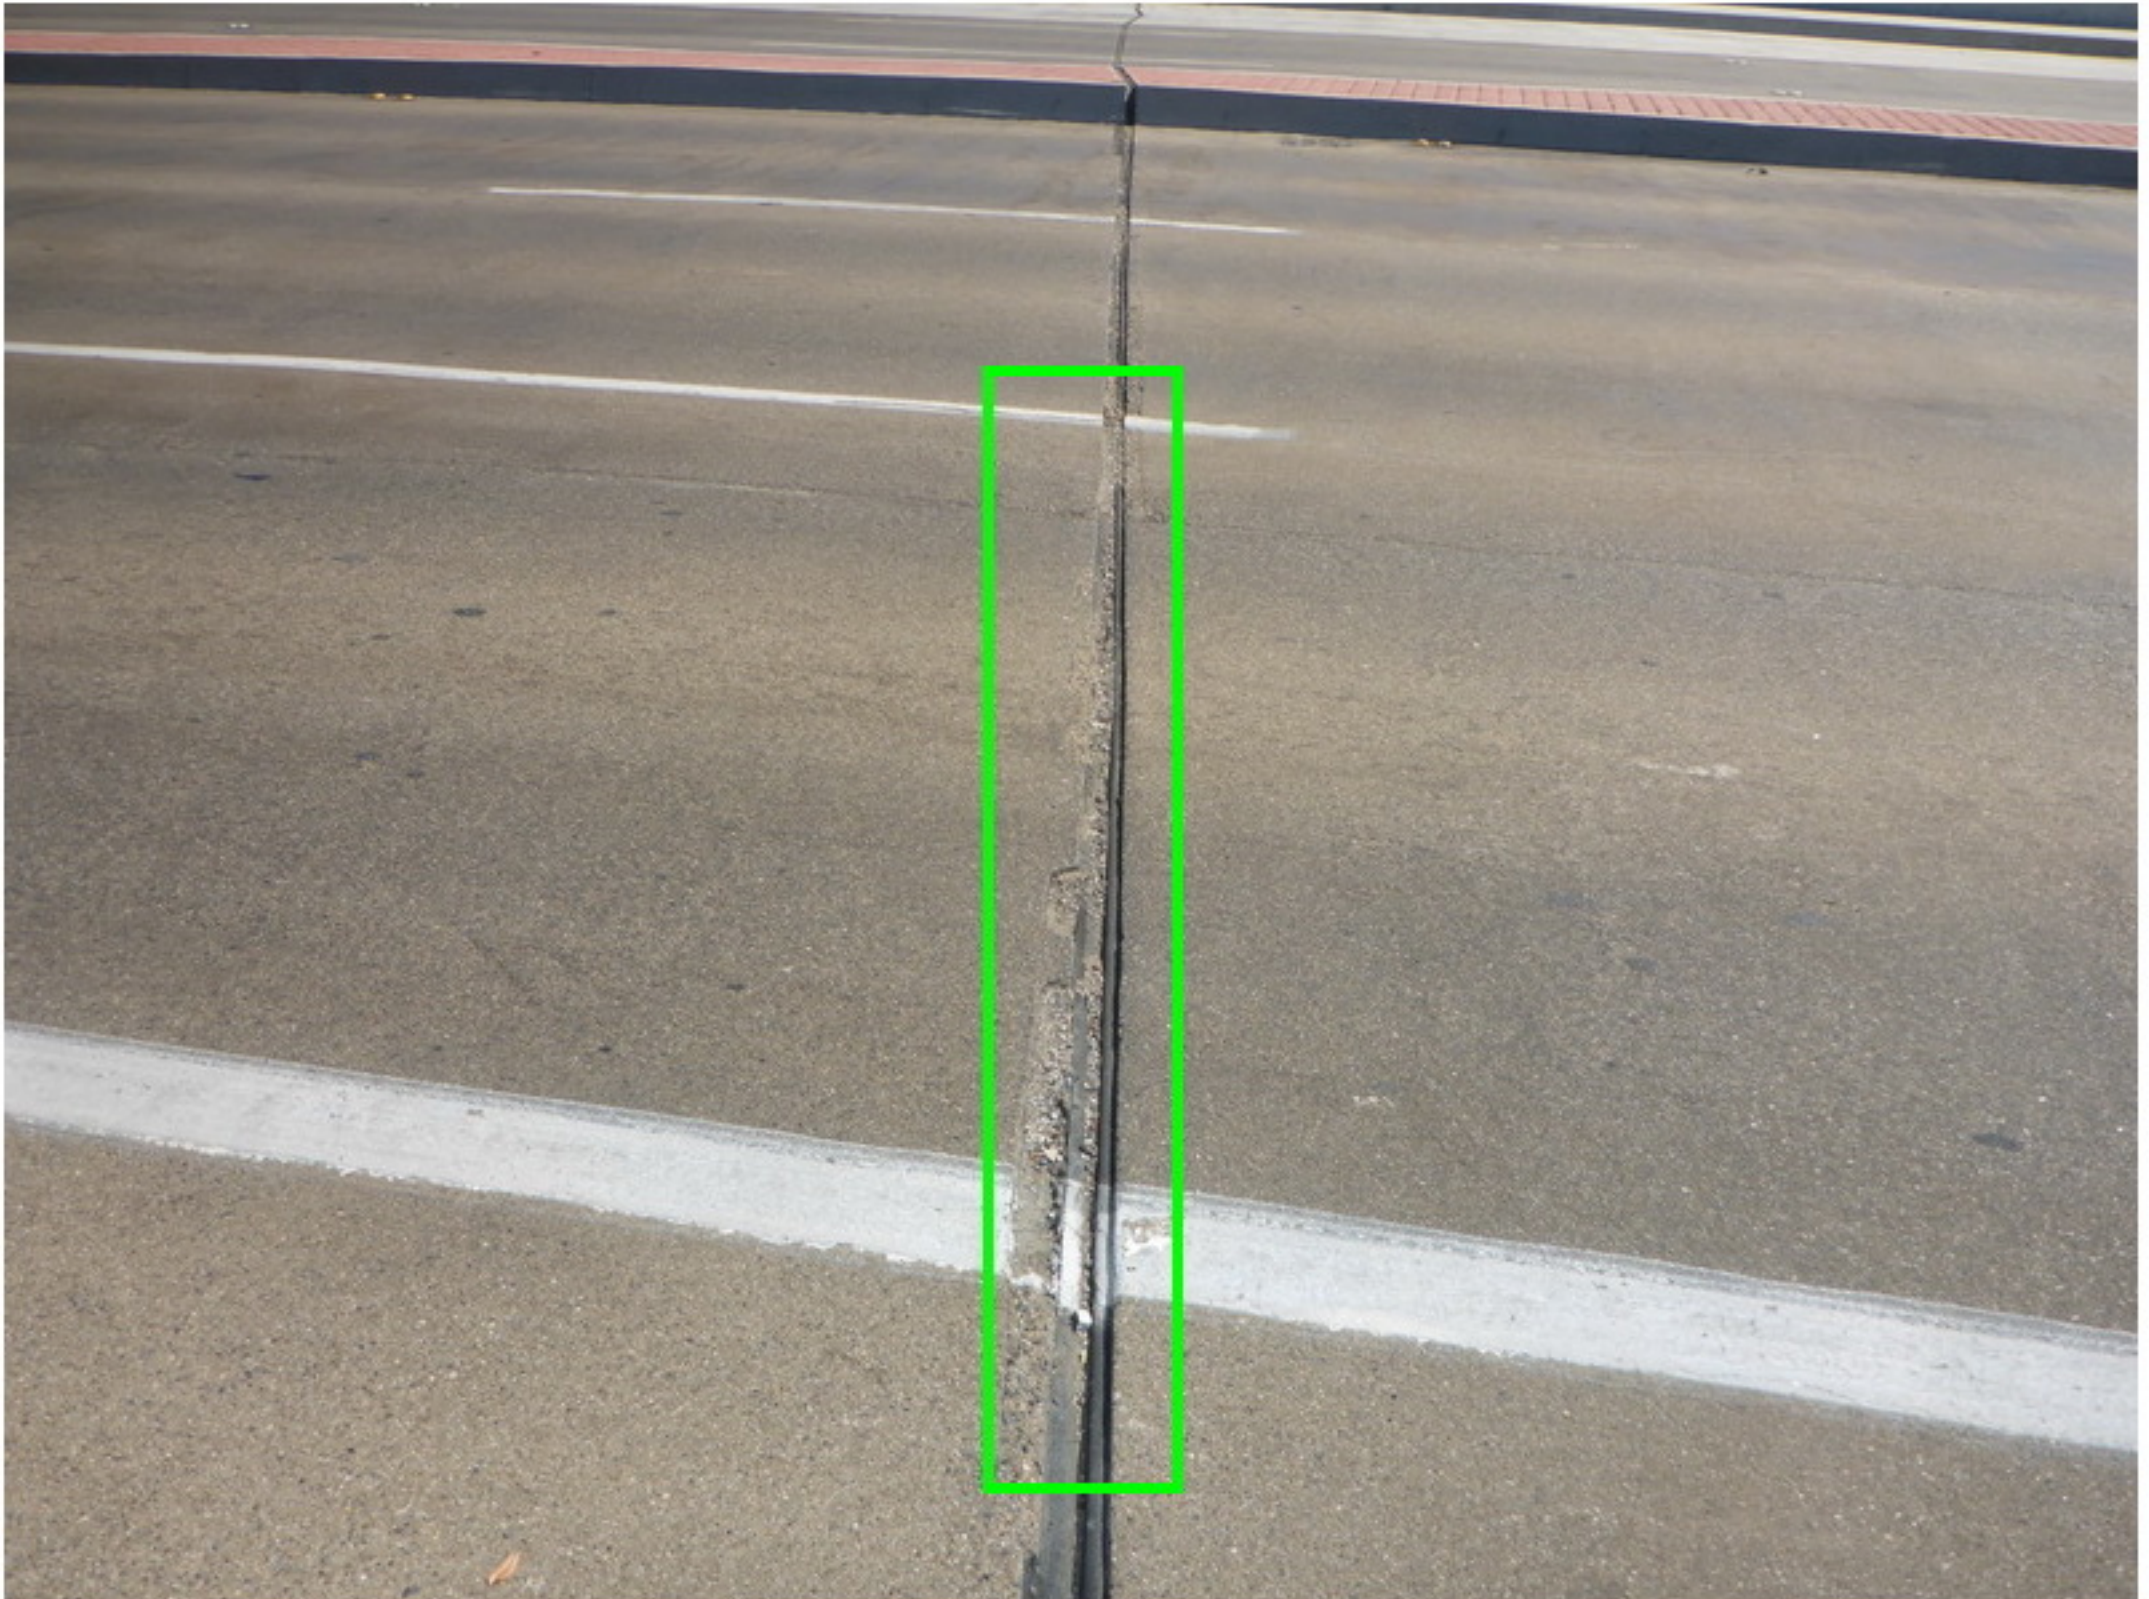
Photo No. 5  
Polyester spall at joint 2.

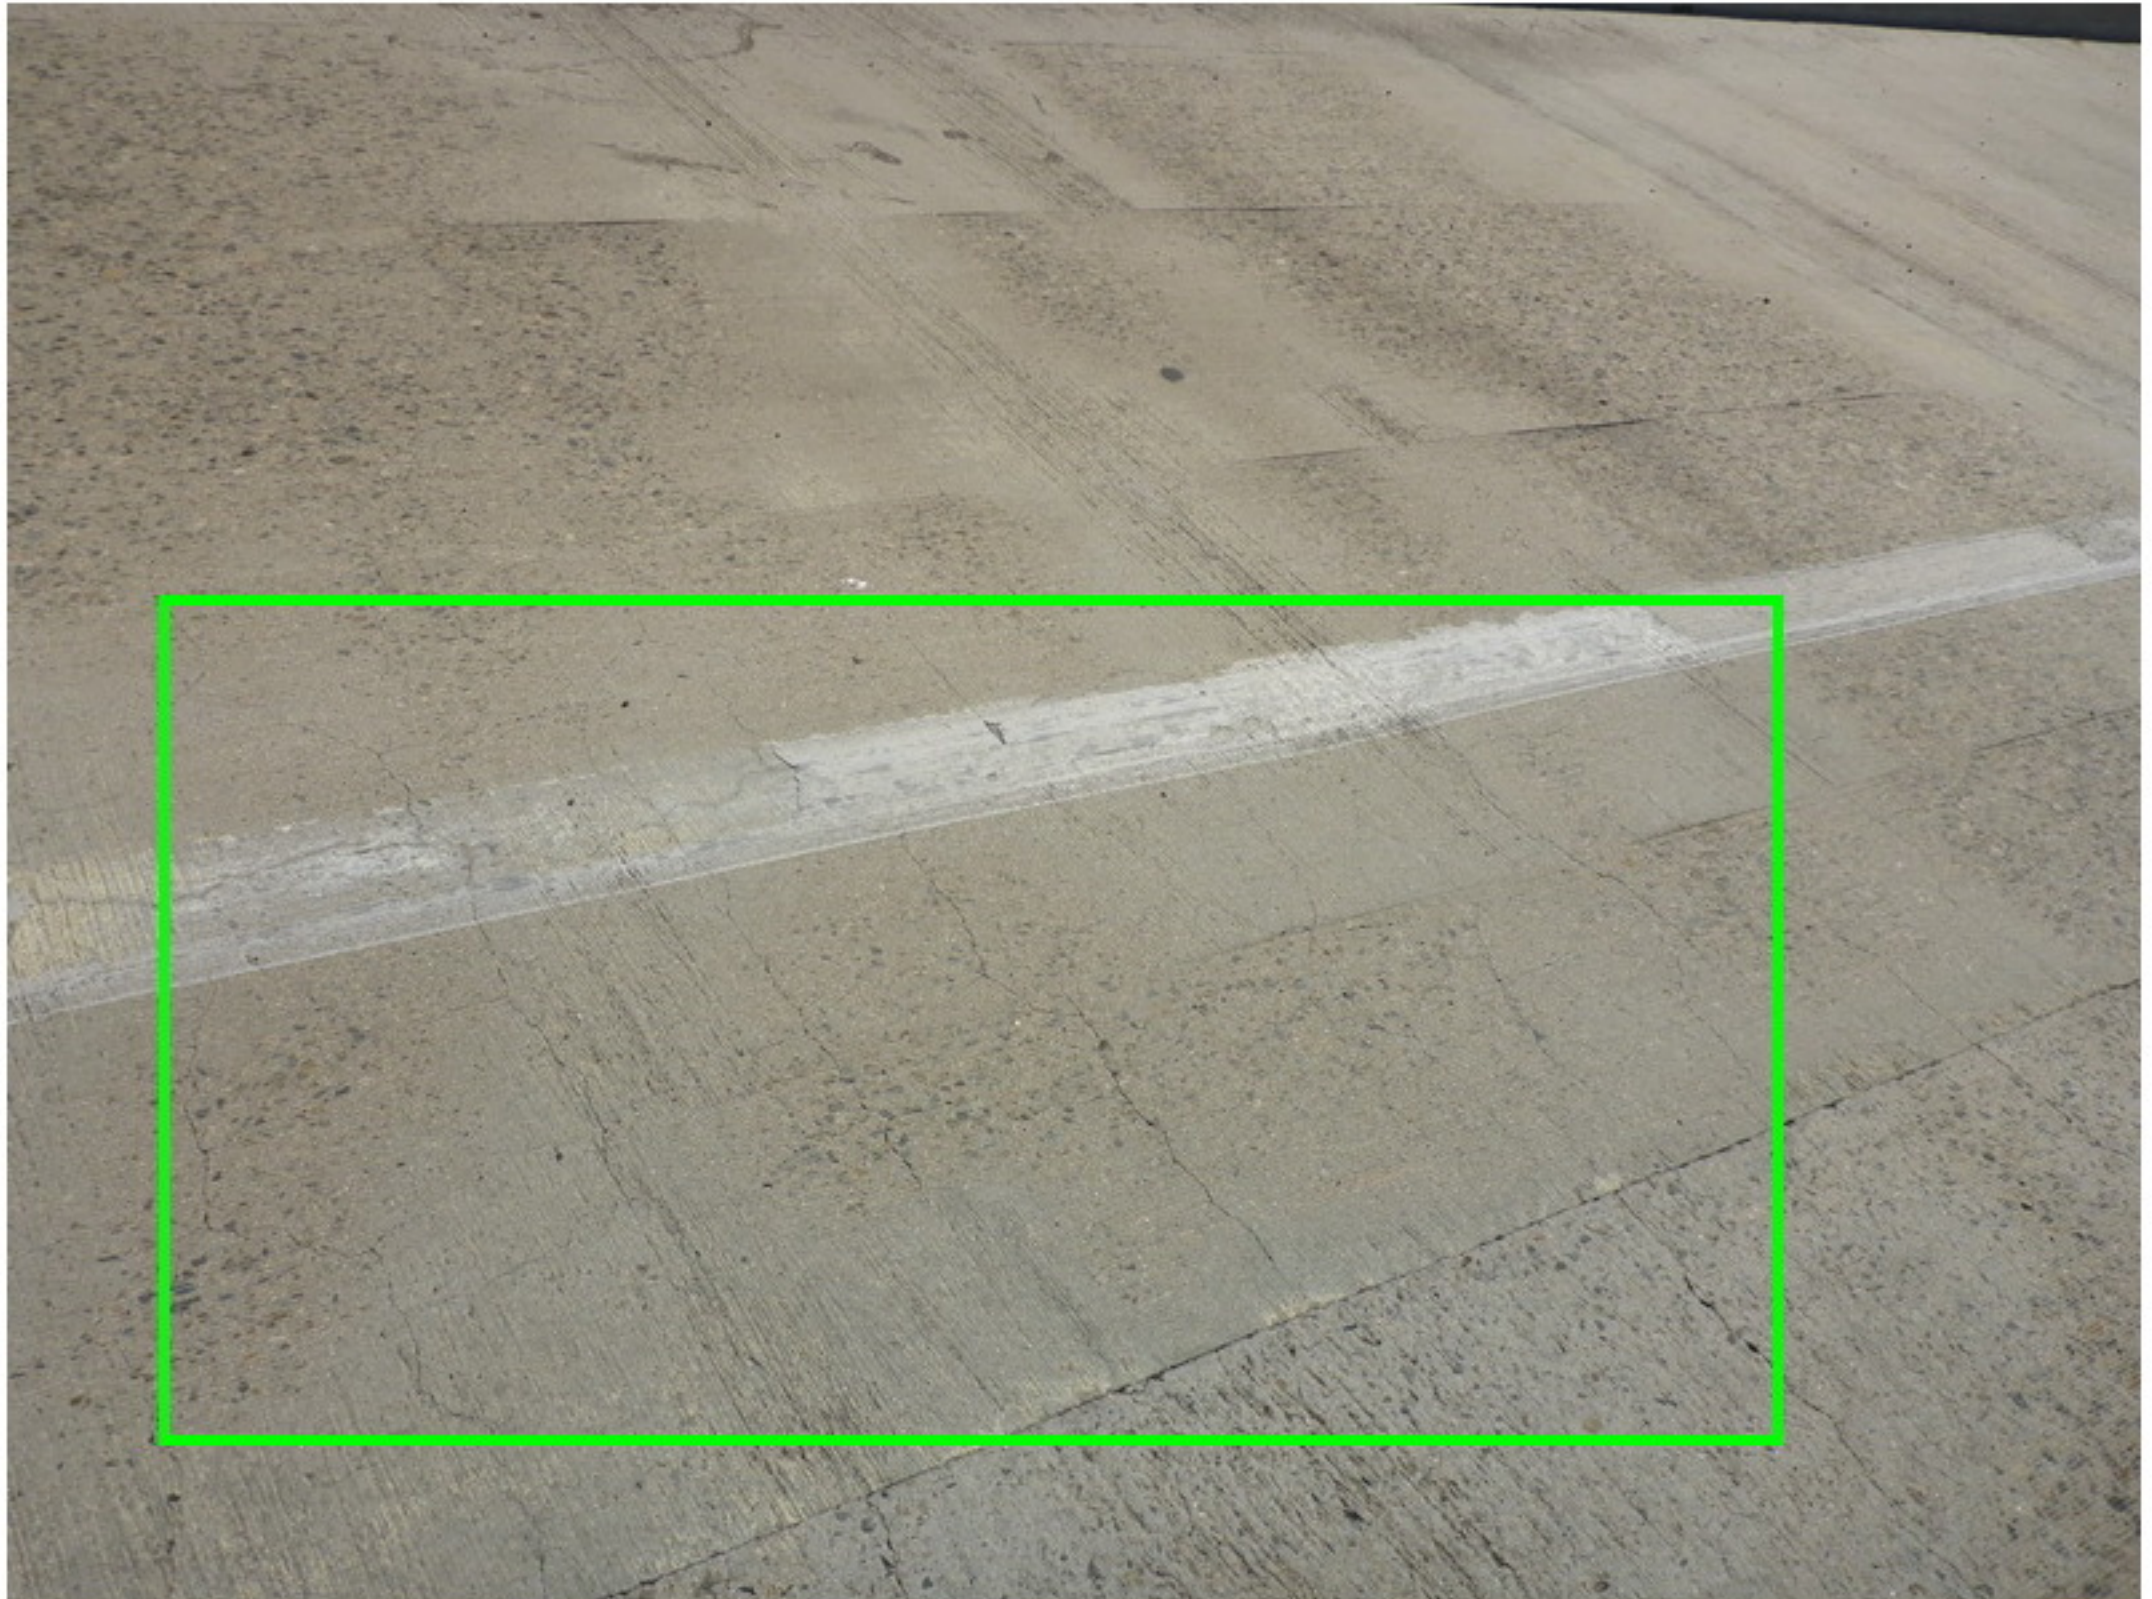
Photo No. 6

Deck transverse cracks.
