**DEPARTMENT OF TRANSPORTATION**  
Structure Maintenance & Investigations

Bridge Number : 55C0148  
Facility Carried: WARNER AVENUE  
Location : 0.1 MI W/O HARBOR BLVD  
City :  
Inspection Date : 06/28/2017

**Bridge Inspection Report**

**STRUCTURE NAME:** SANTA ANA RIVER CHANNEL (WARNER AVE)

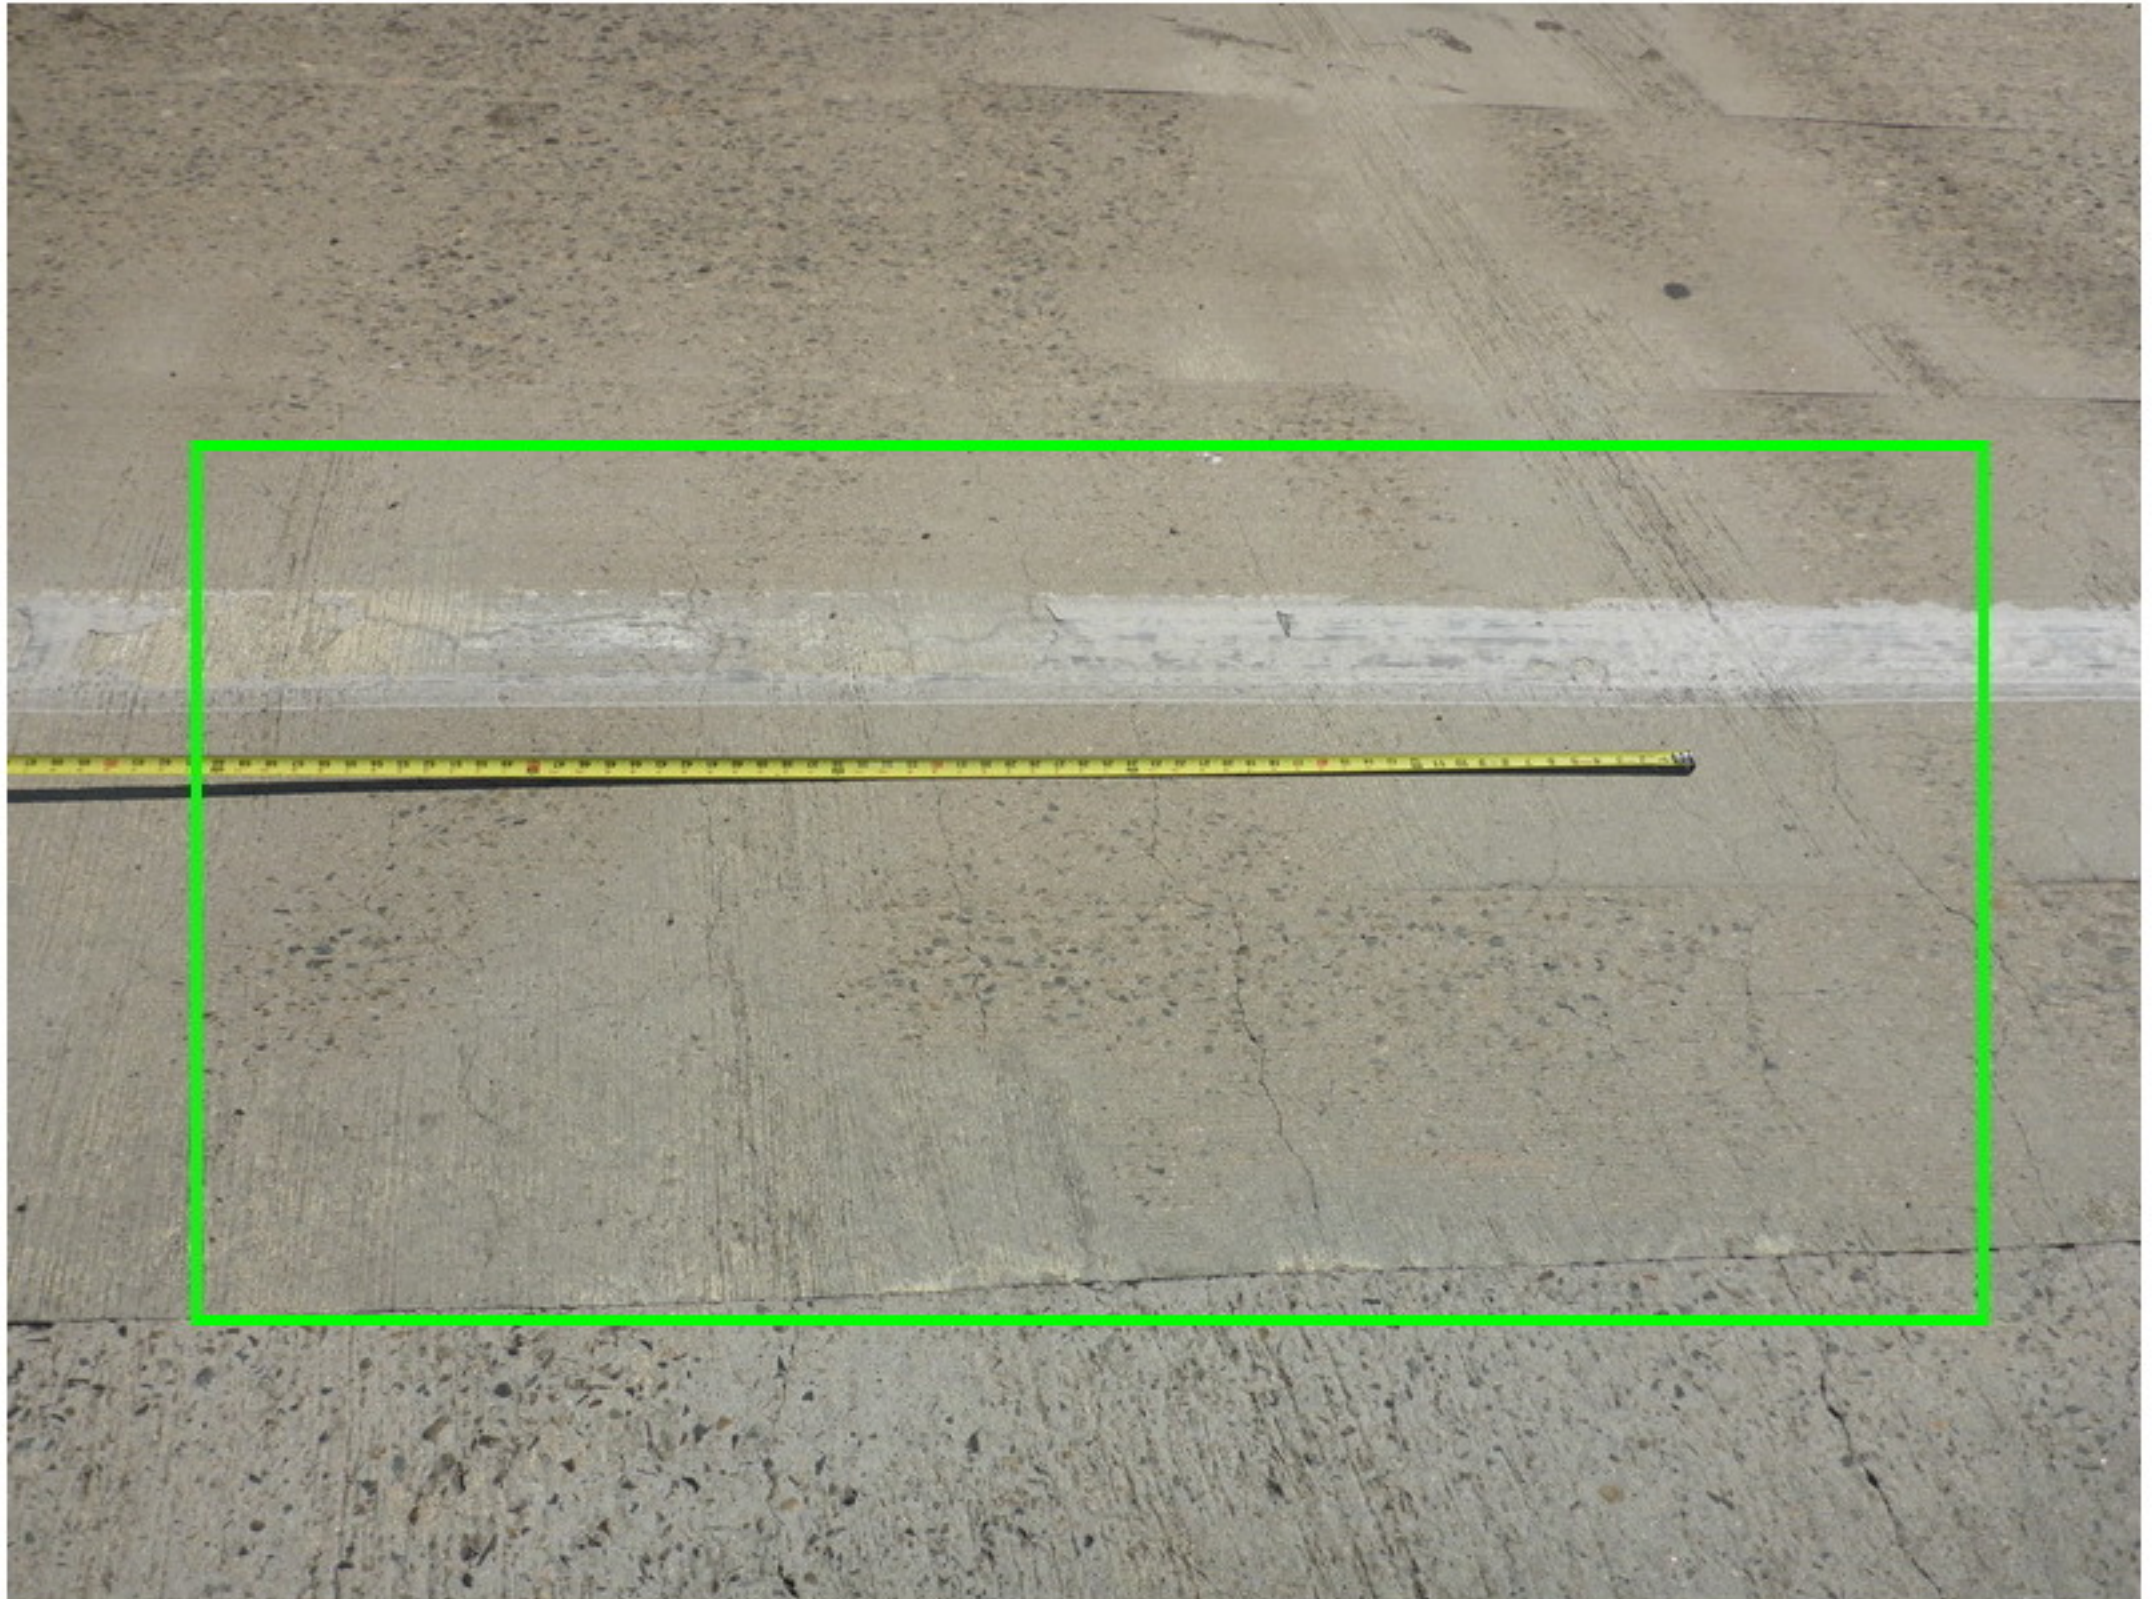
Photo No. 7

Deck transverse cracks.

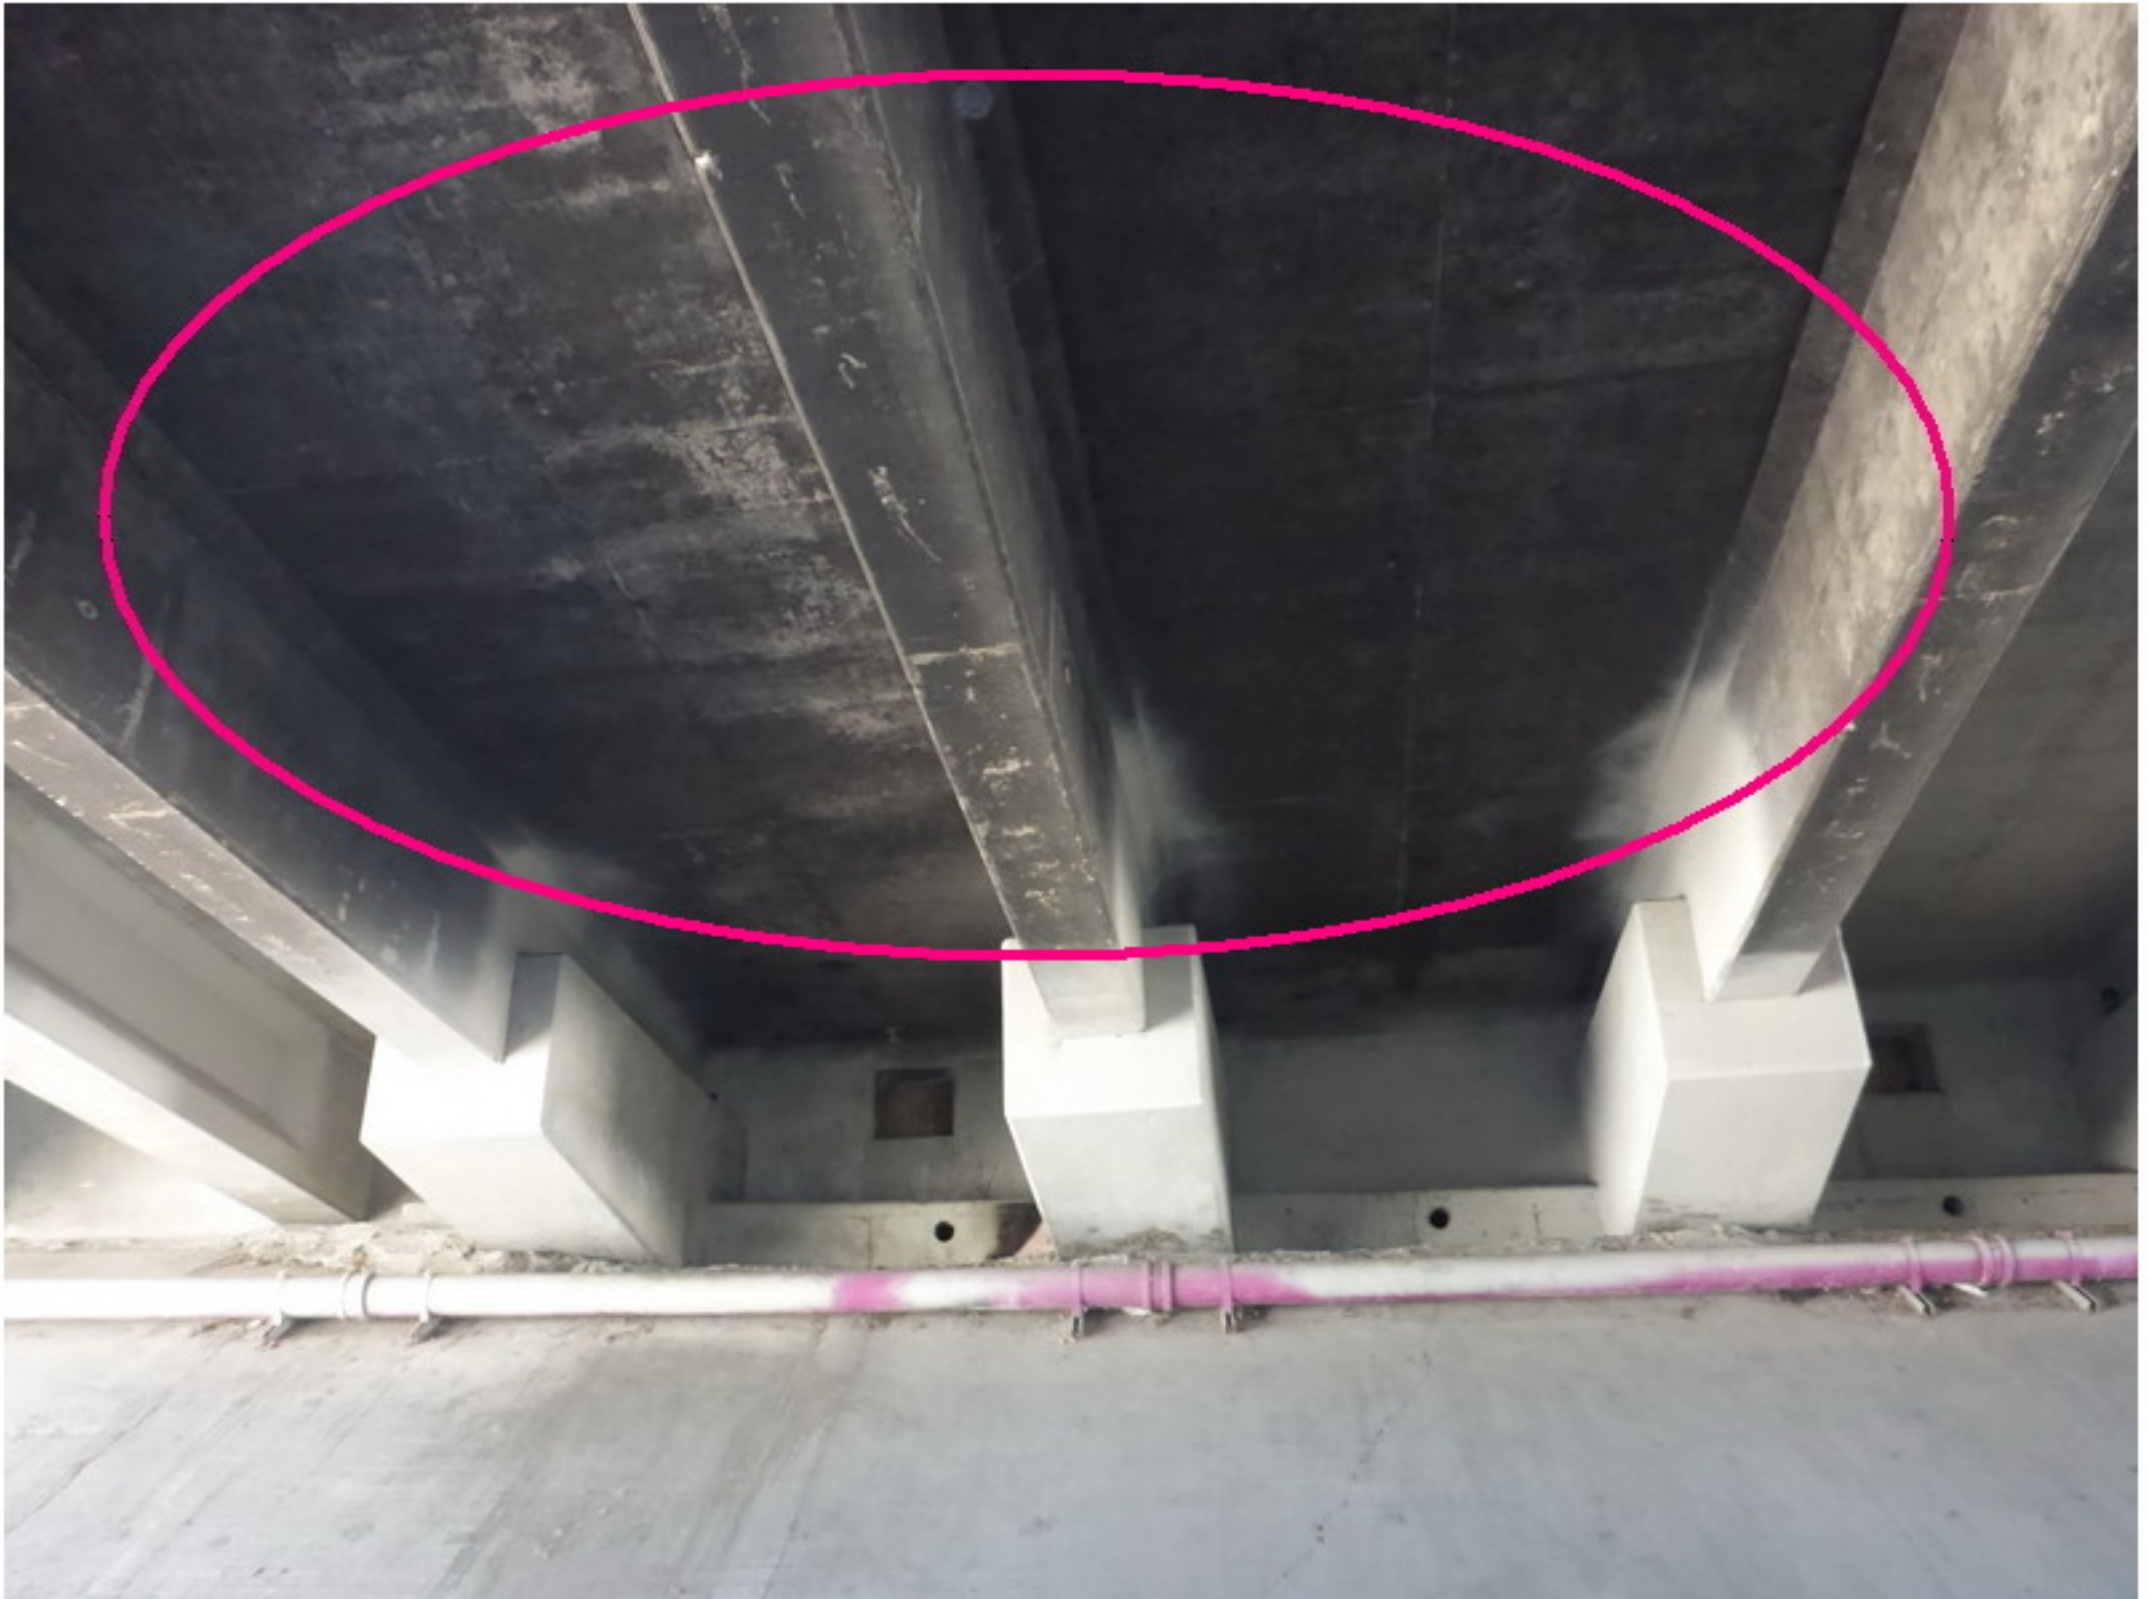
There is soot at the concrete girders at the west span, using the binocular there is no visible damaged noted.

Photo No. 8  
Soot is noticed at the westerly span under the RC girders.

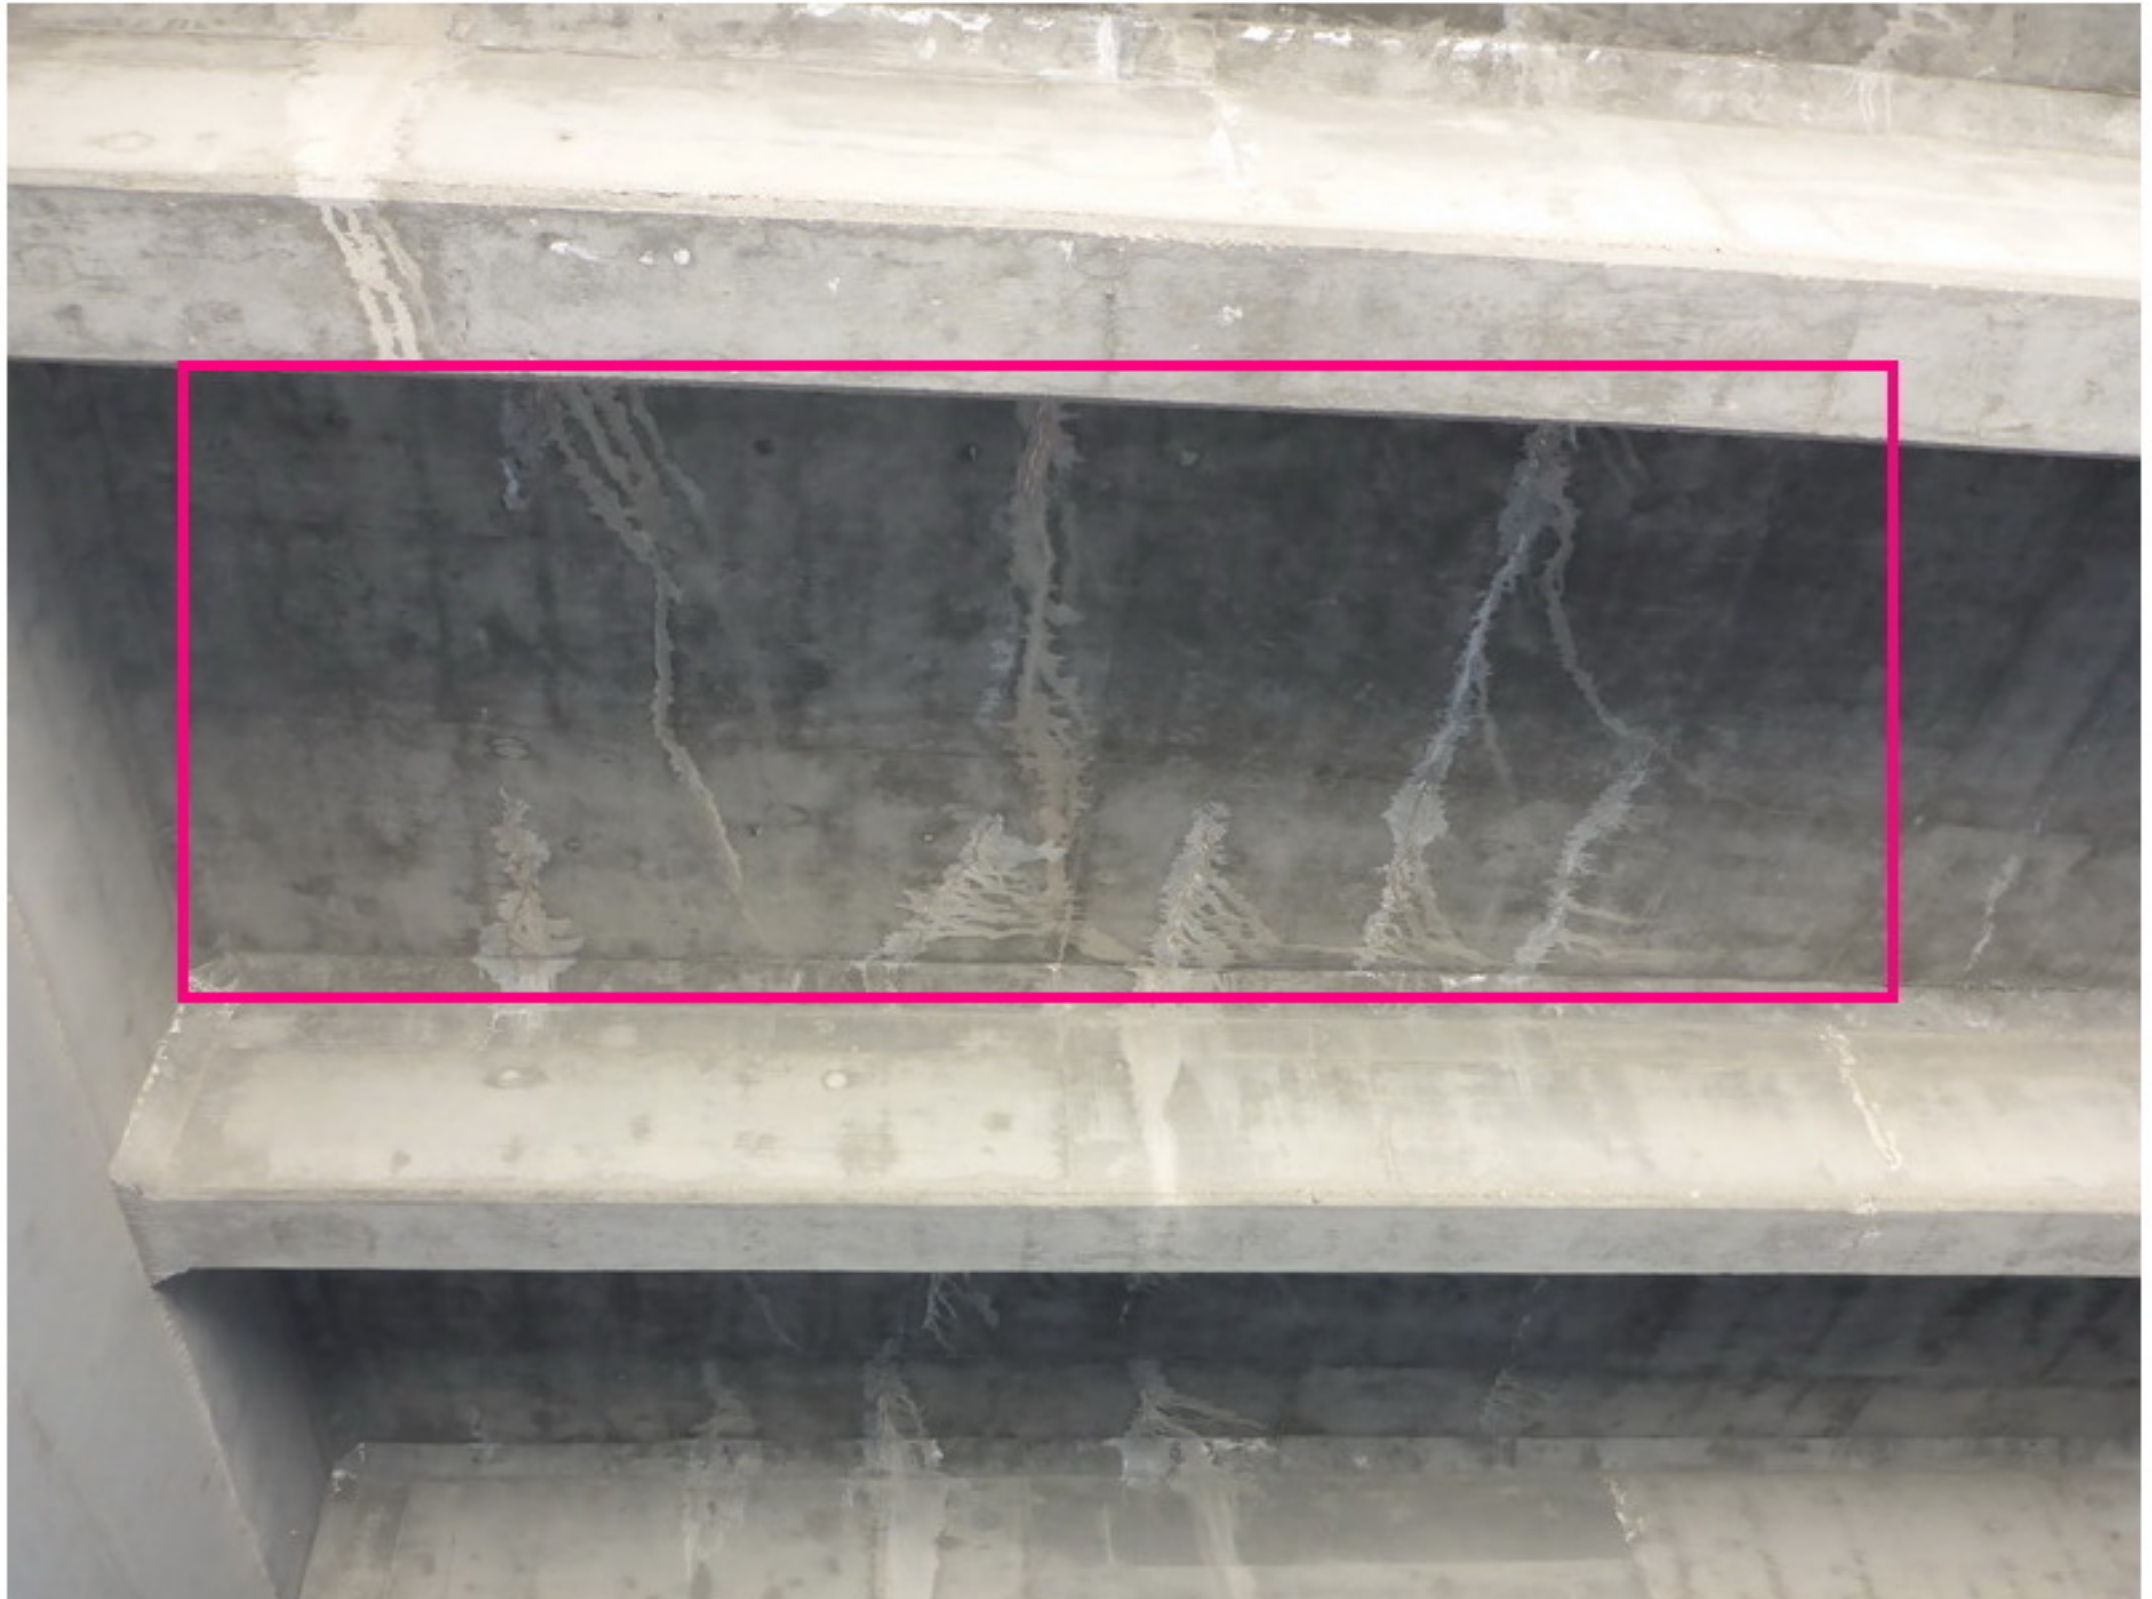
Photo No. 9

(16)										
There were no significant defects noted.										
(16-1120)										
The soffit of the original portion exhibits transverse cracks with white efflorescence at few bays in all spans.										
(16-511)

Transverse cracks with white efflorescence at the soffit, mainly at the original portion.
