**Bridge Report Transmittal Sheet****Batch 39621****County of Orange**

Bridge Number : 55C0148  
Facility Carried: WARNER AVENUE  
Location : 0.1 MI W/O HARBOR BLVD  
City :  
Inspection Date : 06/28/2017

**Bridge Inspection Report**

**STRUCTURE NAME: SANTA ANA RIVER CHANNEL (WARNER AVE)**

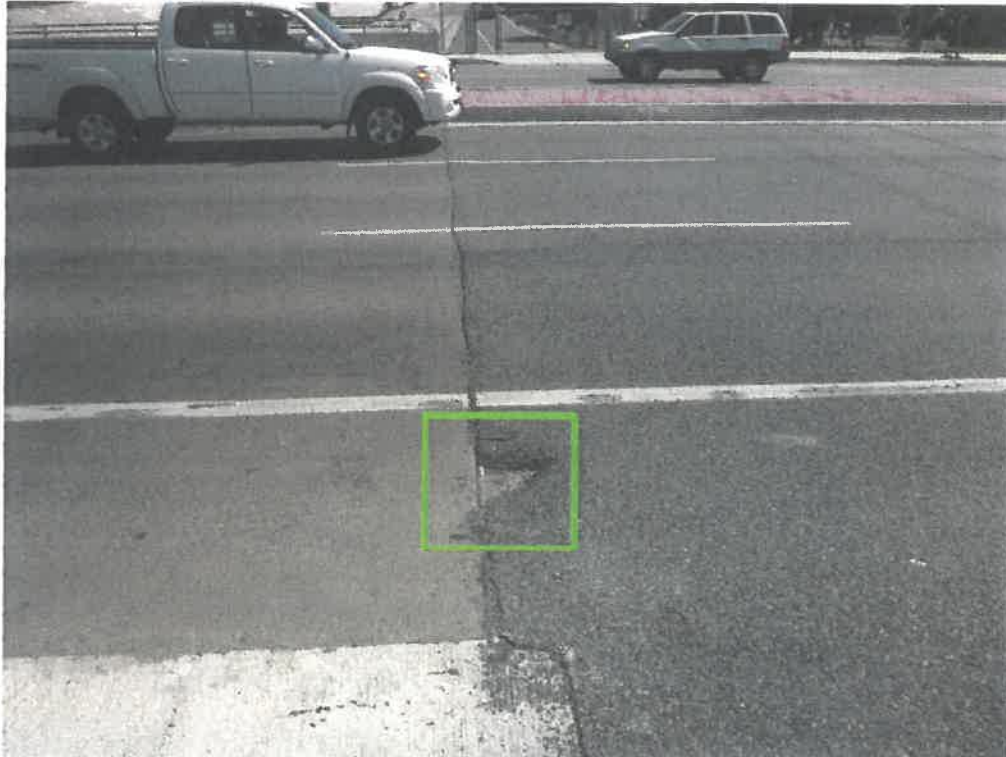
Photo No. 1

The roadway at the east side roadway of eastbound lanes has a pothole 1.5 feet X 1 foot X 3 inches at the south shoulder. (see the attached photos no. 1 to 3)

AC roadway at the outh shoulder EB llanes has a pothole 1.5 ft X 1 ft X 3 inches.

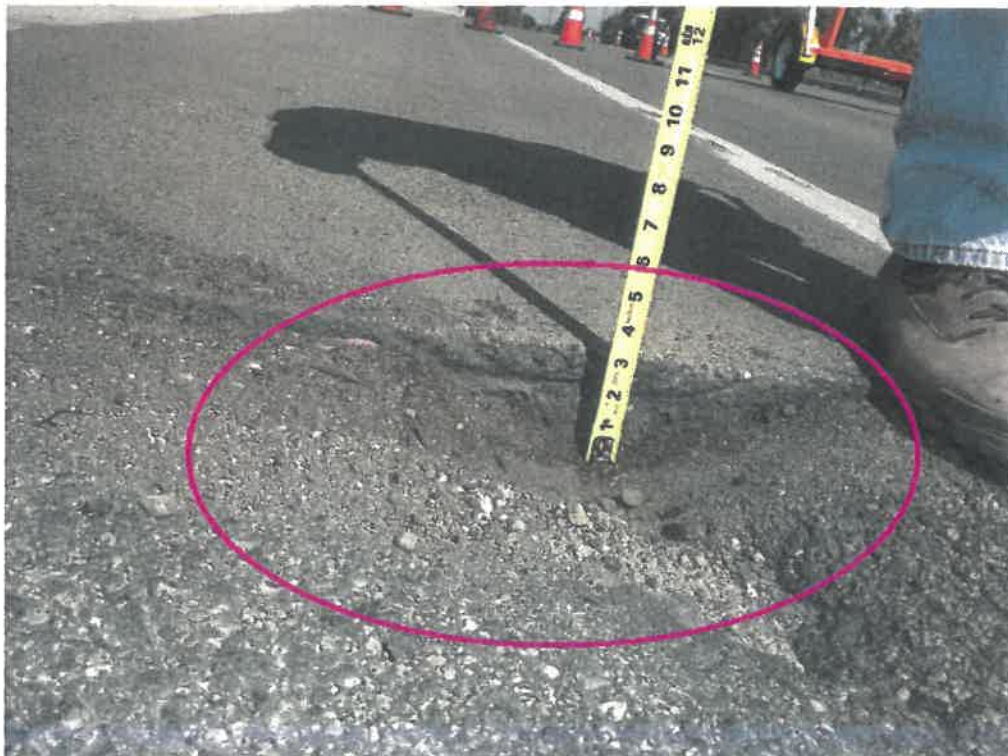
Photo No. 2

AC roadway at the outh shoulder EB llanes has a pothole 1.5 ft X 1 ft X 3 inches.

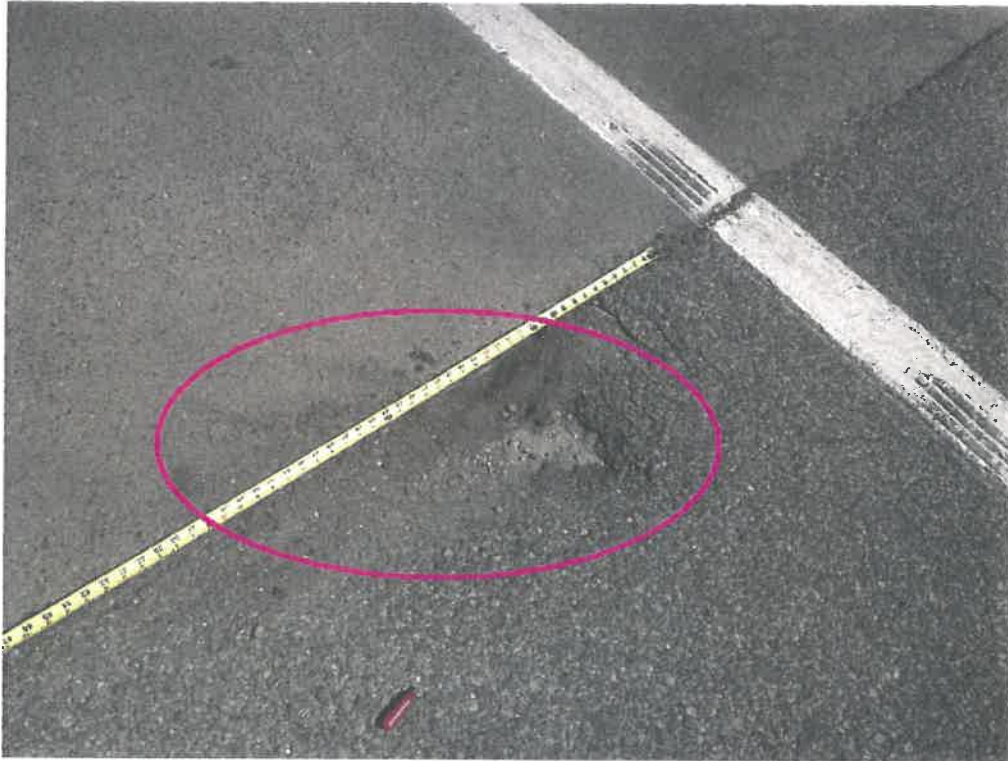
**Photo No. 3**

**AC roadway at the outh shoulder EB lanes has a pothole 1.5 ft X 1 ft X 3 inches.**

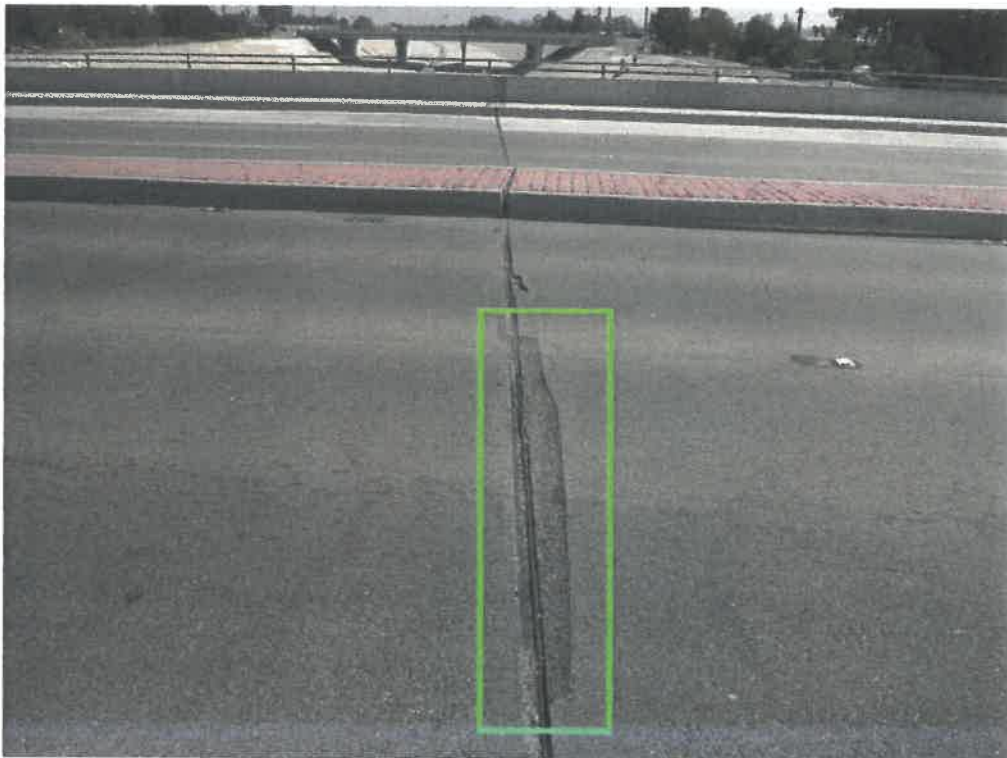
**Photo No. 4**

**Polyester spall at joint 5.**

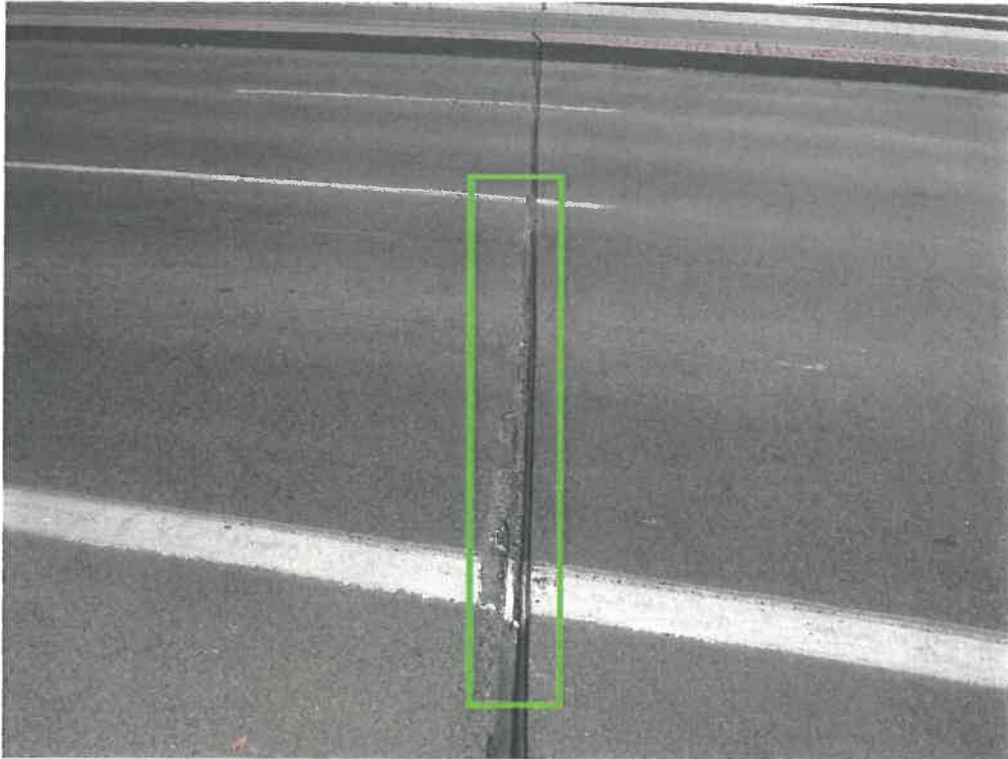
**Photo No. 5**  
**Polyester spall at joint 2.**

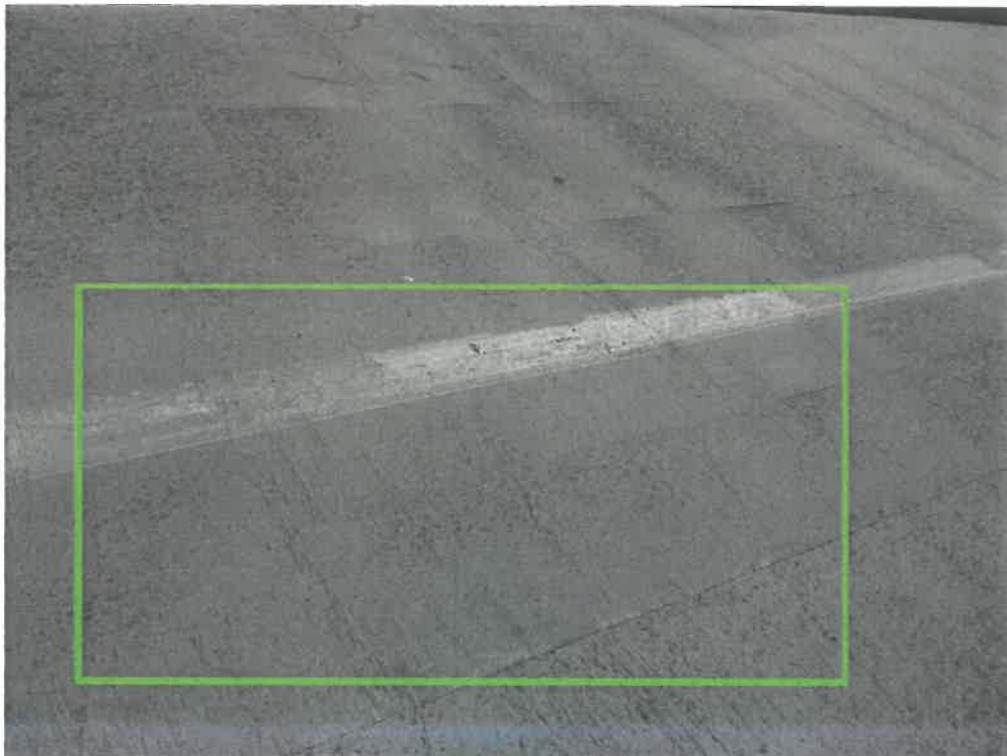
The concrete deck exhibits several cracks with 5-10 feet long, 1.00 foot spacing and up to 0.05 inches wide at westbound lane 3 and south shoulder. (see the attached photos no. 6 & 7)

**Photo No. 6**  
**Deck transverse cracks.**

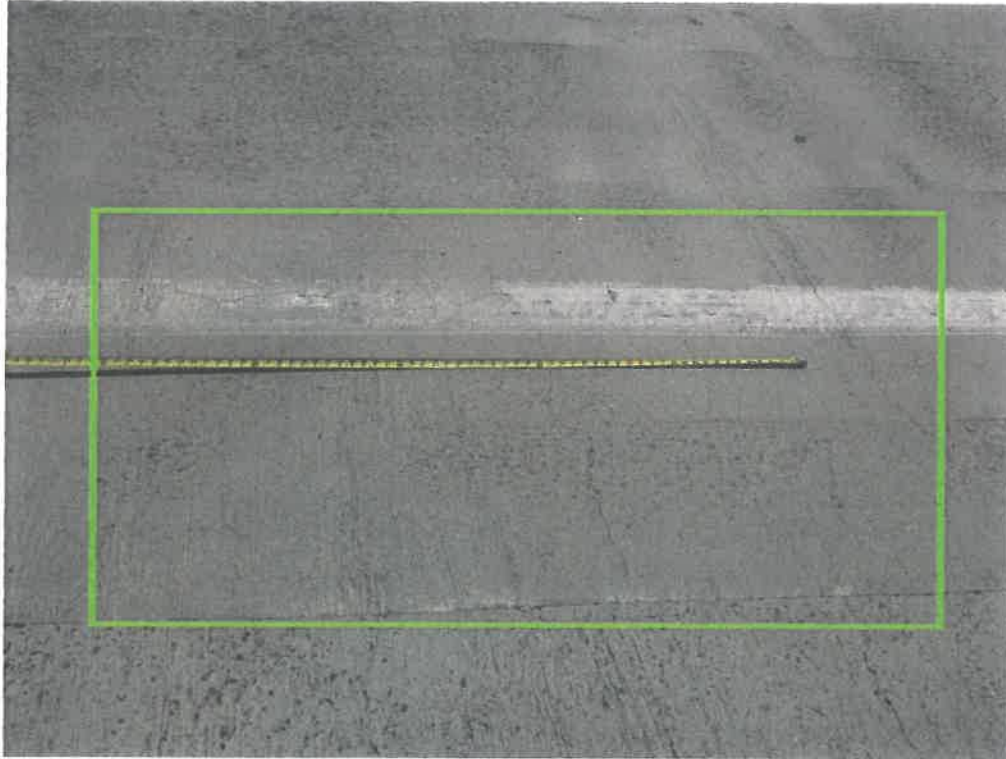
**Photo No. 7**

**Deck transverse cracks.**

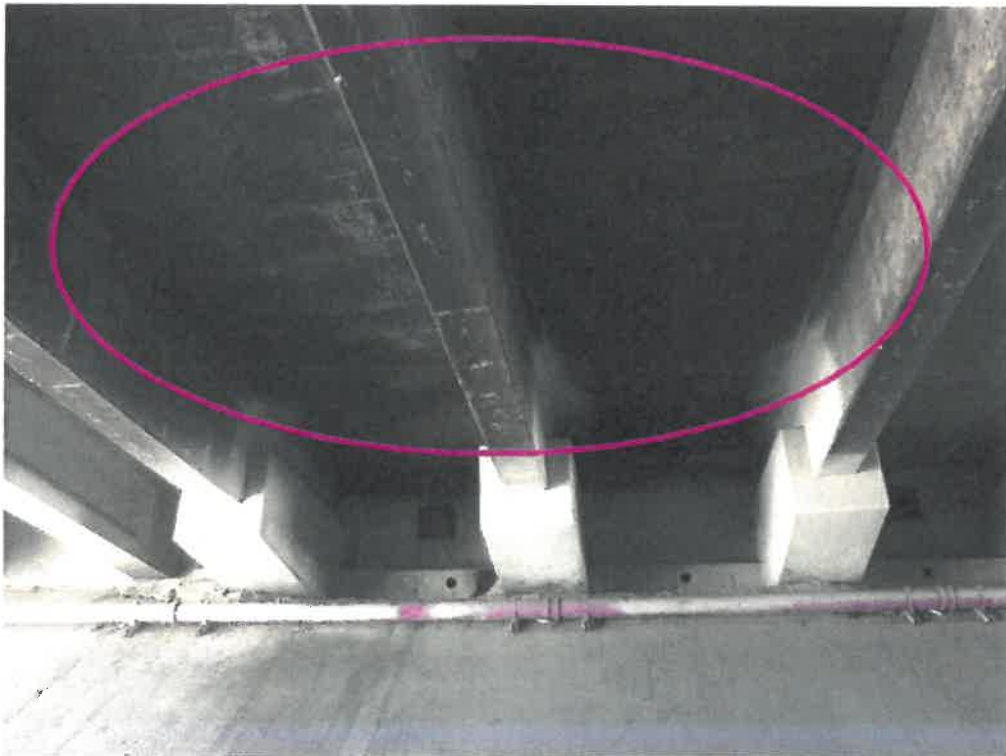
**Photo No. 8**

There is soot at the concrete girders at the west span, using the binocular there is no visible damaged noted.

**Soot is noticed at the westerly span under the RC girders.**

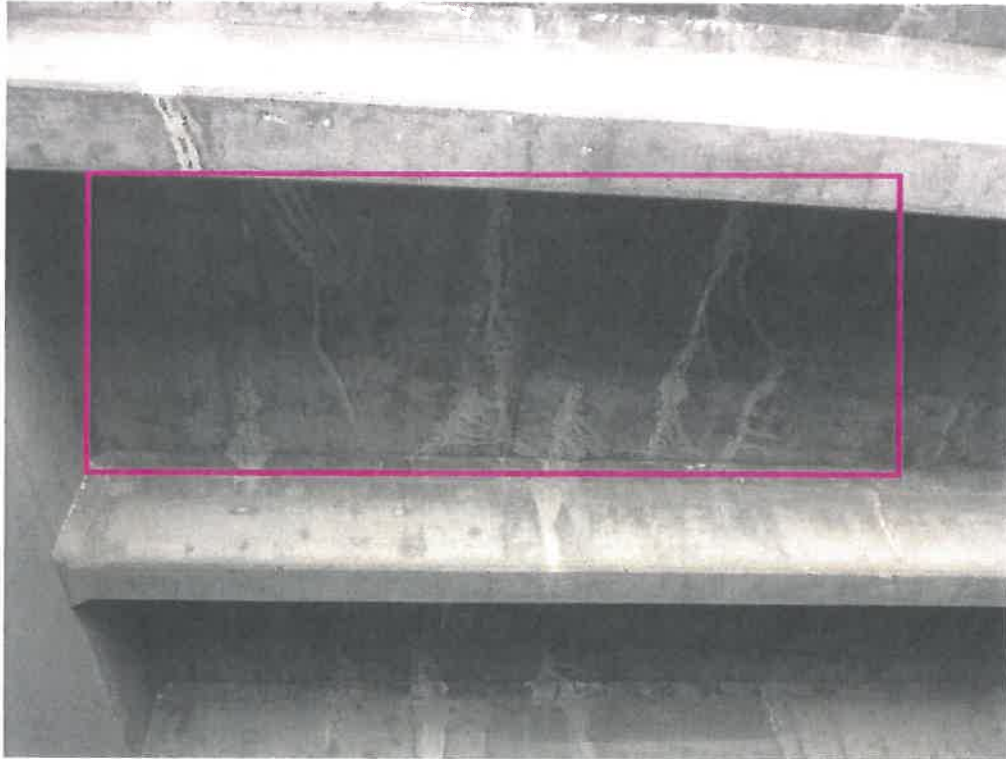
**Photo No. 9**

The soffit of the original portion exhibits transverse cracks with white efflorescence at few bays in all spans.

**Transverse cracks with white efflorescence at the soffit, mainly at the original portion.**
