**Bridge Number : 55C0154**  
**Facility Carried:** EDINGER AVENUE  
**Location :** 0.3 MI. E/O HARBOR BLVD  
**City :**  
**Inspection Date :** 12/24/2018

## Bridge Inspection Report

**STRUCTURE NAME:** SANTA ANA RIVER CHANNEL (EDINGER AVE)

# **SANTA ANA RIVER CHANNEL (EDINGER AVE)**

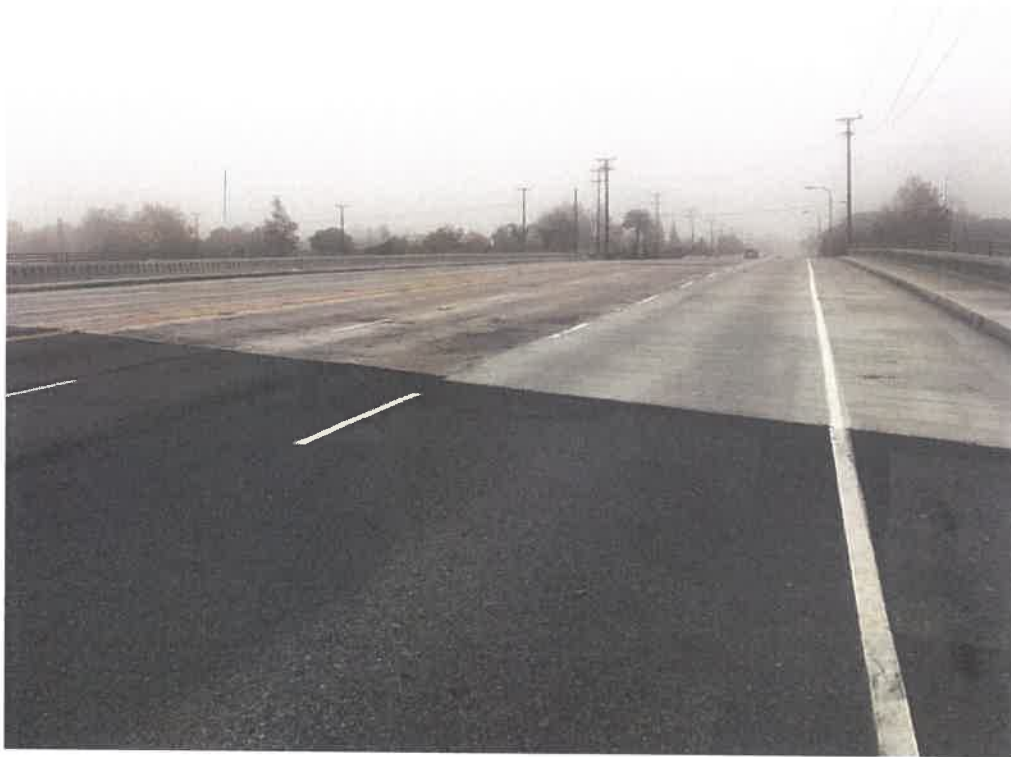
100 - PHOTO-Routine-Roadway View

**Deckview Looking East**

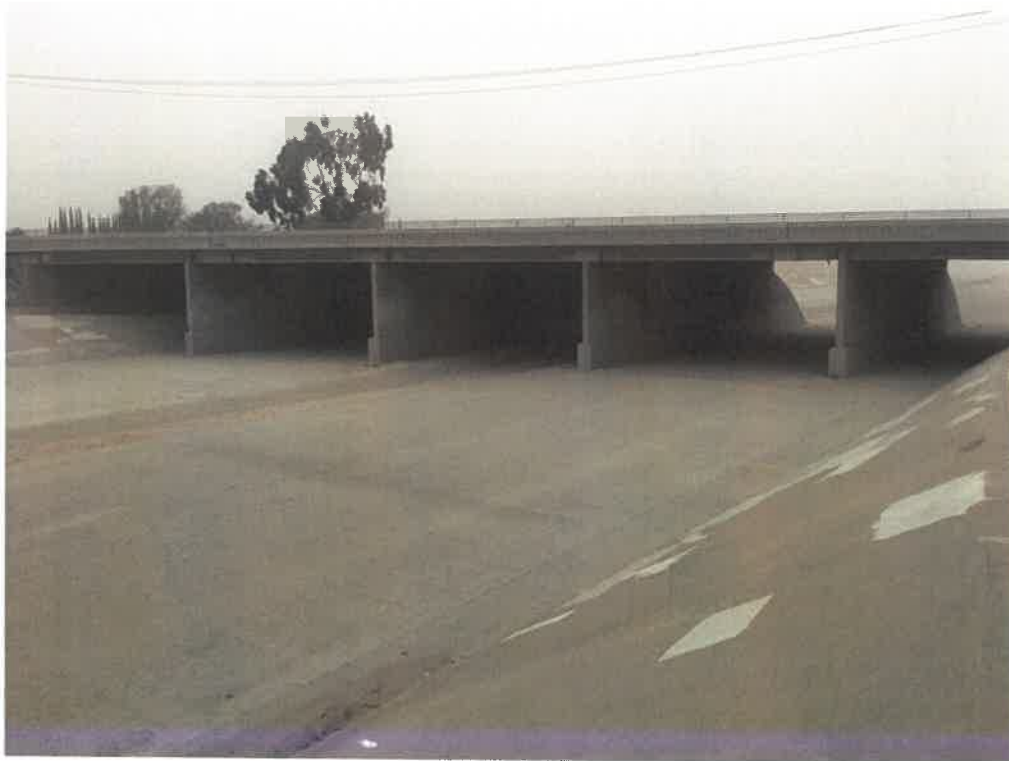
101 - PHOTO-Routine-Elevation View

**Sideview Looking North**

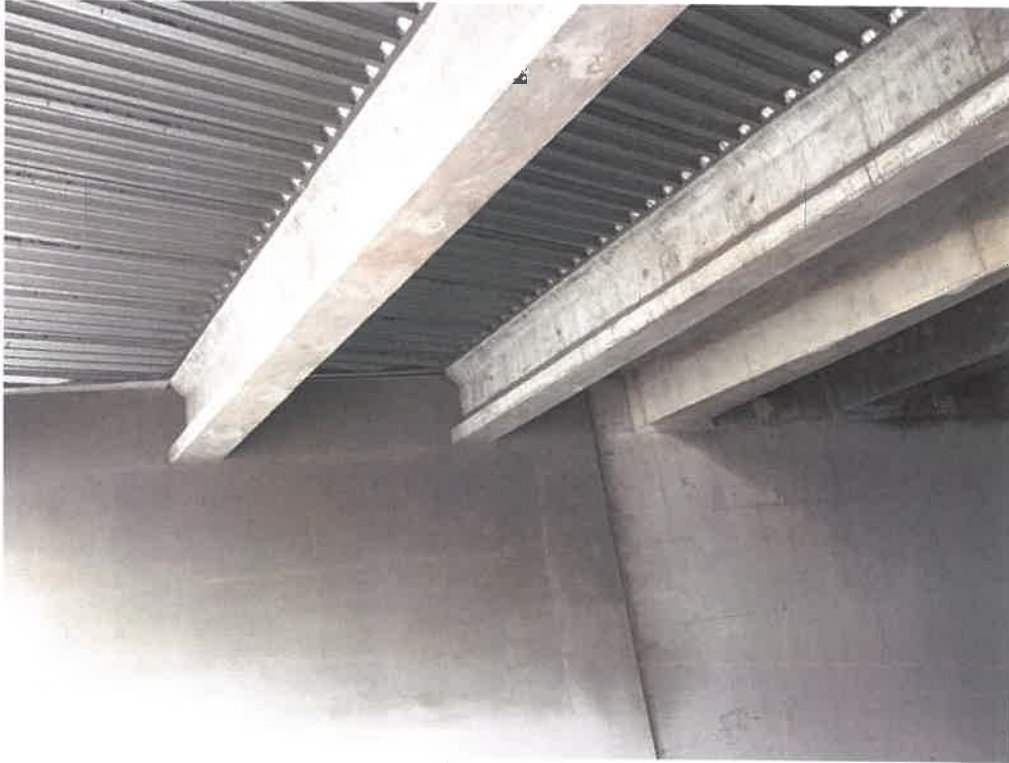
135 - PHOTO-Routine-Underside View

**Underside View: Widened Section**

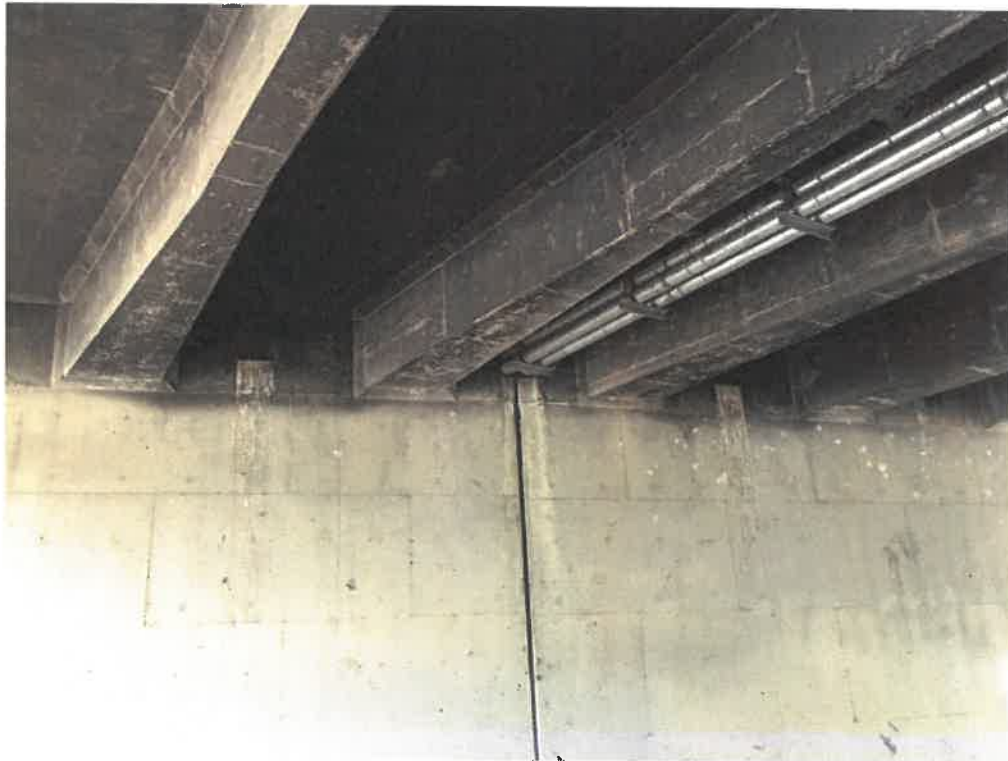
135 - PHOTO-Routine-Underside View

**Underside View: Original Section**
