Bridge Report Transmittal Sheet**Batch 40274****County of Orange**

Bridge Number : 55C0168
Facility Carried: AMAPOLA AVENUE
Location : 0.2 MI E/O ORANGE PK BLV
City :
Inspection Date : 09/07/2017

Bridge Inspection Report

STRUCTURE NAME: HANDY CREEK

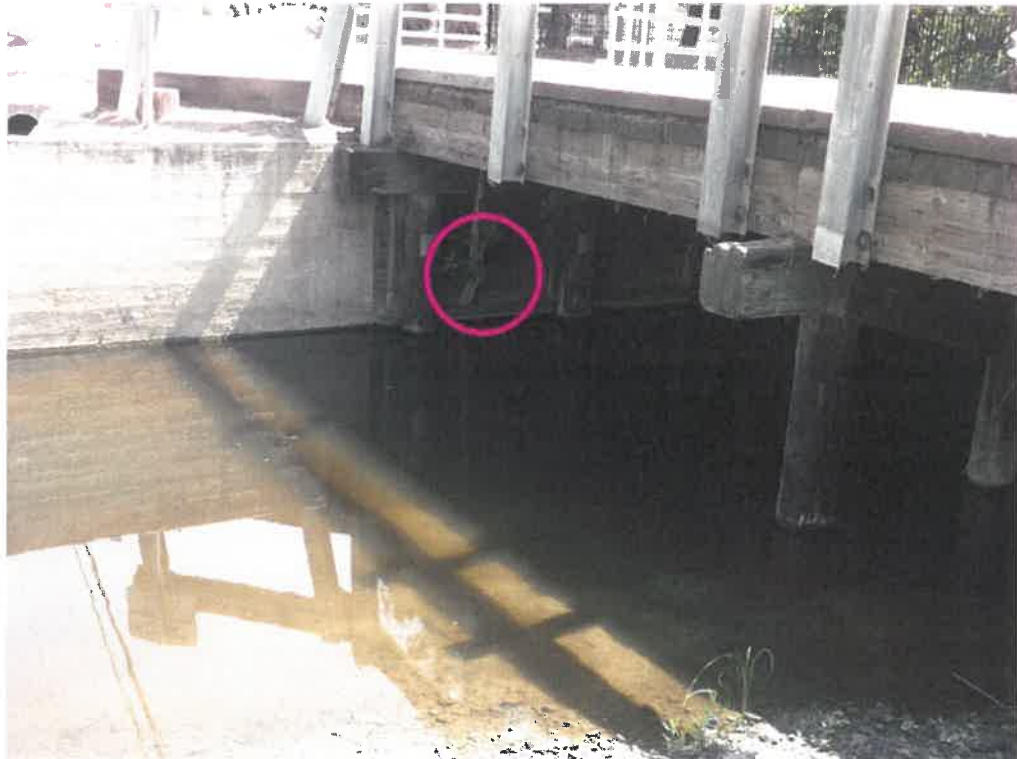
Photo No. 2

At the east abutment north side there is a tree growing in between the timber planks. (see the attached photos no. 2 and 3)

Tree is growing at the north end of the east Abutment blanks.

Replace the deteriorated timber plank at

8 inches from the bottom and remove the

tree at the north side of the abutment

between timber planks.

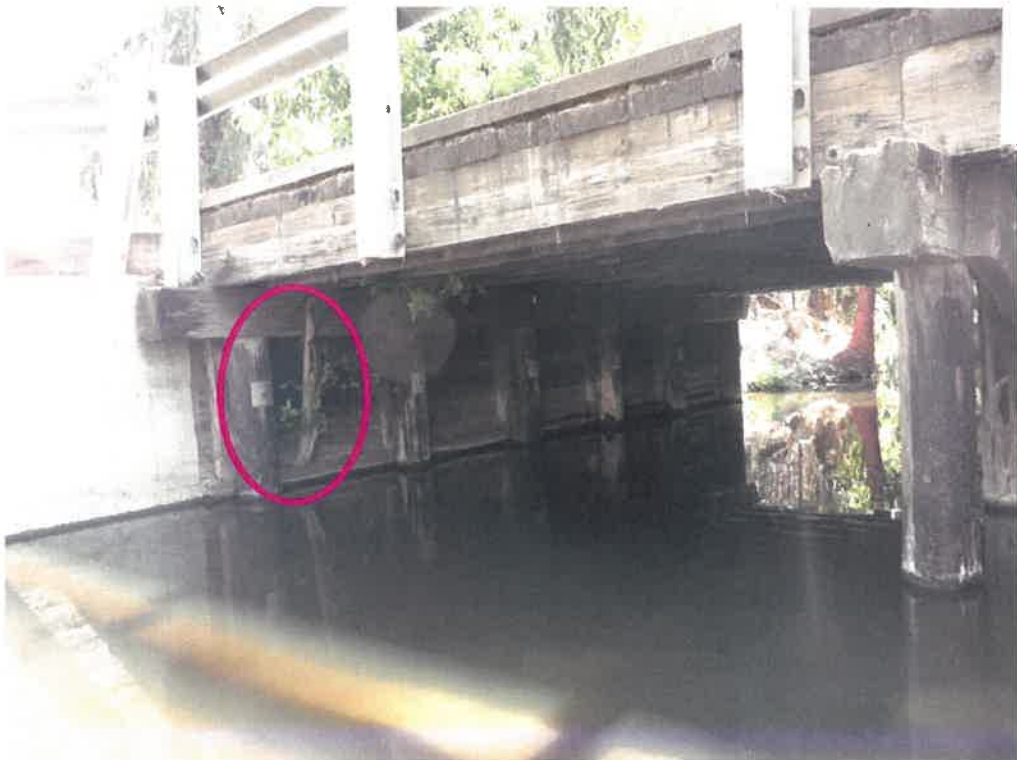
Photo No. 3

Tree is growing at the north end of the east Abutment blanks.
