**Bridge Report Transmittal Sheet****Batch** **44281****County of Orange**

Bridge Number : 55C0172  
Facility Carried: MODJESKA CANYON RD  
Location : 0.1 MI N/O MODJESKA GR R  
City :  
Inspection Date : 05/10/2018

**Bridge Inspection Report**

**STRUCTURE NAME:** SANTIAGO CREEK

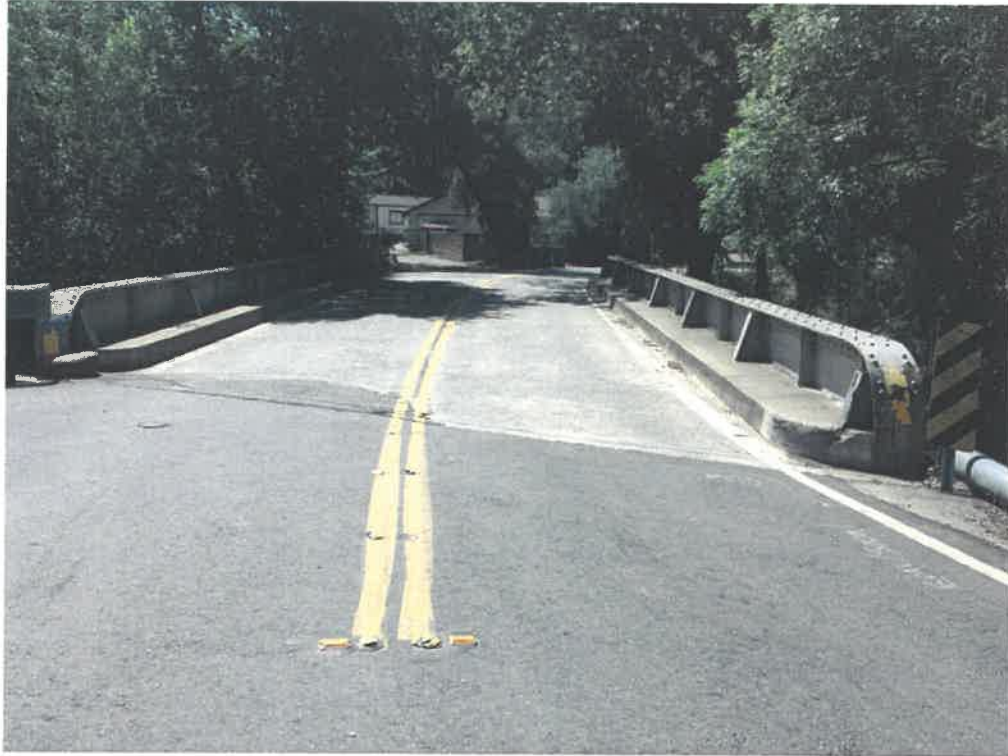
Photo No. 1

Roadway view of the structure

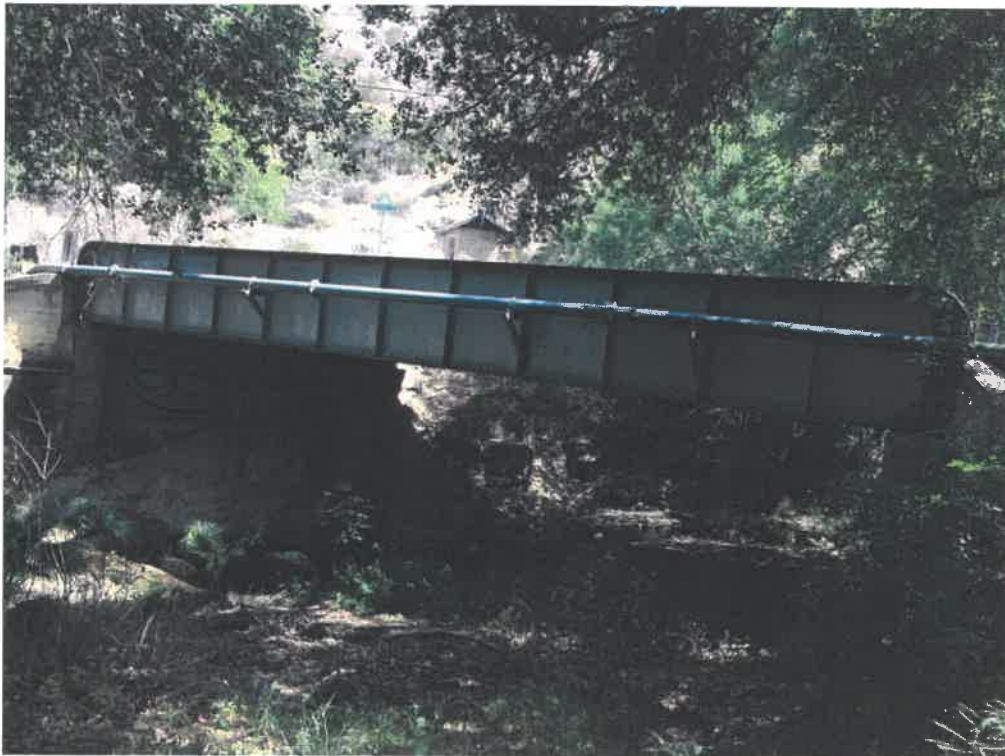
Photo No. 2

Top flange of the westerly girder at the north end is rusted 2 feet long X 10 inches wide. (see the attached photo no. 2)

Elevation view of the structure

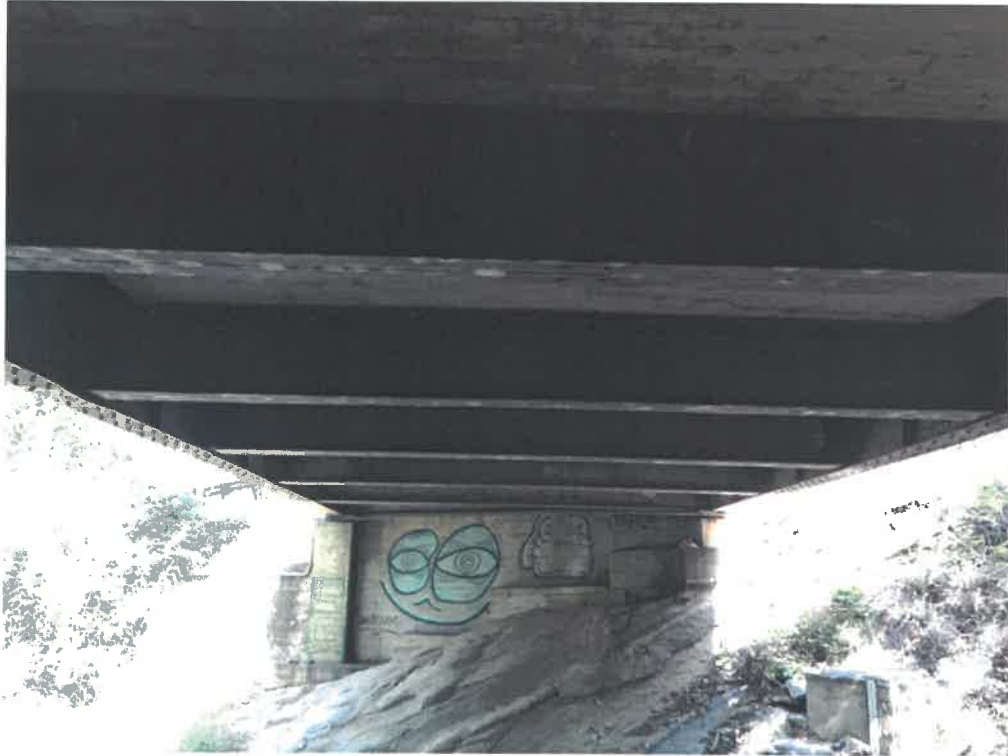
Photo No. 3

The north Abutment has a diagonal crack at the west face of the westerly pedestal. (see the attached photo no. 3)

Underside view of the structure

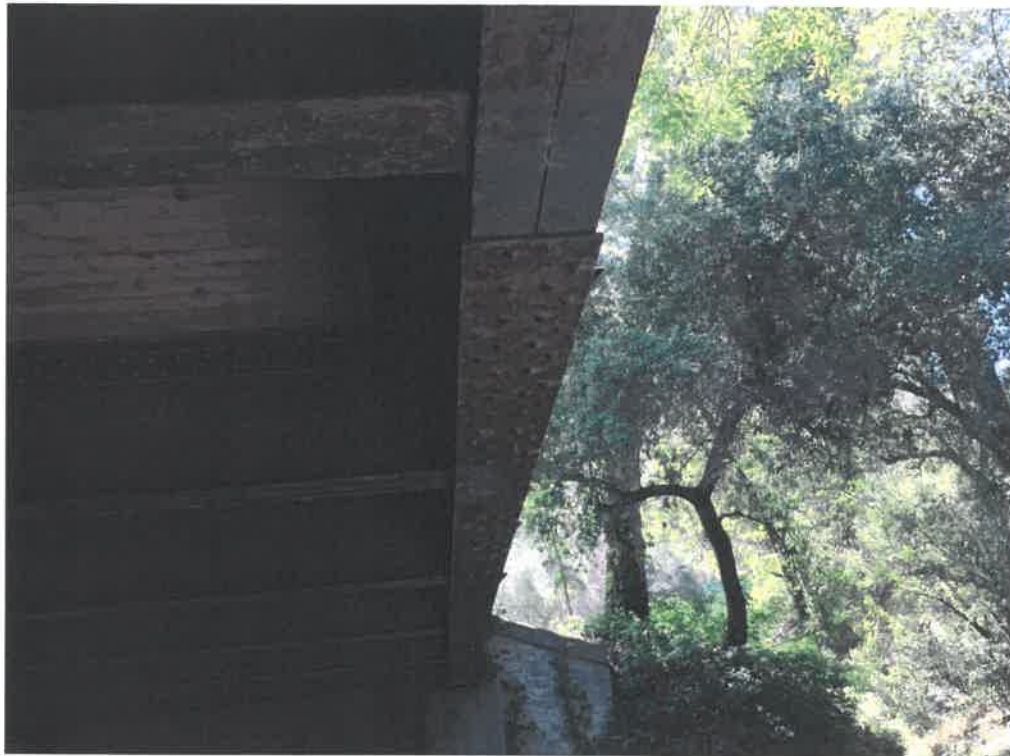
Photo No. 4

Elem No.	Defect /Prot	Element Description	Env	Total Qty	Units	Qty in each	Condition	State	
						St. 1	St. 2	St. 3	St. 4
(301)									
(301-2330)									
The joint seal is detrriorated at the south Abutment.									
(301-2350)									
The pourable joint is partially filled with debris at the south Abutment.									
311		Bearing-Moveable	2	2	each	0	2	0	0
1000		Corrosion	2	2		0	2	0	0
(311)									
There were no significant defects noted.									
(311-1000)									
The steel plate of the bearing is rusted at the north bearings. (see the attached photo no. 4)									
313		Bearing-Fixed	2	2	each	2	0	0	0
(313)									
There were no significant defects noted.

Typical view of a girder with a cover plate
