**DEPARTMENT OF TRANSPORTATION**  
Structure Maintenance & Investigations

Bridge Number : 55C0172  
Facility Carried: MODJESKA CANYON RD  
Location : 0.1 MI N/O MODJESKA GR R  
City :  
Inspection Date : 07/25/2012

**Bridge Inspection Report**

**STRUCTURE NAME:** SANTIAGO CREEK

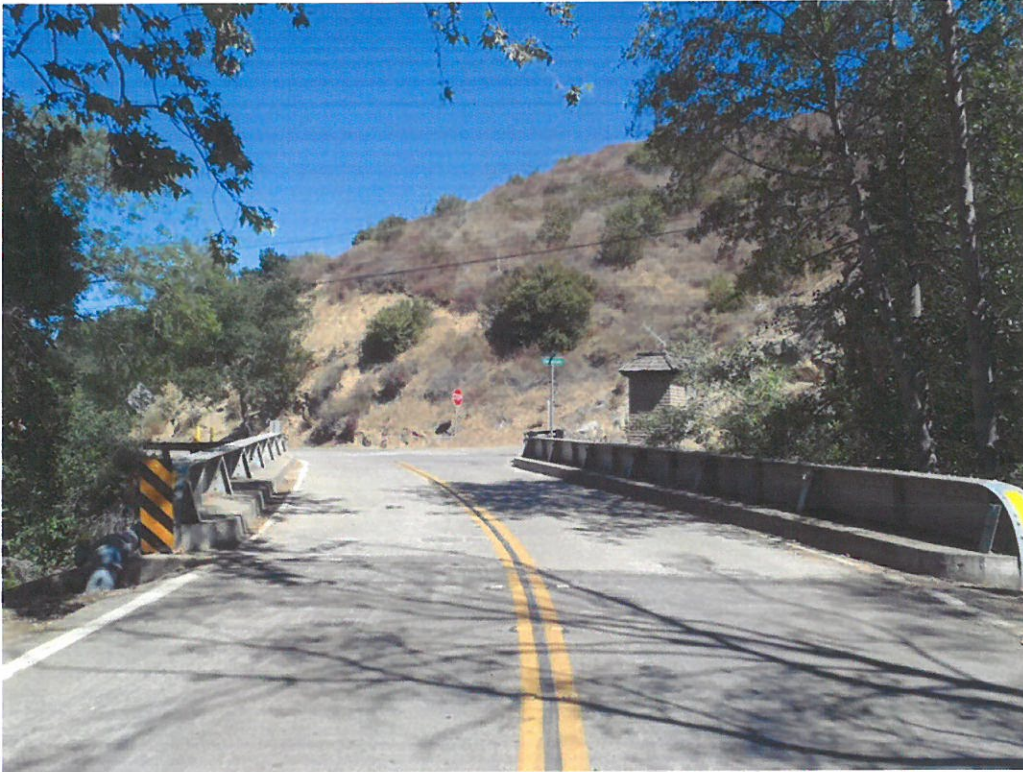
Photo No. 1

Roadway view of bridge - looking north

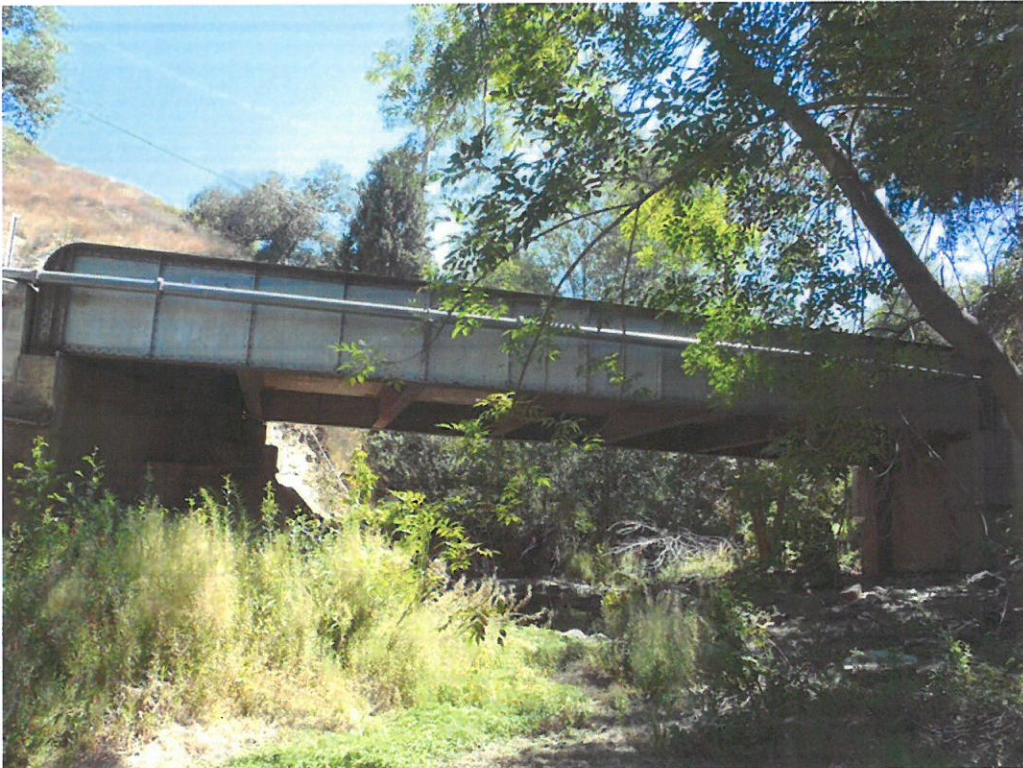
Photo No. 2

Elevation view of bridge - looking east

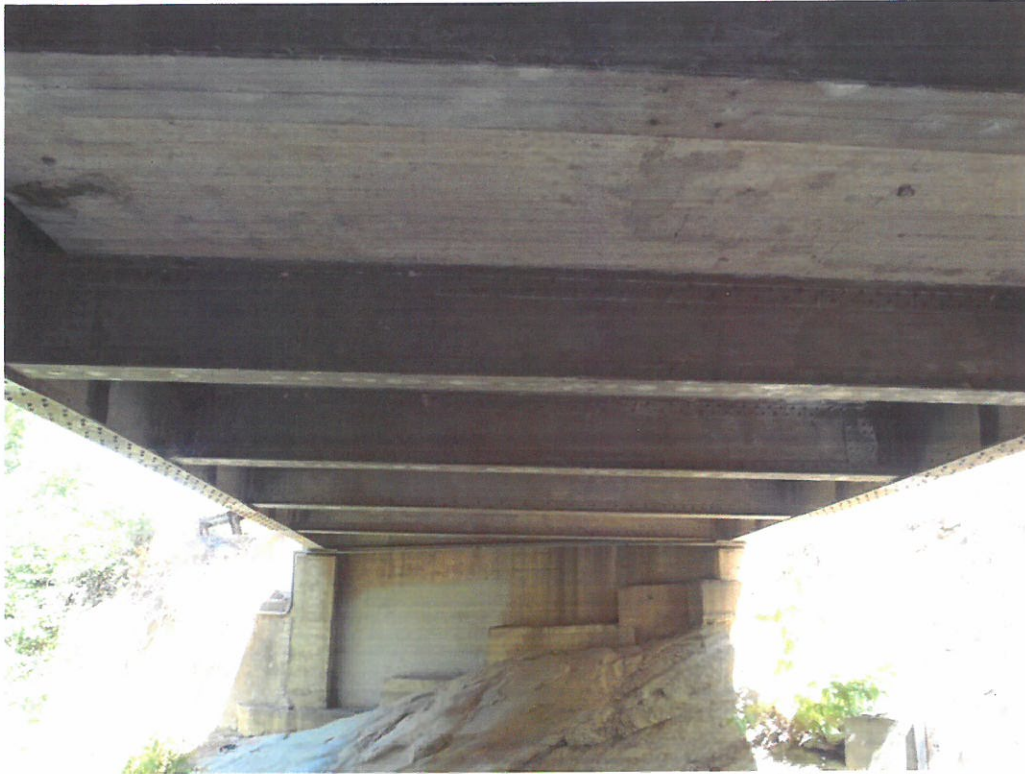
Photo No. 3

Bridge underside view

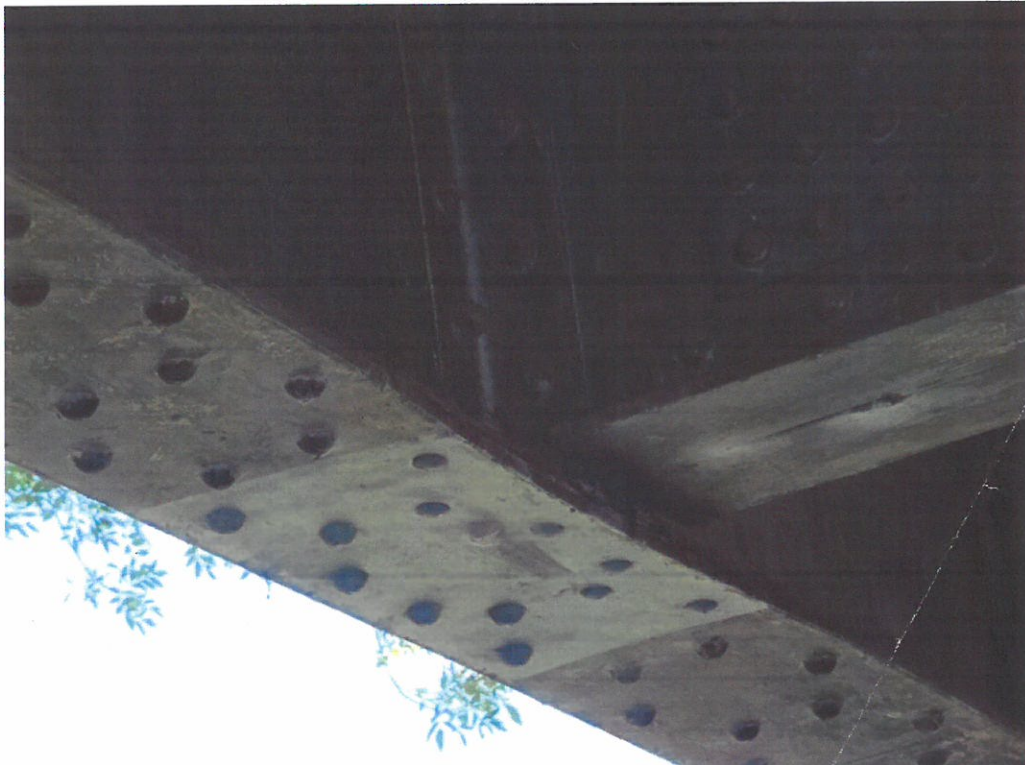
Photo No. 4

During the 05/21/2008 fracture critical inspection, up to 19 mm (3/4 in) thick pack rust was found between the bottom flange of the floor beam and the bottom flange of the girder at the following locations:

- Floor Beam 5 to Girder 1 connection
- Floor Beam 2 to Girder 2 connection
- Floor Beam 3 to Girder 1 connection (previously recorded as Girder 2 in error)
- Floor Beam 4 to Girder 2 connection

No increase in corrosion has occurred at these locations. These areas will continue to be monitored for any significant increase in corrosion during the next fracture critical

Detail of typical pack rust at floor beam to girder connection
