Bridge Report Transmittal Sheet**Batch** **35485****County of Orange**

Bridge Number : 55C0172
Facility Carried: MODJESKA CANYON RD
Location : 0.1 MI N/O MODJESKA GR R
City :
Inspection Date : 05/19/2016

Bridge Inspection Report

STRUCTURE NAME: SANTIAGO CREEK

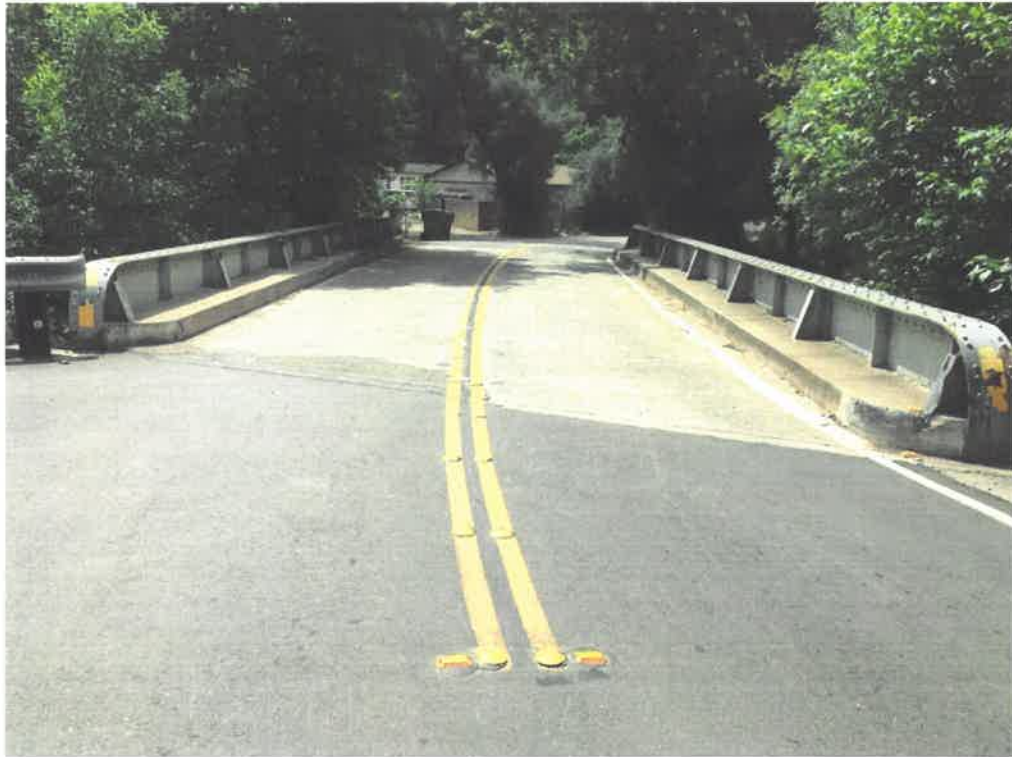
Photo No. 1

Roadway view of the structure

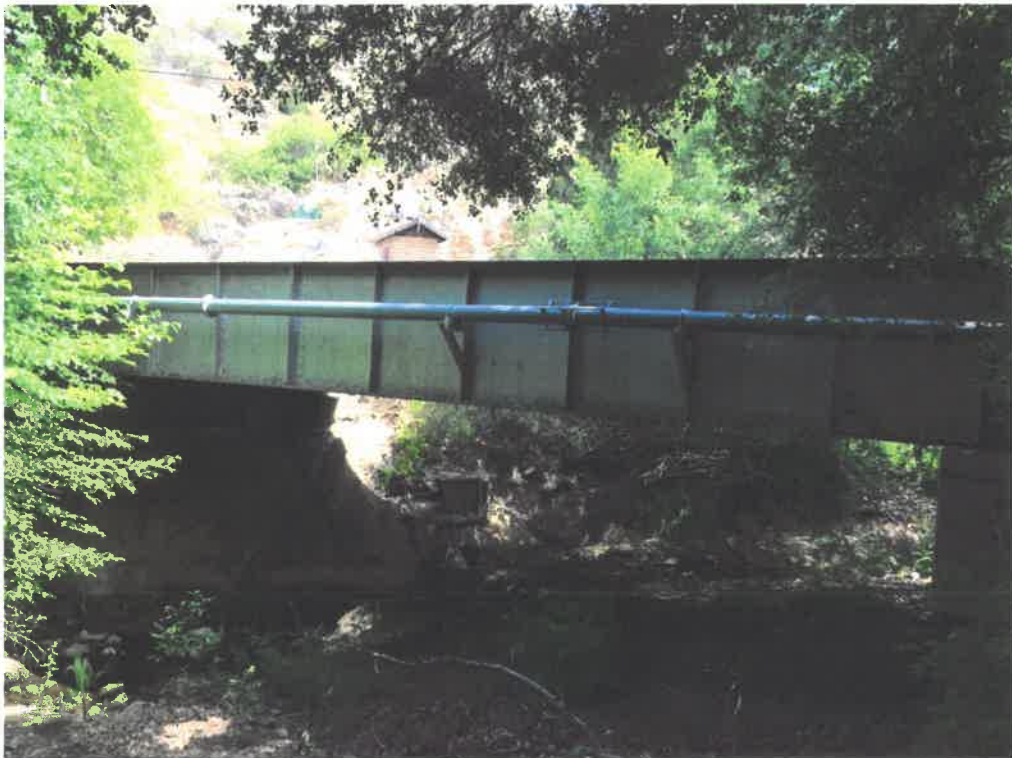
Photo No. 2

Elevation view of the structure

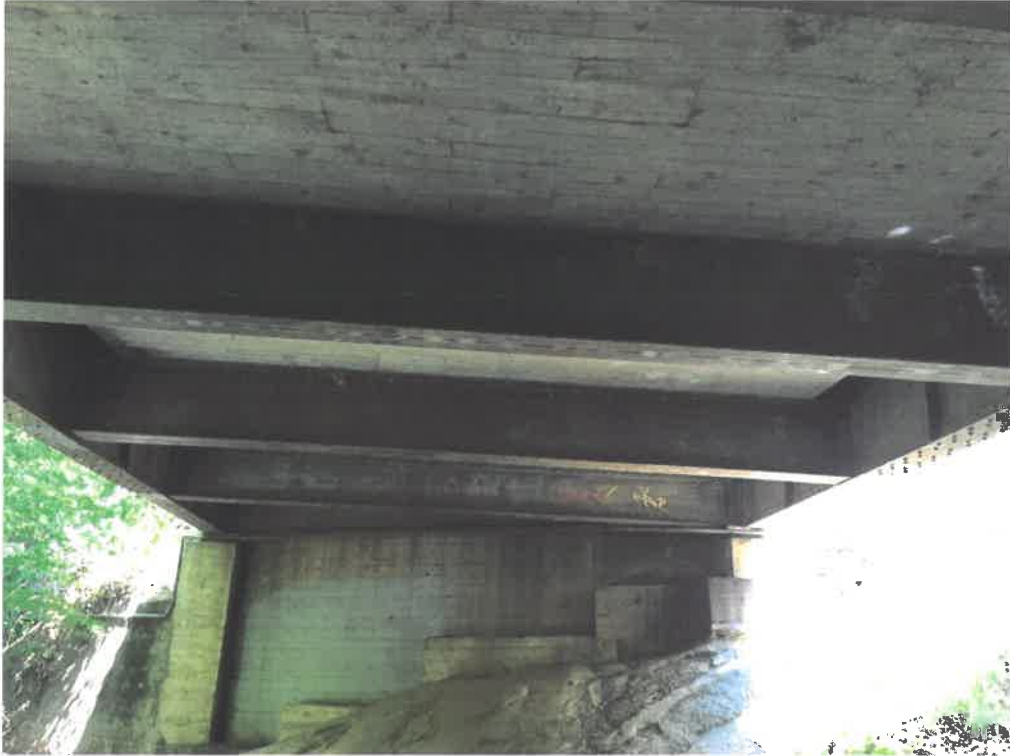
Photo No. 3

Underside view of the structure

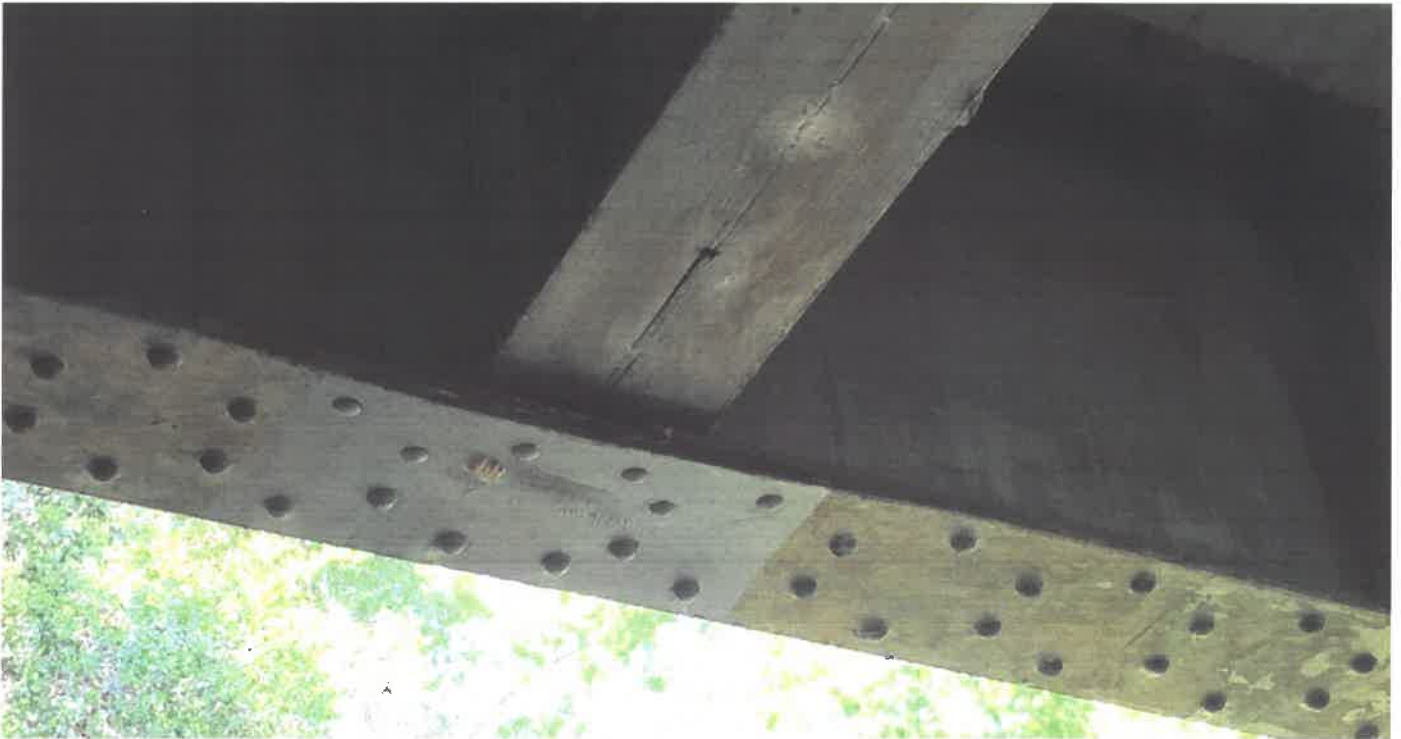
Photo No. 4

During the 05/21/2008 fracture critical member inspection, up to 19 mm (3/4 in) of pack rust was found between the bottom flange plates of the left and right girders at the following locations:

- Girder 1 to Floor Beam 3 connection
- Girder 1 to Floor Beam 5 connection
- Girder 2 to Floor Beam 2 connection
- Girder 2 to Floor Beam 4 connection

No increase in corrosion has occurred at these locations. These areas will continue to be monitored for any significant increase in corrosion during the next scheduled fracture critical member inspection.

Typical view of a girder pack rust corrosion
