Bridge Number : 55C0174
Facility Carried: SILVERADO CANYON RD.
Location : 1.6 MI E/O SANTIAGO ROAD
City :
Inspection Date : 05/10/2018

Bridge Inspection Report

Inspection Type
Routine ☐ FC ☒ Underwater ☐ Special ☐ Other ☐

STRUCTURE NAME: SILVERADO CANYON CREEK

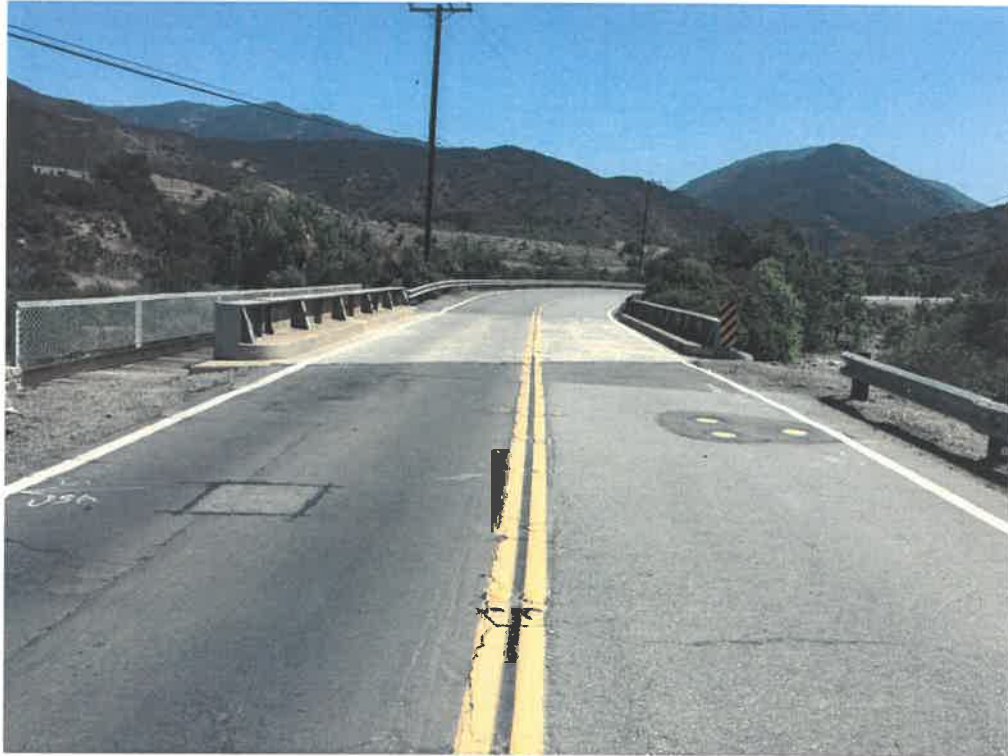
Photo No. 1

Roadway view of the structure

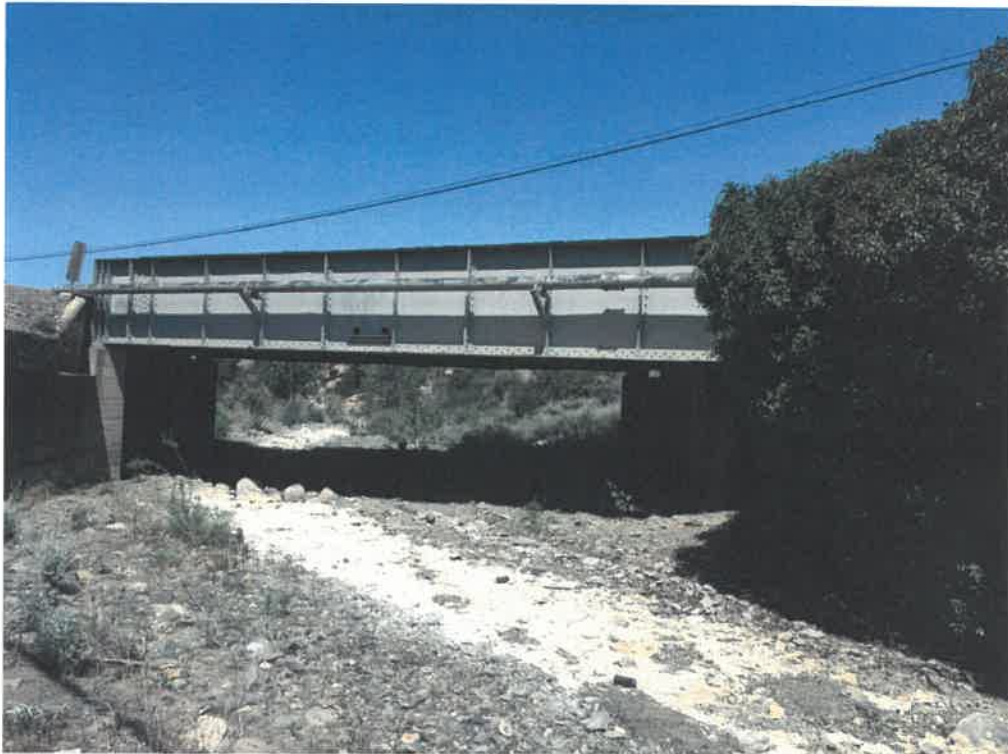
Photo No. 2

Elevation view of the structure

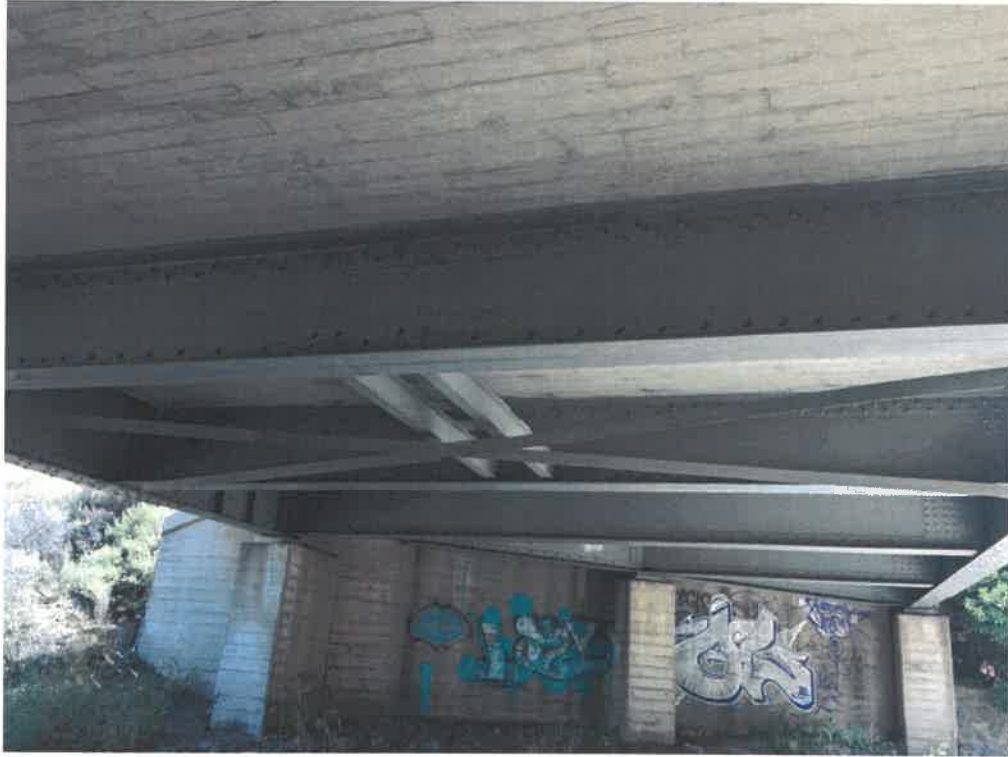
Photo No. 3

Underside view of the structure

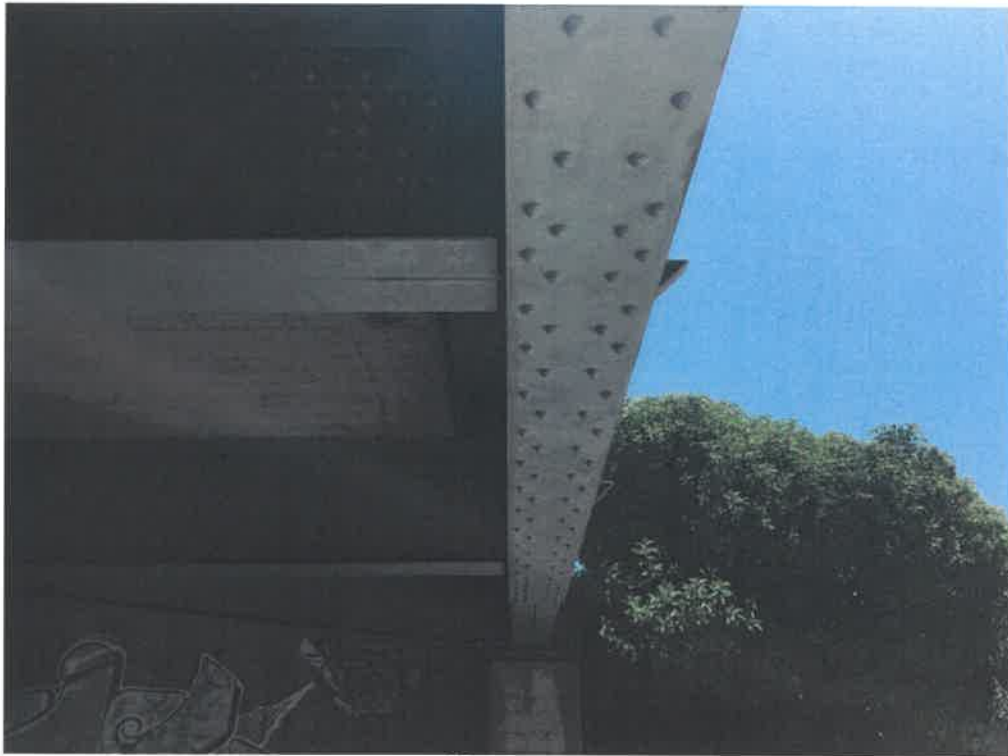
Photo No. 4

Typical view of a girder with a cover plate
