Bridge Number : 55C0174
Facility Carried: SILVERADO CANYON RD.
Location : 1.6 MI E/O SANTIAGO ROAD
City :
Inspection Date : 07/25/2012
Inspection Type
Routine ☒ FC Underwater Special Other

Bridge Inspection Report

STRUCTURE NAME: SILVERADO CANYON CREEK

55C0174

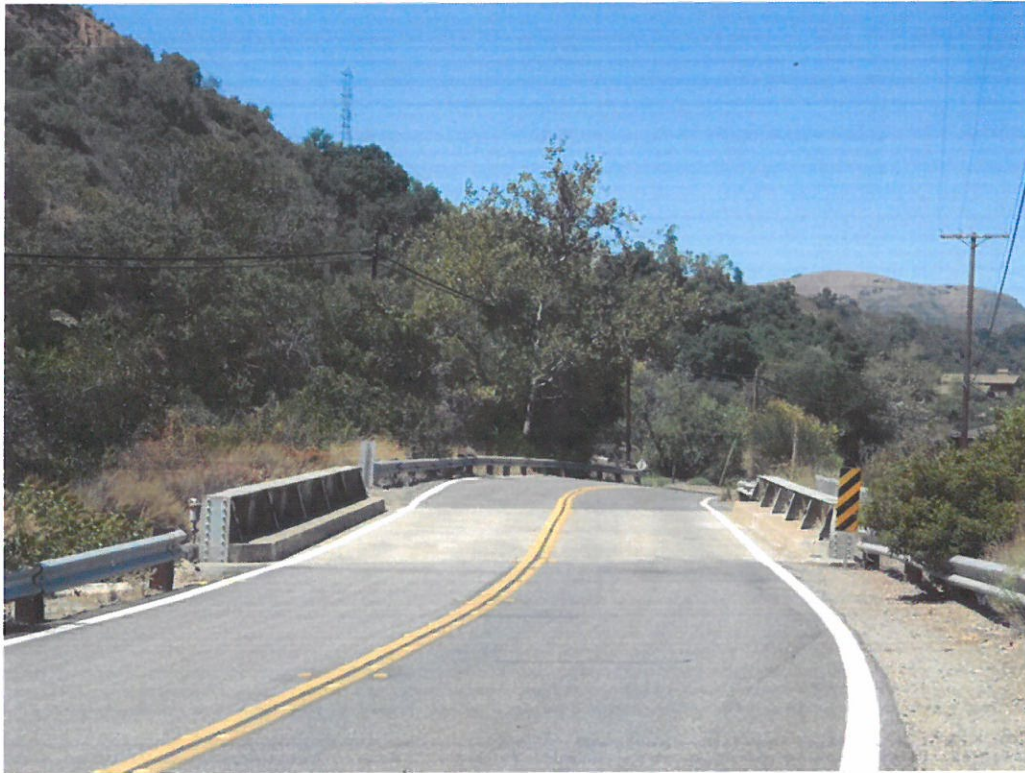
Photo No. 1

Roadway view of bridge - looking west

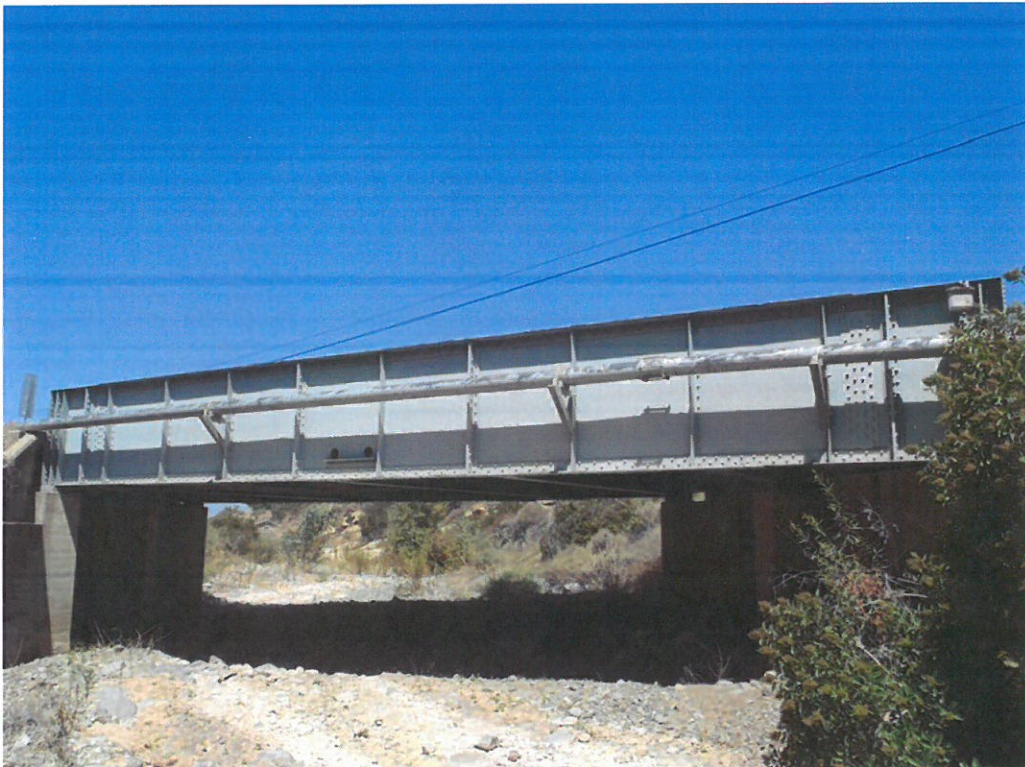
Photo No. 2

Elevation view of bridge - looking north

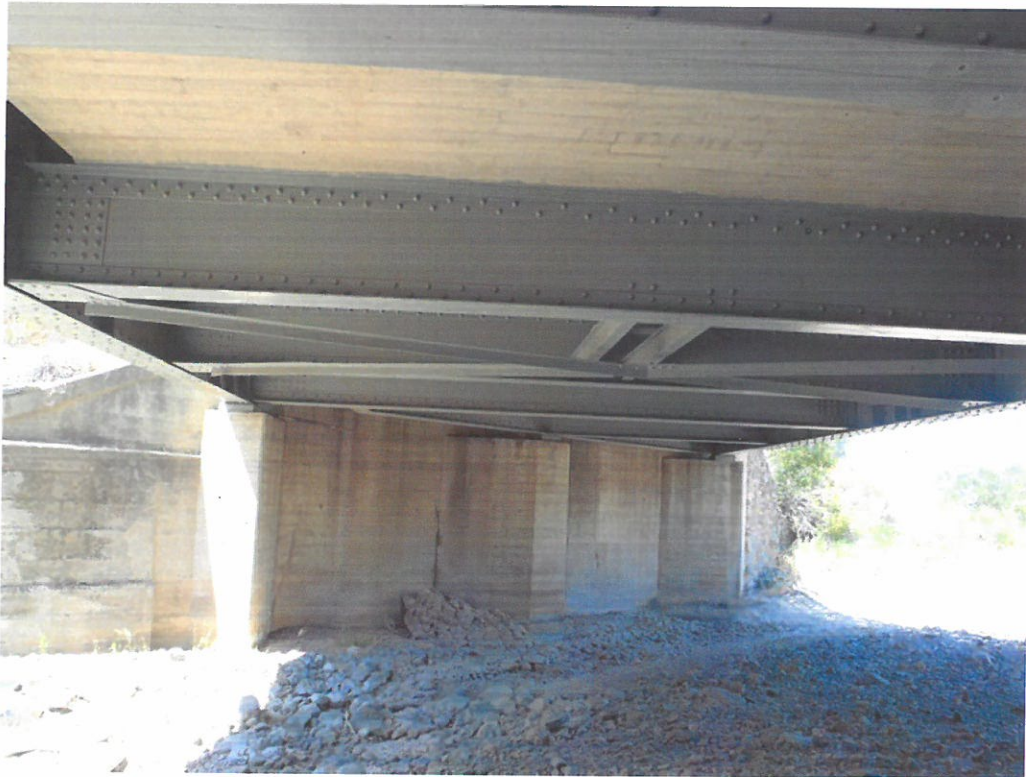
Photo No. 3

Bridge underside view

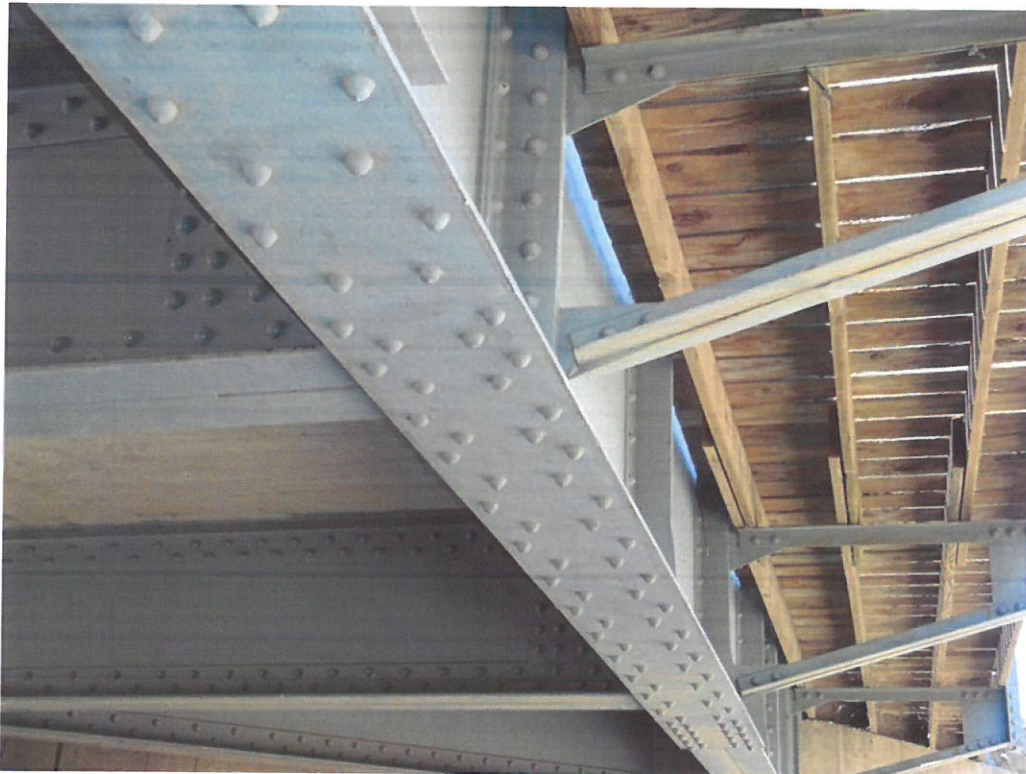
Photo No. 4

Detail of typical steel girder
