Bridge Number : 55C0174
Facility Carried: SILVERADO CANYON RD.
Location : 1.6 MI E/O SANTIAGO ROAD
City :
Inspection Date : 07/25/2012
Inspection Type
Routine ☒ FC Underwater Special Other

Bridge Inspection Report

STRUCTURE NAME: SILVERADO CANYON CREEK

FRACTURE CRITICAL INVESTIGATION

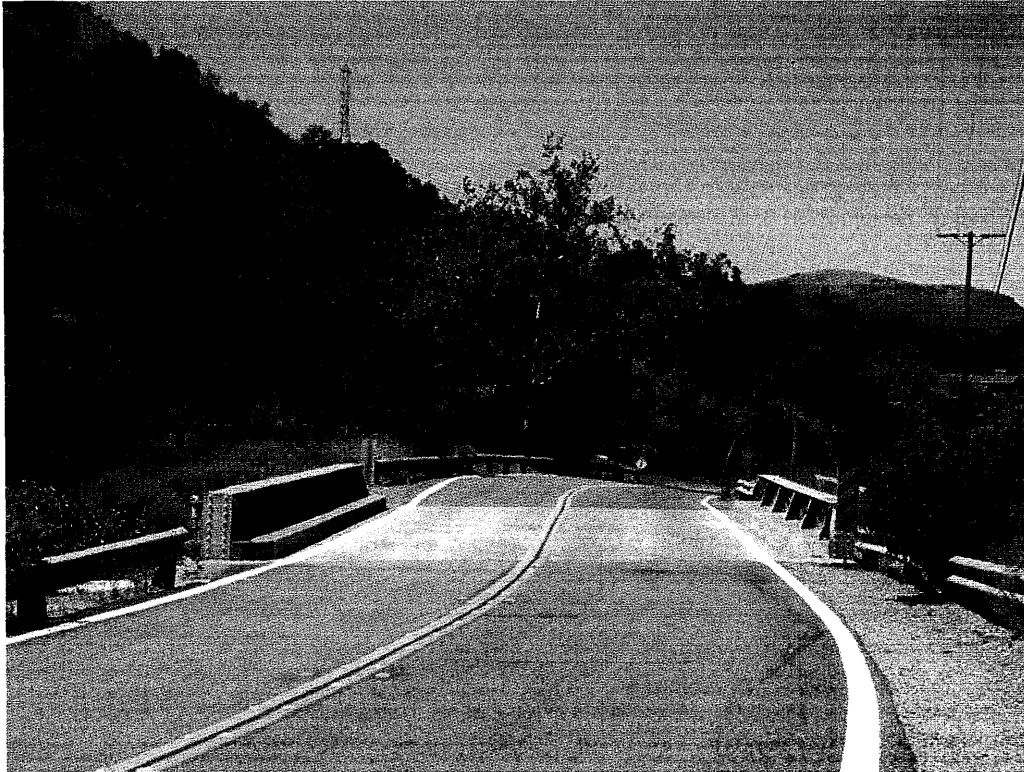
Photo No. 1

Roadway view of bridge - looking west

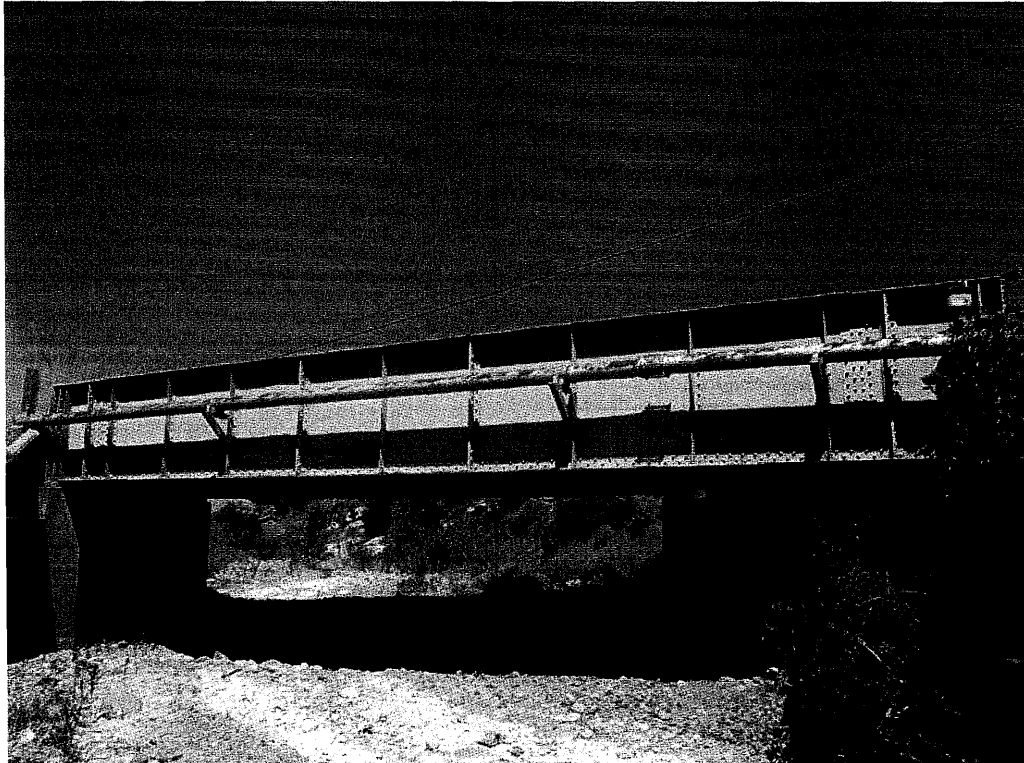
Photo No. 2

Elevation view of bridge - looking north

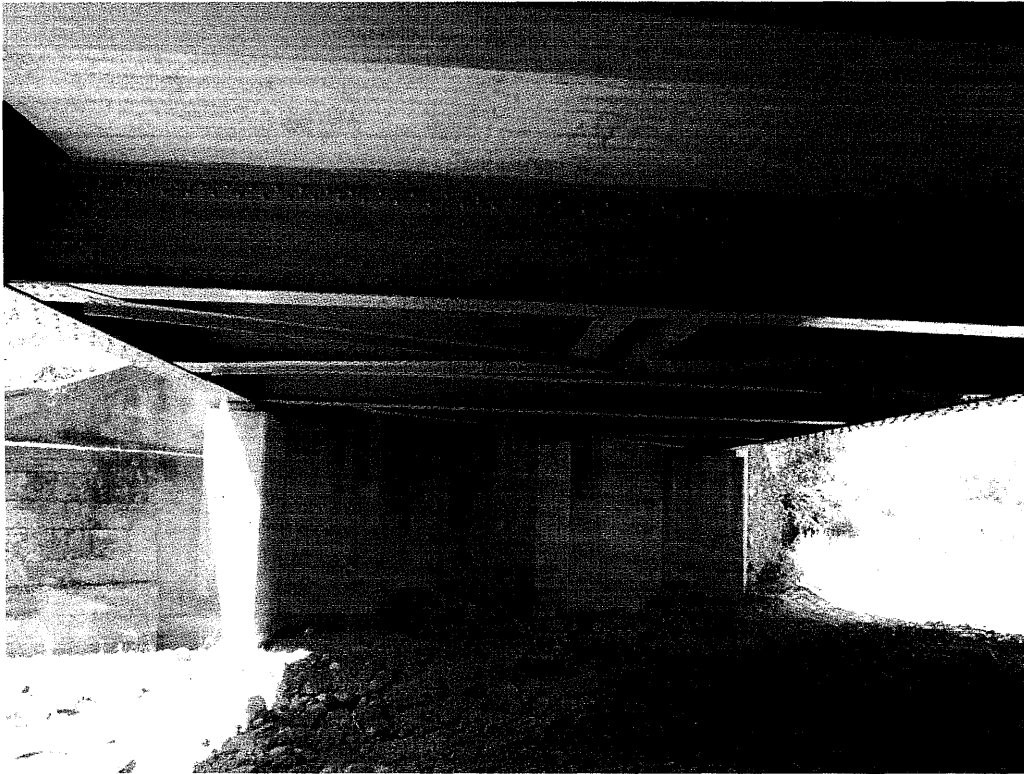
Photo No. 3

Bridge underside view

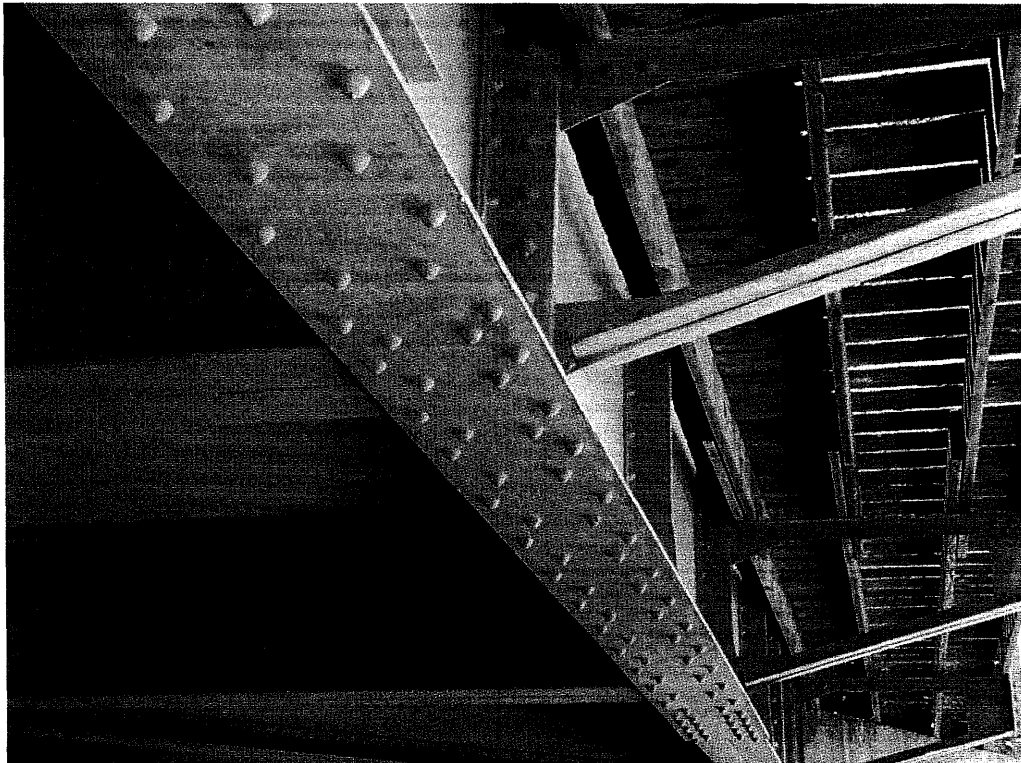
Photo No. 4

Detail of typical steel girder
