Bridge #	Bridge Name	Location	Inspection		Outstanding	
			Date	Type	Work	Cost
55C0172	SANTIAGO CREEK	0.1 MI N/O MODJESKA GR RD	05/19/2016	Fracture Critical	Y	\$
55C0174	SILVERADO CANYON CREEK	1.6 MI E/O SANTIAGO ROAD	05/19/2016	Fracture Critical	Y	\$

Bridge Number : 55C0174
Facility Carried: SILVERADO CNYN RD.
Location : 1.6 MI E/O SANTIAGO ROAD
City :
Inspection Date : 05/19/2016
Inspection Type
Routine ☒ FC Underwater Special Other

Bridge Inspection Report

STRUCTURE NAME: SILVERADO CANYON CREEK

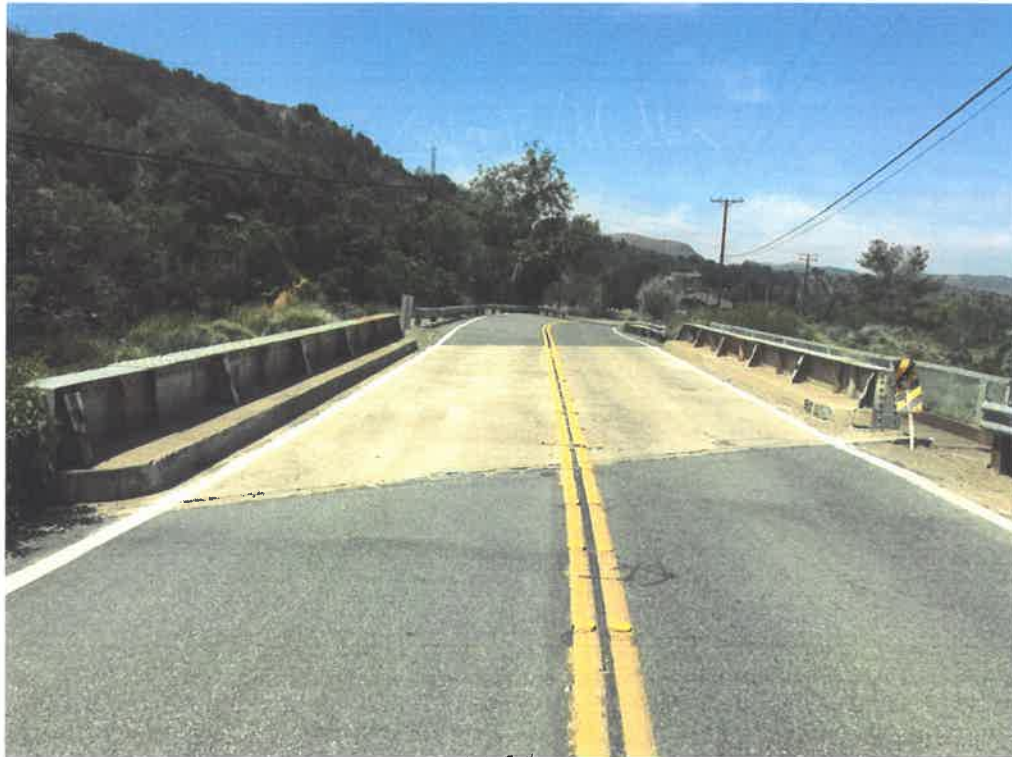
Photo No. 1

Roadway view of the structure

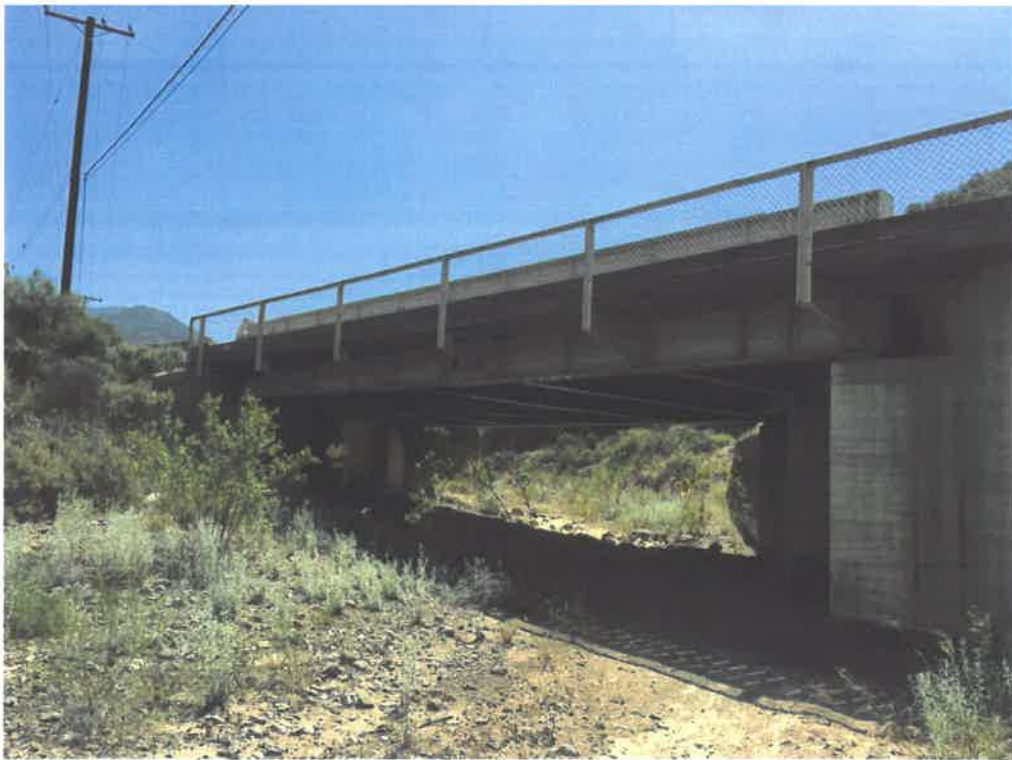
Photo No. 2

North elevation of the structure

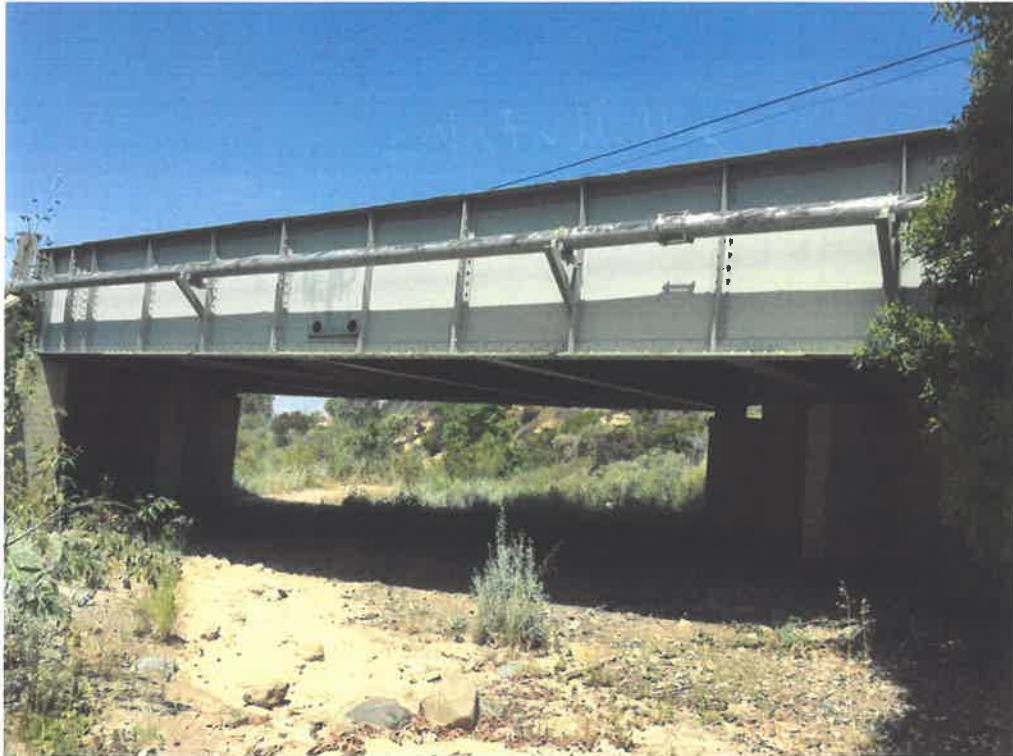
Photo No. 3

South elevation of the structure

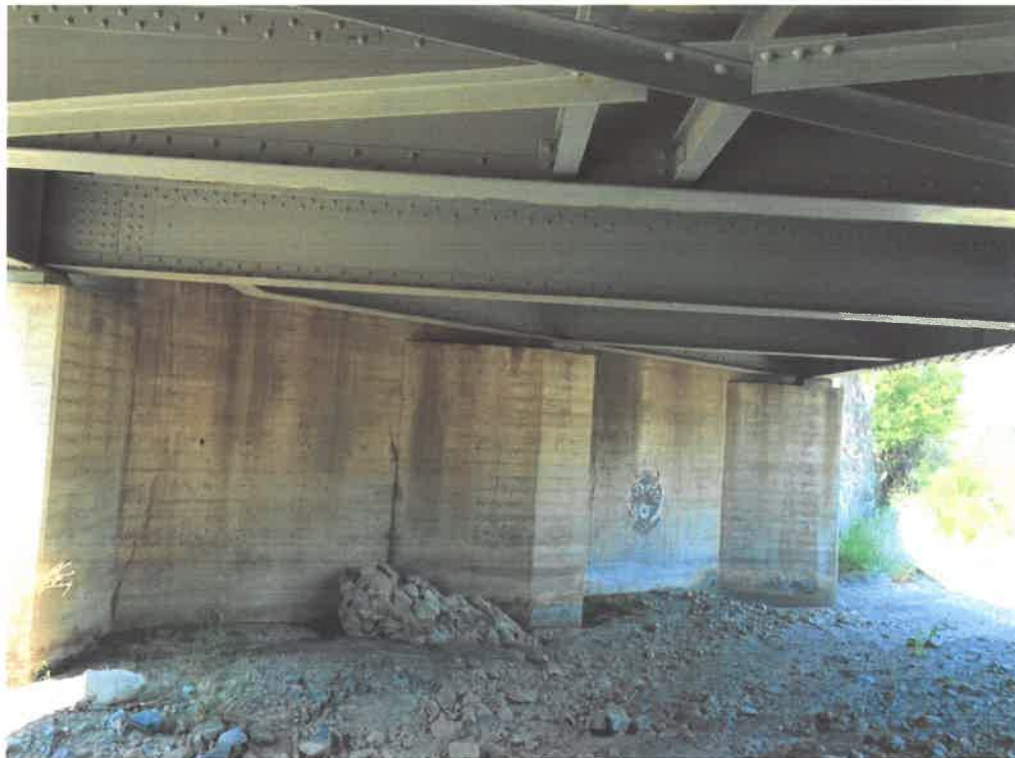
Photo No. 4

Underside view of the structure
