Bridge Number : 55C0174
Facility Carried: SILVERADO CANYON RD.
Location : 1.6 MI E/O SANTIAGO ROAD
City :
Inspection Date : 12/15/2017

Bridge Inspection Report

STRUCTURE NAME: SILVERADO CANYON CREEK

Structure Description: CIP/RC deck on riveted steel floor beams on simply supported riveted steel through girders (2) on RC pedestals on RC closed end backfilled cantilever abutments on spread footings.

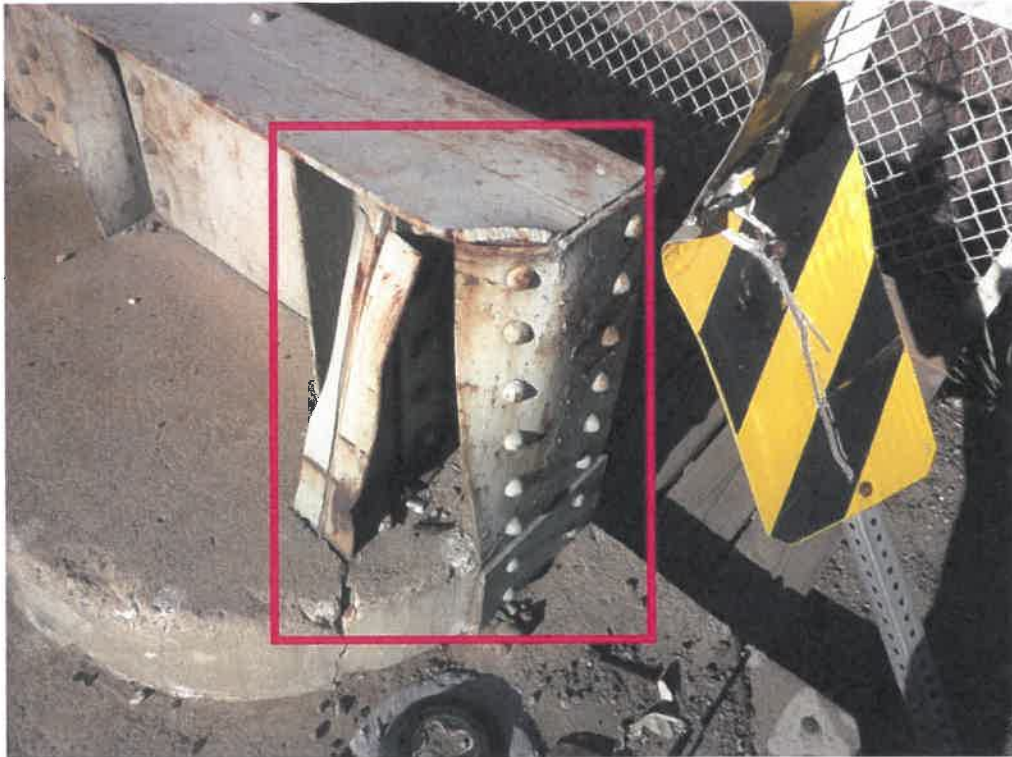
Photo No. 5

Both through girders were hit and deformed especially at the east end. (see the attached photo no. 5)

Through steel girder was hit and deformed at the east end.

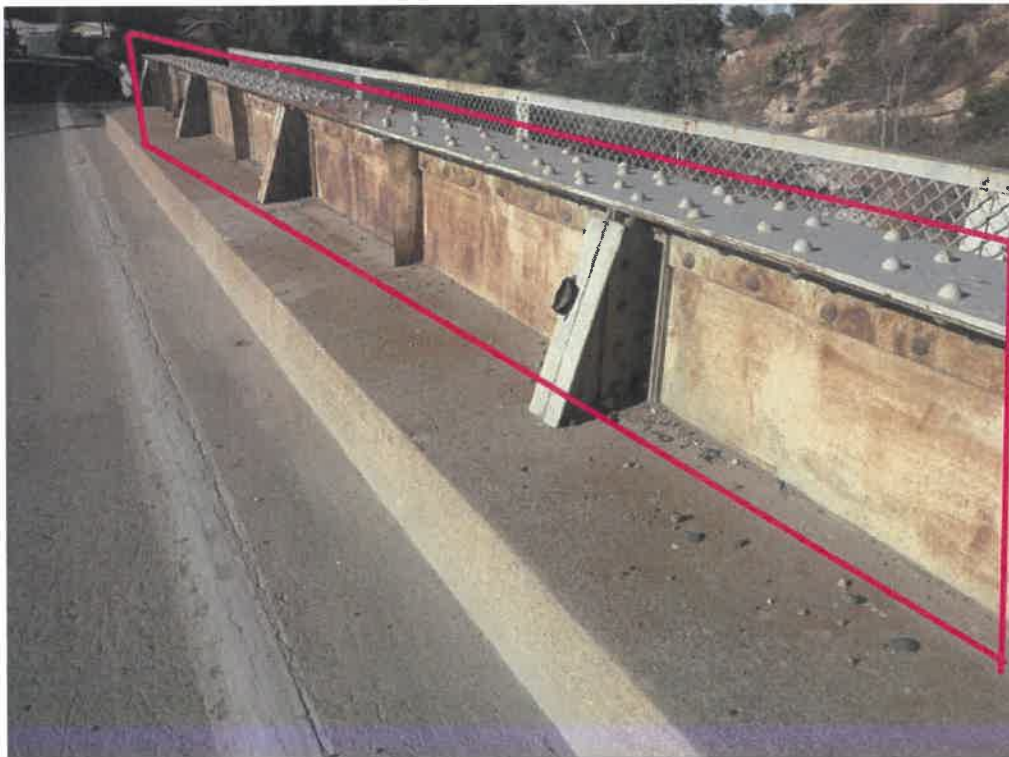
Photo No. 6

Freckled rust has formed on the above the deck portions of the through girders. (see the attached photo no. 6)

The paint system was failed, where the top portion of the steel through girder is rusted.

North steel girder is rusted.

RecDate: 12/15/2017	EstCost:	Patch the spall 1.5 feet X 3 inches X 3
Action : Sub-Patch spalls	StrTarget: 2 YEARS	inches with rebar exposed and rusted at
Work By: LOCAL AGENCY	DistTarget:	Northeast wingwall.
Status : PROPOSED	EA:	
RecDate: 02/14/2005	EstCost:	Spot blast and paint the freckled rust
Action : Paint-Spot Prep/Pain	StrTarget: 6 YEARS	portions of the through girders above the
Work By: LOCAL AGENCY	DistTarget:	deck.
Status : PROPOSED	EA:

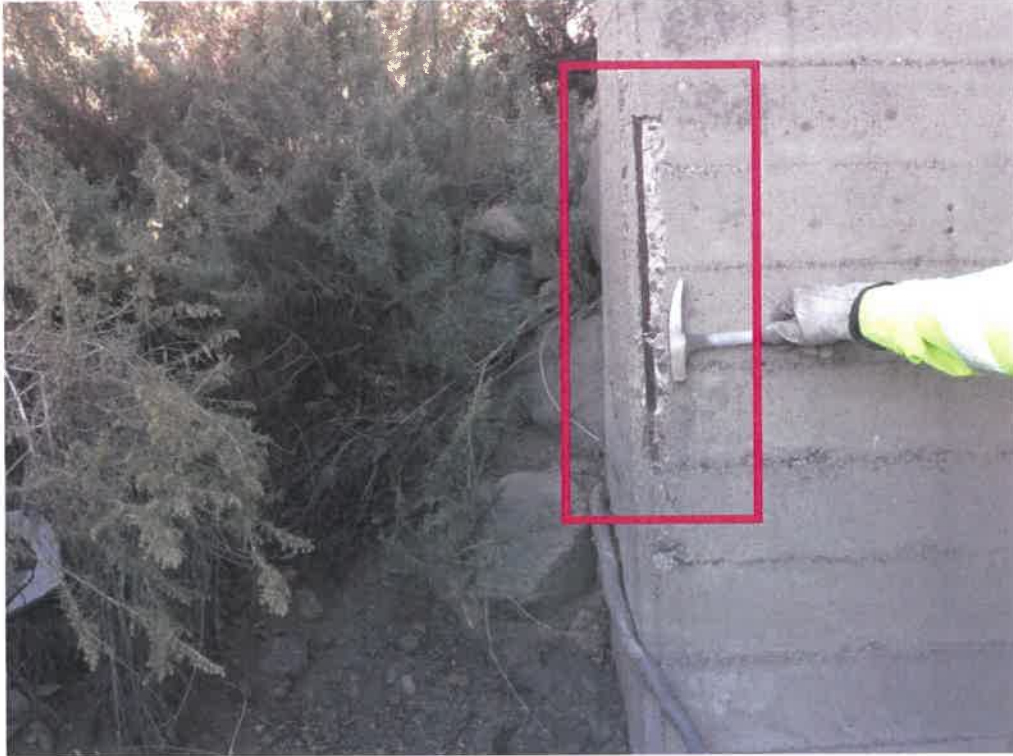
Photo No. 7

Elem No.	Defect /Prot	Element Description	Env Qty	Total Qty	Units	Qty in each Condition State			
						St. 1	St. 2	St. 3	St. 4
Northeast wingwall has a spall 1.5 feet X 3 inches X 3 inches with rebar exposed and rusted. (see the attached photo no. 7)									
There three spalls 12 inches X 3 inches X 2 inches at the top of east back wall.									
(215-1130)									
There are three vertical and diagonal cracks, up to 0.05 inches at west abutment.									
311		Bearing-Moveable	2	3	each	2	1	0	0
	1000	Corrosion	2	1		0	1	0	0
(311-1000)									
South bearing is rusted above the east abutment.									
313		Bearing-Fixed	2	3	each	3	0	0	0
(313)									
There were no significant defects noted.

A spall 1.5 ft X 3 in. X 3 in at northeast wingwall with exposed rebars.
