Bridge Number : 55C0175
Facility Carried: SILVERADO CANYN RD
Location : 2.2 MI. E/O SANTIAGO ROA
City :
Inspection Date : 12/15/2017

Bridge Inspection Report

STRUCTURE NAME: LADD CANYON

55C0176

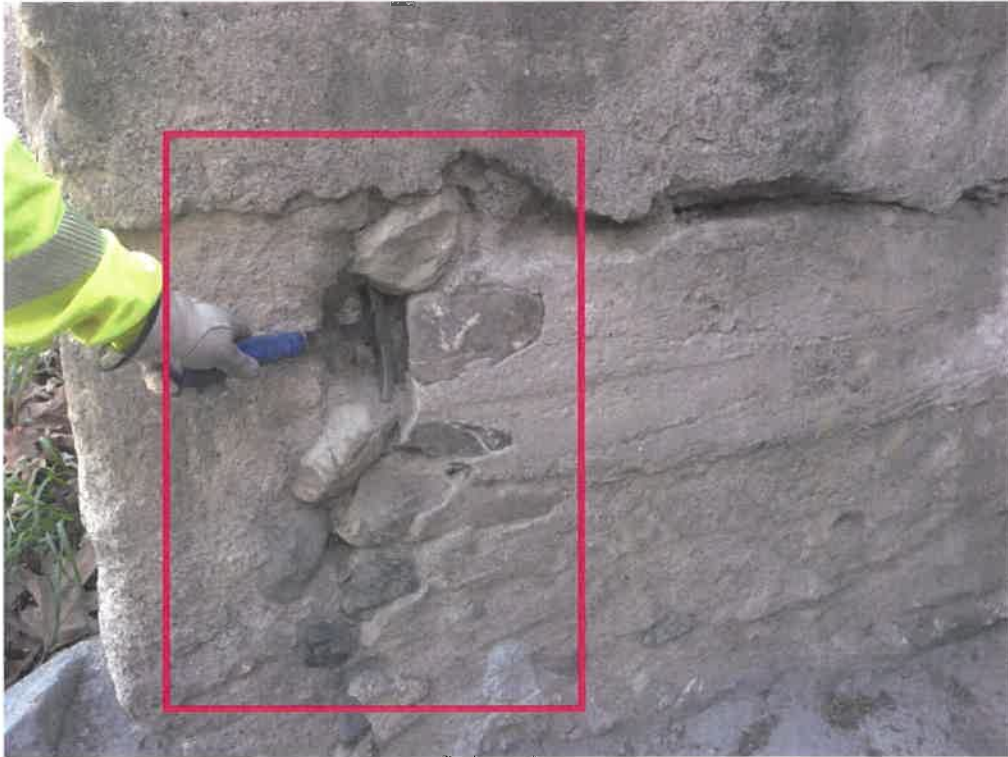
Photo No. 1

Some aggregates were missing from the north abutment westerly end.

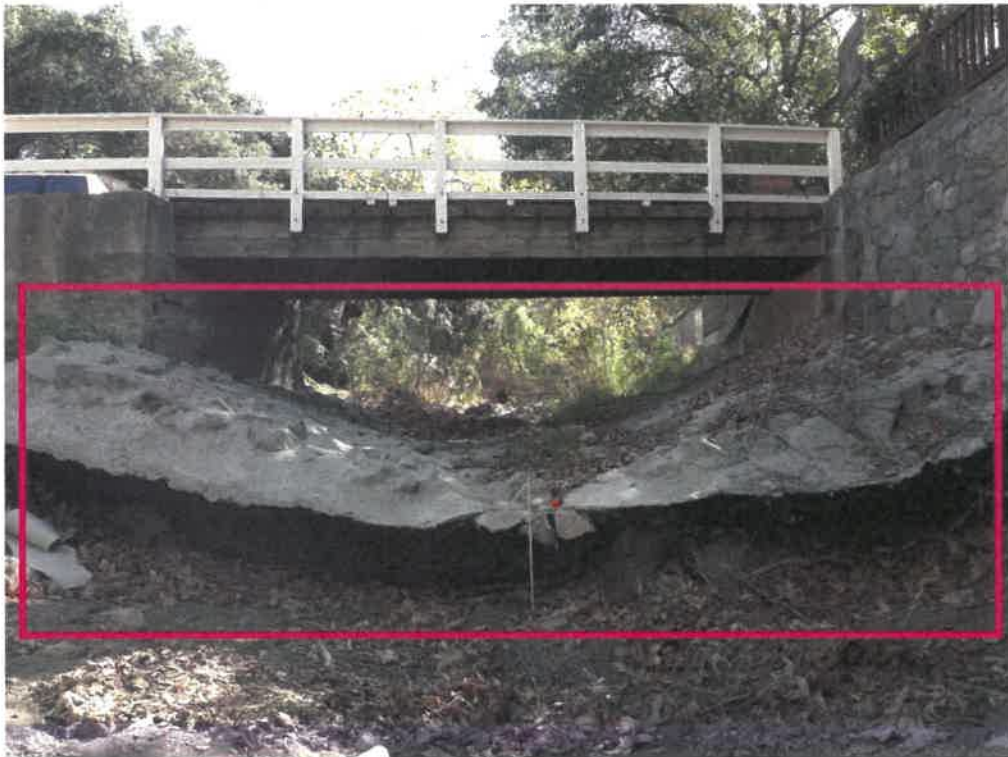
Photo No. 2

Undermining 2.5'X 5' X 20' at 10 ft from the west end of the bridge.

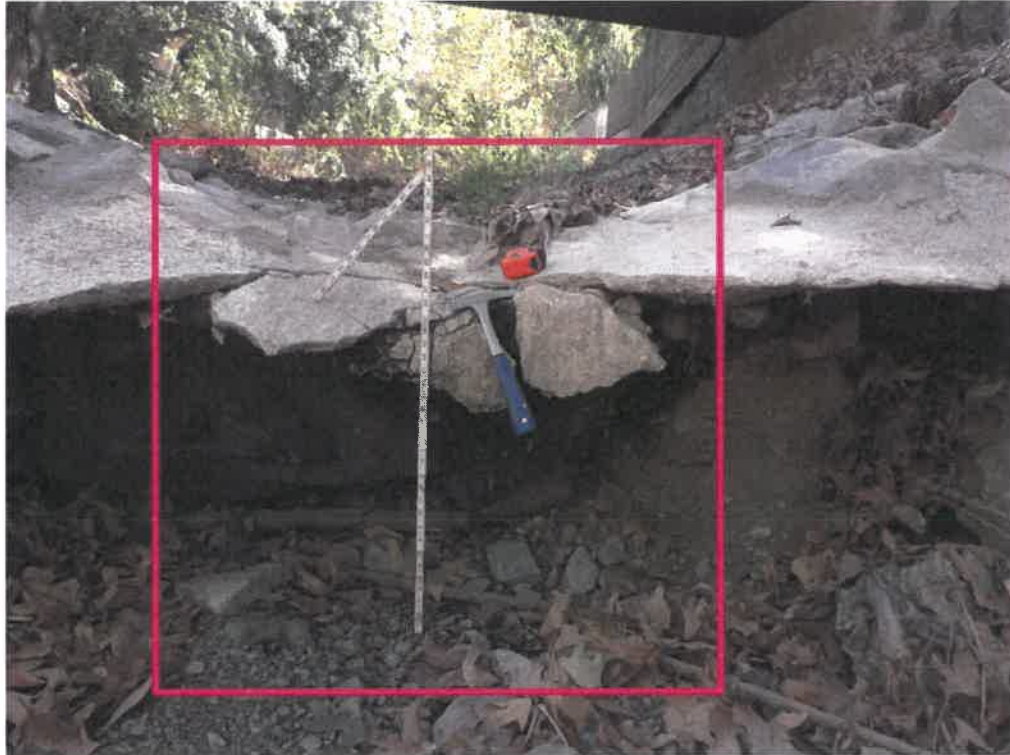
Photo No. 3

Undermining 2.5'X 5' X 20 ' at 10 ft from the west end of the bridge.

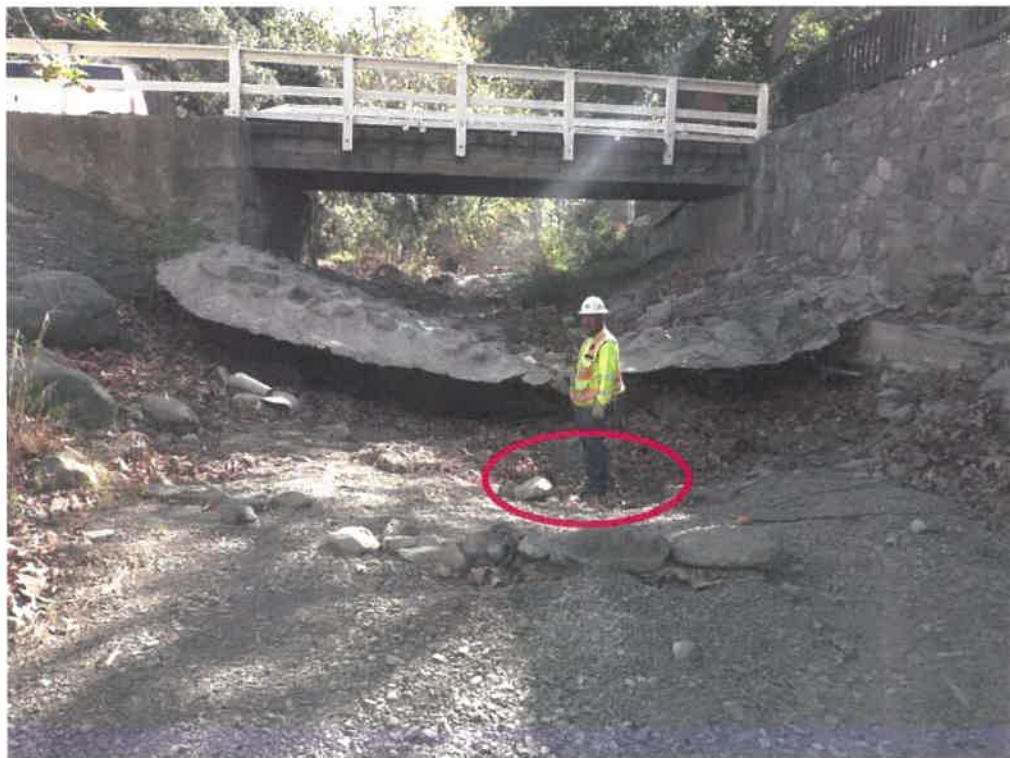
Photo No. 4

The channel bed is degraded in front of the grouted channel bed 20' dia. X 3 ' Deep.

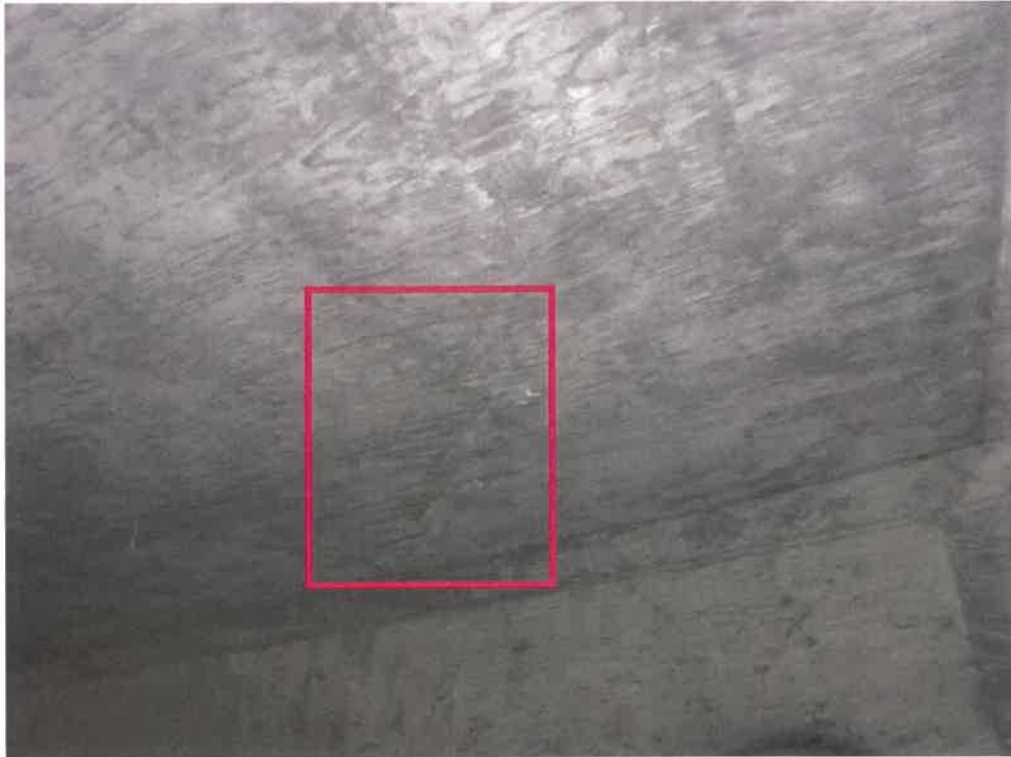
Photo No. 1

Diagonal and longitudinal cracks with white and brown efflorescence.
