DEPARTMENT OF TRANSPORTATION
Structure Maintenance & Investigations

Bridge Number : 55C0176
Facility Carried: KITTERMAN DRIVE
Location : 0.1 MI. S/O SLVRDO CYN R
City :
Inspection Date : 12/15/2017

Bridge Inspection Report

STRUCTURE NAME: SILVERADO CANYON CREEK

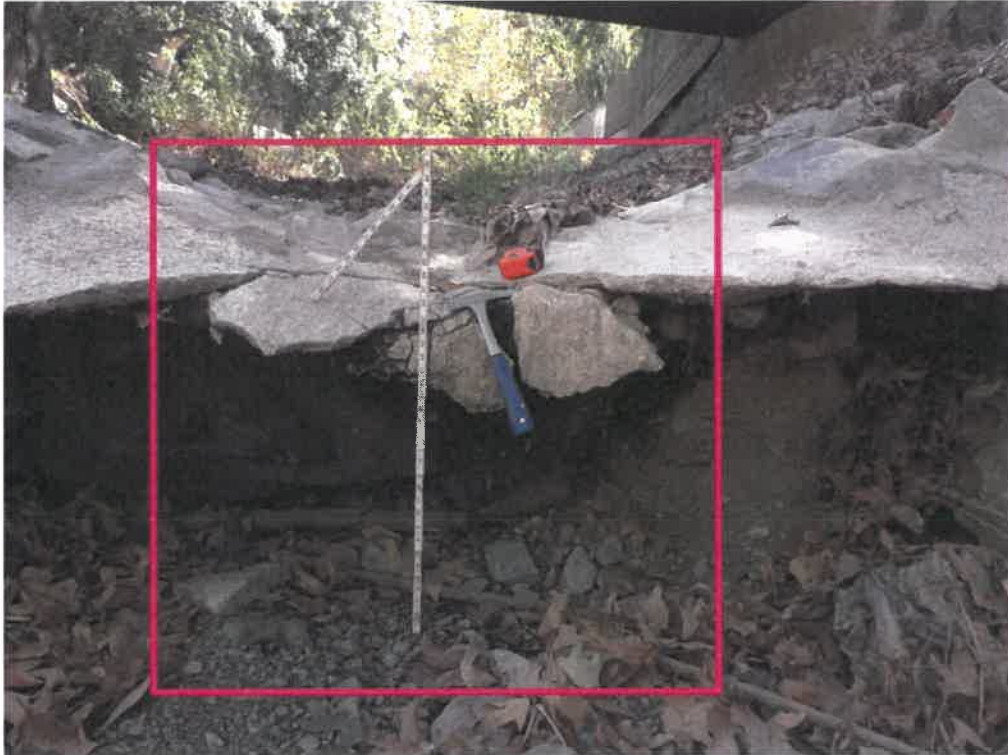
Photo No. 3

The grouted channel bed has undermining up to 2.5 feet deep, 5 feet deep with full channel (20 feet long) width at the downstream side at 10 feet from the west end of the bridge. (see the attached photos no. 2 & 3)

Undermining 2.5'X 5' X 20' at 10 ft from the west end of the bridge.

Protect the grouted channel bed that has undermining up to 2.5 feet deep, 5 feet deep with full channel (20 feet long) width at the downstream side at 10 feet from the west end of the bridge.

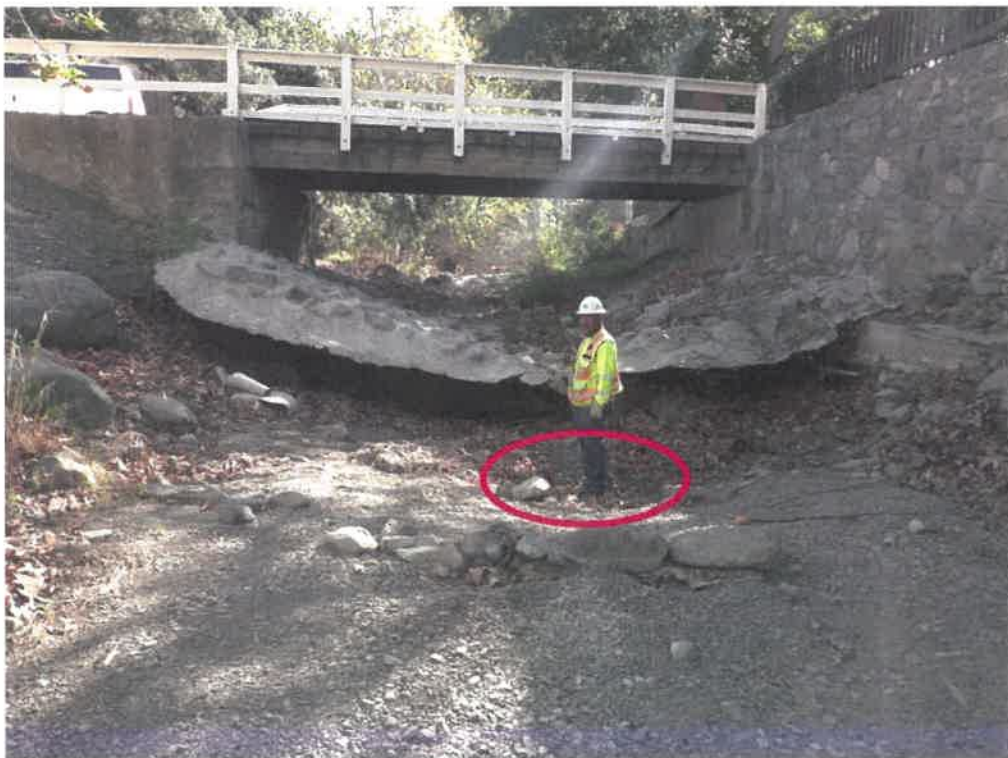
Photo No. 4

The channel bed is degraded in front of the grouted channel bed, 20 feet wide X 3 feet deep. (see the attached photo no. 4)

The channel bed is degraded in front of the grouted channel bed 20' dia. X 3' Deep.
