**Bridge Report Transmittal Sheet****Batch 41392****County of Orange**

**Bridge Number** : 55C0177  
**Facility Carried**: SILVERADO CANYN RD  
**Location** : 4.4 MI. E/O SANTIAGO ROA  
**City** :  
**Inspection Date** : 12/15/2017

**Bridge Inspection Report**
**Inspection Type**

**STRUCTURE NAME:** SILVERADO CANYON CREEK

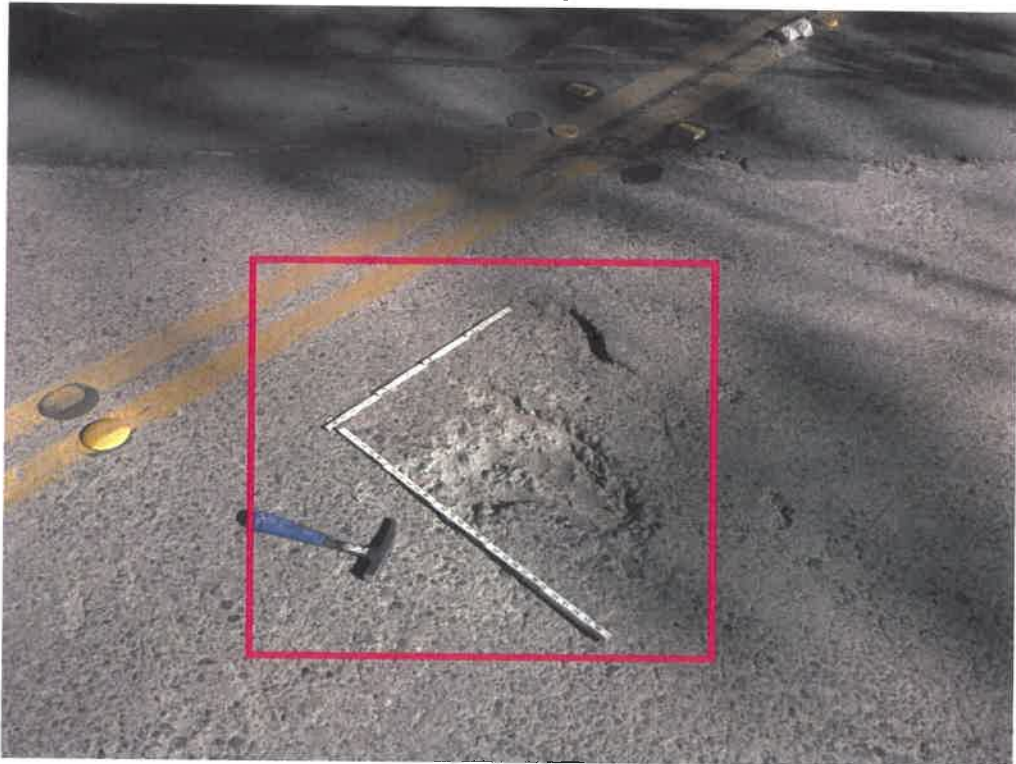
Photo No. 1

<b><u>ELEMENT INSPECTION RATINGS AND COMMENTARY</u></b>									
<b>Elem No.</b>	<b>Defect /Prot</b>	<b>Element Description</b>	<b>Env</b>	<b>Total Qty</b>	<b>Units</b>	<b>Qty in each Condition State</b>			
						<b>St. 1</b>	<b>St. 2</b>	<b>St. 3</b>	<b>St. 4</b>
12		Deck-RC	2	105	sq.m	39	50	16	0
	1080	Delamination/Spall/Patched Area	2	1		0	0	1	0
	1120	Efflorescence/Rust Staining	2	10		0	10	0	0
	1130	Cracking (RC and Other)	2	55		0	40	15	0
	1190	Abrasion (PS Conc./RC)	2	2		2	0	0	0
(12-1080)									
There are two spalls 15 inches X 10 inches X 2 inches in the eastbound direction at 3 feet from the east end; and around these spalls, there is an unsound concrete area 4 feet X 3 feet. (see the attached photos no. 1 and 2)									
(12-1120)									
The soffit exhibits:

Deck spall and unsound area 3 feet X 2 feet at 3 feet from east end , eastbound lane.

Repair the deck spall 15 inches X 10 inches X 2 inches in the eastbound direction at 3 feet from the east end; and around this spall, there is an unsound concrete area 4 feet X 3 feet.

Clean and seal the deck cracks with methacrylate.

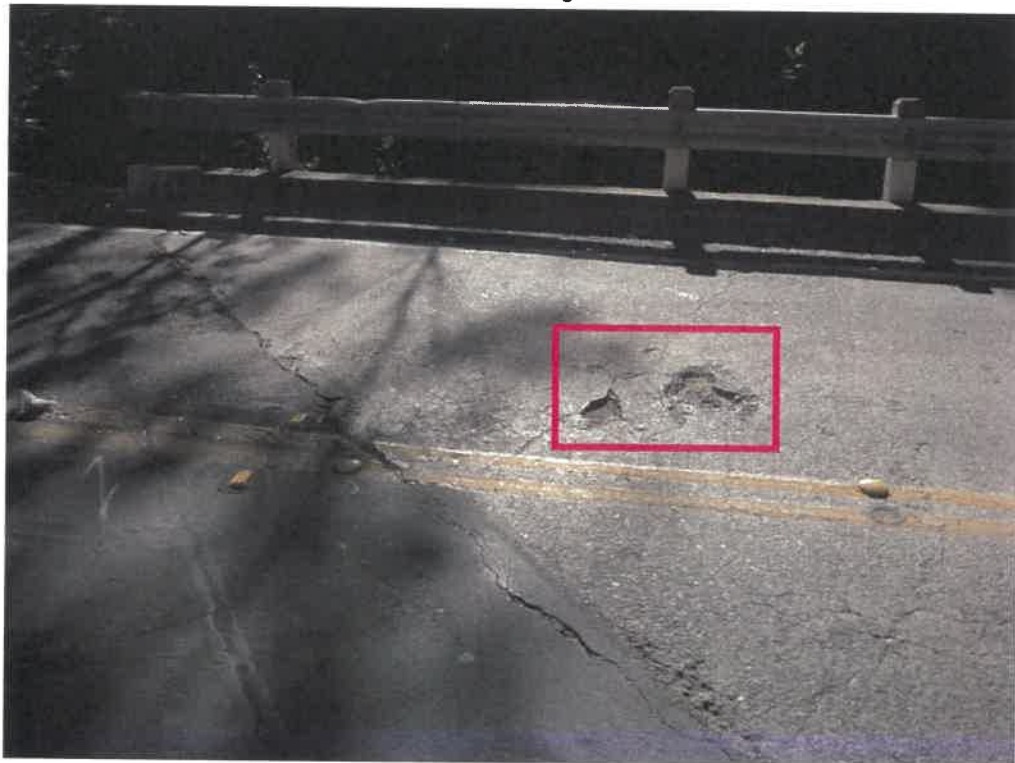
Photo No. 2

Deck spall and unsound area 3 feet X 2 feet at 3 feet from east end , eastbound lane.

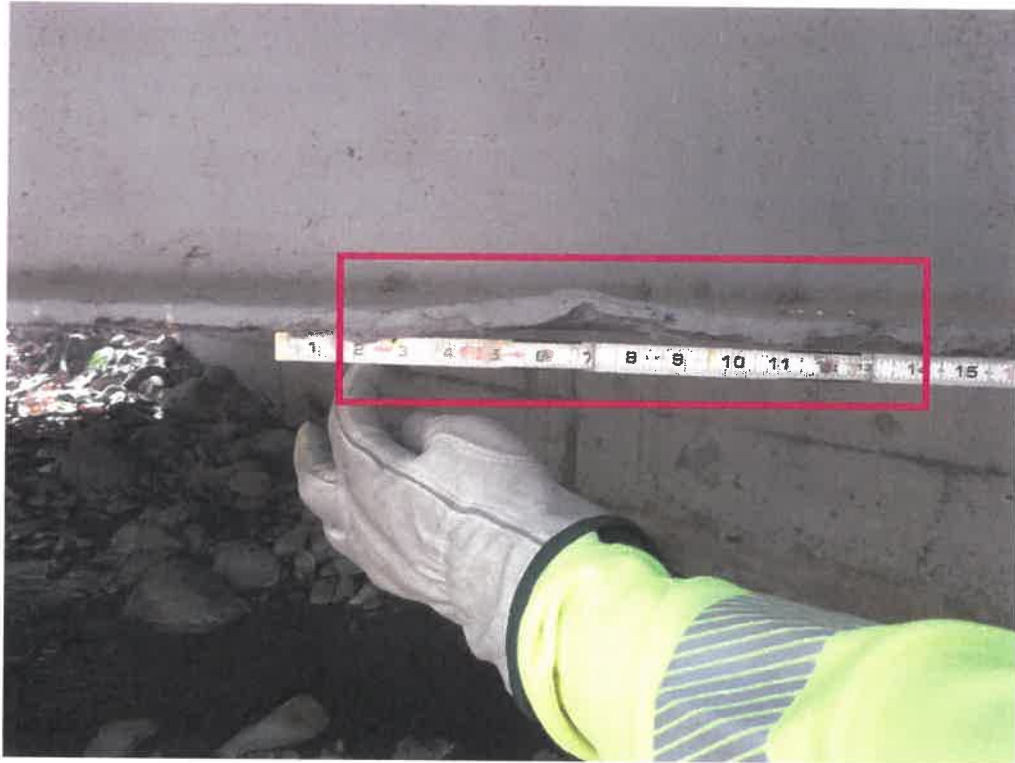
Photo No. 3

Elem No.	Defect /Prot	Defect	Element Description	Env	Total Qty	Units	Qty in each Condition State			
							St. 1	St. 2	St. 3	St. 4
	515		Steel Coating-Paint	2	116	sq.m	64	26	20	6
		3440	Effectiveness (Steel PC)	2	52		0	26	20	6
(107-1000)										
The steel girders exhibit pitting rust the surface.										
(107-1900)										
Steel girder #1 (north girder) exhibits 3 inches dent at the bottom flange at 10 feet from the west abutment. (see the attached photo no. 3)										
(107-515-3440)										
The paint system is failed especially at the the bottom flange of all girders.										
	215		Abutment-RC	2	24	m	22	2	0	0
	1130		Cracking (RC and Other)	2	2		0	2	0	0
(215-1130)										
The concrete Abutments have few vertical cracks, up to 0.05 inches wide.										
	312		Bearing-Enclosed	2	2	each	2	0	0	0

3 inches dent at the girder 1.
