**Bridge Report Transmittal Sheet****Batch 41392****County of Orange**

Bridge Number : 55C0178  
Facility Carried: SILVERADO CANYN RD  
Location : 4.9 MI. E/O SANTIAGO ROA  
City :  
Inspection Date : 12/15/2017

## Bridge Inspection Report

**STRUCTURE NAME:** SILVERADO CANYON CREEK

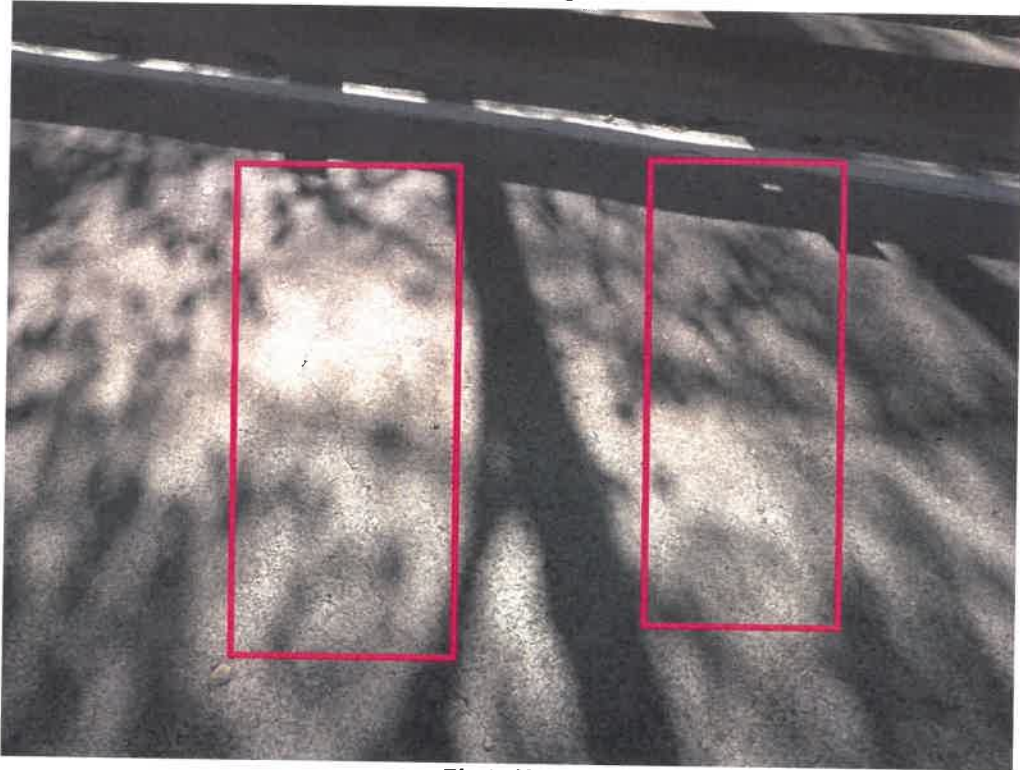
Photo No. 1

102 - PHOTO-Deck-Damage/Deterioration

Deck transverse cracks.

RecDate: 07/12/2011      EstCost:      Seal the deck cracks with methacrylate.  
 Action : Deck-Methacrylate      StrTarget: 2 YEARS  
 Work By: LOCAL AGENCY      DistTarget:  
 Status : PROPOSED      EA:
