**Bridge Number** : 55C0179  
**Facility Carried**: SILVERADO CANYN RD  
**Location** : 5.4 MI E/O SANTIAGO CYN  
**City** :  
**Inspection Date** : 12/15/2017

**Bridge Inspection Report**

**STRUCTURE NAME:** SILVERADO CANYON CREEK

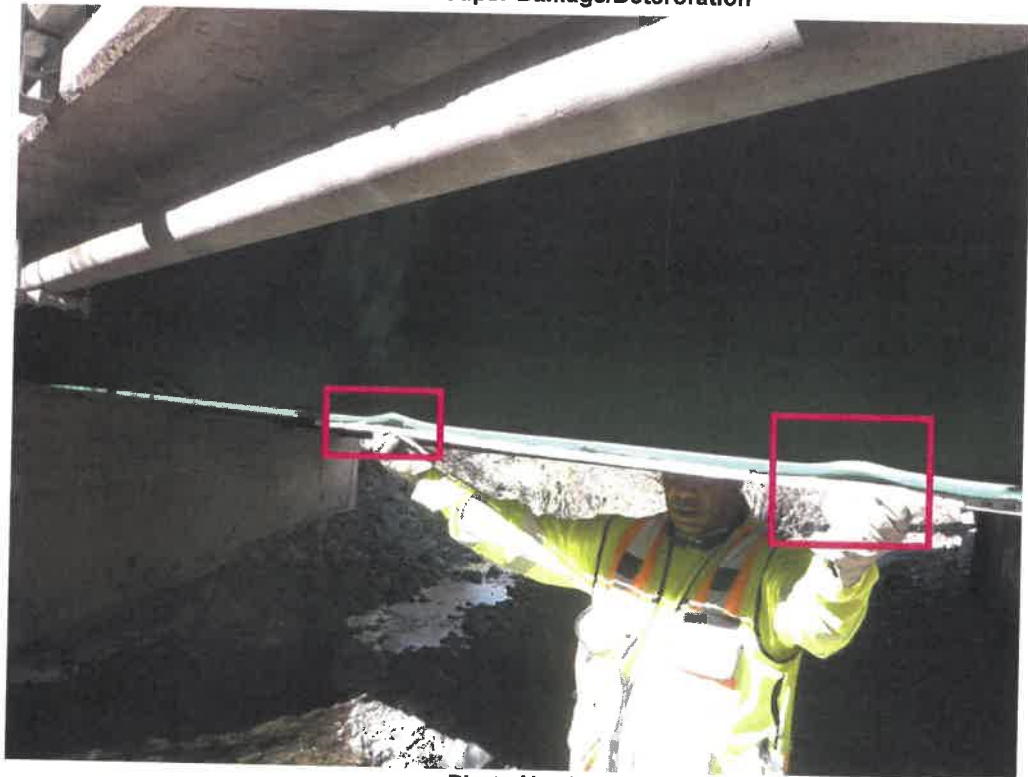
Photo No. 1

In steel girder #4 (south), the bottom flange is damaged and bent at three different locations at mid-span, the total length of this deterioration is 18 inches total. (see the attached photo no. 1)

Dents at girder #4.
