Bridge Report Transmittal Sheet

Bridge Number : 55C0180
 Facility Carried: SILVERADO CNYN RD
 Location : 2.7 MI E/O SANTIAGO ROAD
 City :
 Inspection Date : 12/15/2017

Bridge Inspection Report

STRUCTURE NAME: SILVERADO CANYON CREEK

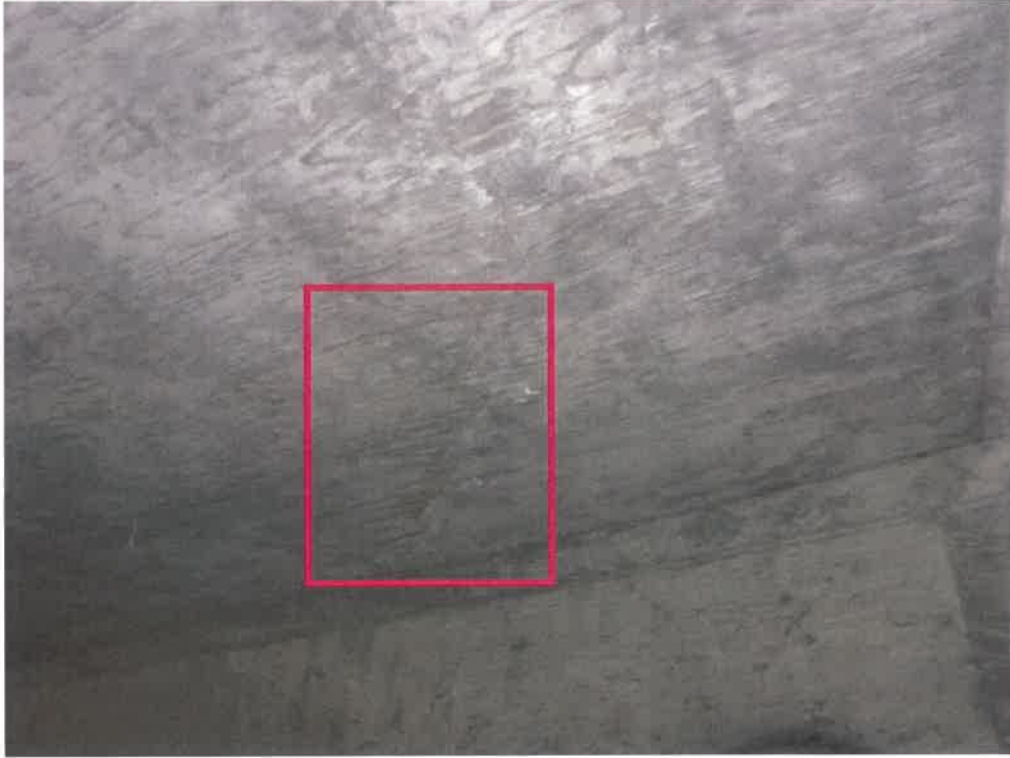
Photo No. 1

There are three longitudinal and two diagonal cracks on the soffit near both abutments, up to 8 feet long with light brown efflorescence. (see the attached photo no. 1)

Diagonal and longitudinal cracks with white and brown efflorescence.
